Horton Kirby Ground Water Treatment Works, Ray's Hill, Horton Kirby, Kent; A Historic Building Recording and Archaeological Watching Brief Report

AOC Project No: 32047

Site Code: WRH11

Date: December 2011

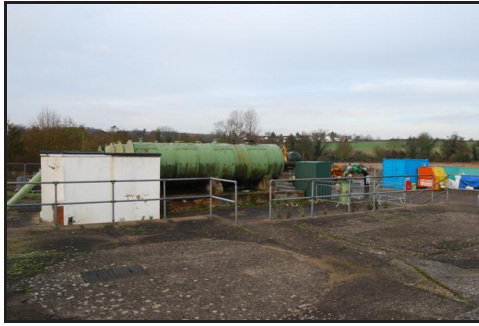
Plate A. General Shot of Tanks Looking West

- 6.1 The five historic contact tanks are located centrally within the modern water treatment works complex, which is surrounded by grassland associated with the Darenth river valley (Figure 2; Plates A and B).

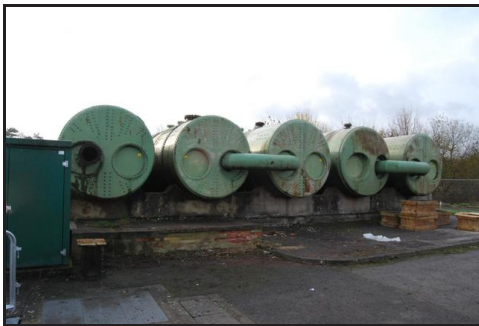
Plate C. Northwest Elevation of Tanks Looking South

- 6.2 The five tanks are uniformly positioned side by side, each separated by a distance of between 0.50m to 0.60m, with the long-axis of the group orientated northeast-southwest (Figure 3; Plates C and D). The tanks are linked in series by short sections of pipe work which adjoin adjacent tanks, alternating between the northwest and southeast elevations. In/out flow pipes are located on the southeast elevation of Tank 1 and the northwest elevation of Tank 5.

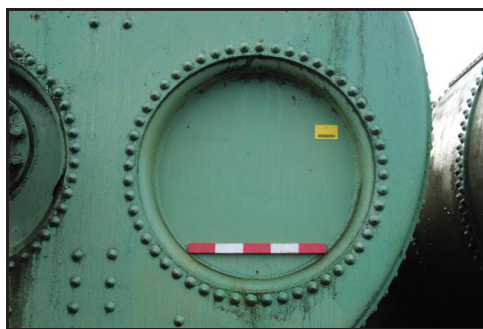
Plate E. Detail of Sealed Opening Tank 5
Northwest Elevation Looking Southeast

- 6.5 The five tanks were, in general, all of a similar form, consisting of a cylindrical design sealed at both ends. Each tank was 9.10m in length by 2.50m in diameter, constructed from sections of steel rings 1.20m in length and steel end plates 2.60m in diameter to the southeast elevation and 2.30m in diameter to the northwest elevation (Figures 3, 4 and 5). All structural elements of the tanks had been riveted together and all external steel surfaces had been treated with a green anti-corrosion paint. A consistent feature shared by all five tanks were two large openings at each end, 0.80m in diameter to the northwest elevation and 0.95m in diameter to the southeast elevation, which had been sealed using welded plates (Plates E and F). The 0.45m diameter pipes linking the tanks had welded attachments to these plates. Other common features include the presence of bolted attachments set within oval frames at the southeast base of each tank (Plate G), and with the exception of Tank 2, the decorative use of rivets on the northwest and southeast elevations.

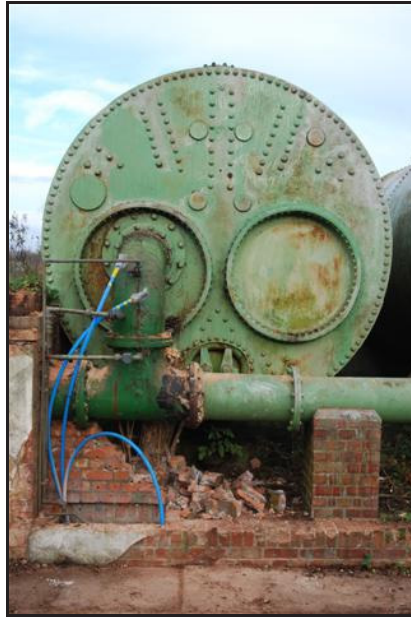
Plate H. Tank 1 Southeast Elevation Looking Northwest

- 6.6 Further analysis of the tanks revealed three different designs which were primarily differentiated by their southeast elevation (Figure 4). Tanks 1 and 3 were of the same design containing protruding rims to the large sealed openings, four vertically capped pipes on the roof of the tanks, six smaller openings on the upper elevation which had been capped and welded, plus a distinctive pattern of decorative rivets (Plate H). Apart from the standard paired rivet sequence, the rivet pattern incorporates a single circumference ring, with the bolted attachments framed by rivets and crowned by a pyramidal rivet set. Tank 3 contained two features which differentiated it from its twin: a

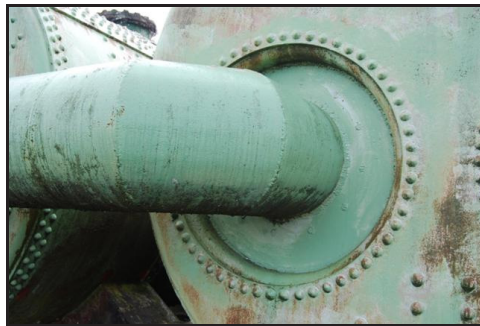
Plate I. Tank 3 Detail of Sealed Opening Northwest Elevation Looking East

vertically set pipe and valve attached to the underside of its southeast elevation and the sealed holes in the plate set within the large northeast circular opening on the northwest elevation (Plate I).

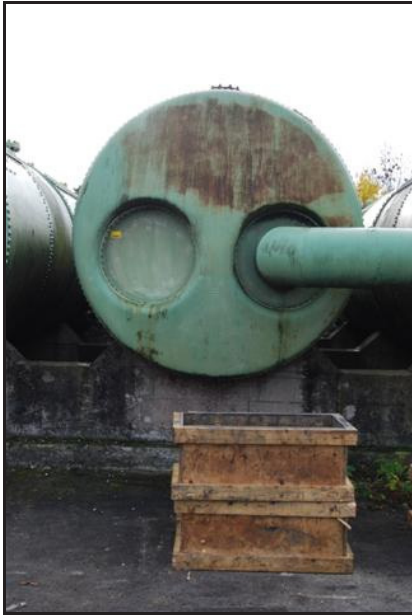
Plate J. Tank 2 Northwest Elevation Looking Southeast

- 6.7 Tank 2 was unique in its form, with the main distinction being the use of concave instead of flat end plates (Figures 3 and 4; Plates J and K). The design of Tank 2 did not incorporate any decorative rivet patterns, although it did possess two vertically capped rising pipes, while the southeast elevation contained protruding rims to the large sealed openings, three smaller capped and welded openings to the upper elevation, and a vertically set pipe and valve attached to the underside of the tank.

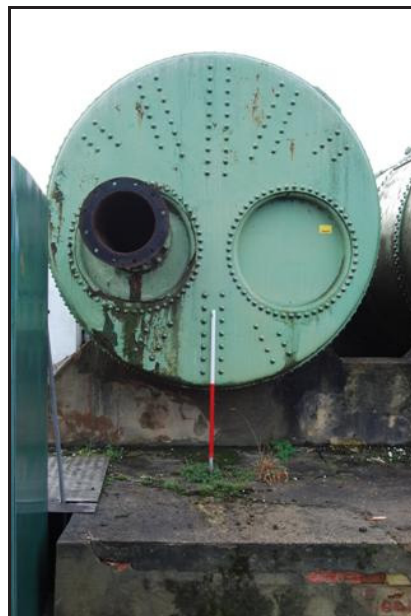
Plate L. Tank 5 Northwest Elevation Looking Southeast

- 6.8 Tanks 4 and 5, the northeast most of the group, were of identical construction (Figures 3 and 4; Plates L and M). Four vertically capped pipes were located on the roof of the tank with the southeast elevation contained five smaller capped and welded openings to the upper elevation. The rivet pattern on the southeast elevation distinguished itself due to the single circumference ring of rivets around the large sealed opening and double circumference ring around the tank edge and bolted attachments. The two tanks were linked at the base of the southeast elevation by a 0.12m diameter pipe.

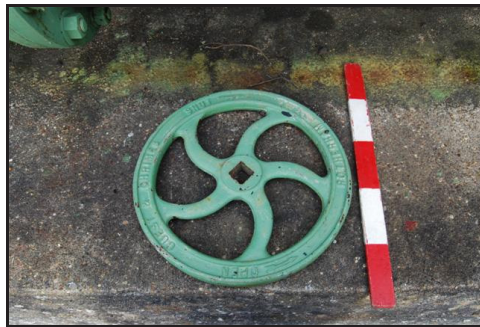
Plate N. Detail of Handle

- 6.9 An additional feature identified during the survey was the detached circular valve handle lying adjacent to the tanks (Plate N). It too had been treated with the same green anti-corrosion paint as used on the tanks. The lettering 'GUEST & CRIMES' and 'ROTHERHAM' was moulded into the handle's design. The valve handle is thought to be associated with valves set below the southeast elevations of either Tank 2 or 3.

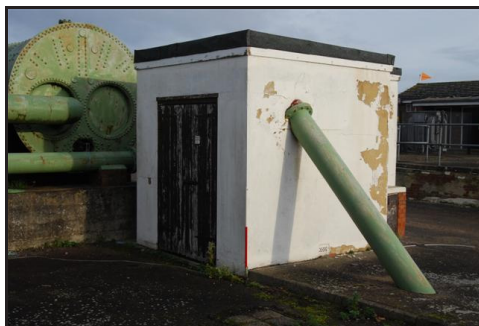
Plate O. Eastern Kiosk Looking Northeast

- 6.10 Immediately surrounding the five tanks were five kiosks of varying design and age. The earliest kiosk design used rendered brick, with the later designs made of fibre glass (Plates O and P). These kiosks were used to house valves, monitoring and dosing equipment used in the treatment of ground water.

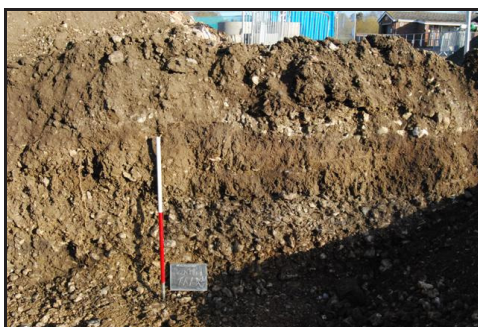
Plate Q. Trench 1 Sample Section Looking Northeast

- 7.1.2 Trench 1 was located in the central area of the site, orientated northwest-southeast and measured 10.50m by 7.50m (Figures 2 and 6; Plate Q).

7.1.3 The earliest deposit encountered was a loose, brown, natural silty flinty gravel (103) identified at a height of 25.15m AOD. Natural gravel (103) was overlain by a firm, mid brown, clayey silt soil horizon (102), 0.60m thick. Above context (102) was a layer of firm, brown, clayey silt made ground (101) which contained frequent flint and measured up to 0.30m thick. The layer as a whole appeared highly disturbed. Sealing the sequence was a soft, dark brown, clayey silt organic made ground deposit (100) 0.20m thick, which was interpreted as a horizon of imported topsoil.

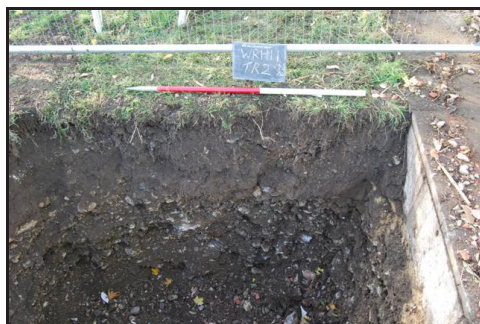
Plate R. Trench 2 Sample Section Looking Southwest

7.2.2 Trench 2 was located in the southeast area of the site, orientated northwest-southeast and measured 2.10m by 1.30m (Figures 2 and 7; Plate R).

7.2.3 The earliest deposit identified in Trench 2 was a loose, brown, natural silty flinty gravel (202) recorded at a height of 25.68m AOD. Overlying natural gravel (202) was a firm, mid to dark brown, clayey silt soil horizon (201), 0.35m thick. Sealing the sequence was a soft, dark brown, clayey silt deposit (200) thought to be an imported topsoil horizon. Context (200) was 0.30m thick.

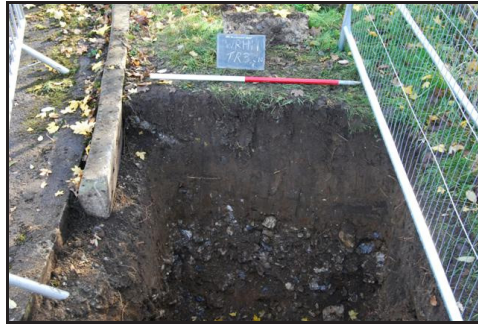
Plate S. Trench 3 Sample Section Looking Southeast

7.3.2 Trench 3 was located in the central southern area of the site, orientated northwest-southeast and measured 2.10m by 1.30m (Figures 2 and 7; Plate S).

7.3.3 The earliest deposit observed was a loose, brown, natural silty flinty gravel (302) recorded at a height of 25.44m AOD. Immediately above the natural gravel (302) was a hard, mid brown, clayey silt subsoil horizon (301), 0.40m thick. Sealing the sequence was a soft, dark brown, clayey silt topsoil deposit (300), 0.40m thick.

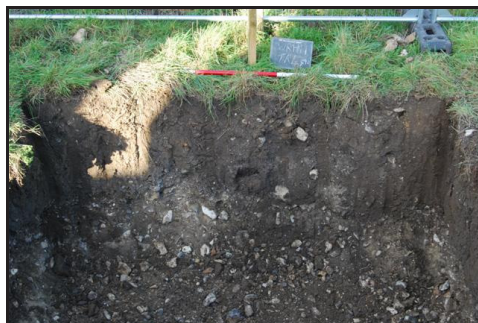
Plate T. Trench 4 Sample Section Looking Northwest

7.4.2 Trench 4 was located in the northern area of the site and measured 2.30m by 2.30m (Figures 2 and 6; Plate T).

7.4.3 The earliest deposit recorded in Trench 4 was a loose, brown, natural silty flinty gravel (402) recorded at a height of 25.34m AOD. The natural gravel (402) was overlain by a firm, mid brown,

clayey silt subsoil horizon (401), 0.35m thick. Sealing the sequence was a soft, dark brown, clayey silt topsoil deposit (400), 0.35m thick.

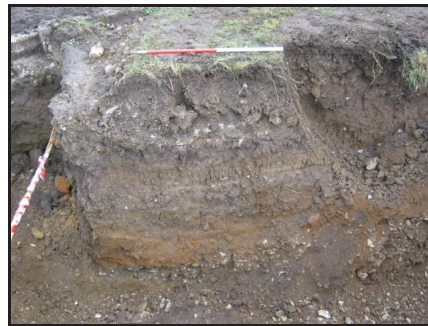
Plate U. Trench 5 Sample Section Looking Northeast

7.5.2 Trench 5 was located in the central southern area, orientated northwest-southeast of the site and measured 10m by 1m (Figures 2 and 7; Plate U).

7.5.3 The earliest deposit encountered in the trench was a loose, brown, natural silty flinty gravel (504) recorded at a height of 24.80m AOD. At the northern end of Trench 5 the natural gravel (504) was overlain by a firm, mid brown, sandy clay horizon (503), 0.30m thick, for a distance of 3.40m. Located above clay horizon (503) and occupying the full area of the trench was a firm, mid brown, clayey silt soil horizon (502), 0.50m thick. Overlying soil horizon (502), restricted to a distance of 2.90m in the northern end of Trench 5 was layer of firm, dark brown, clayey silt material (501) interpreted as a buried topsoil deposit measuring up to 0.15m thick. Sealing the sequence was a soft, dark brown, clayey silt imported topsoil deposit (500), 0.50m thick.

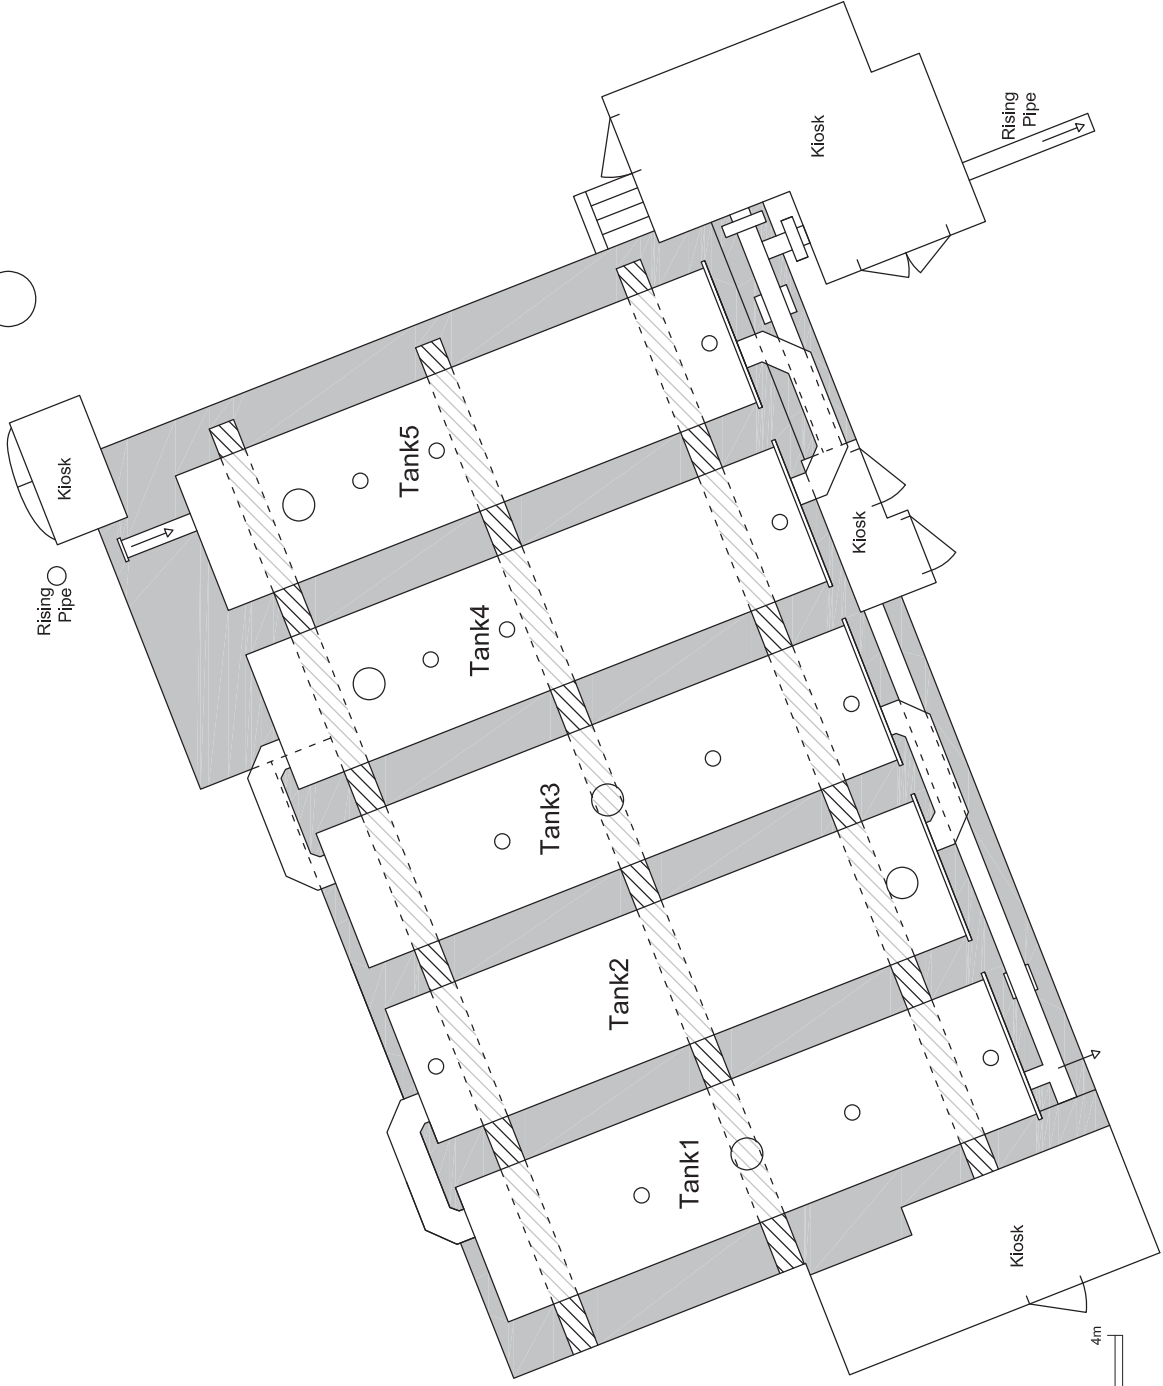
Figure 3: Plan of Contact Tanks

- Concrete Base
- Concrete Strut
- Concrete Strut Under Tank

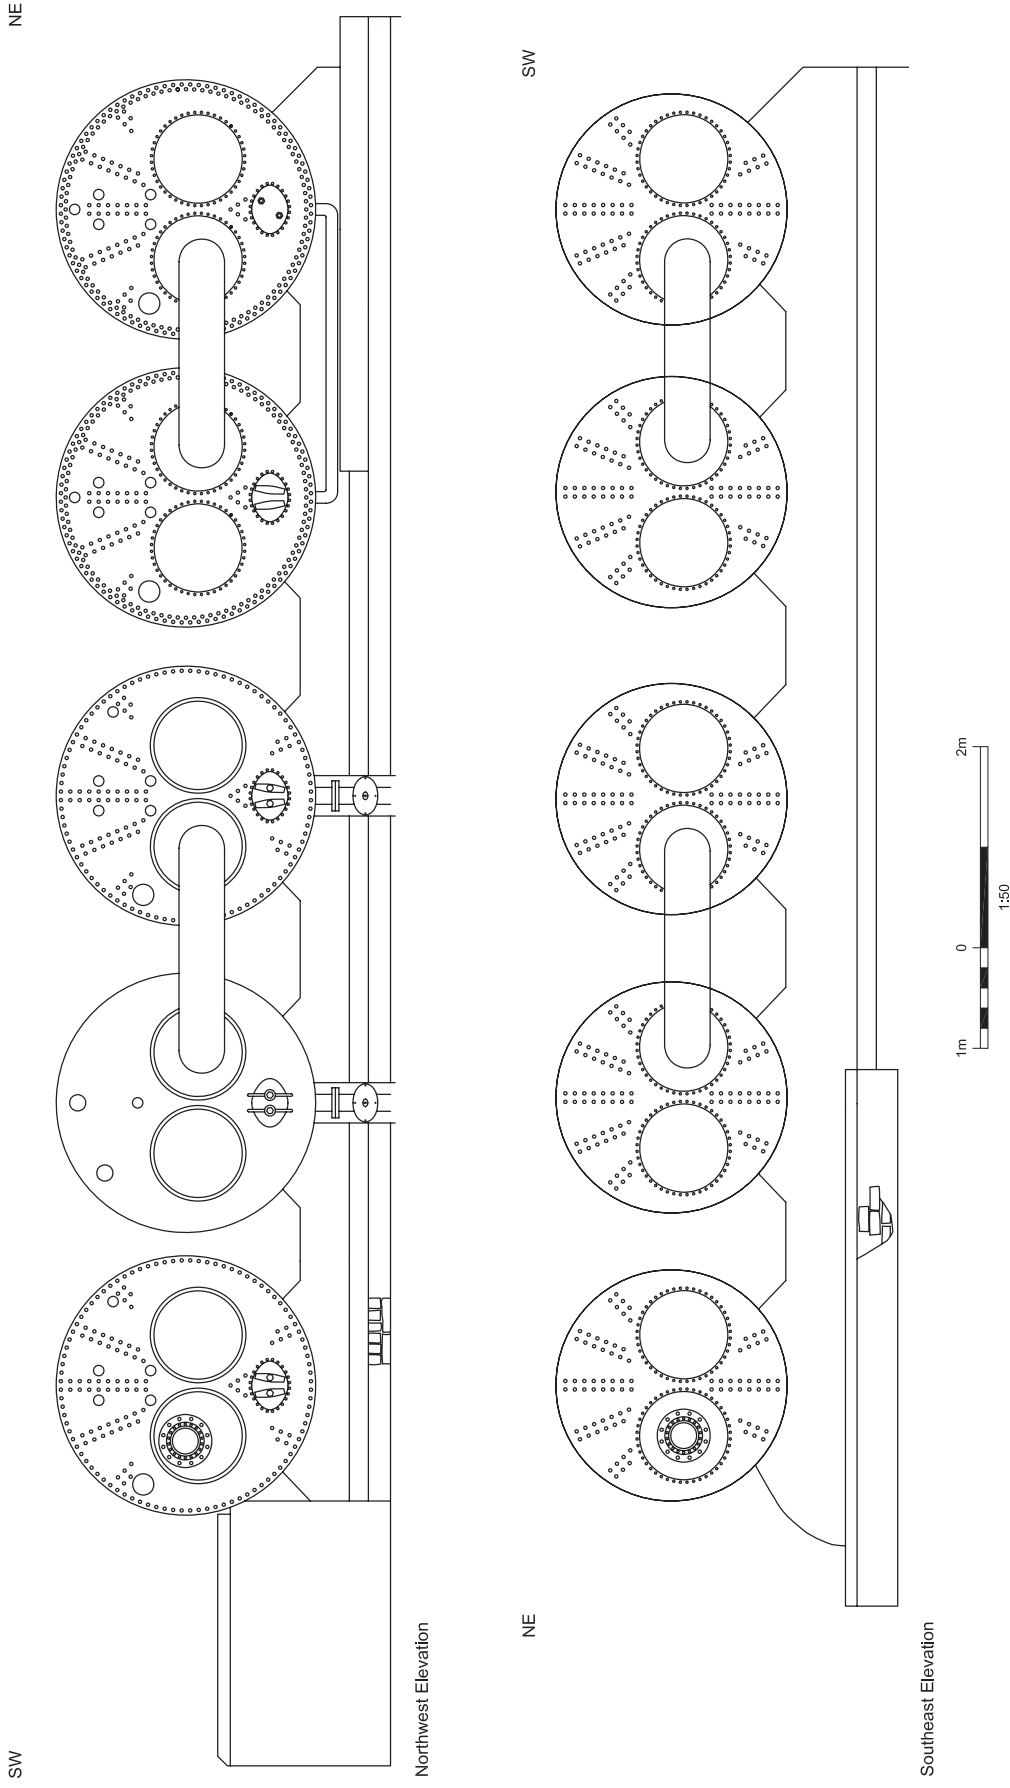
Figure 4: Northwest and Southeast Elevation of the Contact Tanks

- 6.3 The tanks are supported by a foundation pad 16.10m long by up to 11.80m wide, rising 0.50m above ground level on the northeast side of the pad (Figures 4 and 5; Plate C). A small set of stairs on the northeast side provide access to the upper surface of the foundation pad. The southwest side of the foundation pad, below Tanks 1, 2 and 3, was made from shuttered concrete, whereas the northeast side of the pad, below Tanks 4 and 5, was of rendered red brick capped with a 0.10m concrete slab. Where the brickwork was visible the bricks measured 220mm by 110mm by 65mm, and were laid in stretcher courses using a cement mortar.
- 6.4 Built on top of the foundation pad were three parallel rows of tank supports, set at 3.20m intervals. The supports set the base of the tanks 0.60m above the upper surface of the foundation pad. Those
