# Clifton Hall School, Newbridge, Watching Brief: Data Structure Report

AOC 21893

Planning Reference No. 11/00865/FUL

29<sup>th</sup> July 2011

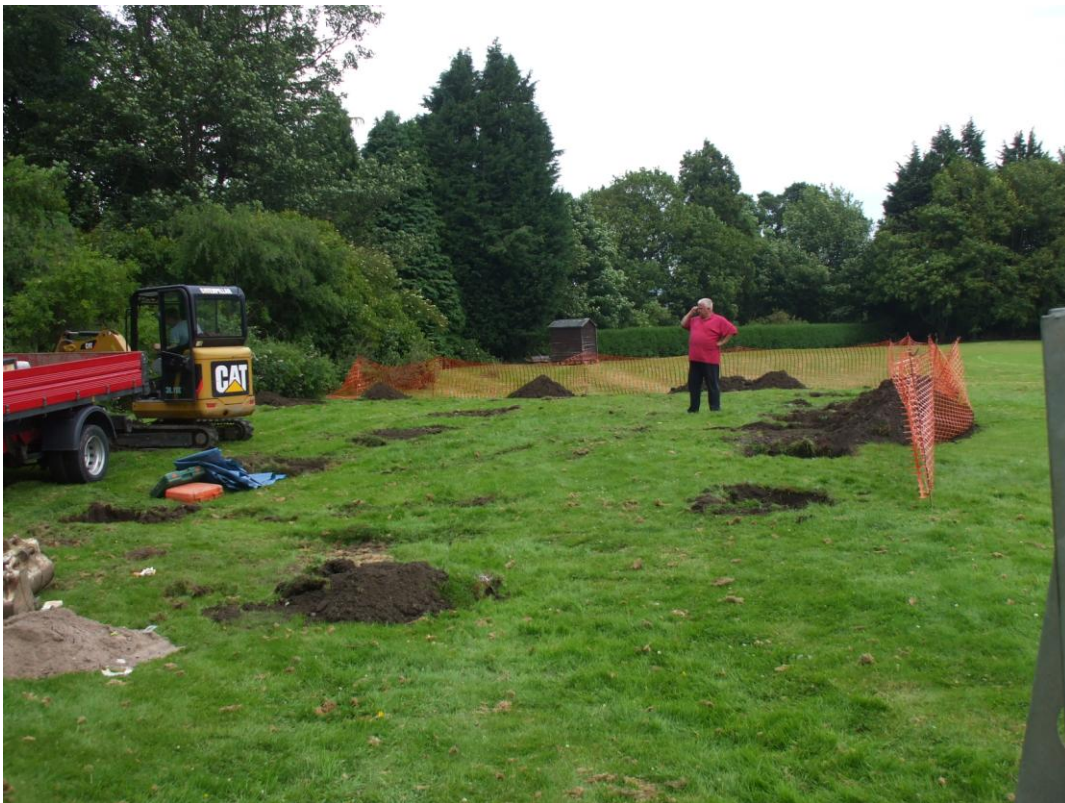
Plate 1 – Foundation pad excavations for temporary building from south

- 4.2 Twenty foundation pads were excavated over the footprint of the temporary building (Figure 2). The pads varied in size between 0.8 m square and 1.3 m square, and were generally between 0.5 m and

0.6 m in depth beneath the present ground surface, with a single pad (the south-easternmost) excavated to a depth of 1.0 m. The area presently comprises a hummocky area of playing field. Generally between 0.2 m and 0.3 m of modern topsoil, comprising dark grey sandy clay silt with moderate small stone inclusions, overlay between 0.1 and 0.4 m of levelling or madeground deposits (often not bottomed) which most commonly comprised fairly loose topsoil material, with occasional patches of rubble and ashy dumped material. The original, undisturbed and therefore more compact, topsoil was visible occasionally at a depth of between 0.37 m and 0.55 m below the present day surface, in particular within foundation pad excavations in the south of the temporary building footprint. This material was not bottomed. The occasional presence of frogged brick and 19<sup>th</sup>/20<sup>th</sup> century pottery within the deposits underlying the modern topsoil indicates that the playing field area has seen substantial dumping and movement of material in the recent past.

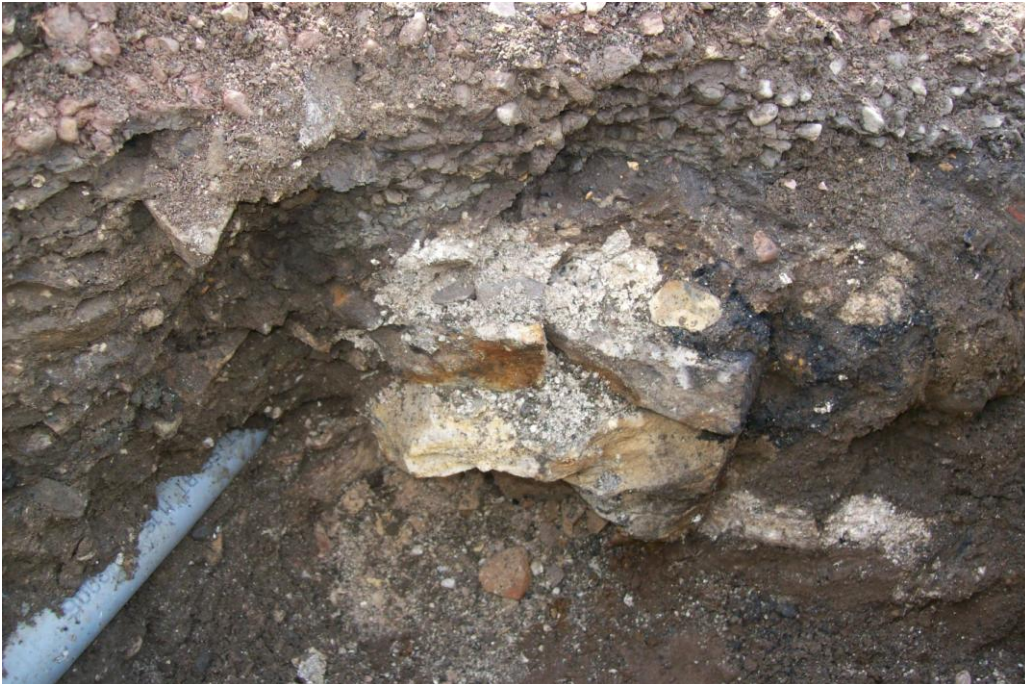
Plate 3 – Wall in Service Trench 2

- 4.4 The second service trench extended from the new assembly hall on a more south-easterly route for 43 m and measured 0.3 m wide and varied from 0.75 m in depth for the first 20 m from the new hall to 0.6 m thereafter. The topsoil was seen to have a depth of 0.75 m within this trench. Where the trench left the grass area and was dug through the hard standing surrounding the main school building the remains of a small wall were located (Plate 3). This wall had been previously damaged by the laying of telecom cables. The remains were stone built and lime mortared and appeared to be

random coursed. They were located at 0.2 m below the present surface and had a height of 0.4 m and were 0.5 m wide.

- 5.1 The deposits visible within the playing field area over which much of the groundworks were undertaken indicate that the area has been subject to substantial movement of material (most commonly topsoil) in the recent past. A single wall found in Service Trench 2 is the only archaeologically significant find; possibly the remains of a wall that once surrounded the lawn area to the north of the school buildings. No other archaeological deposits, features or small finds were encountered.
- 5.2 No further archaeological works are considered necessary.
