96 Great Guildford Street, London Borough of Southwark: A Historic Building Record

Planning Application Number: 11/APP/1688

AOC Project No: 32025

Date: February 2012

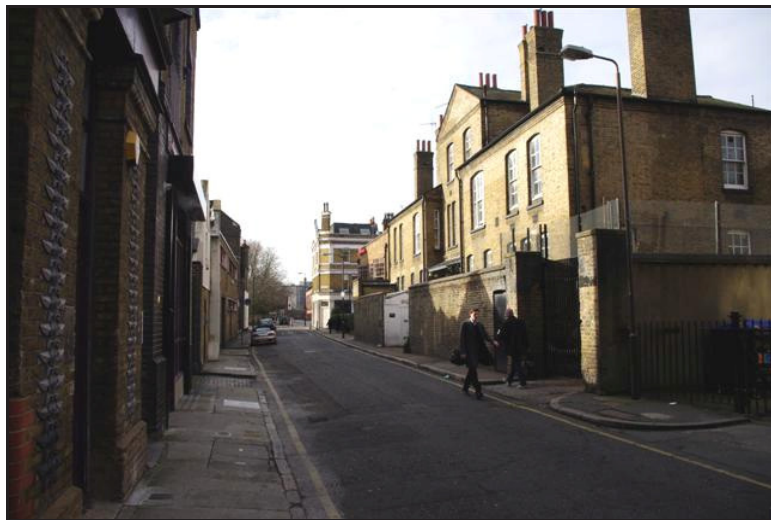
Plate 1: General View of the St. Mungo's Building Looking Southwest.

- 8.1.2 The St. Mungo's building is roughly T-shaped consisting of a northeast-southwest orientated frontage set parallel to Great Guildford Street. A northwest-southeast orientated wing runs at a right angle from the rear of the main road frontage building (Figure 2). Overall, the building measures approximately 25m northeast-southwest, by 33m southeast-northwest.

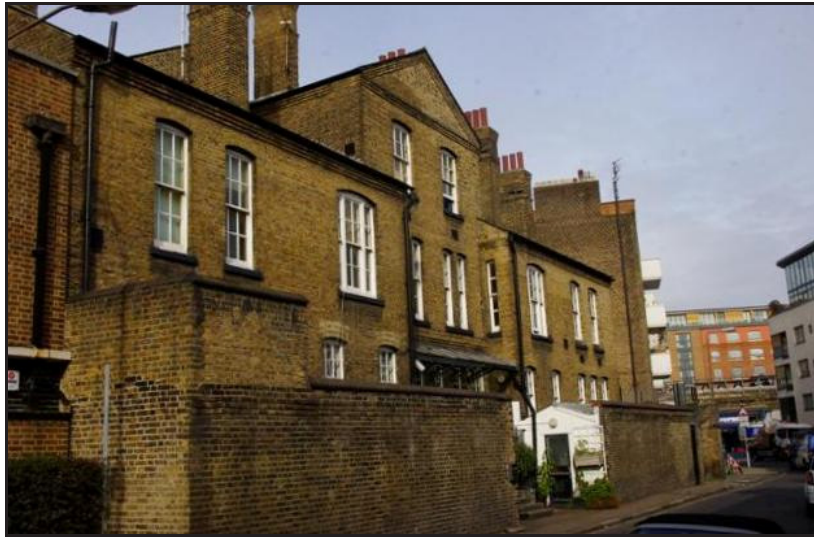
Plate 3: St. Mungo's Building Looking North

- 8.1.3 The yellow stock brick building has two to three storeys, with basement, under attic (Figures 3 to 9, Plate 3). The frontage contains five bays, with the central pedimented gabled bay containing three storeys, while the flanking bays each contains two storeys. The roof is hipped and covered using slate. Six simple brick chimney stacks are located at regular intervals to the frontage. The southeast elevation is has regular fenestration containing wooden sash windows with dressed brick cambered arches and painted stone sills. The current entrance is located on the ground floor to the southwest side of the central bay and accessed by means of plain set of concrete steps from road level leading to a simple veranda with cast iron railings. To the northeast side of the frontage is a cast iron gate facilitating access to the rear of the building. Part of elevation to the ground floor is obscured by a high wall to the street frontage.

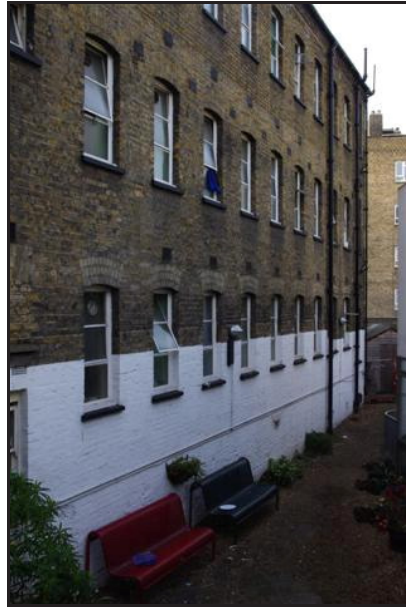
Plate 4: Northeast Elevation Looking West

- 8.1.4 The northeast, southwest, and northwest elevations are all similar, sharing the same simple architectural style as the main southeast elevation, as well as the lack of decorative features (Figure 3, Plates 4 & 5). The northeast and southwest elevations associated with the rear wing are distinctive due to the highly repetitive fenestration utilising metal casement windows, due to its relationship to the buildings accommodation section. Part of the southwest ground floor elevation is obscured due to the presence of the Phase 2 single storey extension. Alterations to the exterior fabric of the building are limited. The most substantive alteration is present to the northeast side of the northwest elevation located to the first floor. This takes the form of a small stock brick built single storey extension supported on small cast iron columns (Plate 6). Other alterations include the blocking of windows to the northwest elevation, one located to the first floor on the southeast side of the elevation, with three others located centrally to the ground floor (Plate 7). Later insertions of doors and windows have occurred in several locations to the northwest elevation, the most significant of which is related to the construction of a fire exit stairwell at the northwest end of the building. Rough patches of masonry were noted at regular intervals to the ground floor, evenly spaced between each window. The use of paint on the ground floor brick work obscured any potential detail associated with the rough masonry.

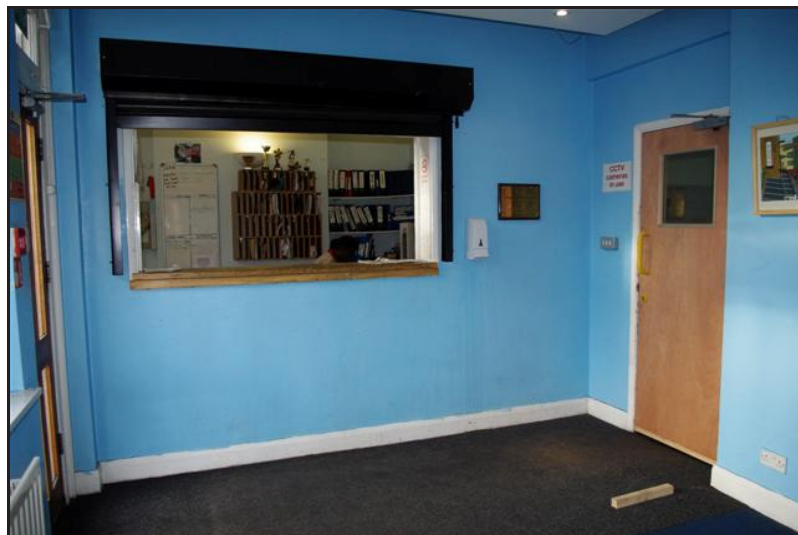
Plate 8: Room G1 Looking West

8.1.5 Internally, the function of the ground floor rooms could be divided into several groups (Figure 4). Rooms G1, G2 and G8 formed reception rooms (Plate 8); G4 to G7 were residential facilities in the form of small kitchen, lounge, medical surgery and potting shed (Plate 9); G8 to G12 office facilities (Plate 10); G16 to G24 residential accommodation (Plate 11); G13, G15, G31, G32 and G33 associated toilet and washing facilities (Plate 12); corridors G3, G14 and G30 linked these different areas. Further office space was provided by Rooms G34 to G37 located in the later Phase 2 extension to the southwest side of the building, primarily accessed through the office area G11 (Plate 13).

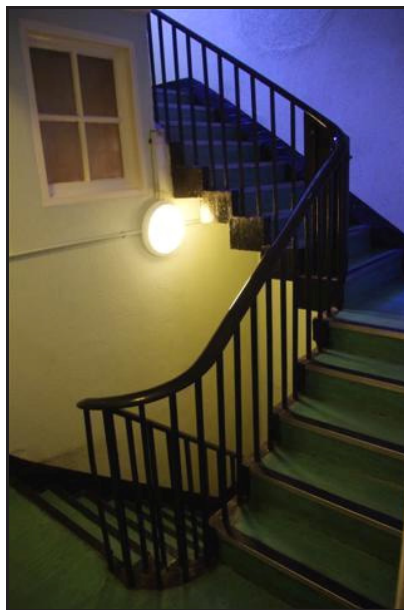
Plate 14: Southern Stairwell Looking North

- 8.1.6 Original features on the ground floor were limited due to the extensive modern refurbishment to facilitate the buildings use as a hostel. Plastered ceiling and wall surfaces and vinyl floors obscured the original building fabric throughout. All internal doors were modern replacements. The only original features identified were blocked and featureless chimneybreasts in Rooms G5, G6, G8 and G10. The parquet flooring in Room G6 is also likely to be original. Decorative features were limited to the insertion of later, Phase 2, plain skirting boards throughout the reception, resident's facilities, and office areas. All stairwells contained concrete stairs with replacement metal banisters (Plate 14).

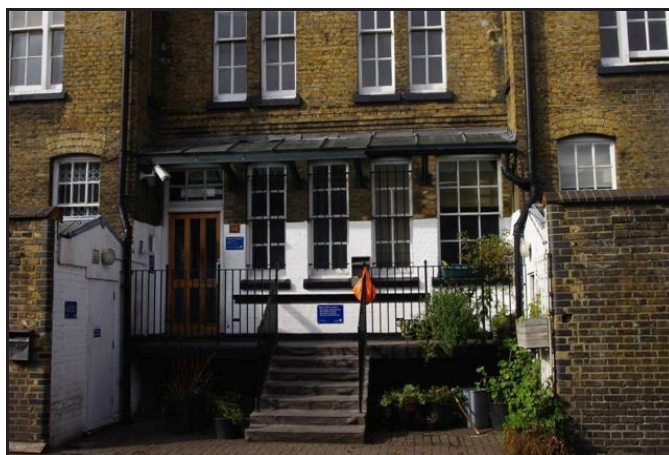
Plate 15: Detail of Southeast Elevation Looking Northwest

- 8.1.7 Later, Phase 2, alterations were evident throughout the ground floor. The most significant alterations were associated with the residential accommodation where alternate stud and brick walls had been introduced in order to subdivide each room into suitably sized single bedrooms with recessed desks and cupboards. The toilet and wash facilities had also been subdivided to create toilet and shower cubicles. The bathroom at the northwest end of the building had had a later doorway and window inserted during the instillation of an exterior metal stairwell. In the reception area the main alteration was the construction of the later veranda and the possible replacement of an external doorway in Room G2 with a six pane wooden sash window (Plate 15). Rooms G1 and G2 had been partitioned by means of a stud wall, with later internal windows inserted into the northwest and southwest walls of Room G1. Room G1 also contains a wall mounted brass plaque which reads 'ST MUNGO'S. GREAT GUILDFORD STREET. WAS OPENED BY Rt Hon HARRIET HARMAN MP SECRETARY OF STATE FOR SOCIAL SECURITY ON WEDNESDAY SEPTEMBER 10 1997' (Plate 16). In Room G10 two new doorways had been inserted, as well as a corridor stud partition in the north of the room. The wall between Room G10 and G11 had been knocked through at some point, with a later brick wall and doorway built at the northwest end of Room G11 to create further internal space. Alterations in the resident's facilities were limited to the creation of new openings in Rooms G4 and G5.

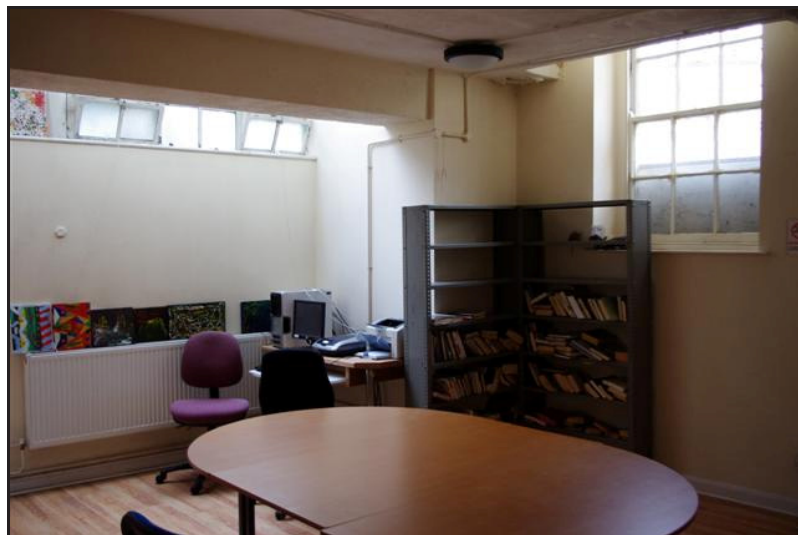
Plate 17: Room B10 Looking North

- 8.1.9 The function of the basement rooms is utilitarian in character (Figure 5). The northeast end of the basement is given over to a staff room (B10) (Plate 17), photographic darkroom (B11 and B12), laundry (B9), and toilets (B6 and B7) (Plate 18). Storage rooms dominate, consisting of Rooms B2, B3, B5, and B15 to B17 (Plate 19). The boiler room occupied Rooms B13 and B14 (Plate 20), while corridors B1 and B4 provided access to these areas, Room 8 was a sealed former light well.

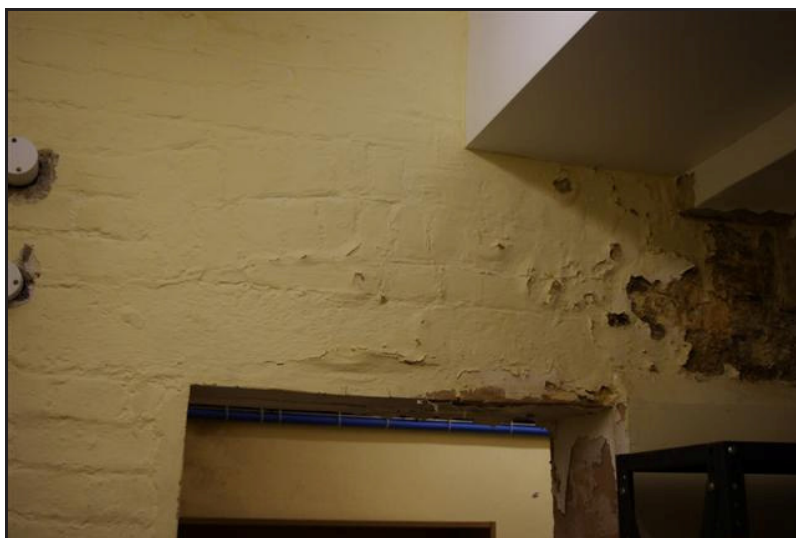
Plate 21: Partially Blocked Arch Room B2 Looking North

8.1.10 Rooms B1 to B12, with exception of B8, received the same modern utilitarian finish as observed on the ground floor, whereas Rooms B13 to B17 had received a much simpler finish, with the brickwork only receiving a coat of paint and concrete floors noted throughout these rooms. The featureless bases of chimneys are present in Rooms B10, B15, and B17, while partially blocked archways are associated with Rooms B2 and B7 (Plate 21). A partially blocked coal hole was located on the southeast wall of Room B15 (Plate 22). Structural alterations associated with Phase 2 included the insertion of steel beams in Room B13 and the knocking through of a doorway on the northeast side of Room B15. Later stud wall partitions had been inserted to separate Rooms B9, B11, B12 and B16, as well as separate corridor areas B1 and B4. A stud wall has also been constructed to separate Rooms B13 and B15. The only blocked opening encountered was on the northeast side of Room B14 which appeared to prevent access to the space beneath the stairwell.

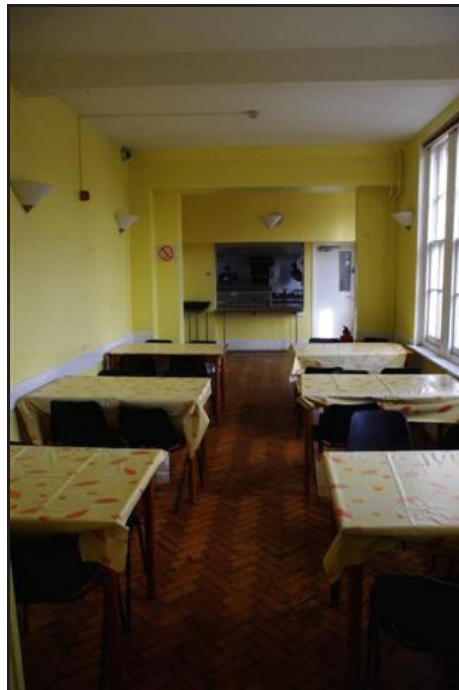
Plate 23: Room F8 Looking Northeast

- 8.1.12 As with the previous floors, original features are limited, obscured by modern fixture and fittings in all rooms. Blocked chimneybreasts or evidence for their former location are evident in Rooms F4, F7, F9 and F10, while parquet flooring survives in Rooms F7 to F9 (Plate 23).

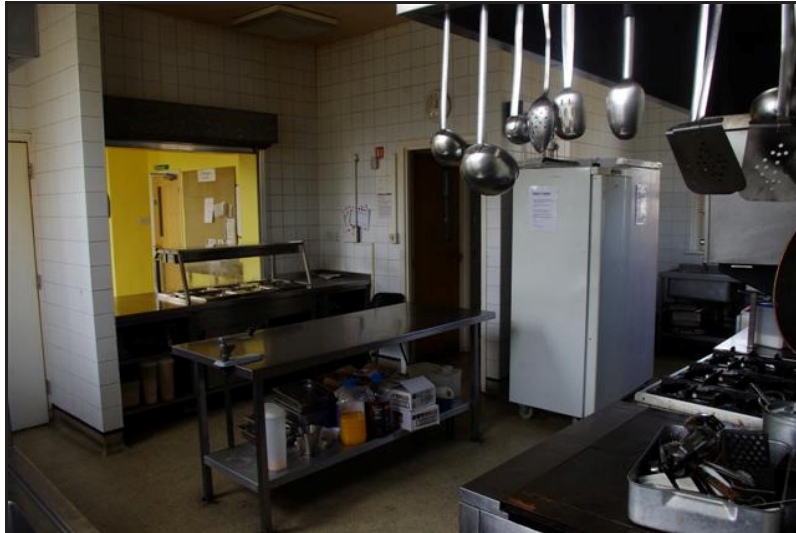
Plate 24: Room F4 Looking West

8.1.11 The layout of the first floor is similar to that of the ground floor, with the larger rooms located towards the road frontage, while the accommodation area occupies the northwest wing (Figure 6). The larger rooms are given over to catering and recreational facilities, comprising a lounge (F9), dining rooms (F7 and F8) (Plate 23), kitchen (F4) (Plate 24), and catering offices (F5 and F6). Rooms F10, F11, F16 to F21, and F23 to F29 provided residential accommodation (Plate 25), while Rooms F3, F12, F13, F15 and F22 are associated storage and toilet facilities. Corridors F1, F2 and F14 provide access to all rooms.

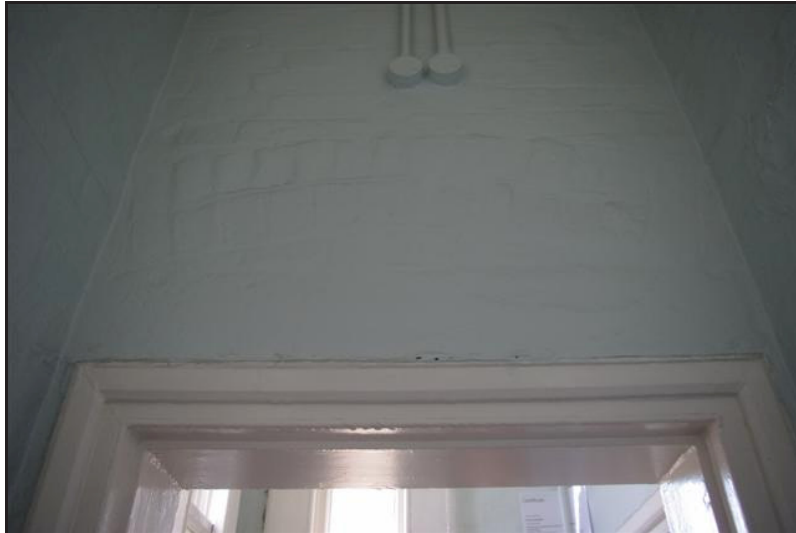
Plate 26: Detail of Window Arch Room F5 Looking Southeast

- 8.1.13 The earliest evidence for alterations to the building, those associated with Phase 1 amendments, can be identified relating to Room F5. Room F5 can be observed on the northwest elevation as a single storey extension supported from the ground floor by cast iron columns. The use of stock bricks and the manner of keyed in construction suggest the extension was built not long after the original late 19th century construction of the St. Mungo's building. To provide access to the extension the window which formerly occupied the space now occupied by the doorway leading from Room F6 was removed. A faint trace of the former window arch can be seen from inside Room F5 (Plate 26).

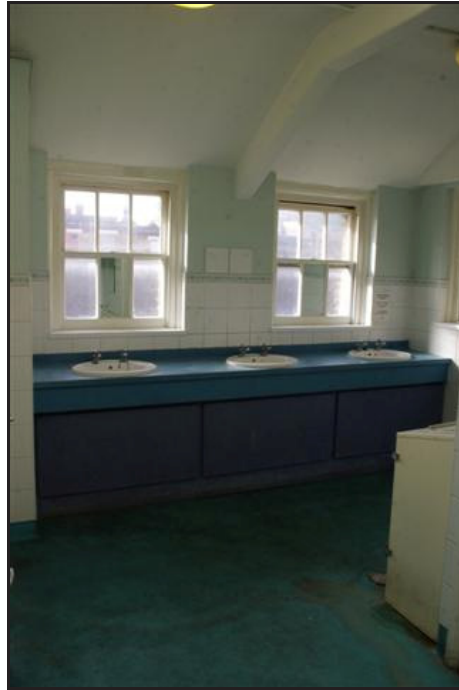
Plate 27: Room S23 Looking South

- 8.1.15 The third floor is purely given over to accommodation (Rooms S2, S4 to S13, and S17 to S22) and associated toilet and bathroom facilities (Rooms S14, S15, S16 and S23) (Plate 27) containing the same modern fixtures and fittings as seen throughout the building (Figure 7). Corridors S1 and S3 provide access to these rooms. Original features are restricted to the chimneybreasts in Rooms S24 and S3/S4. Large skylights provide external light sources to corridor S1 (Figure 9). In the northwest wing later partitions follow the same pattern as on previous floors, in addition to stud wall partitions subdividing the larger rooms at the southeast end of the building in order to make more accommodation space available. The attic space could not be accessed.

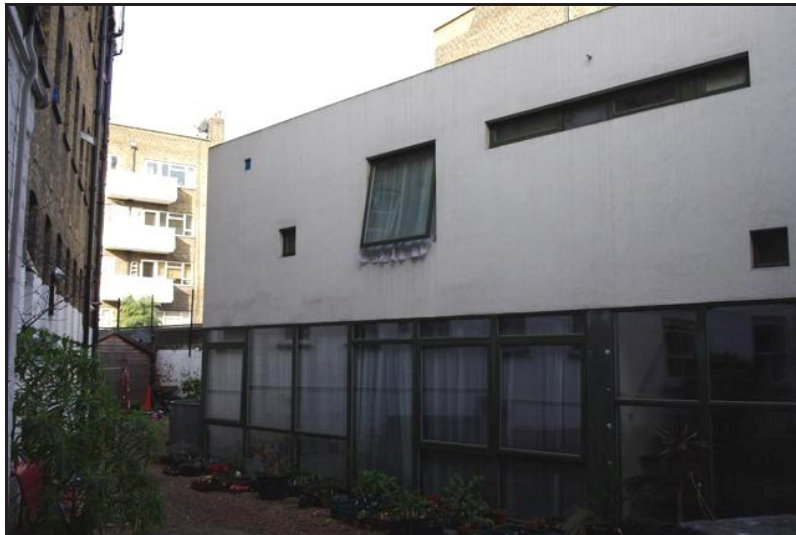
Plate 28: Modern Building to North of Main Building

8.1.16 Located immediately to the north of the St Mungo's building is a two storey, over basement, three bay auxiliary building (Plate 28). The building is metal framed with a flat roof, and currently provides self contained accommodation facilities for residents. The design of the building indicates it was constructed during the late 20th century. The boundary wall to the St Mungo's site contains numerous scars and features which relate to previously existing external storage areas.

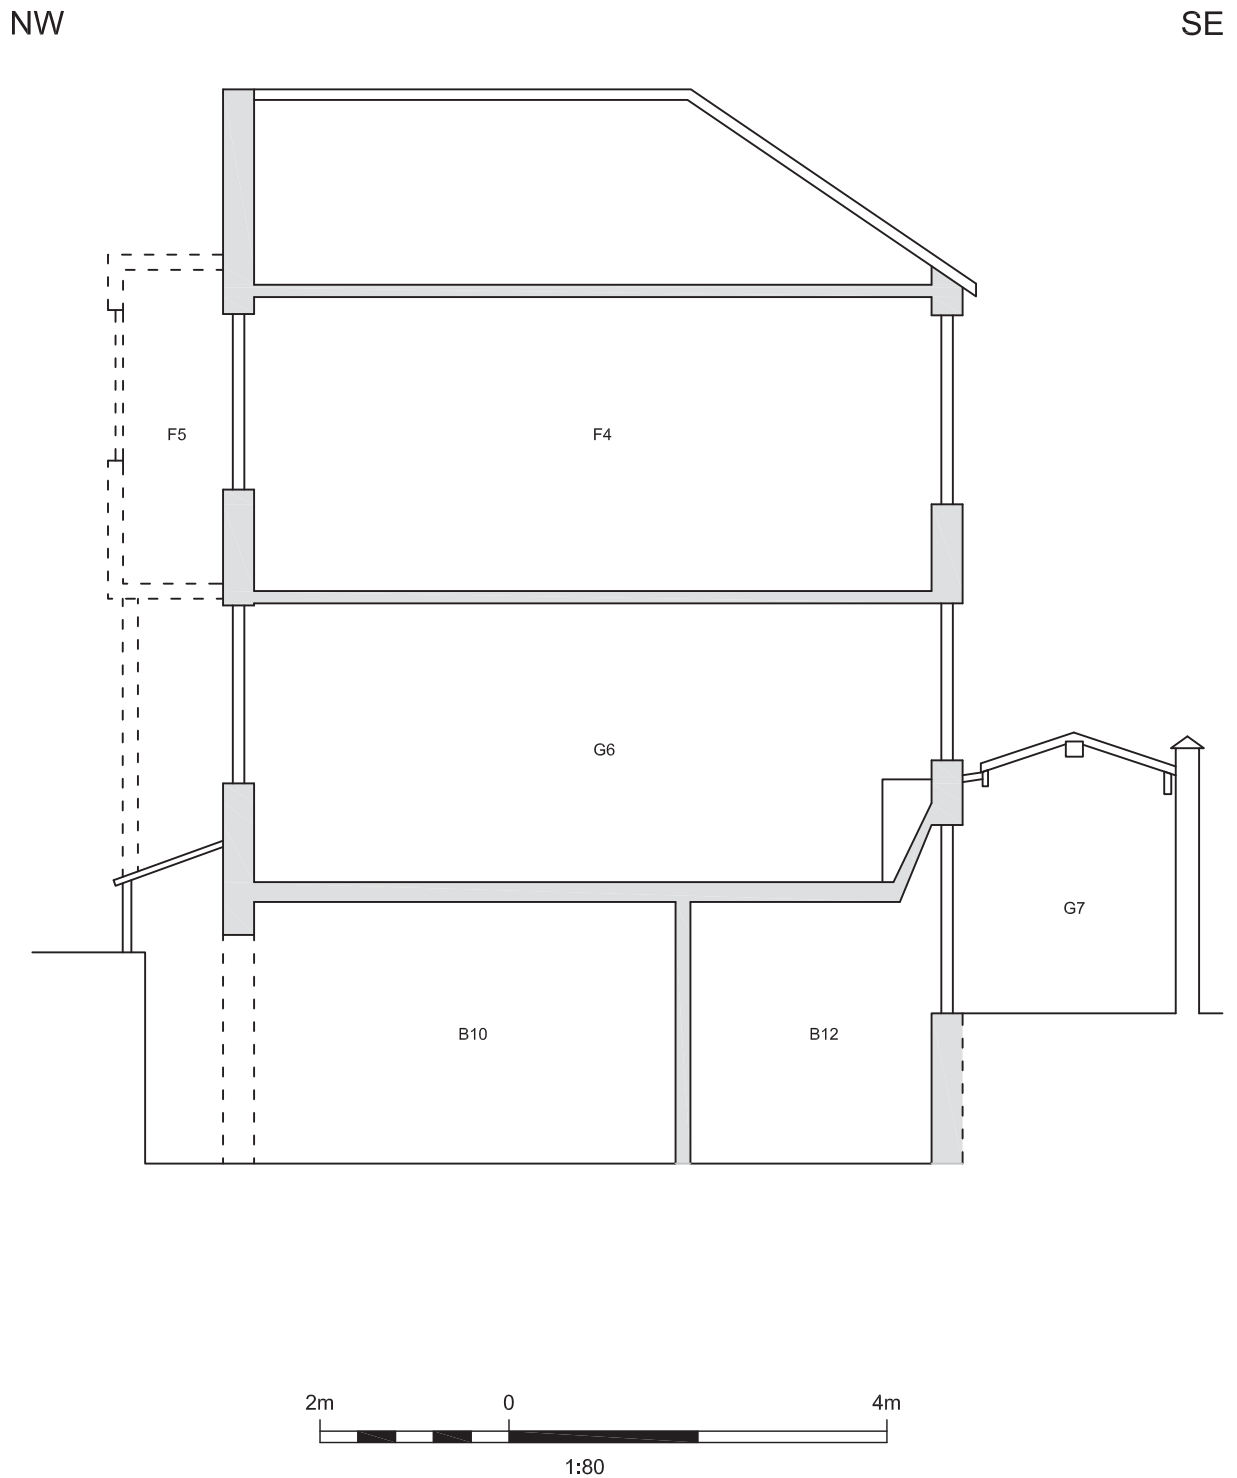
Figure 8: Cross Section 1

- 8.1.8 The most interesting element of the later alterations was the creation of further internal space by bricking up the southwest and northeast ends of Rooms G7 and G9, respectively, which used to define external yard areas. A sealed environment in both rooms was created by the addition of a glass roof supported by segmental arched, laterally spanning, cast iron beams. The floor of each room is set at pavement level, meaning they are approximately 1m lower than the established floor level within the building (Figure 8).
