26 – 31 Charlotte Square, Edinburgh: Evaluation Data Structure Report

AOC Project 21994

Planning Application No. 11/01996/LBC

18th January 2012

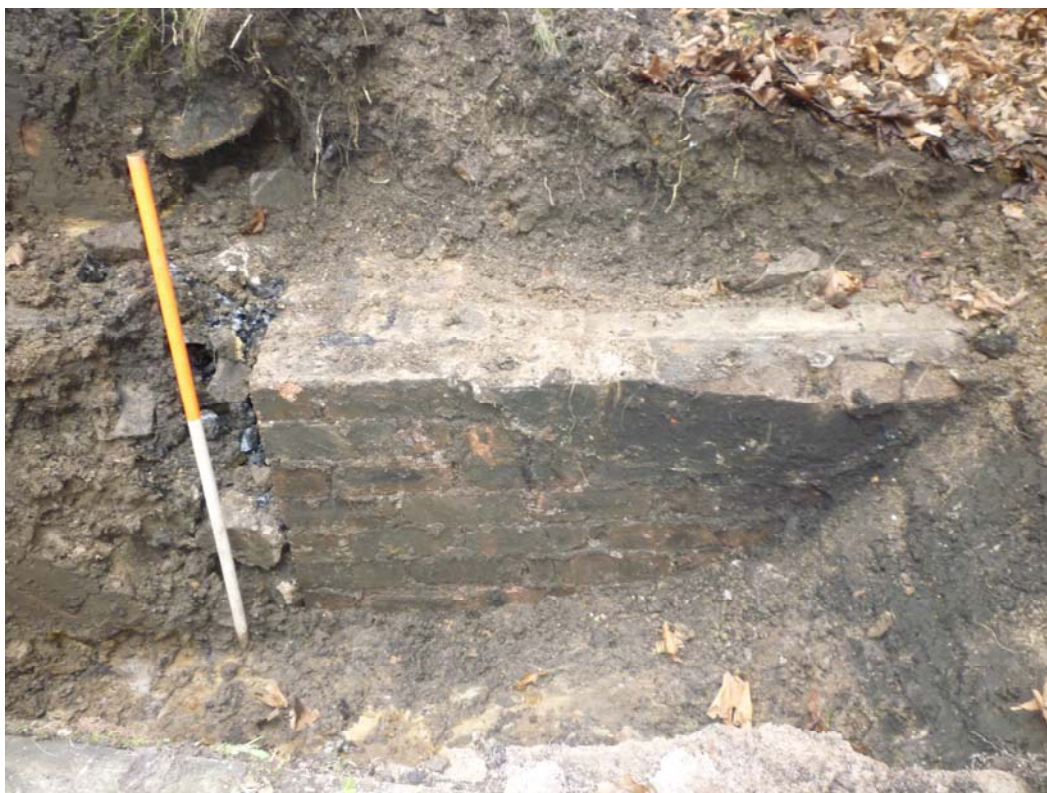
4.2.1 Trench 1 (Figures 2 and 3) was located in the west garden plot. This area was covered by turf and sloped toward the north dropping 0.7 m over a distance of 4 m. Directly underlying turf (101) was a deposit of made ground (102) consisting of loose mid brown/grey silty clay containing moderately frequent large angular stones and occasional bricks. The depth of this deposit was a maximum of 0.9 m at the southern end of the trench, reducing to 0.6 m in the north. This change in height reflected the slope of the ground surface. Cutting made ground (102) were the remains of a brick wall (103). This wall consisted of frogged bricks, laid as stretchers and bonded with mortar (Plate 5). The pointing of the brickwork was rough indicating that these were foundations. The wall extended from the northern end of the trench for a distance of 1.4 m at which point it turned 90° to the west and continued for a further 0.3 m into the trench section. The wall had been built within a construction cut (104) and stood to a height of 0.6 m above the natural clay (106) through which the construction cut had been excavated. The depth of the cut was in excess of 0.6 m and was back filled with a dark grey silty clay containing frequent stone rubble. Set within the surface of the wall were the remains of lead fixings reminiscent of iron railings.

Plate 4; Showing wall (103) (Taken from east)

- 5.1 The wall found within Trench 1 directly behind 26 Charlotte Square probably dates from after 1852 and forms part of a structure that seen on the 1894 Ordnance survey map (Plate 3). However, the remains found in Trench 2 cannot be correlated with historic mapping. Both these trenches contained a buried/garden soil below the excavated features and this soil continued through into Trench 3. This buried soil may provide the potential for further archaeological survival in these areas.
- 5.2 However, the natural clay in Trenches 4 and 5 lies directly below modern madeground indicating greater levels of truncation in the area to the rear of 30 and 31 Charlotte Square, potentially eradicating any archaeological potential.
