# Land at Savile Street, Sheffield, South Yorkshire: Archaeological Evaluation and Watching Brief Report

AOC 51043  
September 2011

<b>On Behalf of:</b>	<b>Santon Group Developments Limited Saunders House 52-53 The Mall Ealing London W5 3TA</b>
<b>Planning reference:</b>	<b>09/00523/FUL</b>
<b>National Grid Reference (NGR):</b>	<b>SK 3615 8826 (centred)</b>
<b>AOC Project No:</b>	<b>51043</b>
<b>Prepared by:</b>	<b>David Lakin</b>
<b>Date of Fieldwork:</b>	<b>November 2010 / March-July 2011</b>
<b>Date of Report:</b>	<b>September 2011</b>

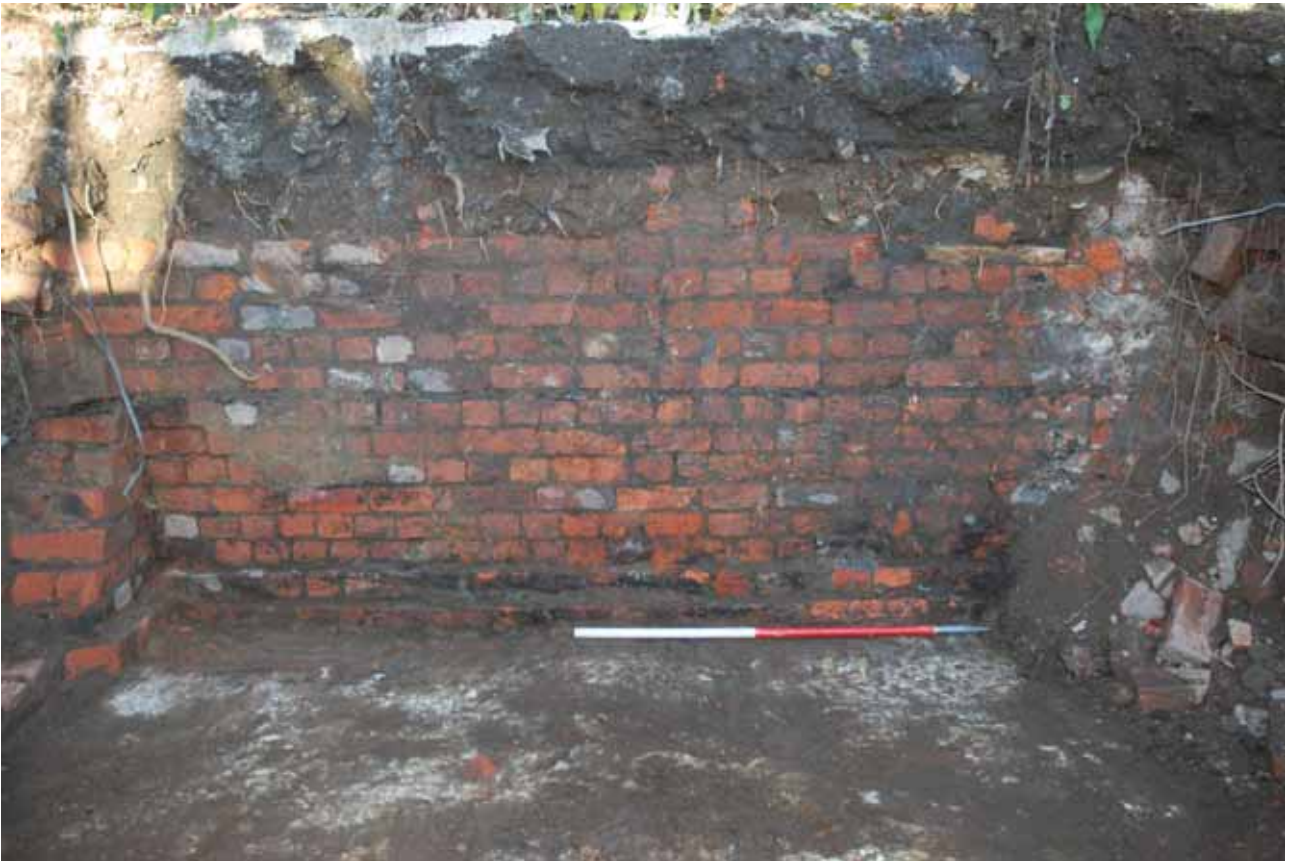
- 5.3.2 The northern range was comprised of at least three rooms. The westernmost room that was observed was seen in Trench 3 – here the northern wall of the building was observed to run parallel and immediately adjacent to the foundations of the access ramp (context 3/001; Plate 1). The wall ran the entire width of the northern part of the trench and survived to a height of 1.17m. It was composed of un-frogged red bricks 230 x 110 x 70 mm in size, and was laid in Old English bond with a greenish grey sandy mortar with black inclusions. One of the sampled bricks from wall 3/001 was probably manufactured between 1690 and the mid 18<sup>th</sup> century (Appendix 2). It appears to have been reused from an earlier structure, however, as the remainder of the bricks from the building date from c.1730-1850 (and possibly even later in the 19<sup>th</sup> century; Appendix 2). A north-south wall was also noted (3/002) in the north-west angle of Trench 3 which is presumed to form an internal partition wall and marks the limit of the westernmost room to be observed. A contemporary concrete floor lay at c 44.85m AOD. The southern part of the room was truncated by a later concrete intrusion (3/003), but it seems probable that the southern limit of the room was formed by wall 3/010, giving an overall north-south dimension for the room of approximately 11.5m.

Plate 1: Northern Wall (3/001) of building seen in Trench 3

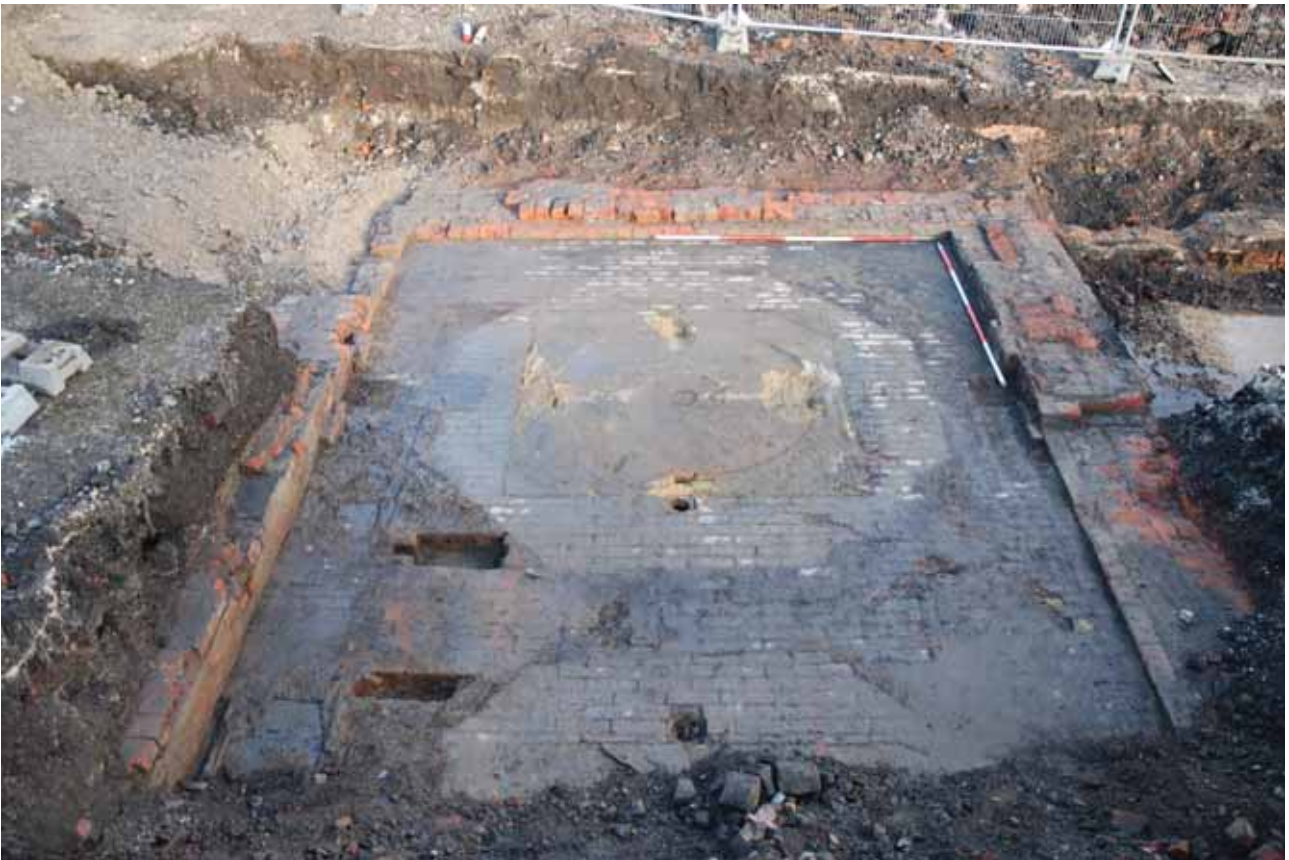
- 5.3.8 In Trench 2 and the adjacent watching brief area a room in the southern range was identified which has been tentatively identified as a ‘machine room’ (Plate 2). The room was formed by walls 2/004, 2/005, 2/009, 2/010, 2/017 and 102. The walls were composed of red bricks set in a grey mortar in Old English bond and were approximately 0.75m wide. The room had internal dimensions of approximately 8m x 4m with its long axis running parallel with the alignment of the range. The floor of the room was composed of blue (reduced) engineering bricks with two large gritstone blocks inset into the floor. The engineering bricks are thought to date from the 19<sup>th</sup> or 20<sup>th</sup> centuries (Appendix 2). The gritstone blocks measured 2m x 2m, and a circle of just under 2m in diameter was inscribed within the blocks to a depth of approximately 2mm (these are presumed to be machinery settings). At the cardinal points of the eastern setting four deeper indentations (c 100mm) were noted, one of which contained the remains of a metal lug suggesting that these would have formed the fixing point for the machine. A pierced stone drain cover lay between the two stone slabs and ceramic drain pipes were set vertically against the opposing inner faces of the slabs, both of which suggest that water management formed part of the function of this room. Each slab was surrounded by an octagonal ‘ghost’ impression suggesting that the machine settings lay within a frame of timber or other organic material. Two rectangular recesses, the thickness of the brick floor, lay adjacent to the northern side of the machine settings. Two post settings, 300mm x 300mm, were also sunk into the floor against the north and south walls of the room. A line between these two post holes crosses the easternmost machine setting centrally and it is assumed that the posts assisted in the functioning of the machinery in some fashion. The floor in the machine room lay at 45.30m AOD, approximately 0.70m higher than the floor in the adjacent room in the north range and approximately 0.90m higher than the ‘corridor’.

Plate 2: Trench 2 Machine Room

6.3 The function of the building could not be determined from the excavated remains as the interior was devoid of any material which might have indicated its use and plant had likewise been stripped from the machine room. A photograph of the Wicker Station taken in 1912 (Plate 6) shows the building and its prominent chimney quite clearly (far right of photograph). Most noticeable is the three storey tower-like construction which appears to sit in the approximate position of the machine room, perhaps explaining the more substantial nature of the foundations in this part of the south range of rooms. The tower is strongly reminiscent of a water tower, a feature which might be expected in a station where steam trains were operating. The machine room may therefore have contained

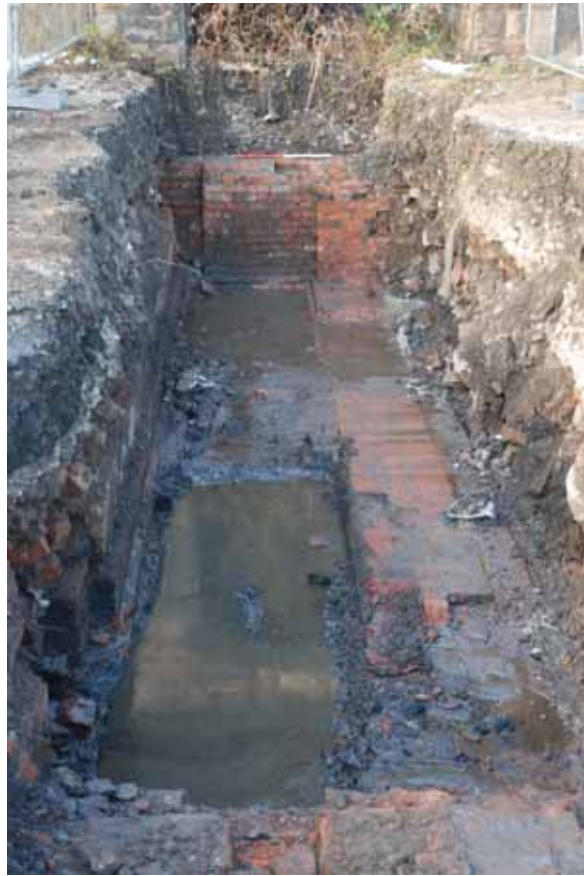
- 5.3.4 The northern range of rooms continued in Trench 2 with a narrow corridor like room<sup>1</sup> 1.25m wide running north-south across the range (Plate 3). The eastern wall of the room (2/002) ran the width of the range and its alignment continued southwards into the south range and beyond (2/005, 2/009, 2/014). The wall was composed of red bricks in Old English Bond identical to that used in the room observed to the west and for the majority of its length had been cropped to floor level (presumably during demolition of the building). The approximate date of manufacture for the bricks falls within the range 1730-1850 (Appendix 2). The western edge of the corridor was formed by wall 2/006. This wall was identical in construction to the other walls observed in the northern range and unlike wall 2/002 had not been cropped during demolition and survived to a height of just over 1m. Wall 2/006 stopped short of the main walls of the range at both north and south ends resulting in two narrow niches or returns each less than 1m wide. The function of these niches/returns is unclear as they lay largely outside the evaluation trench and were filled with rubble. However, the floor in the corridor lay at 44.37m AOD, somewhat lower than the floor level in the room to the west, suggesting that the returns may have held flights of steps allowing movement up to the higher level.

Plate 3: Trench 2 'Corridor'

<sup>1</sup> It is possible that this room may have formed the wheel pit which would have transformed the power generated by the engine house into a form useable elsewhere in the building – in the absence of any diagnostic fixtures this is however highly speculative.

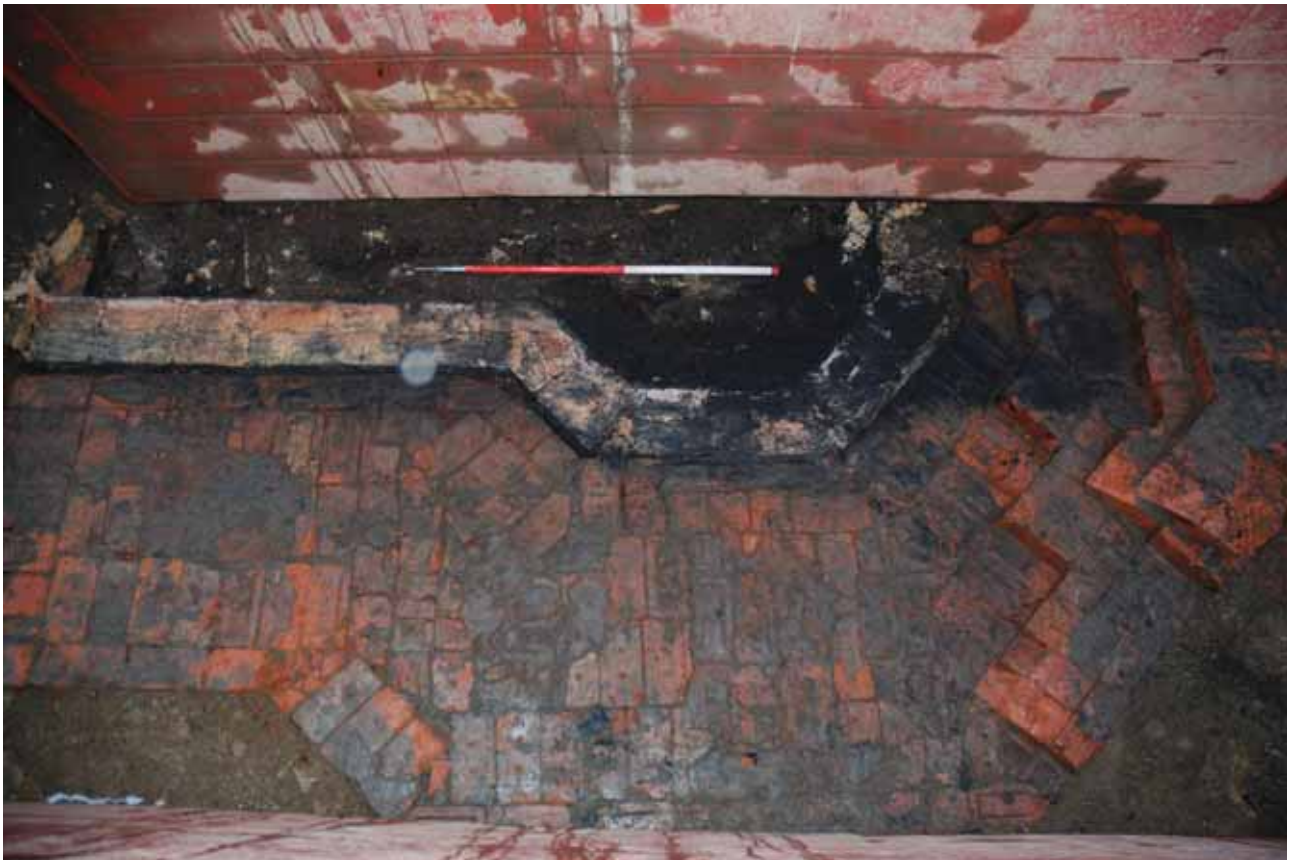
- 5.3.6 Beyond the eastern end of the northern range lay a brick-built chimney base (Plate 4). The base was polygonal with an estimated external dimension of 4.50m. The main body of the structure was composed of red brick (1/006) although the interior was lined with a double skin of fire bricks, the latter most likely of 19<sup>th</sup> century date (1/005; Appendix 2). A flue (Plate 5) ran from the north side of the chimney base curving to the west suggesting that the engine house which served the chimney lay in the northern range of rooms. The flue was composed of red bricks (1/002 and 1/007) and lined with fire bricks (1/003 and 1/013). The base of the flue was in good condition and its soft, sooty silt fill contained a quantity of fire brick rubble, suggesting that the original brick vault had collapsed into the flue (possibly during demolition).

Plate 4: Trench 1 Chimney Base

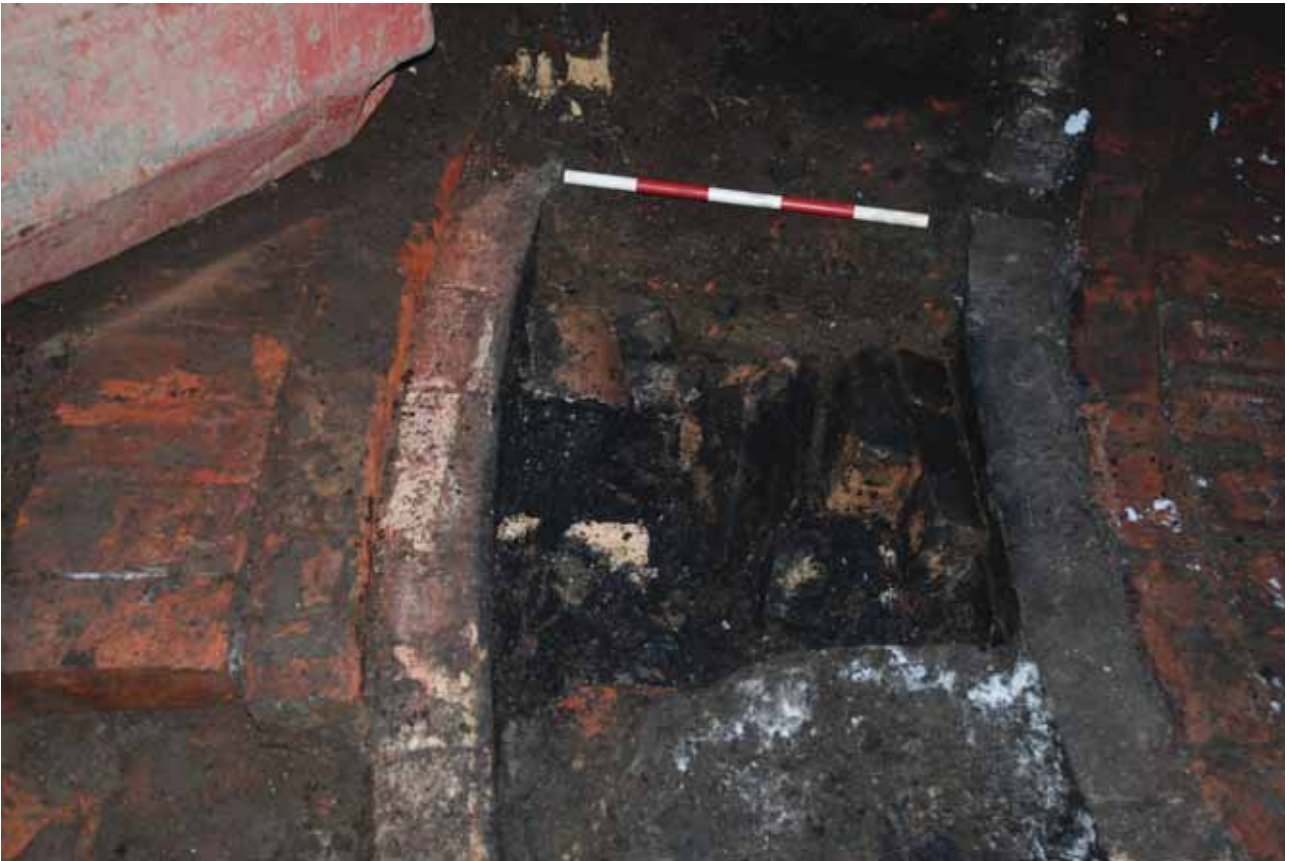
5.3.10 The structures noted above seemed to form a single phase of construction with few indications of subsequent modification. However, in Trench 1 the flue (1/002) connecting the putative engine house with the chimney base had clearly been partially demolished before a very slight brick foundation (1/001) was constructed over it. The foundation was only one brick wide and may have served as the foundation for a lean-to or shed; it may be related to a similar foundation (1/007) which lay at right-angles to it.

Plate 5: Flue detail of cross-section

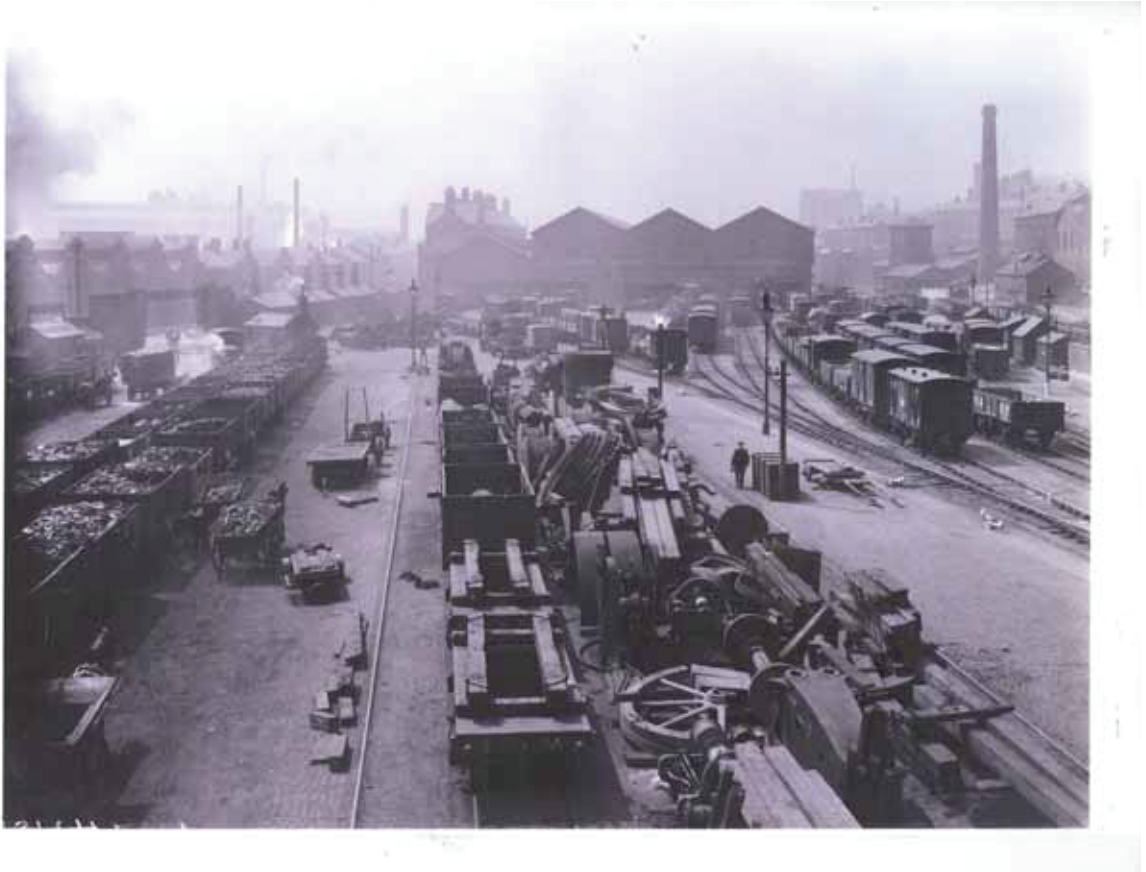
Plate 6: View of Midland Railway Goods Yard 1912, showing the Electric Light Station building on the far right
