# Renfrew Town Hall: Watching Brief Data Structure Report

AOC 21648  
August 2010

# Renfrew Town Hall: Watching Brief Report

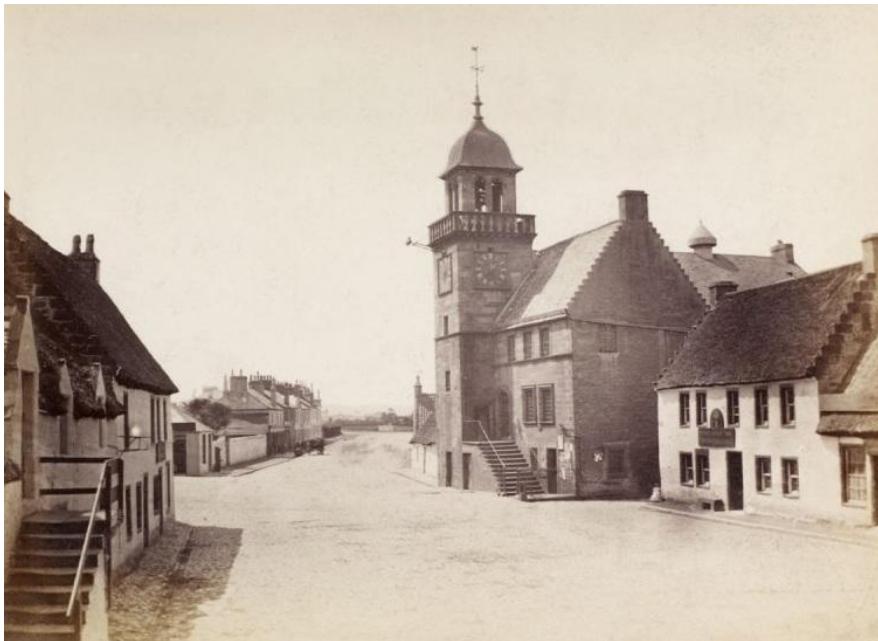
Plate 1: Undated 19<sup>th</sup> century photograph showing the 1670 Town Hall prior to its demolition in 1871. From 'Renfrew: Photograph Album No. 146' The Thomas Annan Album, copyright RCAHMS.

- 1.2.2 The first town hall at Renfrew was constructed in 1670 and comprised a jail, a keeper's house and a small hall. Despite its civic function maintenance appears to have been an issue as records suggest that that the building was decayed and in need of repair as soon as 1688. Courts were held in the Town Hall until 1748. The building was refurbished in 1826, when the construction of a new wing allowed it to be remodeled with the council chamber on the ground floor and a hall above, an arrangement shown on an undated 19<sup>th</sup> century photograph of the building (**Plate 1**). The remodeled hall of 1826 was comparatively short-lived as it was demolished in 1871 and replaced by the present town hall which stands upon its site. Category A Listed, the Renfrew Town Hall of 1871 was built to designs by James and Baillie Lamb in the French Gothic Style.

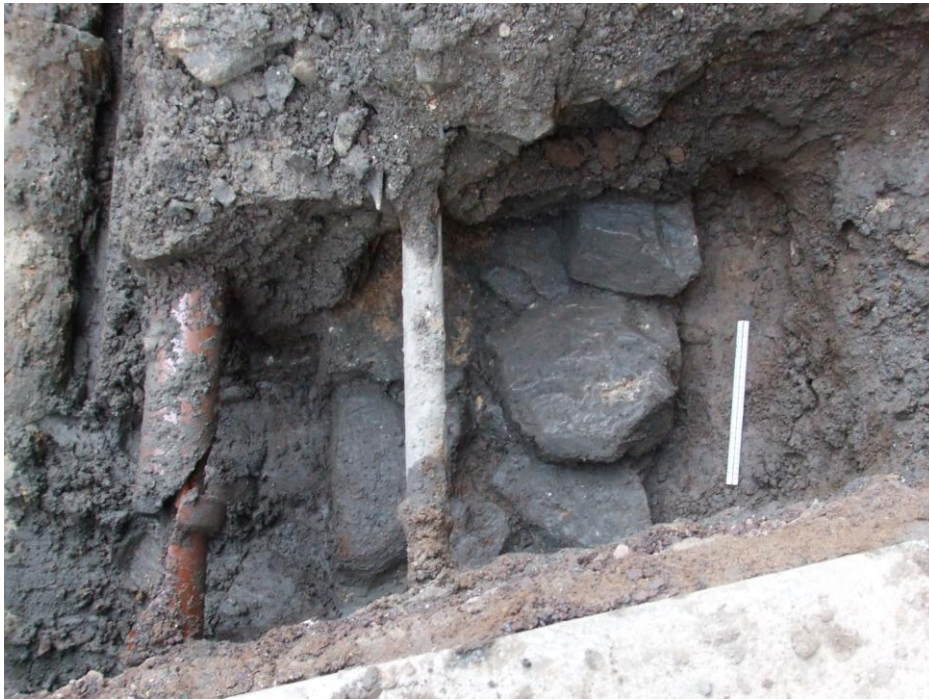
Plate 3: Wall [001]

4.4 A single northwest - southeast aligned foundation wall [001] was identified west of the southwest corner of Renfrew Town Hall (**Fig. 2**) (**Plate 3**). Constructed from yellow sandstone blocks wall [001] was 0.6 m wide and survived to a height of at least one course. A cobbled path (011) flanked by a kerb to its west (016) ran east of wall [001] on a north - south alignment. Although the exact relationship between the wall and the path was undeterminable due to the limitations of the excavation, both features were butted by a single deposit (013). Wall [001] was found to have been removed down to its foundations by robber trench [008] which was in turn infilled with a single levelling deposit (009). Dating from two sherds of ceramic recovered from (009) indicate a late 19<sup>th</sup> century date for the demolition of wall [001] (**Appendix 3**). The nature of a second north -south aligned sandstone structure, [012], is unclear as it was only partially exposed along the eastern limit of excavation, although given its position it is likely to represent either a foundation wall or have been a kerb along the eastern edge of the cobbled path (011). The cobbled path was sealed by a single deposit of dark reddish brown silty clay (010) containing scarce quantities of coal and three sherds of late medieval to early post medieval pottery which predated 1750 (**Appendix 3**).

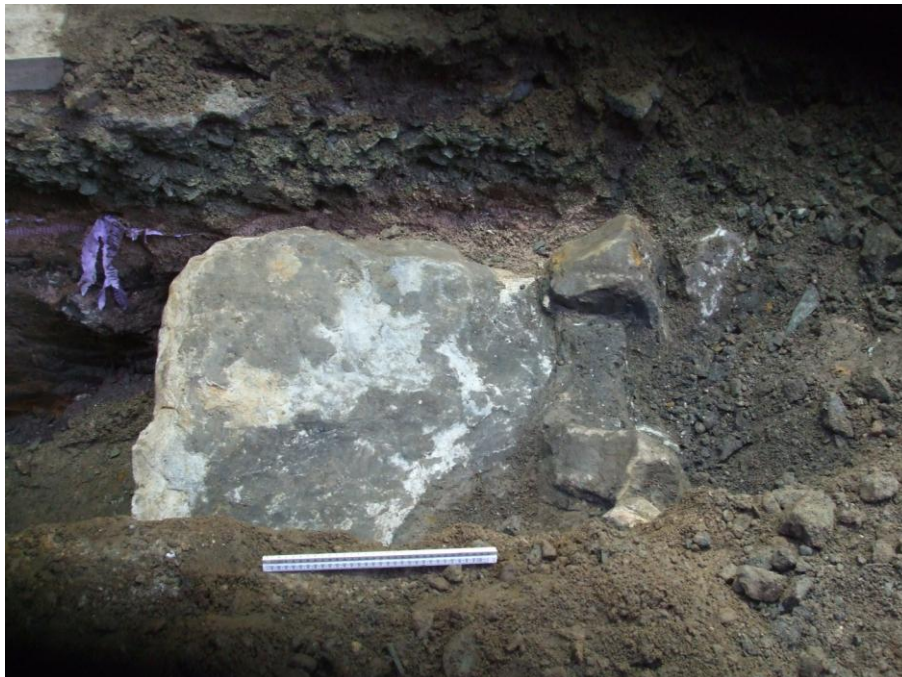
Plate 4: Wall [002]

- 4.5 A second foundation wall [002] (**Fig. 2**) (**Plate 4**), constructed of sandstone blocks and aligned northeast - southwest, was located north of wall [001] beneath the central part of Dunlop Street, 0.3 m below the pre-development ground surface. The date of this wall is unclear as the sherd of modern glass recovered from it is likely to have been intrusive (**Appendix 3**), the wall survived to a height of one course.

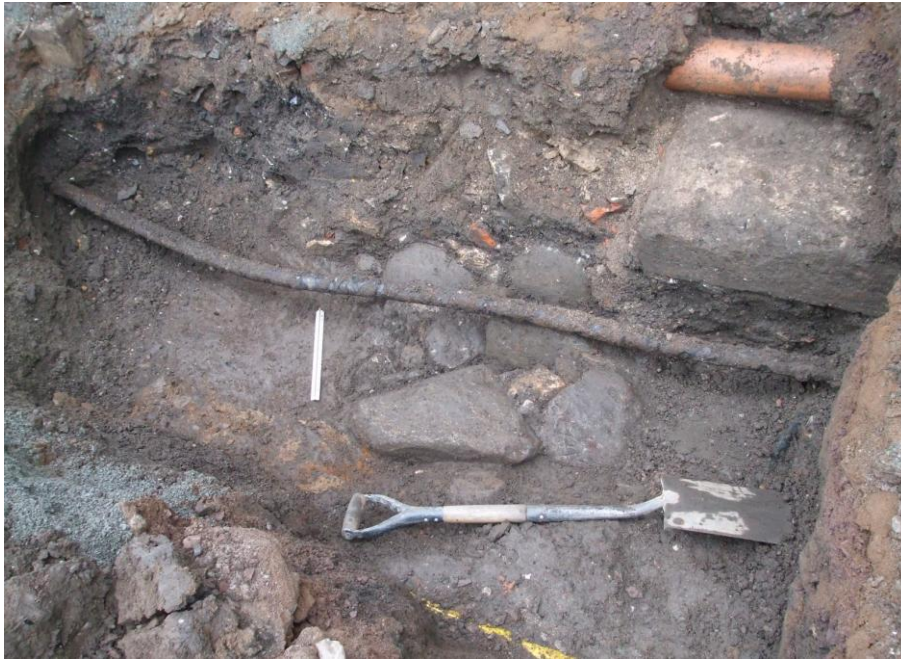
Plate 5: Wall [004]

- 4.6 The third foundation wall, [014] (**Fig. 2**) (**Plate 5**) was partially exposed extending beneath the northeast corner of Renfrew Town Hall. Aligned SSW - NNE, wall [014] was constructed using a mixture of sandstone and large granite beach cobbles, was 0.72 m wide and survived to the height of as single course. A compacted deposit of dark purplish brown sandy clay (015) butted the western edge of the wall. No dating evidence was recovered from either the wall or (015).
