Plots 1 to 3 & 'Stepping Stones' Extension, Seton Mains, Longniddry: Evaluation Data Structure Report

AOC Project 21786
14th January 2011

Plots 1 to 3 & 'Stepping Stones' Extension, Seton Mains, Longniddry Evaluation: Data Structure Report

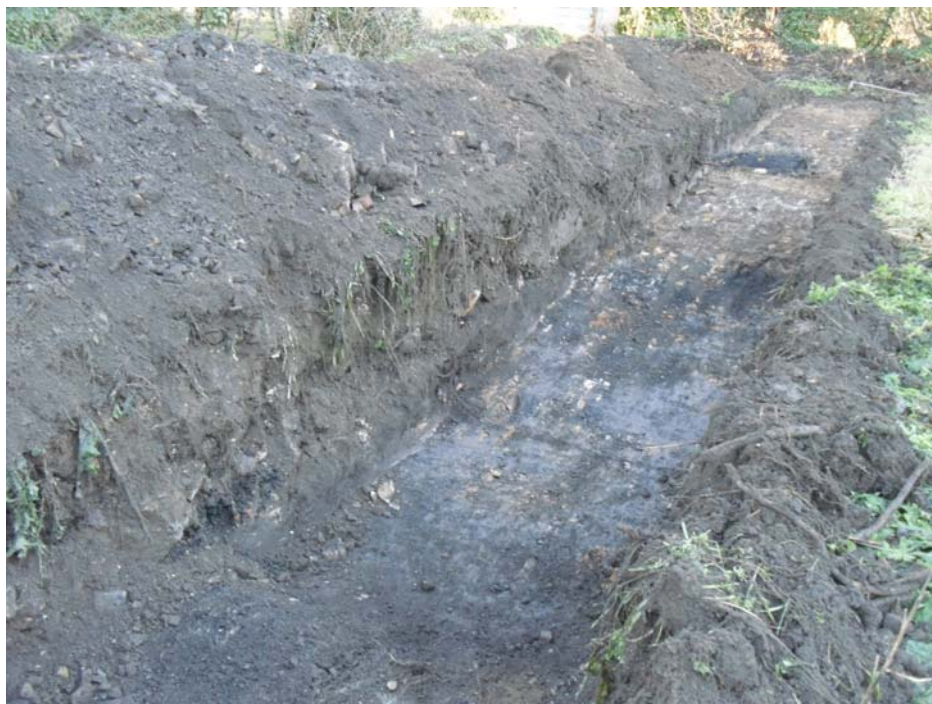
Plate 1: South-facing section of Trench 1 showing build up of dumped material as the trench slopes towards the burn

<i>Dimensions</i>	16.5 m by 2.0 m
<i>Orientation</i>	E-W
<i>Depth of Topsoil</i>	0.15 - 0.24 m
<i>Depth of Excavation</i>	0.20 - 1.05 m
<i>Significant Features</i>	None
<i>Other Features</i>	The natural ground surface fell away sharply from east to west, sloping down steeply towards the burn, however a large deposit of redeposited topsoil mixed with building debris including reinforced concrete, bricks, cement, paving slabs and metal lay under the topsoil creating a flat terrace. This was up to 0.85 m thick at western end of trench.
<i>Subsoil</i>	Gravel and clay
<i>Finds</i>	Modern ceramic, glass and brick noted within both topsoil and redeposited made ground.
