Water Row, Govan

Watching Brief

Data Structure Report

AOC Project 22013
OASIS No. aocarcha1-118753
27th February 2012

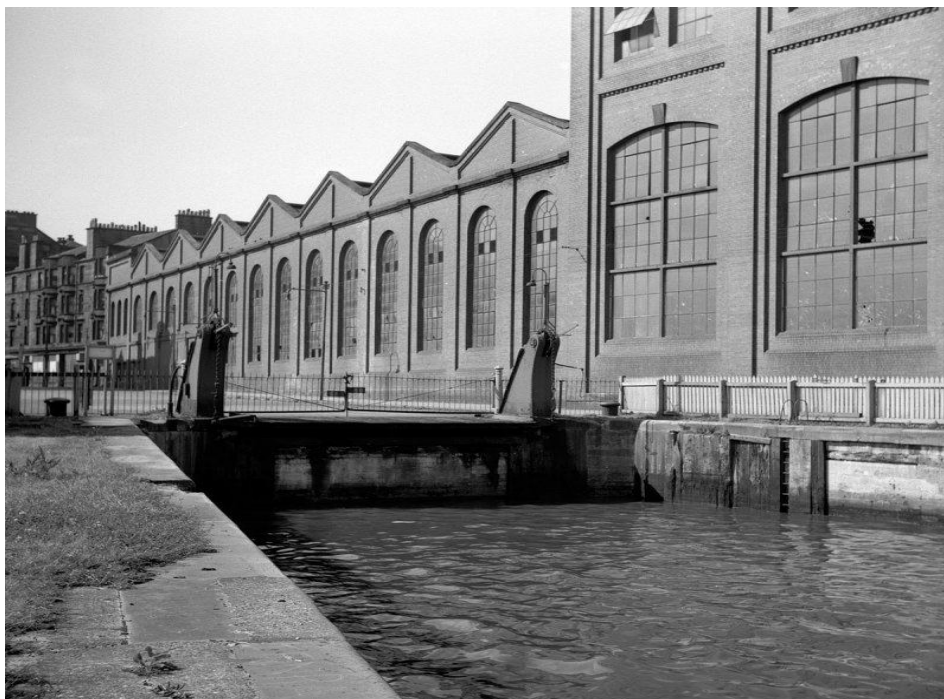
Plate 1 - Historical photograph showing Water Row shipyards west of Water Row

1.3.2 The area to the west of Water Row is the likeliest location for encountering remains dating from Govan's medieval development; however both sides of the street were heavily developed by the Govan and Water Row shipyards in the 19th and 20th centuries (Plate 1). Thus it seems likely that medieval or earlier archaeology in this area will have been subject to severe truncation.

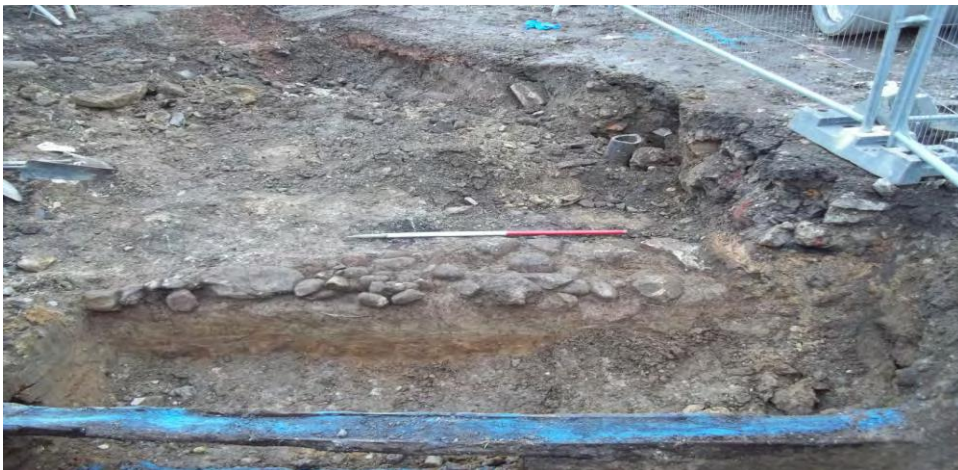
Plate 2 - The remains of cobbled surface [003]

4.2 A small section of cobbled surface [003] was revealed within the longer trench located to the SE end of the site (Figures 2 & 3; Plate 2). The surface was of irregularly sized, rounded cobbles and measured 0.57 m by 1.71 m wide where exposed. The surface most likely ran NW-SE but had been truncated to the NW by an electric cable and then the road make-up, and to the SE by the shipyard walls and services. The cobbles were set into a buried soil [004] that was later noted again in section further north-east of the cobbled surface (Figure 2). No artefactual material was found within the buried soil or within the cobbled setting.

- 5.1 The majority of the ground-works conducted within the cobbled roadway of Water Row revealed no archaeologically significant features or finds. Only when ground-breaking works moved outwith the cobbled road surface was archaeology located in the form of cobbles [003] and buried soil [004].
- 5.2 No further archaeological works are considered necessary. This recommendation will require confirmation by WoSAS.

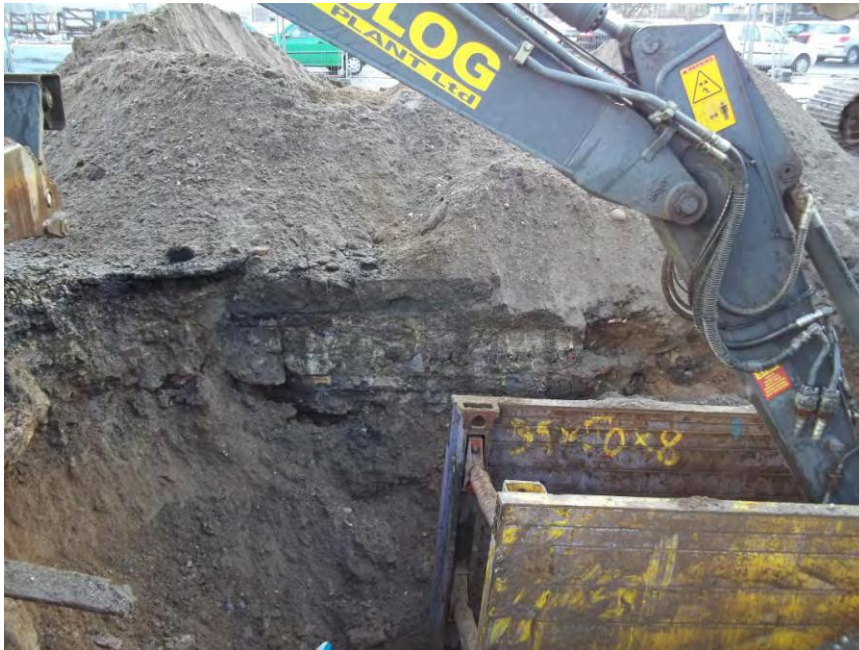
Plate 3 - An example of modern foundations throughout the site

- 4.3 The only other features observed were modern and consisted of large sandstone walls with concrete foundations most likely belonging to the Govan Shipyards that used to align the street (Plate 3). The eastern wall of the shipyards slipway (Figures 4) was also revealed at the north end of the street with the area to the west having been backfilled with re-deposited sand and gravel to a depth of over 3 m.
