# Blyth Bank Farm Archaeological Evaluation Data Structure Report

AOC 21461  
September 2009

## Blyth Bank Farm Archaeological Evaluation: Data Structure Report

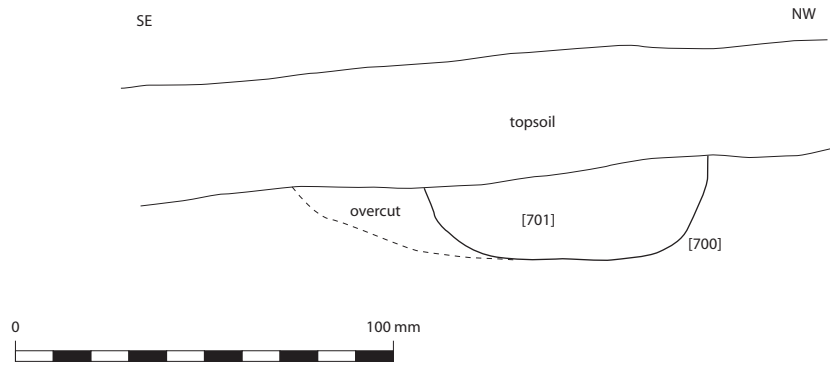
Figure 3: North-east facing section through linear cut [700] in Trench 7d

4.3.1 Trench 7d was bisected by a clearly defined linear ditch feature [700], aligned E-W across the trench. The feature measured in plan c.0.80 m wide with a shallow profile, with depths between 0.15 m and 0.22 m. it contained a single fill [701].

Dimensions	30.0 m by 2.0 m
Orientation	NW - SE
Depth of Topsoil	0.20 m to 0.21 m
Features	Linear ditch feature [700], aligned E-W across trench. Shallow profile, irregular in plan c.0.80 m wide on average with depths between 0.15 m and 0.22 m. Single fill [701].
Subsoil	Red/Pink sandy boulder clay
Finds	None

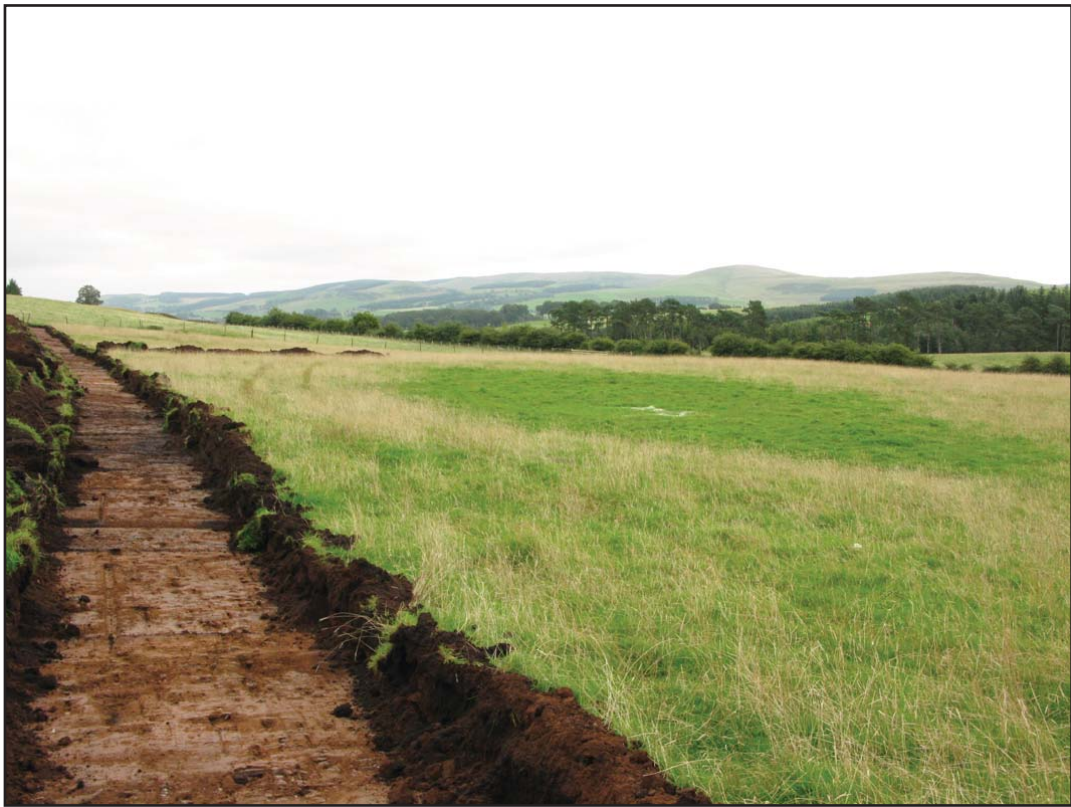
4.5.1 Adjacent to a boggy marshy area of field (southeast of Trench 5c) there was an area of modern machine disturbance, possibly associated with gravel extraction.

Plate 1: Area of modern disturbance adjacent to a boggy area immediately south of Trench 5c

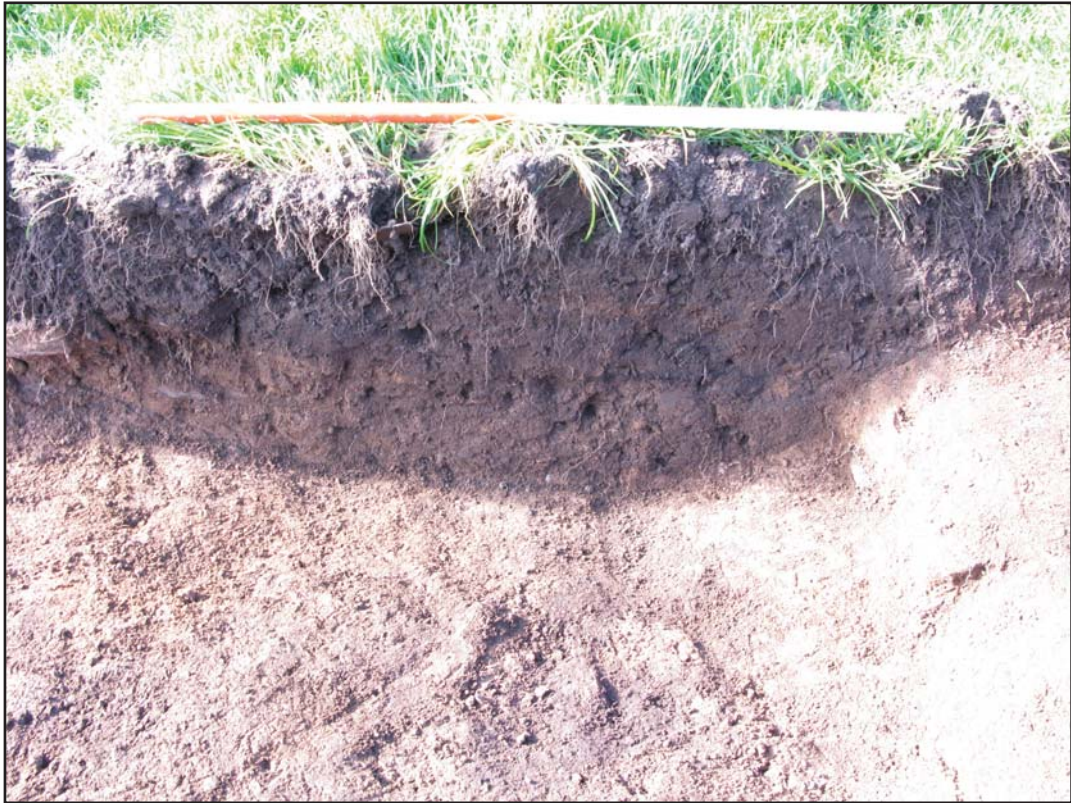
Plate 2: North-east facing section through cut [700] in Trench 7b

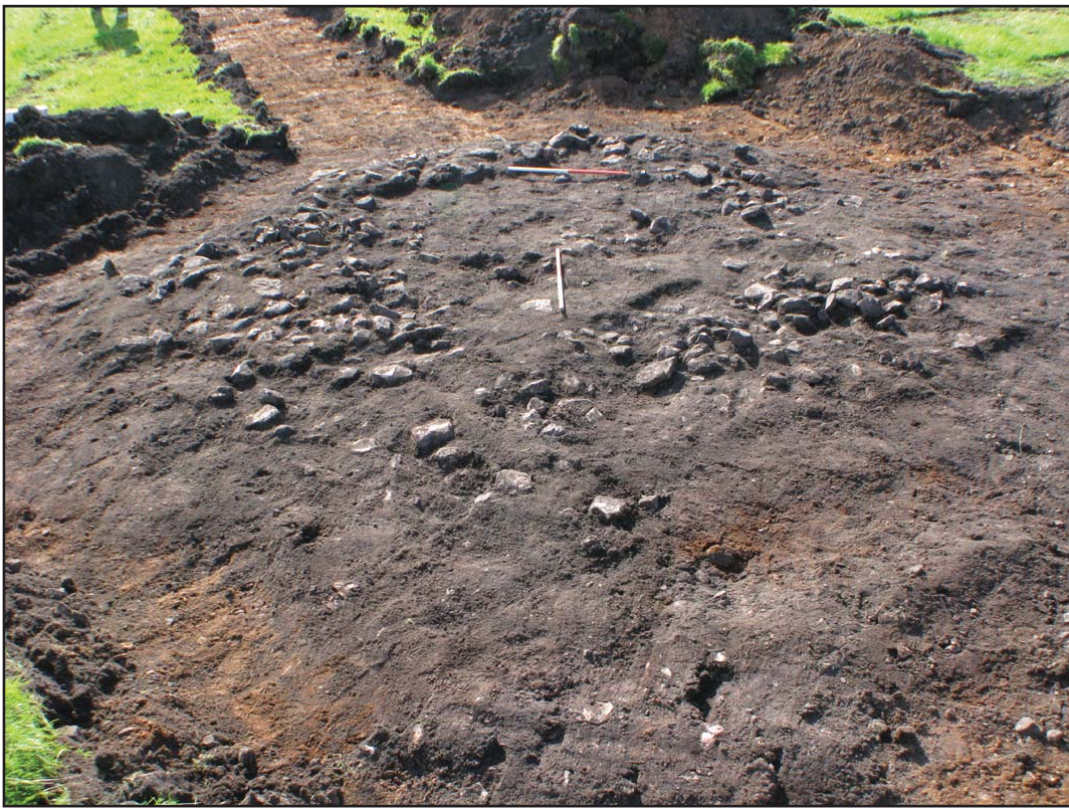
4.4.1 In Trenches 8a and 8b there was the remains of a small sub-square structure [800]. This consisted of poorly sorted stones, from 0.38 m by 0.28 m by 0.15 m down to less than 0.06 m in diameter forming the stone foundation of a small structure. The structure measured c.5.0 m long by 4.5 m wide with walls up to 1.0 wide. There was the suggestion of an entrance to NW.

4.4.2 The stones directly overlay the natural subsoil of sands and gravels with no cut present. The spread of stones was suggestive of a rubble wall and no real great height could be expected. No mortar, wallfacing, dressed stonework or coursing was visible. The cleaning undertaken during the evaluation showed that not only were the stones not resting within an actual foundation cut but also that no internal 'floor' levels were present.

Plate 3: General view of stone founded structure [800], in Trench 8a and b, from the east
