Air Balloon Primary School, Hillside Road, Bristol: A Historic Building Record Report

AOC Project No: 32100

A Historic Building Record Report

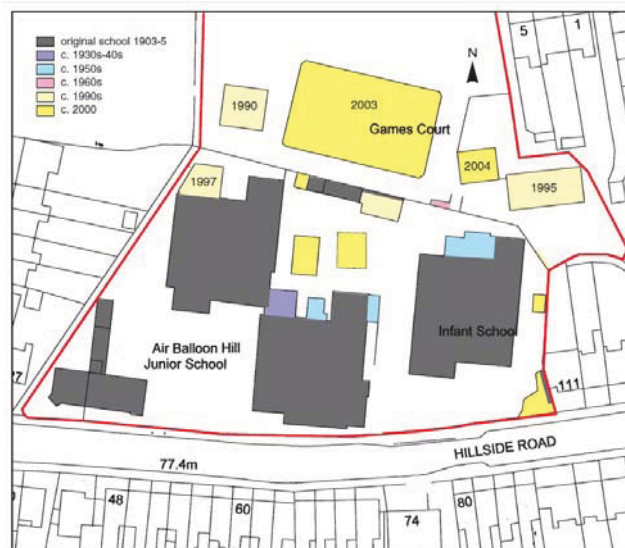
PLATE 1: Phases of Building Development (adapted from BARAS 2011)

- 5.3.4 There were various changes and additions to the school during the 20th century. It became a secondary modern and by the 1960s there were separate infants' and juniors' schools. A number of temporary classrooms were constructed within the school site between 1990 and 2011 and a permanent extension to the former boys' school block was constructed in 1997 (BARAS 2011, 4). The phases of development in and around the school buildings are shown on Plate A, below.

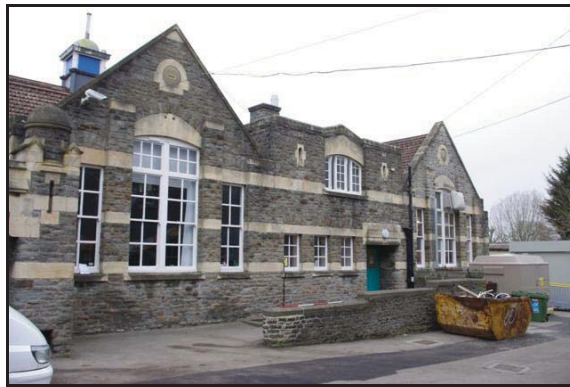
Plate 2: Eastern Elevation of Building A Looking Northwest

8.2.3 With reference to Plate 2, the area to be obscured to the eastern elevation of Building A extends from the large wooden sash windows located centrally to the southern gable on the left hand side of the plate, up to the northern side of the entrance located centrally to the plate.

8.2.4 This area of the elevation incorporates both one and two storeys and three bays, with the elevation built from roughly dressed, roughly coursed, grey stone blocks. Yellowish brown stone string courses have also been incorporated within the elevation.

8.2.5 The southern end of the affected elevation consists of a gable frontage which contains two centrally set wooden sash windows, flanked by two individually set wooden sash windows, with each incorporating four panes within a single frame. The two central windows are lent extra height by frames containing six panes. The casement arch to the central windows is dressed using the same yellowish brown stone as the string course, while all windows have decorative stone relieving arches and stone sills. A blocked stone dressed ocular is located near the gable apex.

8.2.6 The two storey bay to the ground floor contains three wooden frames incorporating six panes and an entrance consisting of a double set of replacement wooden doors. The three windows have decorative stone relieving arches and stone sills, while the entrance is framed by a stone hood.

8.2.7 The first floor contains a central group of wooden casement windows each containing eight panes set within a rounded arch dressed by the yellowish brown stone. Located each side of this window is a decorative window slit, framed by the same type of stone.

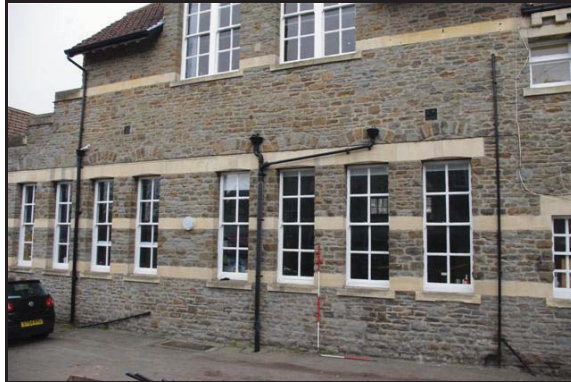
Plate 3: Western Elevation of Building B Looking Northeast

- 8.2.8 The area to be obscured to the western elevation of Building B extends from the southwest corner of the building to roughly the centre line of the elevation (Plate 3). This area of the elevation incorporates two storeys and three bays, and is constructed in the same manner as the eastern elevation of Building A.

- 8.2.9 The ground floor incorporates groups of both four pane and six pane wooden sash windows with decorative stone relieving arches and stone sills. To the northern side of the first floor, within the area of the effected elevation, are set large wooden four pane sash windows below six pane frames. The southern side of the first floor contains two wooden casement windows.

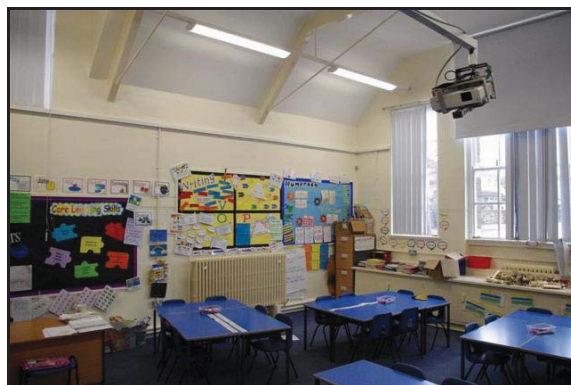
Plate 4: Room 1 Looking Southwest

Room 1 is located in the southwest side of Building A (Figure 3). Room 1 is a large room in use for teaching, with internal features consisting of wooden sash windows, wooden beams incorporating metal bracing, shoulder high decorative moulded course, wooden door with nine panes, a loft hatch, and metal radiators (Plate 4). Apart from the metal radiators, all of these features appear to be early 20th century in date. Due to the layout of the room it was noted that the original northern wall to Room 1 had been removed and rebuilt approximately 2m further north. This increased the floor space available within Room 1, and as a result decreased the floor space associated with the original floor plan of Room 2.

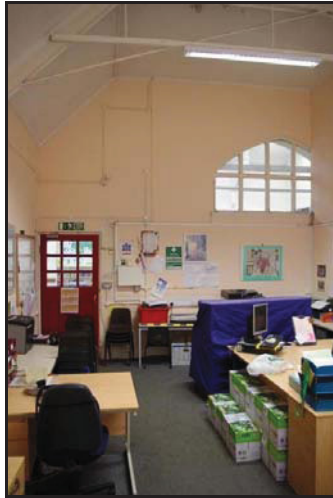
Plate 5: Room 2 Looking East

Room 2 is located on the west side of Building A (Figure 3). Room 2 is a high yet narrow room in use as an office, with the same internal features as Room 1 (Plate 5). Apart from the metal radiators, all

of these features appear to be early 20th century in date. A wide blocked doorway in the southern wall indicates that Room 1 and 2 used to be directly linked. The narrow perception of Room 2 has been created by the rebuilding of Room 2's southern wall reducing the overall width of the room.

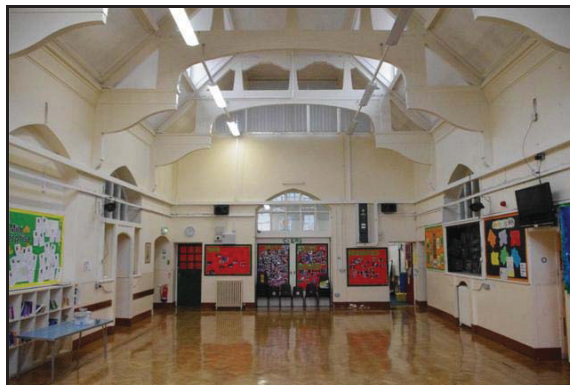
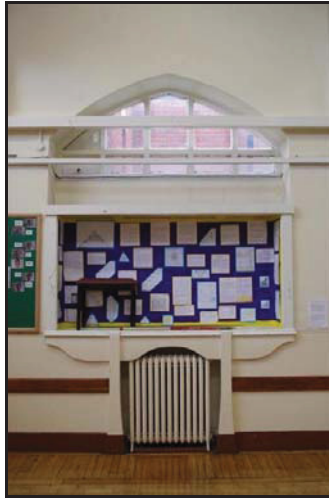
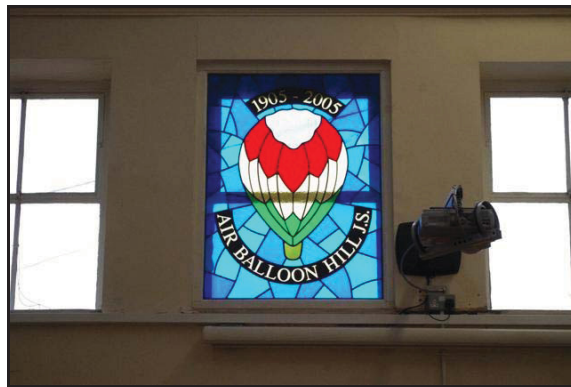
Room 3 is located centrally within Building A (Figure 3). Room 3 is an extensive room in use as an assembly hall. The room is dominated by a hammer beam roof incorporating wooden framed dormer windows (Plate 6). On all four sides are wooden framed windows set within three-pointed arches to share light with the adjacent rooms, one of which has been subsequently blocked (Plate 7). The northern arched window is external and incorporates a stained glass window celebrating the school's centenary (Plate 8). Below this external window appears to be a blocked double entrance. Internal features consist of original waist high moulded cornice, a parquet floor, and later metal radiators.

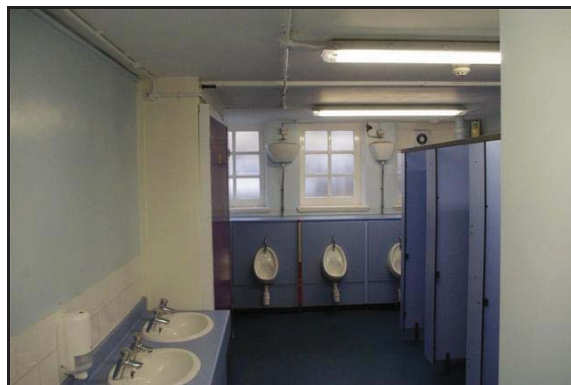
Plate 9: Room 4 Looking South

Rooms 4 and 5 are located in the southwest corner of Building A (Figure 3). Room 4 is a moderate sized room in use as a children's lavatory. All internal features are late 20th century in date apart from the original wooden casement windows (Plate 9). A modern stud wall has been inserted into the northwest corner of Room 4 to create Room 5, a small storage area. Room 5 contained no features of historic interest.

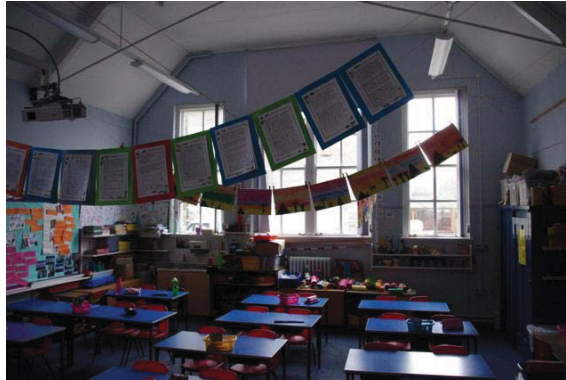
Plate 10: Room 6 Looking Northeast

Room 6 is located in the east side of Building A (Figure 3). Room 6 is a large room in use as a class room, with the same internal features as Room 1 (Plate 10). Apart from the metal radiators, all of these features appear to be early 20th century in date.

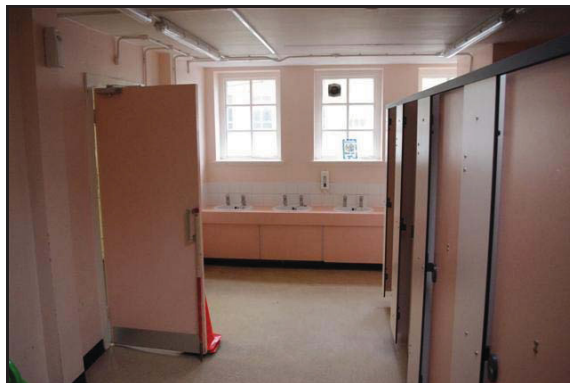
Plate 11: Room 7 Looking East

Room 7 is located in the east side of Building A (Figure 3). Room 7 is a moderate sized room in use as a children's lavatory. All internal features are late 20th century in date apart from the original wooden casement windows (Plate 11).

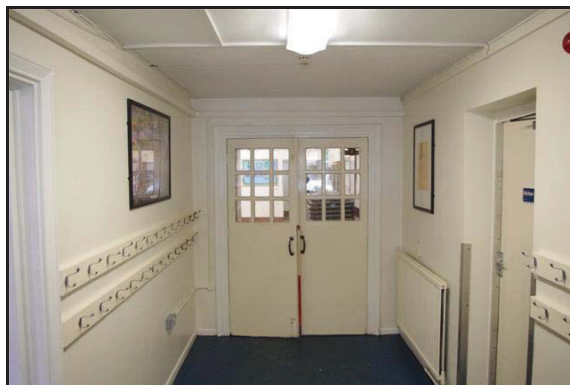
Plate 12: Room 8 Looking West

Room 8 is located in the northeast area of Building A (Figure 3). Room 8 is a corridor linking the northeast entrance of the building to the main assembly hall (Room 6). The corridor is simply decorated incorporating original internal double doors, plain shirting boards, and moulded door surrounds (Plate 12). The coat hooks, metal radiator and external doors are all later alterations.

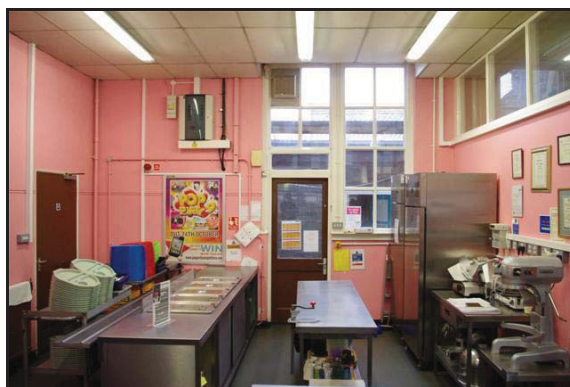
Plate 13: Room 9 Looking East

Room 9 is located in the northeast corner of Building A (Figure 3). Room 9 is a large room in use as the school's kitchen. Original features are limited, restricted to wooden sash windows and head height plain moulded course (Plate 13). Later alterations include internal partitions on the northern side of the room, a suspended ceiling, and internal and external doors.

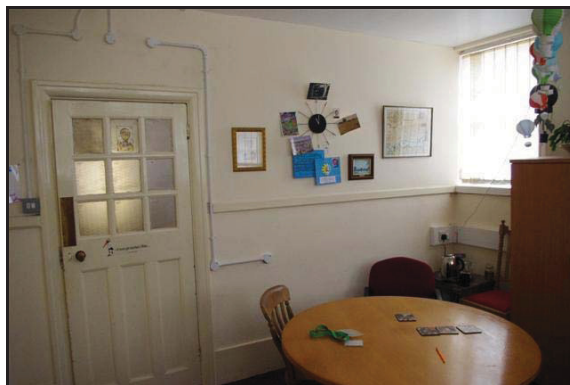
Plate 14: Room 10 Looking East

Rooms 10, 11 and 12 are located in the southwest side of Building B (Figure 3). Rooms 10 and 11 are two small office spaces, both containing wooden sash windows, and plain dado rails and skirting boards which appear to be original fittings (Plate 14). The nine pane wooden panelled door which links the two rooms is also original. All other fittings and fixtures are later, including the metal radiators. Room 12 acts as a small on-suite lavatory for Room 10, which incorporates brown glazed bricks to waist height as part of its design.

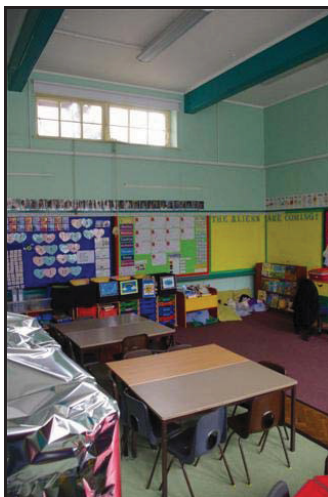
Plate 15: Room 13 Looking Southeast

Room 13 is located on the west side of Building B (Figure 3). Room 13 is a large room in use as a class room, with internal features consisting of wooden sash windows, smaller wooden casement windows with opening mechanism, moulded wooden beams, head height decorative moulded course, wooden door with nine panes, parquet floor, and metal radiators (Plate 15). Apart from the metal radiators, all of these features appear to be early 20th century in date.

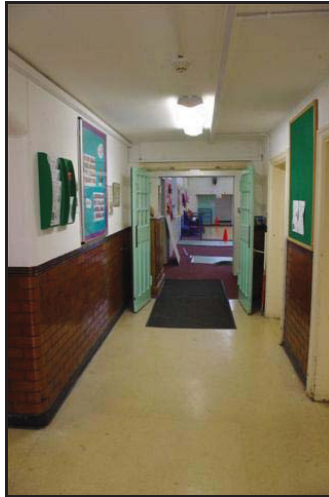
Plate 16: Room 14 Looking North

Room 14 is located in the south area of Building B (Figure 3). Room 14 is a corridor linking the southern entrance of the building to the central assembly hall of Building B. The corridor contains original internal nine pane double doors, moulded door surrounds and decorative brown glazed bricks to waist height (Plate 16).

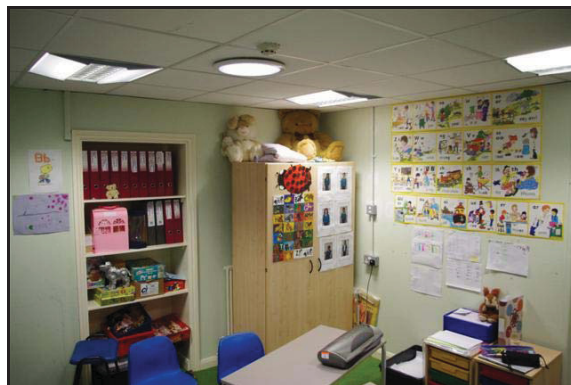
Plate 17: Room 15 Looking Northeast

Room 15 is located in the central southern area of Building B (Figure 3). Room 15 is a small room in use as the school's IT class room. All features within the room are later additions with exception of a doorway with a moulded surround in the northern wall, which has been subsequently blocked with the recess used for shelving (Plate 17).

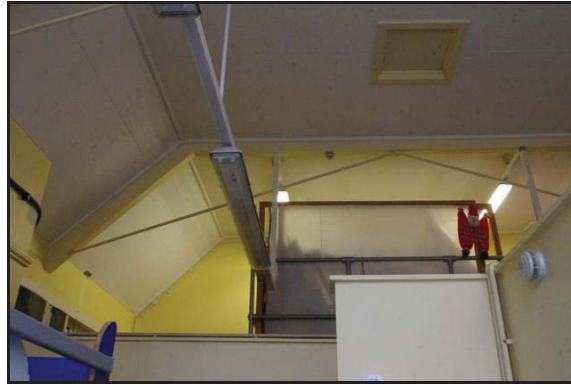
Plate 18: Room 16 Looking North

Room 16 is located in the southeast corner of Building B (Figure 3). Room 16 is a large room in use as a children's lavatory, with internal features consisting of wooden sash windows, wooden beams incorporating metal bracing, moulded picture rail, a loft hatch, and metal radiators (Plate 18). Apart from the metal radiators, all of these features appear to be early 20th century in date. The room has been heavily subdivided at ground level to facilitate its function as a lavatory.

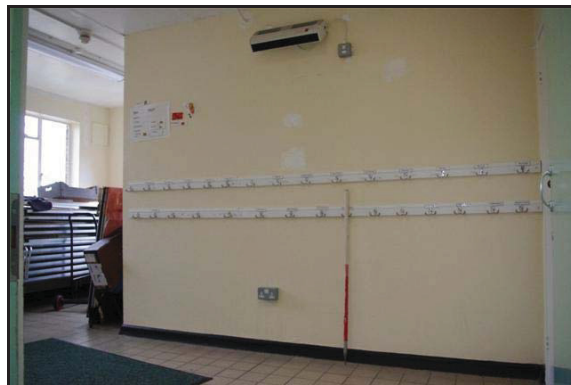
Plate 19: Room 17 Looking North

Room 17 is located in the northwest corner of Building B (Figure 3). Room 17 is a small room in use as a cloak room and storage area. All features within the room, including the tiled floor and coat hooks, are later additions (Plate 19).

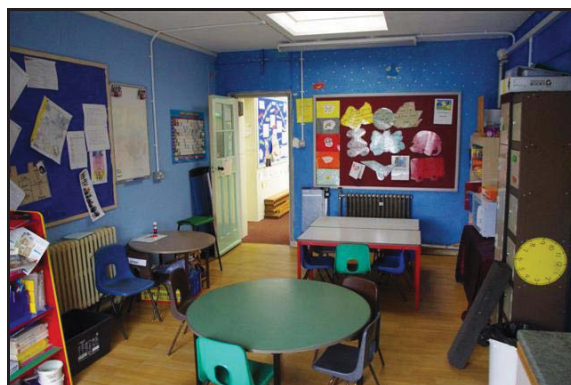
Plate 20: Room 18 Looking South

Room 18 is located in the central northern area of Building B (Figure 3). Room 18 is a small room in use as a class room. Apart from the four pane wooden panelled internal door, all features within the room are later additions (Plate 20).

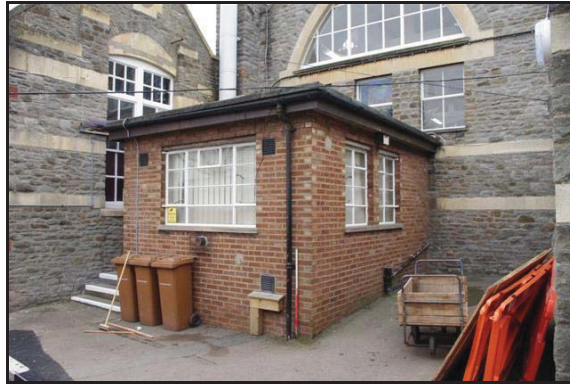
Plate 3: 1950s Extension Looking Southeast

- 8.4.1 The 1950s extension investigated during the programme of historic building recording is located centrally to the northern elevation of Building A (Figure 3). The extension is a single storey, single bay building, with a flat asphalt roof, and made from red brick laid in regular stretcher courses (Figure 4 & Plate 21). The wooden entrance door to the eastern elevation and metal casement windows are consistent with its mid 20th century construction.

- 8.4.2 Internally, a single office area occupies the majority of the space, with smaller rooms on the eastern and western side of the room containing a lavatory and storage cupboard respectively. These smaller rooms appear to be later brick built sub-divisions. All fittings and fixtures appear to be late 20th century in date.

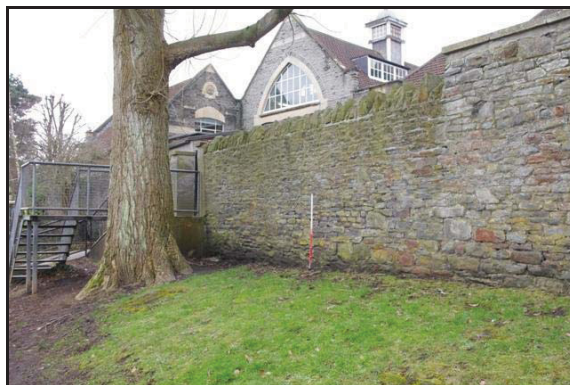
Plate 4: Boundary Wall Looking Southeast

- 8.5.1 Defining the northern boundary of the school site is a stone built retaining wall. A 2m long central section of this wall was incorporated into the current programme of building recording (Figure 3 & Plate 22). The southern elevation is 1.5m in height, while the northern elevation is 2m in height. The wall is constructed from a grey igneous stone blocks, which have been roughly dressed and laid in rough courses. Edge laid stones have been used as a coping course. Analysis of the northern elevation suggests that this section of wall was built after the construction of the wall immediately to the west. At the eastern end of the wall section a modern metal gate with concrete piers has been inserted into the wall. It is likely that the wall section recorded post-dates the original construction of the school, and then was subsequently altered to facilitate access to the school playing fields to the north.

- 9.4 The recording of the boundary wall to the north of Air Balloon School identified a stone wall of simple construction, which is likely to post-date the early 20th century construction of the school. Apart from the later insertion of a gate, no features of interest were identified.

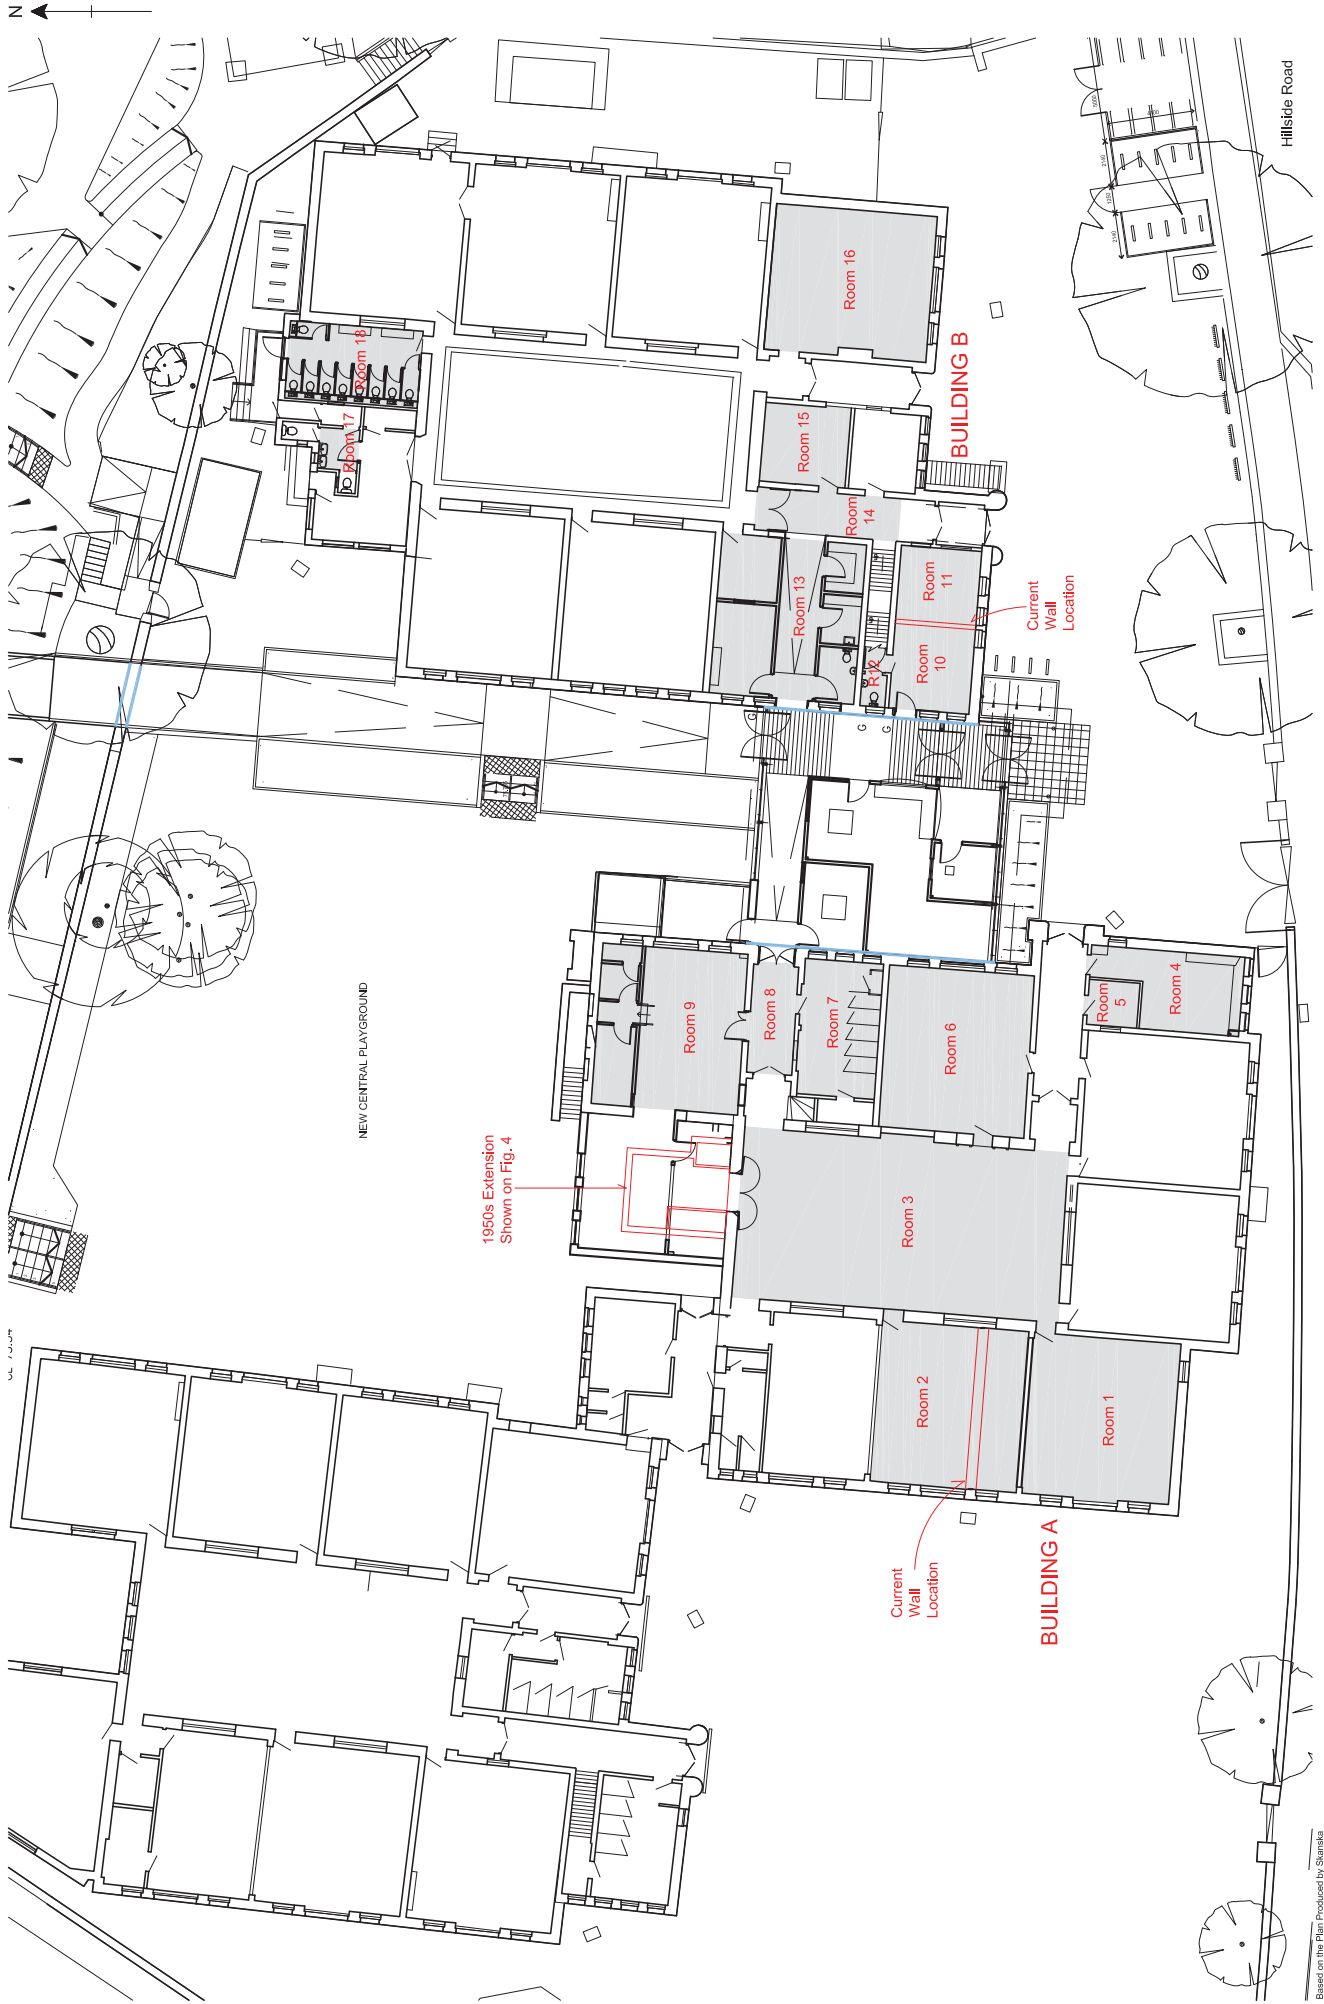
Figure 3: Building Plan

■ Rooms Being Refurbished

— External Elevations Examined

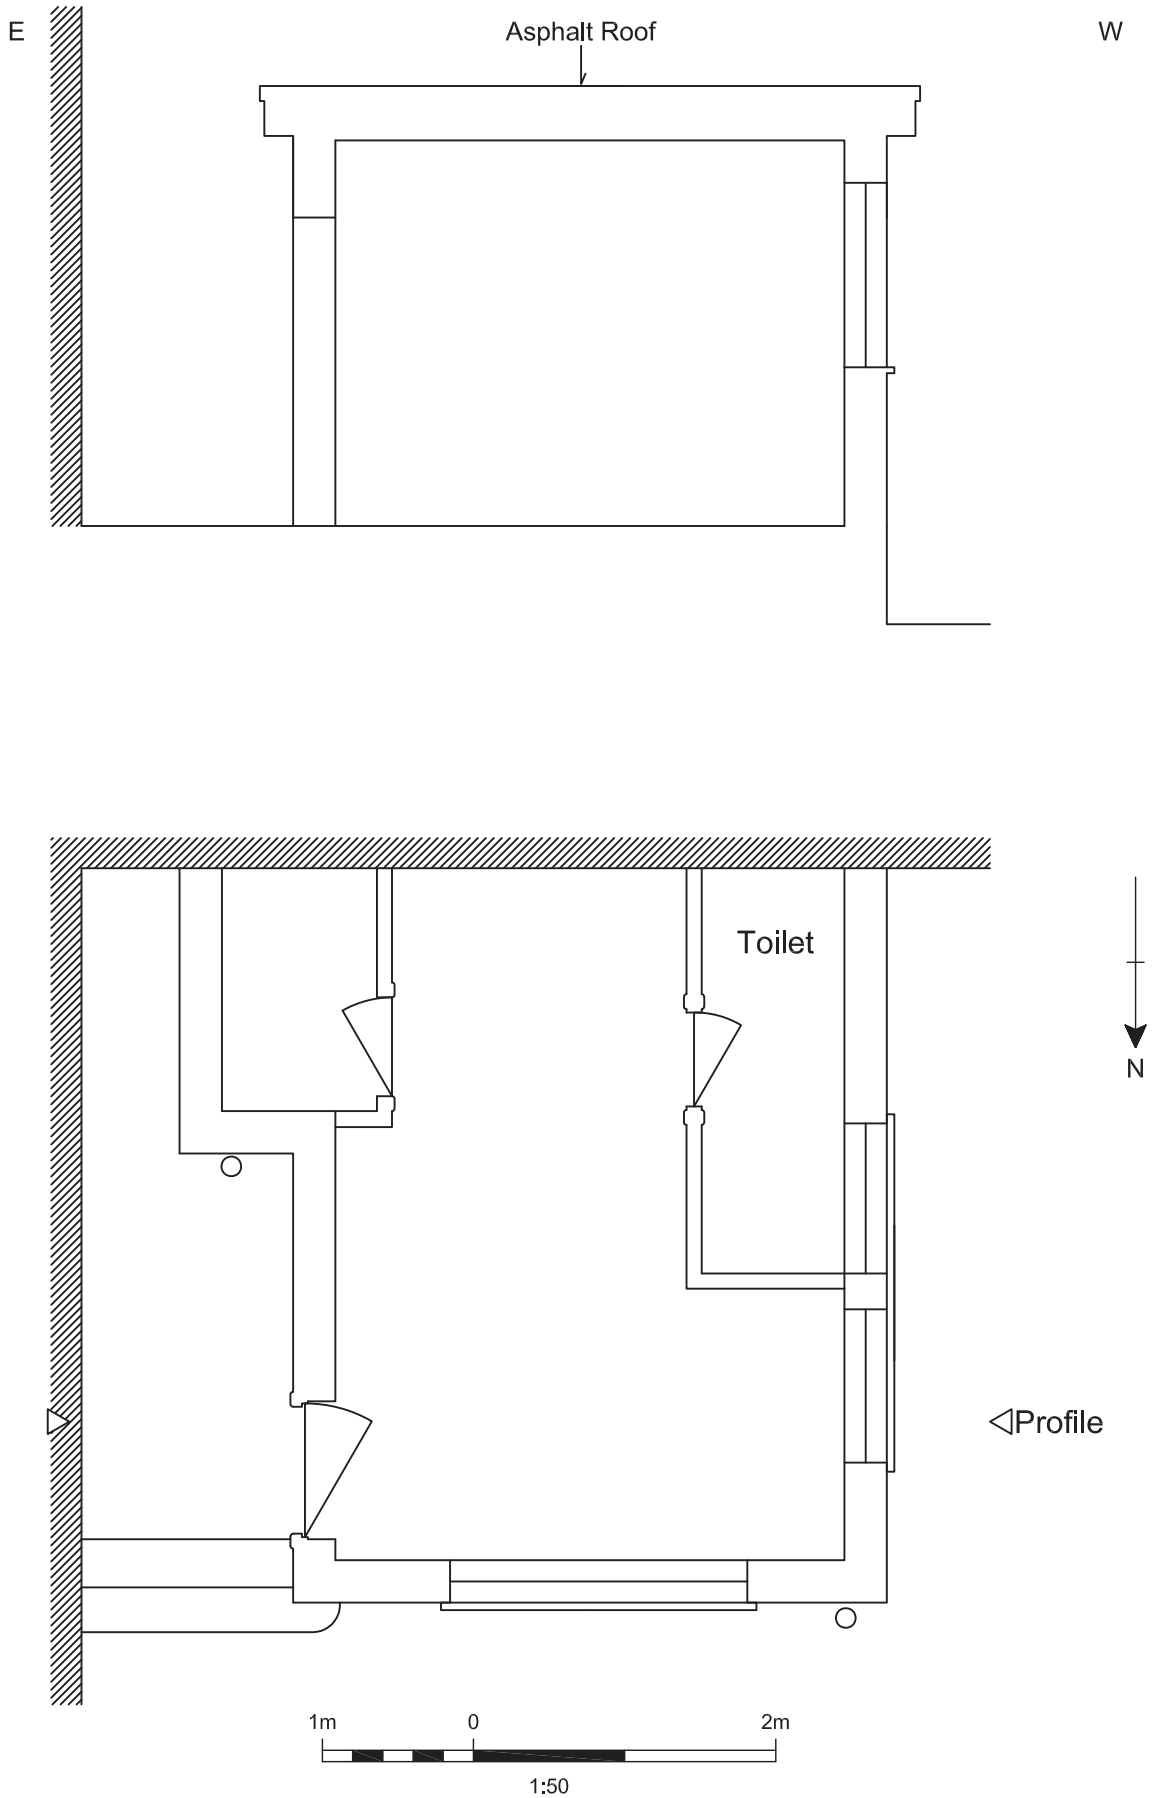
Figure 4: Plan and Cross-section of 1950s Extension

▨ Walls of the Original School Building
