Triple Kirks Excavation, Aberdeen: Data Structure Report

AOC Project 22001
OASIS ID aocarcha1-169899
29th January 2014

Triple Kirks Evaluation, Aberdeen: Data Structure Report

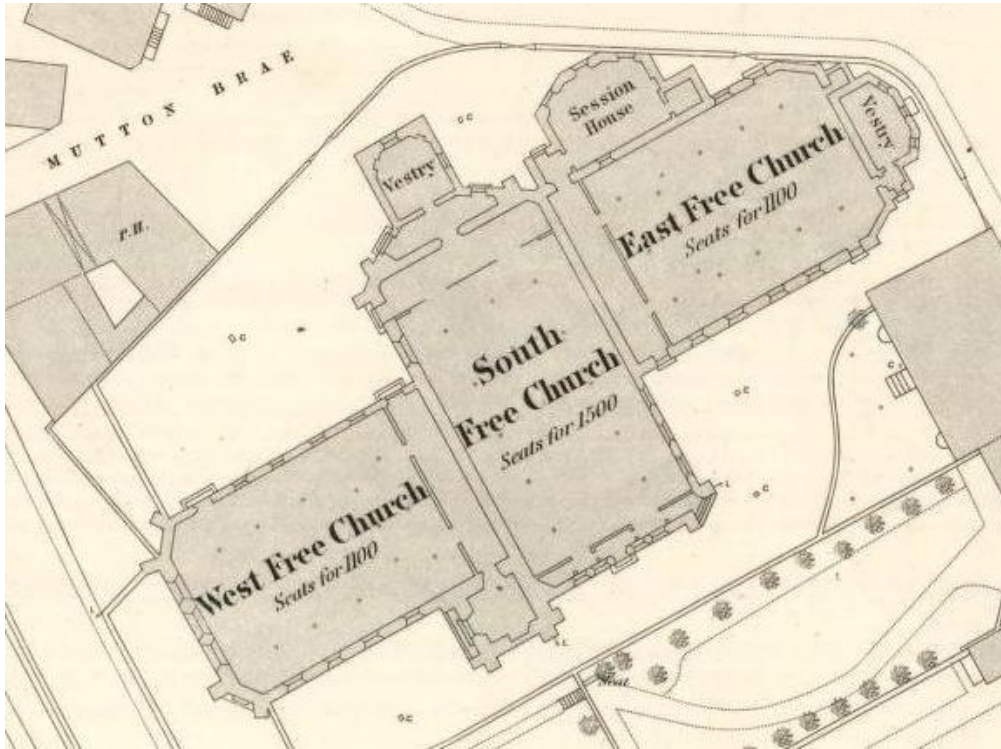
Plate 1 Detail from 1867 1st Edition Ordnance Survey map, 25 inch, Sheet LXXV, 11.13

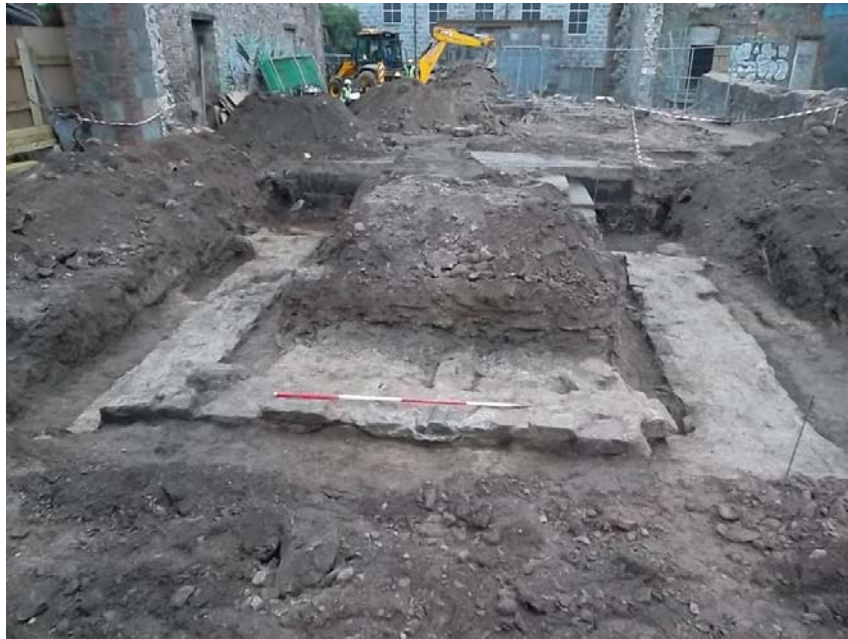
Plate 2: Vestry Foundations [001] and Wall [002].

- v) Appendix 5 contains reproduces the *Discovery and Excavation in Scotland* entry
- 4.2 The northern half of the excavation area revealed in-situ remains of the walls of the South Free Church Vestry, which had originally been identified in Trench 1 of the evaluation (AOC 2012). This consisted of a wall [002] constructed of large blocks of mortared stone, between 0.70 – 0.80 m wide, and up to 0.40 m high. This was sat directly over a foundation level [001], consisting of a layer of massive mortared stone slabs, up to 1.10 m wide. A cut [018] was identified below the foundations, within which a made ground deposit containing dark brown/black sandy clay and silt with fragments of stone, mortar and cinder. Artefactual material was recovered from deposit [017], including pottery, bone, red roof tile, and red brick. The pottery from this deposit has been dated to exclusively c 1820 – 1930 (George Haggarty pers comm.). This deposit directly overlies natural sands and gravels [014] and has been interpreted as a levelling deposit, on which the foundations of the Vestry wall lie.

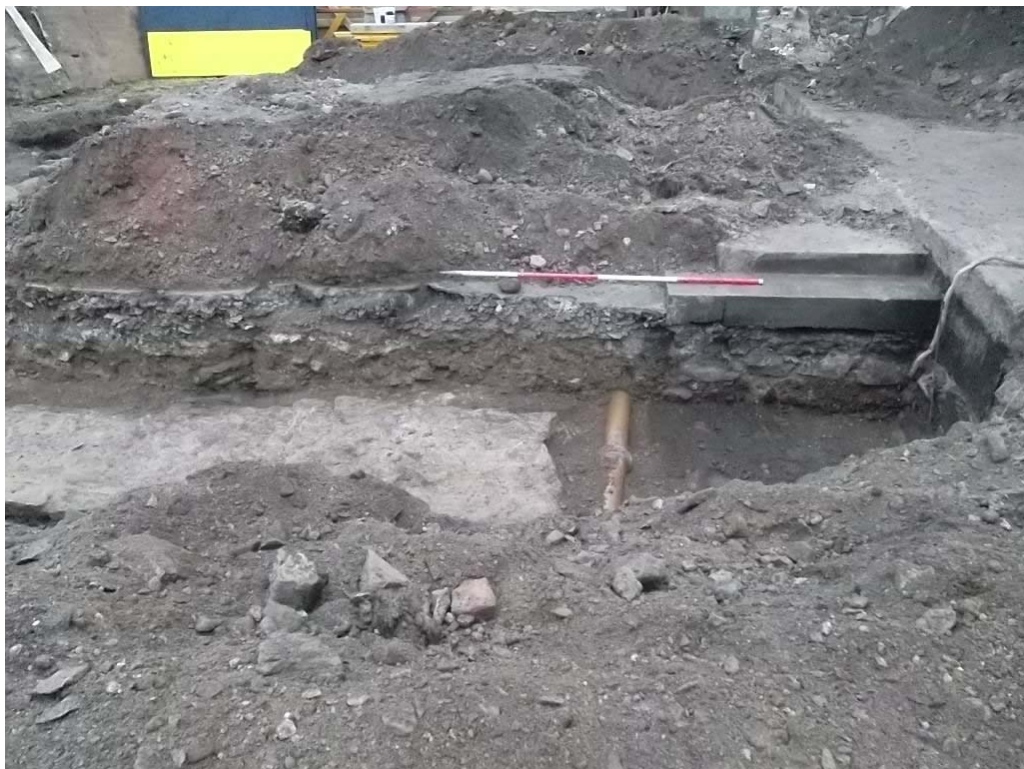
Plate 3: Vestry floor surface [051] and adjacent steps [008].

- 4.3 The surviving floor surface of the vestry was represented by a thin layer of concrete slab [051], c 0.20 m deep, which overlay a series of made ground deposits and abutted a set of concrete steps [008] at the south end of the vestry. These steps allowed access into the vestry area from the main church structure. The steps also abutt wall feature [006], the remains of a well built wall, constructed of large blocks of mortared stone. This is the remains of the north-west foundation wall of the South Free Church against which the vestry would have been built. A small brick built culvert feature [015] was recorded to the north of the vestry remains. A ceramic water pipe was noted cutting through the vestry foundations [001] on both the east and west sides towards the south end.

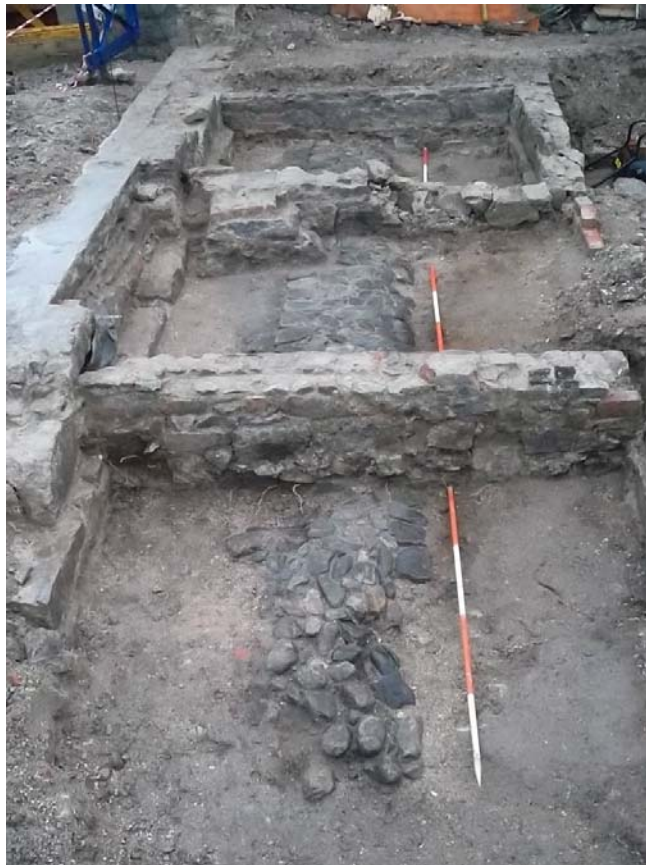
Plate 4: Remains of wall [035]

- 4.6 The remains of a wall foundation [035] were recorded along the northern edge of the southern area. It was constructed of water worn stones the larger of which were used to bound it on its east and west edges. Walls [033], [034] and [038] are built directly over this feature. The wall itself is built directly over the underlying deposit of made ground [044], [049] and [050]. No dating material was associated with this wall, although the feature was built over later made ground.

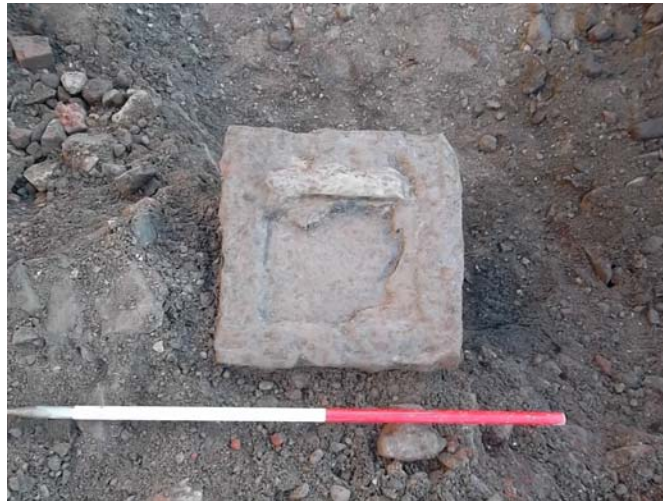
Plate 5: Top of pillar base [030]

- 4.7 A series of possible pillar bases [024], [030], [045], [046], [047] and [048] were also noted in the southern half of the excavation. These constructed of large blocks of mortared stone, on a foundation of brick and slate, and measured c 0.50 m by 0.50 m in plan. The uppermost block of stone, where it survived, had a shallow recess. These may have supported pillars that would in turn have supported an upper floor and/or roof.

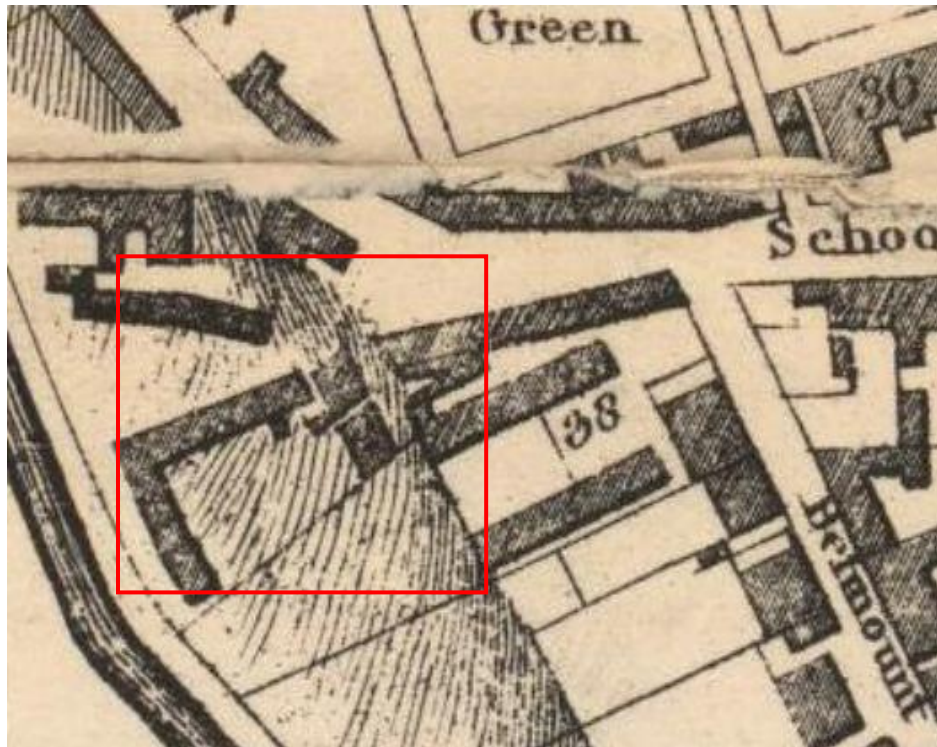
Plate 6: Map showing previous buildings occupying Triplekirk site from Alexander Milne's map of 1789. Red box marks approximate site location

- 5.1 The excavation at Triple Kirks has recorded the surviving remains of the Vestry of the South Free Church in the northern half of the excavation area, and also a series of features, including walls, a wall [035] that predates the church and possible pillar bases beneath the site of the former nave in the southern half of the excavation area. A number of the walls in the southern half of the excavation area, along with the possible pillar bases, are probably associated with the church, particularly those adjacent to wall feature [006], walls [033], [034] and [038] all of which abutt it. These walls, along with wall [032] and [039], which they also abutt, also survive to a greater height than the remaining walls in this area, and are complete, though are of poor constructional quality. The remaining walls and features, including the cobbled pathway or wall are possibly associated with the earlier phase of early industrial buildings shown on Alexander Milne’s and John Wood’s maps of 1789 (Plate 6) and 1832 respectively, which describe the buildings as a ‘Warehouse Factory’. Unlike the

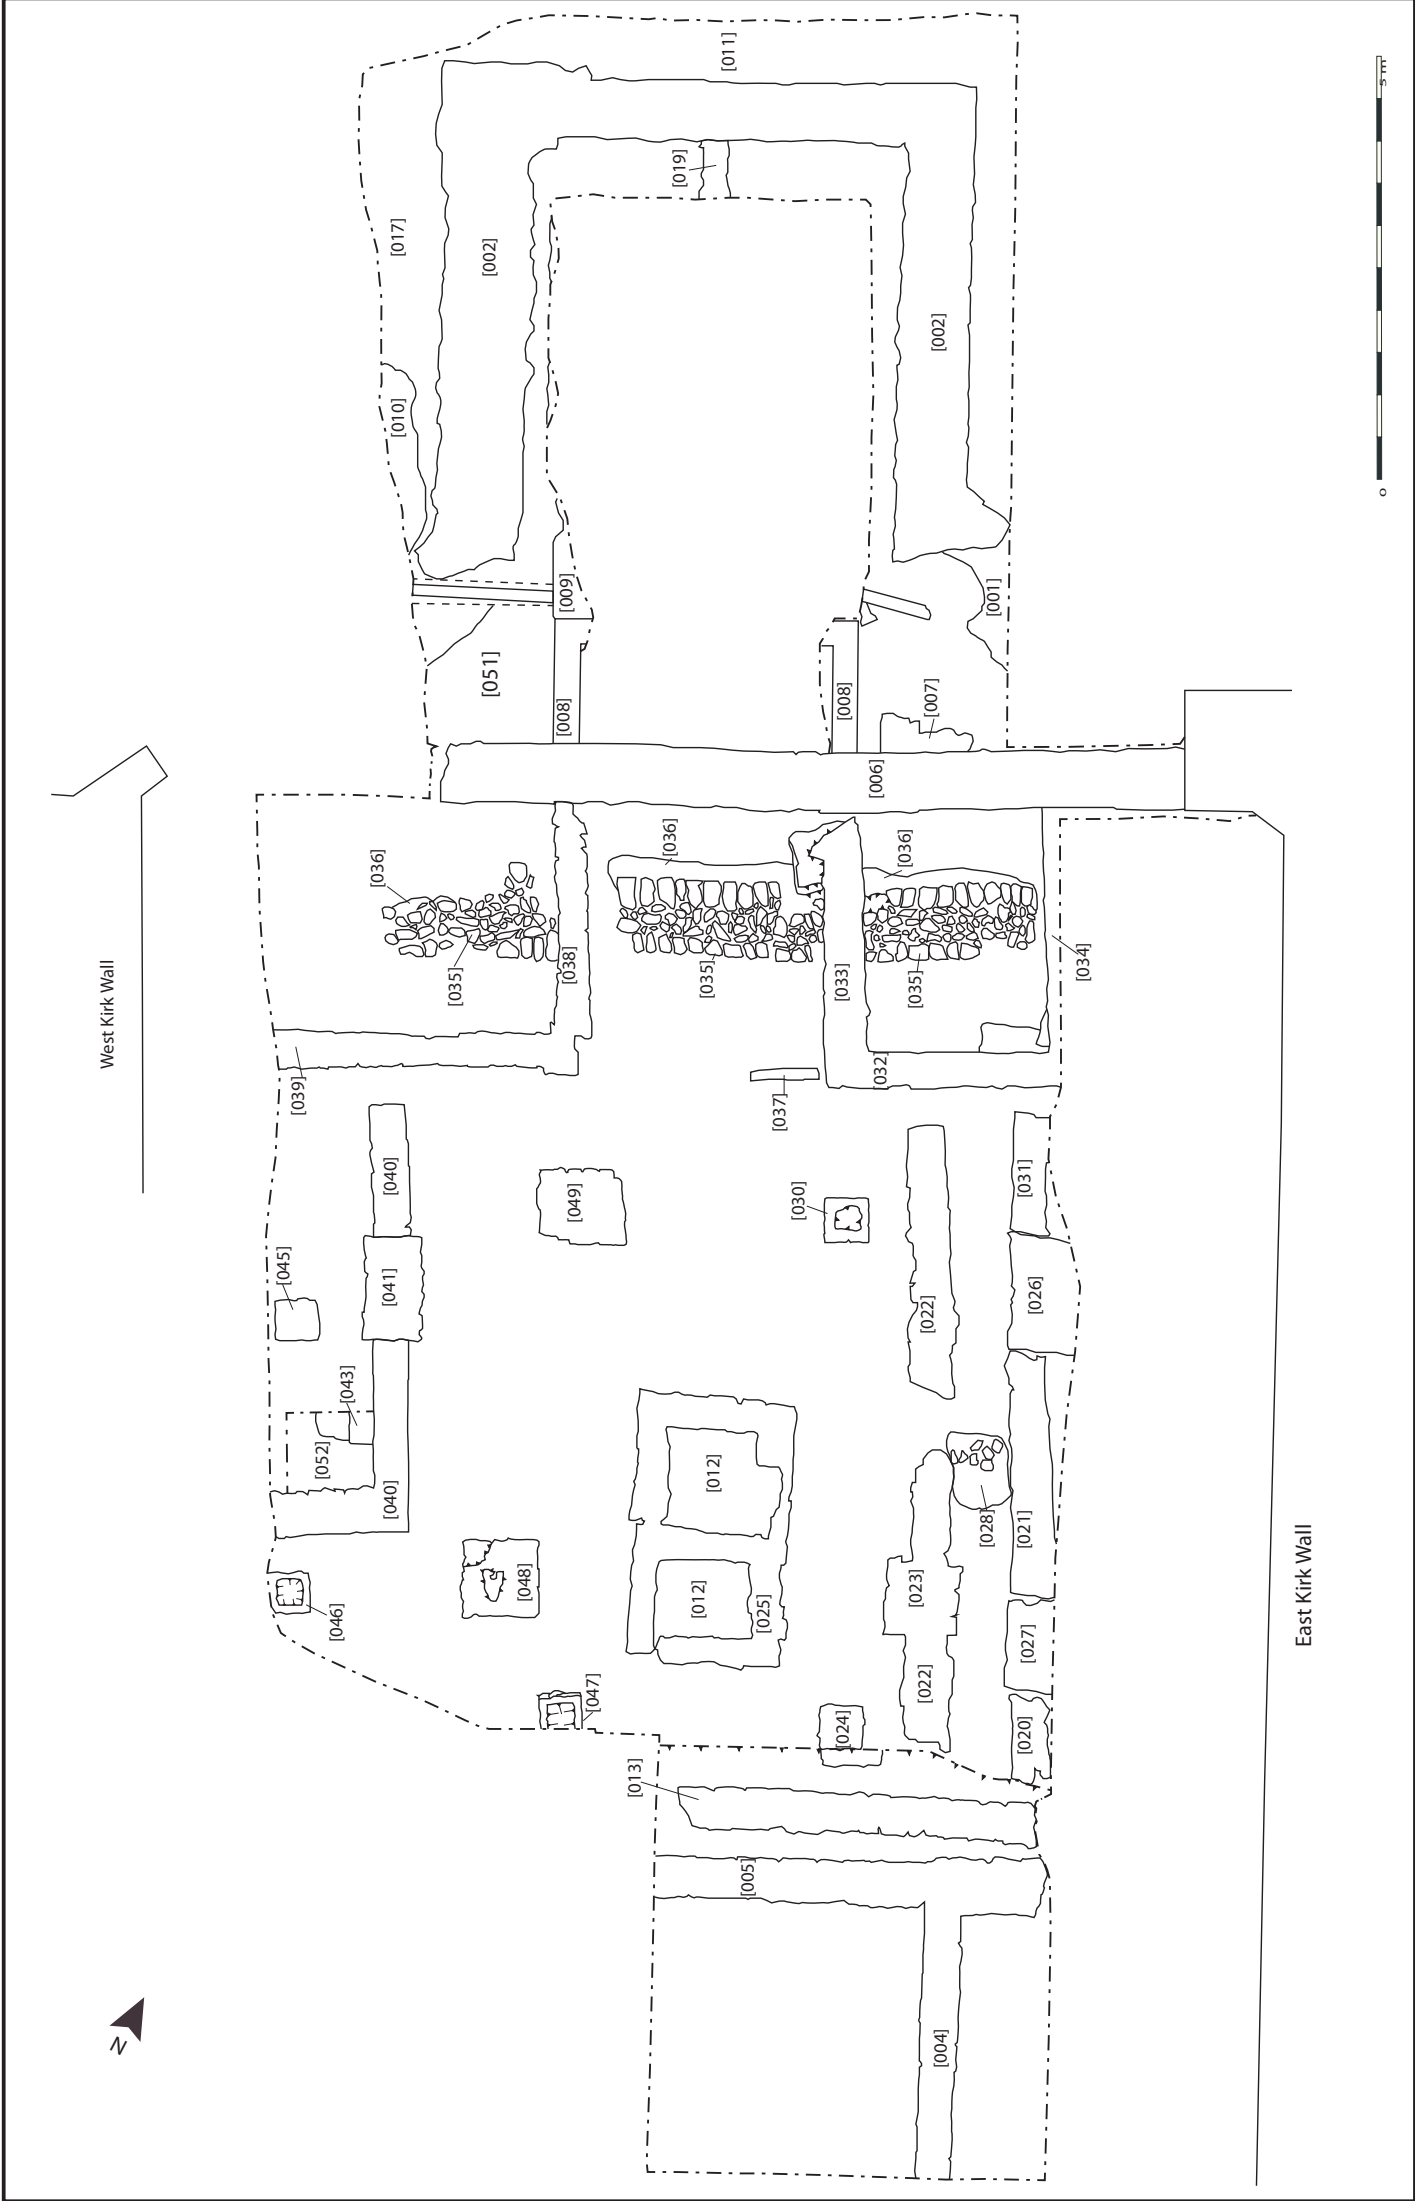
Figure 2 - Plan of features from excavation
