Salamander Place, Edinburgh (Phase 1): Evaluation and Excavation, Data Structure Report

AOC 22075

15th June 2012

Salamander Place, Edinburgh (Phase 1): Evaluation: Data Structure Report

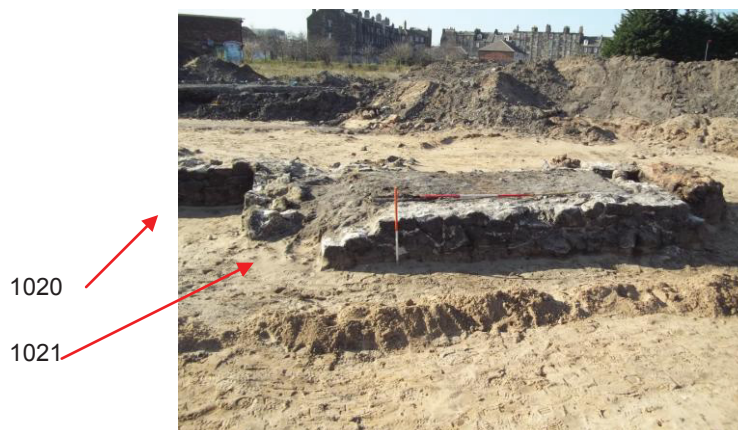
Plate 1: Wall (1020) and room (1021)

4.3.2 Two features were located in the southern part of Area 1. Firstly, the remains of a long wall (1020) running NW – SE across the site (Figure 2; Plate 1). This wall was constructed from roughly-faced stone laid in random courses and bonded with lime mortar. It extended from the eastern baulk for a distance of 29.1 m with a width of 0.55 m and survived to a height of 0.45 m. At the western extents of the wall were the remains of a small room (1021) tied into the northern face which measured 5.9 m by 2.3 m. This wall identified as (101) and (204) in the evaluation may also be associated with robber trenches (603) and (503) also identified during the evaluation (Figure 2).

- 5.2 Firstly wall (1020) and its northward projecting room (1021) can be clearly seen identifying this structure as the northern wall of the rope works. Its path can be traced from Area 1 toward the west where the robber trench (503) and (603) may mark its placement. The concrete raft/wall foundation (1019) running to the south and parallel to (1020) could be taken to be the southern wall of the rope works. However (1020) has no such foundation to it and the form of (1019) has more similarity with regard to its form to (1004) the foundation of wall (1002) in Area 1. Despite this difference its path clearly aligns with the stone wall remains of (3011) in Area 3 which, does not sit on a concrete foundation. It is possible of course that due to slumping of the original building due to the soft underling sand that repairs were necessary at a later date and hence the concrete underpinning.

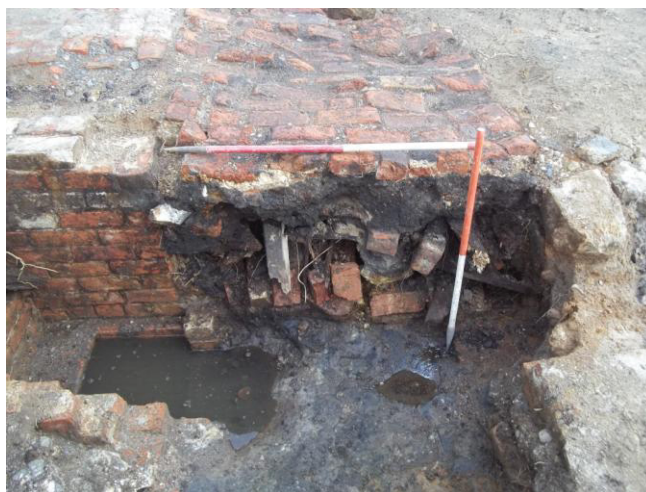
Plate 2: South facing section through pit (1066)

- 4.3.4 The remains exposed in the northern sector consisted of an industrial furnace and flues showing evidence of much alteration through time, plus associated building foundations and floor remains all truncated by later structures. The earliest features within this sector are represented by stone structures (1047) and (1050). The remains of (1047) formed a small room or building built from stone measuring 3.5 m E – W along its northern face by 3.9 m N – S by 1.9 m along its southern edge. The partial remains of a brick floor (1075) and an internal wall (1074) were revealed in a section dug through the northern end of the building but were not seen within a section dug across the southern extent. The building had been back filled with a light grey mix of crushed mortar and small stones and sand, through which a large pit had been dug (1066) measuring 4.2 m N – S by 1.6 m E – W by 0.7 m deep. At its northern end the pit was seen to have vertical sides and an uneven base. However at the southern end the pit appeared to have a mortar lining (147/9). The fill of the pit (1068) consisted of very loose black silty sand containing frequent building rubble (bricks and wood and mortar fragments). Floor (1048) had been built over the top of the pit and due to the loose nature of the fill had become sunken and distorted.

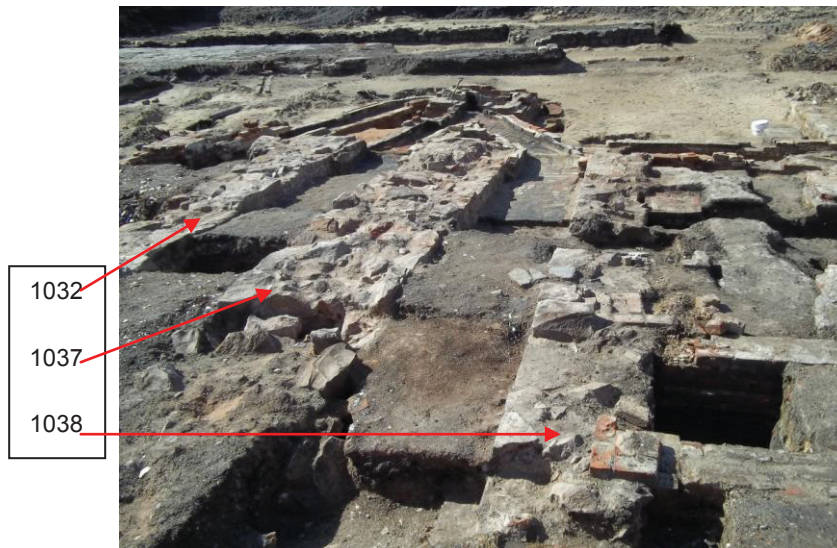
Plate 3: Stone flues (1032), (1037) and (1038)

4.3.9 As noted above the industrial complex was altered through time. The alterations are mainly concerned with the construction of new flues running off the stone walls. The first alteration appears to be the construction of two new brick flues. One (1034) extended from the southern mouth of stone flue (1032/7) and one (1035) from stone flue (1037/8) also running south (Figure 4; Plate 6). Both were built from red brick with the inner faces lined with yellow fire bricks. The base of these flues (1036) was a continuous spread of brick work built directly onto the natural sand on a bed of lime mortar. Where (1036) encountered the earlier flue (1049) at the mouth of (1032/7) it merely abutted the earlier brickwork, however at the mouth of (1037/8) it cut through and removed the earlier flue. Within the mouths of (1032/7) and (1037/8) the floors rose up forming a ridge before continuing into the stone channels as (1041) and (1042) respectively. At the apex of the ridges, in both cases there was an iron strip running across the floor and continuing up the sides (1043) and (1044). These remains were much corroded and their function can only be hypothesized as some sort of mechanism controlling air flow. At their southern extents both these flues converged and joined and entered a square brick built structure (1027) (Figure 4).

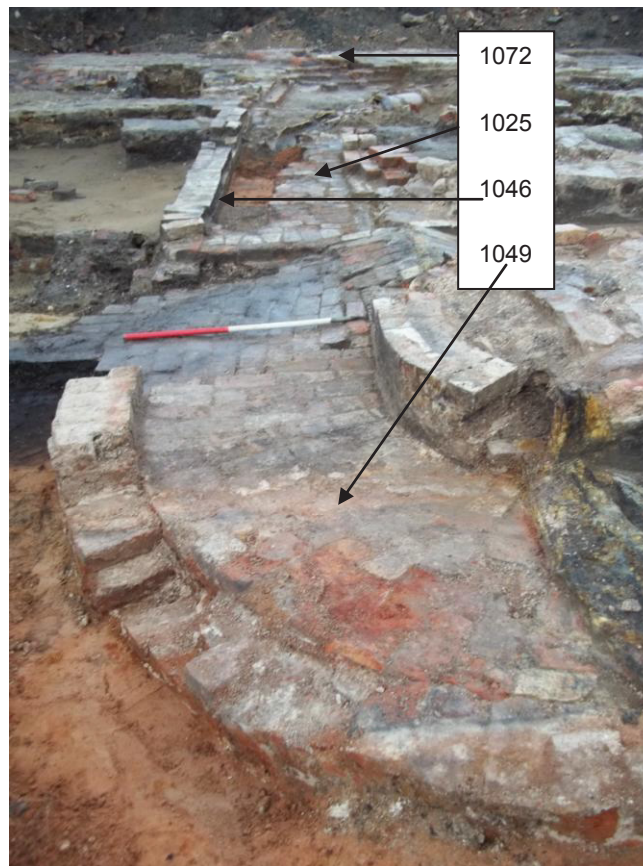
Plate 4: Flue (1049)

- 4.3.7 The earliest form of the complex is represented by remains (1049), (1045), (1046) and (1072) (Figure 4). Remains (1045/6) and (1049) together represent a brick built flue which enters/exits the mouth of flue (1032/7) and immediately turns 90° to the west (Figures 3 and 4; Plate 4). Although truncated by later alterations, it can be traced for a distance of 9.2 m where it meets structure (1072). The westward path of the flue is not straight and it takes a slight deviation where it encounters the northern edge of building 1047 implying that this structure was *in situ* at the time of the flues construction. The bricks in the base of the flue are mostly unfrogged red bricks whilst the inner faces of the walls of the flue (1046) are lined with yellow fire bricks.

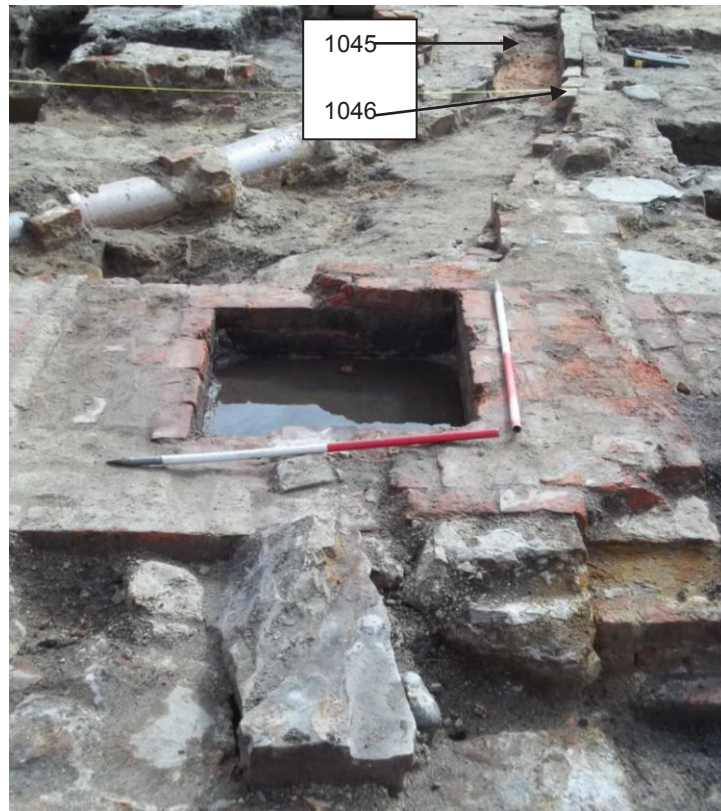
Plate 5: Chimney base 1072

- 4.3.8 Feature (1072) is again built from red brick forming a structure 2.2 m square (Figures 3 and 4; Plate 5). With a central square hole 0.9 m across. A black sooty deposit (1078) filled the base of the hole of which the sides were also blackened. The foundations of this structure consisted of a large square concrete base over 1 m in depth. The absence of fire bricks within the construction of this structure indicates that it was not exposed to great heat as one would find with a furnace, but the sooty deposits may indicate that exhaust gases/fumes were travelling along the flue and leaving via (1072) which could represent a chimney base. If this is correct any heat source should be at the northern end of (1032/7) but unfortunately this area had been badly truncated by modern activity. It is believed that wall (1038) is contemporary with (1037) and (1032) based on construction style however there is no evidence due, to the later alterations, of how it fitted in to the complex at this time.

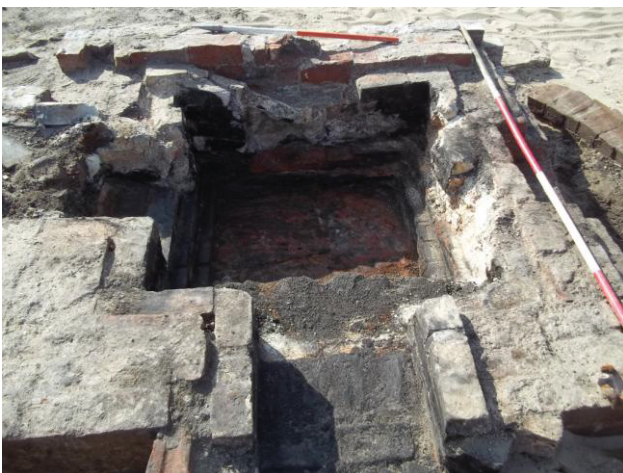
Plate 7: Furnace 1027

The structure had an opening measuring 0.5 m wide in the northern face where the converged flues (1034) and (1035) entered and a second in the eastern face through which a third flue (1029) entered (discussed below). In addition to the two openings there were two niches built into the outer southern and western faces. The function of these niches is not clear but they are of similar size to the openings and may have been constructed to allow for the addition of new flues in the future. The presence of the fire brick lining within this structure and the deterioration may indicate that these remains represent a furnace (although it is not clear where air was drawn from) with the flues taking heat away as indicated by a deposit of soot on the bricks. If this assumption is correct then the flow of air through the earlier stone flues has been reversed. The vast majority of the bricks used in the construction of the furnace and the two associated flues are stamped *W Hunter & Co. Portobello*. This company was only in business for only a short length of time from 1873 to 1881 thus providing a short date range in which these alterations were carried out.

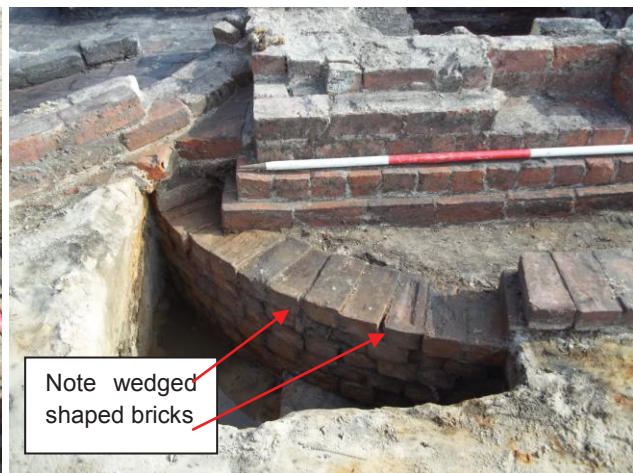
Plate 8: Detail of furnace 1027 foundations

4.3.11 Furnace (1027) had been built on a base of concrete (1052) which was surrounded by a ring of bricks. These bricks were unstamped and laid as headers forming a circular structure. To achieve a good and regular curve every third brick was wedged shaped (Plate 8). The full depth of these foundations was over 2 m with a diameter of 3.5 m. The size of the foundations suggests that the overlying furnace superstructure was of considerable size. The surrounding brickwork extended above the top of the inner concrete core and may have continued upwards forming an outer shell/skin to the furnace.

1052	Foundations of furnace (1027) Circular in shape. Lime concrete core surrounded by outer brick skin. Brick size 240 mm x 112 mm x 70 mm. Every third brick is wedge shaped in order to form curve. Bricks laid as headers and bonded with lime mortar. Diameter 3.5 m. Depth over 2 m.
1053	Flagged floor remains east side of site
1054	West side of stone lined pit
1055	Brick built southern end of pit 1054
1056	Brick surface
1057	Same as 1053
1058	Brick surface
1060	Stone wall
1061	Brick building
1062	Fill of 1061
1063	Cut of square pit Sub rectangular in plan with near vertical sides and flat base. Filled by (1064) and (1065). Measures 1.4 m N – S x 1.2 m E – W. Depth 0.26 m
1064	Fill of 1063 Loose dark grey sandy silt. Frequent brick fragments and small stones. Depth 0.26 m.
1065	Brick lining west and north side of pit 1064 Brick built (250 mm x 115 mm x 70 mm). Bricks unfrogged and laid as a single line of stretchers aligned N – S at western edge of pit and E – W at northern edge of pit. Measures 1.5 m N – S and 1.0 m E – W. Ht of three courses 0.25 m

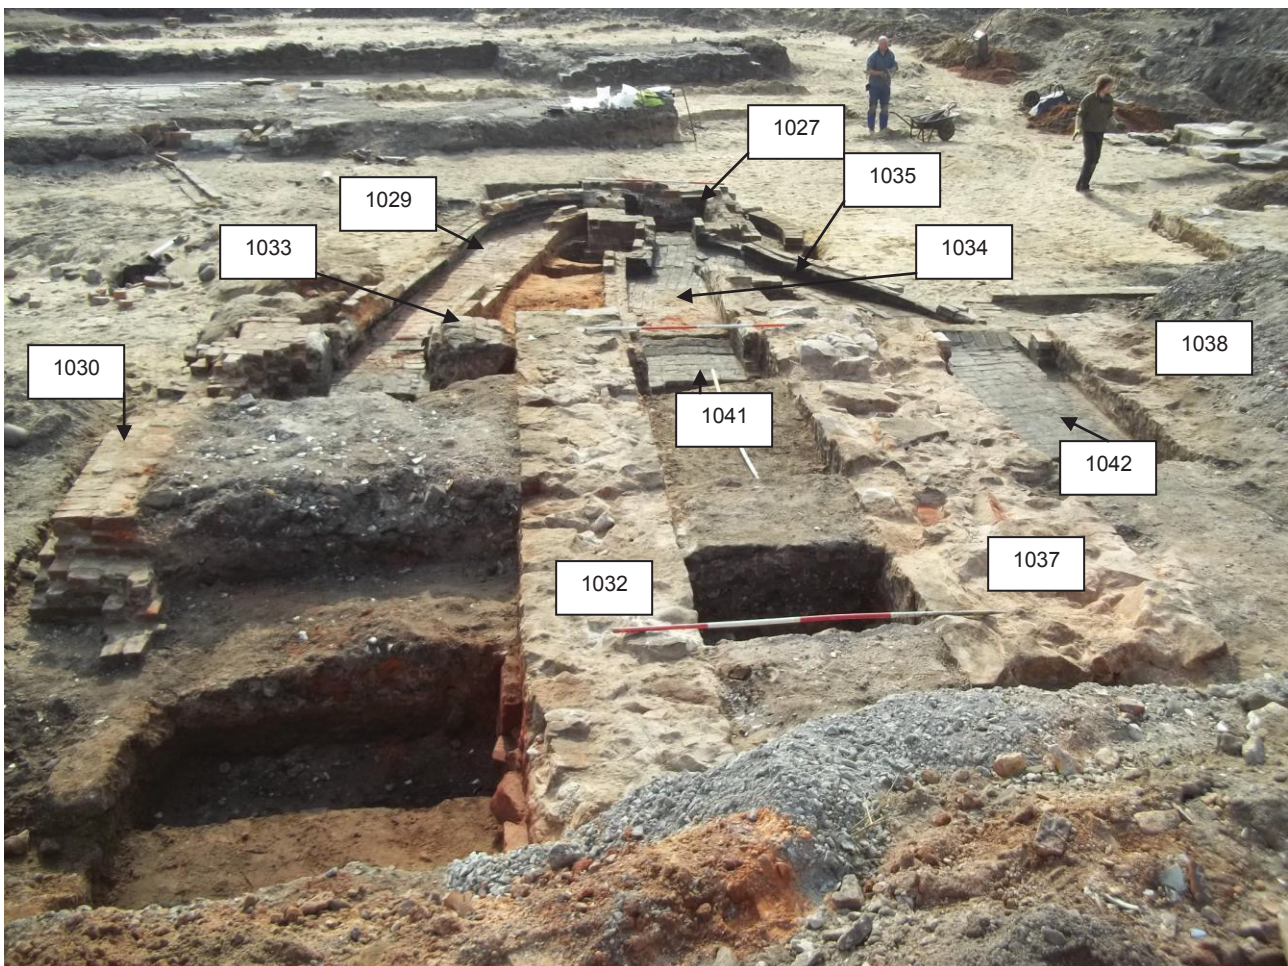
Plate 9: Furnace and flue structure from north

4.3.12 The next major alteration was the addition of a third flue (1030) and (1029) (Figure 4; Plate 9). This was constructed by the building of a large thick brick wall (1030) with a stone base parallel with and along side (1032). The inner face of this wall was lined with fire bricks. The height of the brick work was 0.6m with stone foundations 0.3 m high. The wall was 1.3 m

wide and it formed a flue/chamber 2.6 m wide with the stone wall (1032) to the west. The width of the southern end of the flue had been reduced by the construction of a brick pillar reducing the width at this point to 1.0m. Leading from the mouth was a simple brick flue (1029) similar to (1034) and (1035). Likewise this third flue ran to the furnace (1027) but entered through the eastern gap. This flue is thought to be later than the others due to differences in its construction and form. Firstly, both (1034) and (1035) share the same brick base (1036), while (1029) is entirely separate. Secondly both (1034) and (1035) rise up at the entrance of the stone built sections, whereas (1029) remains flat. In addition the eastern face of wall (1032) was scorched a bright orange. This scorching covers the entire height of the wall and extends below what would have been its floor level. As this area was subjected to the excavation of a large waste pit following its disuse it may follow that this scorching is post use.

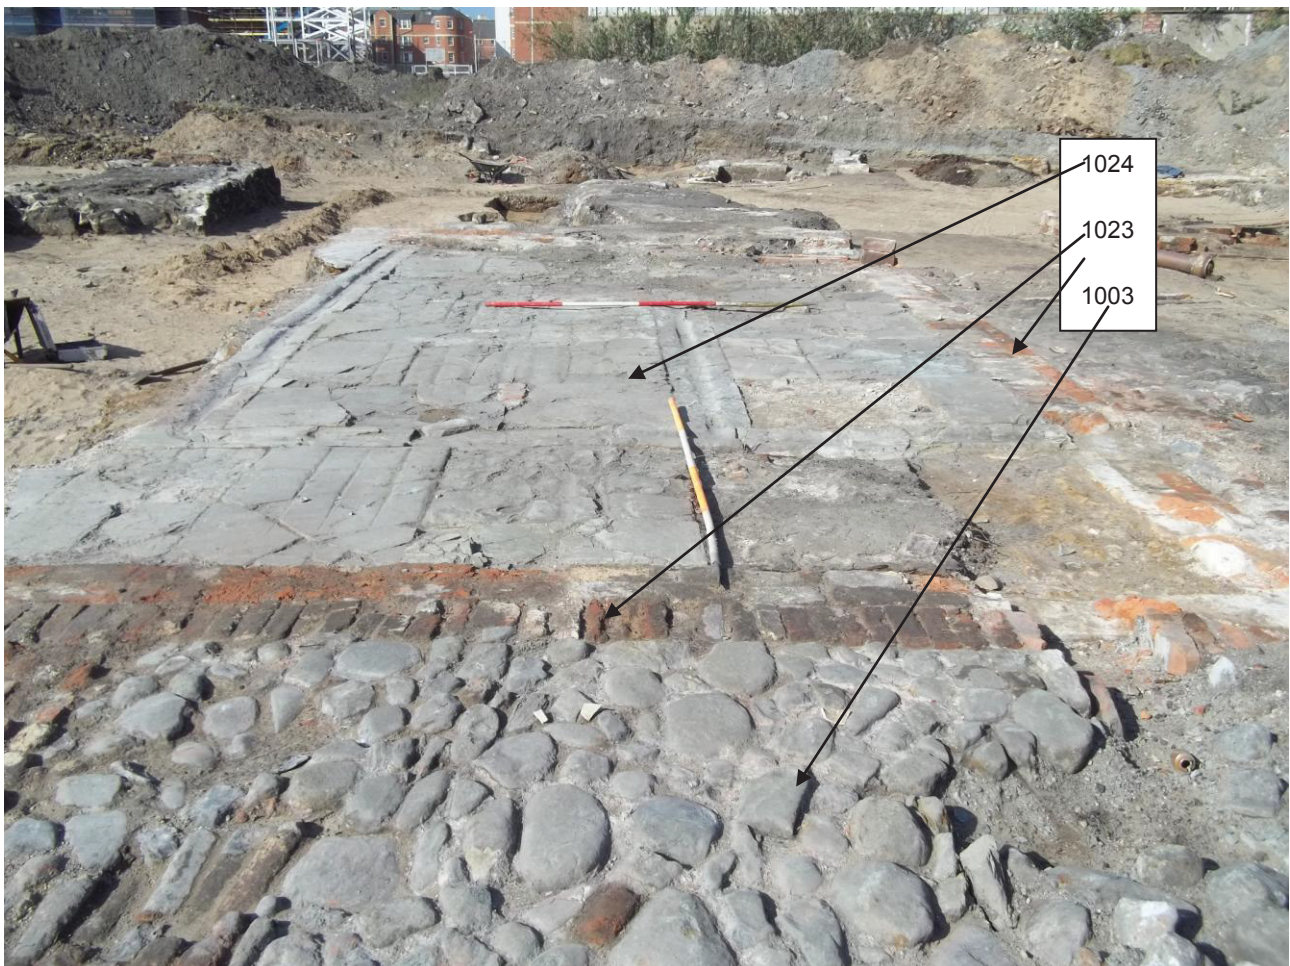
Plate 10: Surface (1024) and surrounding wall (1023)

4.3.18 The next phase in Area A relates to the disuse of the flues which are back-filled with late Victorian rubbish (1031), (1039) and (1040) consisting of ash and cinders mixed with a larger concentration of ceramic fragments. A new building (1002) is then built which covered much of Area 1 (Figures 3 & 4) and cut through the aforementioned remains. This building was constructed from unfrogged bricks laid on a lime concrete foundation containing large brick fragments. Associated with this building were cobbled yard surfaces (1022) and (1116) to the north (Figure 4) and (1003) and (1026) to the south (Figure 3). The cobbled yard remains (1003) and (1026) surrounded a possible internal surface (1024) constructed from stone slabs with shallow drainage channels which in turn was bounded by a brick-built wall (1023). The drainage channels within the surface of this room suggest that it had some sort of industrial use rather than domestic.

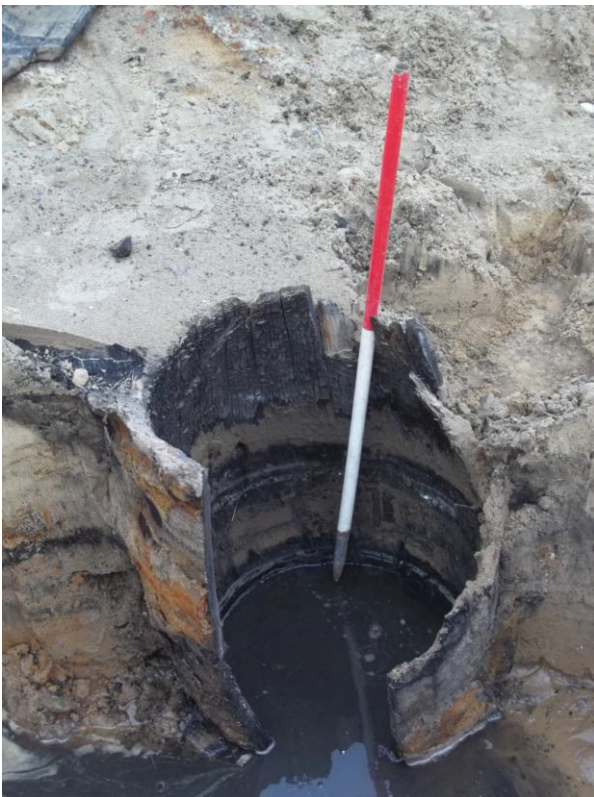
Plate 11: Barrel pit (1084)

4.3.20 Two barrel-lined pits were also identified. Firstly (1084) consisted of a simple barrel measuring 0.55 m in diameter at the top widening to 0.6 m at its mid point with a height of 0.72 m, which had been sunk into the natural sand. The base of the barrel was intact suggesting that its use was for storage rather than a wall lining or a sump (Figure 3; Plate 11). The second barrel pit (Figure 3: Plate 12) was sealed by the yard surface (1026). Here and it was contained within a more complex structure. Firstly a stone-lined pit (1125) was constructed from four edge-set sandstone slabs measuring 1.07 m east to west by 0.8 m north to south. Two brick-built walls (1126) and (1127) were constructed along the external west and east ends of the pit. The base of the pit was lined with lime mortar. A barrel (1123) was then place within the pit. The space between the barrel and the walls of the pit was then backfilled with dark grey sandy silt (1124) which contained occasional whole and fragmented bricks. Like barrel (1084) the base of (1123) was also intact again indicating storage. It is possible that the stone pit itself operated as storage tank but was found to be inadequate hence the placement of the barrel.

1083	Fill of barrel
1084	Barrel Barrel sunk into natural sand. No cut seen Diameter of barrel at top 0.55 m; centre 0.6 m. Ht 0.72 m. Base intact suggesting used for storage.
1085	Grey sand (dirty natural below (1081))
1086	Wall foundation Brick built (250 mm x 115 mm x 70 mm). Bricks unfrogged and laid as headers edged with stretchers. Wall aligned E – W and bonded with lime mortar. Laid over (1081) and tied to (1087). Measures 1.75 m E – W x 0.37 m N – S. Ht 0.2 m
1087	Wall foundation Brick built. Bricks same as (1086). 99 frogged. Laid as stretchers. Forms H shaped structure. Bricks bonded with lime mortar. Covers area approx 6.1 m N – S x 3.0 m E – W. Depth 0.35 m (4 courses). Cut by wall (1002). Evidence of flagged floor remains and mortared surfaces within structure.
1088	Flagged floor Stone slabs up to 0.65 m x 0.48 m x 0.08 m. Upper surface partially worked. Laid on lime mortar base (1089)

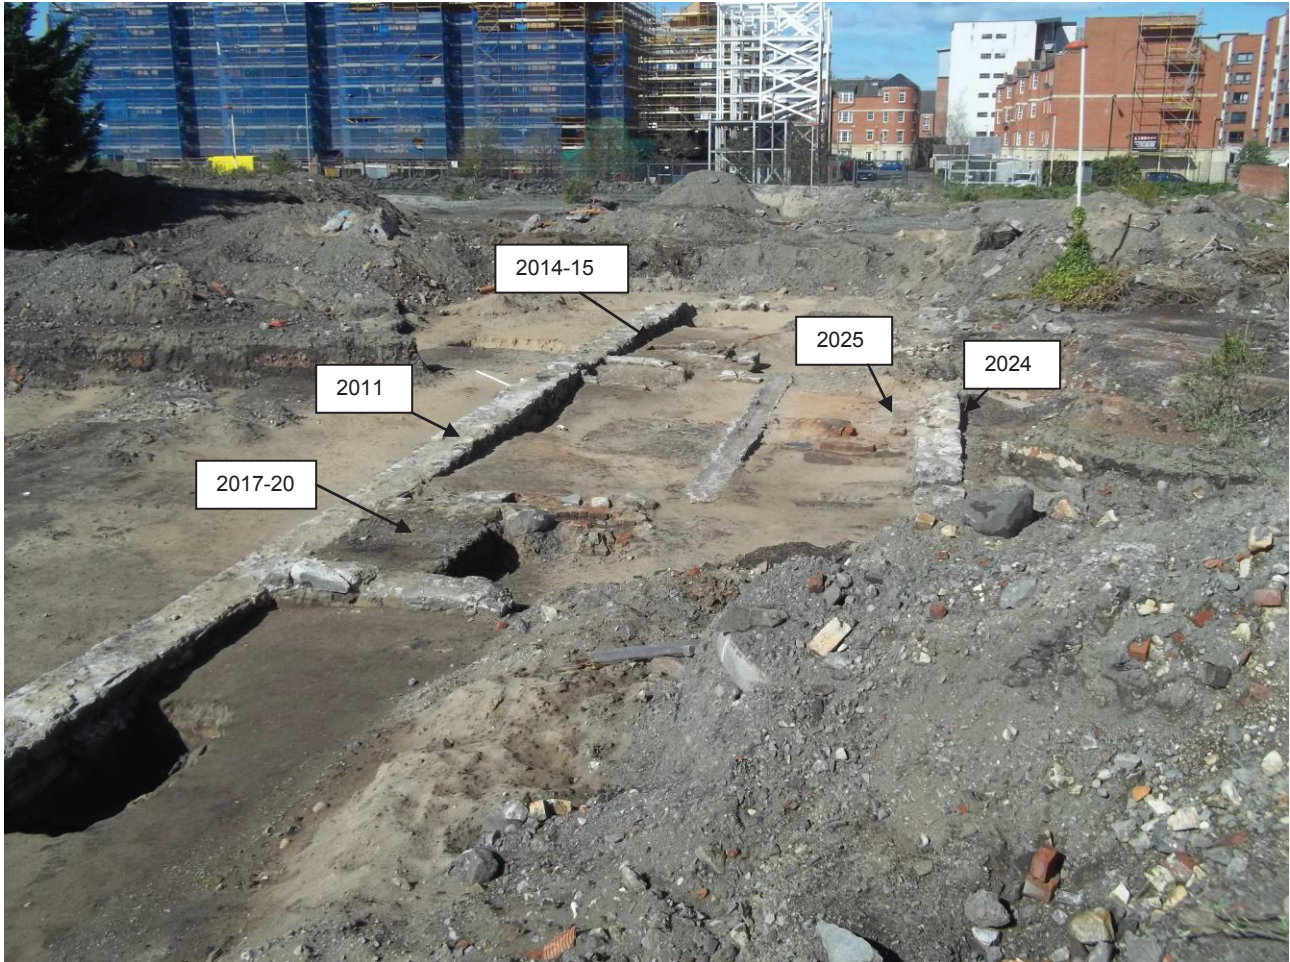
Plate 13: General view of Area 2 from east

- 4.4.1 This area (Figure 5; Plate 13) was dominated by the remains of three long stone built walls and a concrete raft/foundation, all of which were parallel and which crossed the site from NW – SE. The longest of these was wall (2011) which ran for a distance of 30.4 m (near exactly 100 feet). It was constructed from roughly faced stone and bonded with lime mortar. A possible return was located at the western end, however the evaluation showed that this wall continued toward the west (Trench 6; Context 610) and its alignment may indicate that it once joined up with Structure (3007). A return at its eastern end marked the wall's full extent in this direction. Both returns ran toward the north.

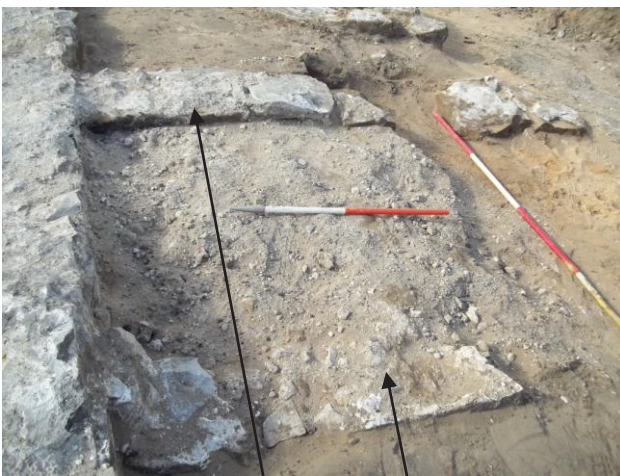
Plate 14: Walls (2014) and (2015)

- 4.4.3 Moving eastwards the remains of a possible room (Plate 14) were formed by walls (2014) and (2015). Both of these walls were tied into wall (2011) and both were stone built and bonded with lime mortar. No back wall was found associated with these remains which extended toward the north for 3.0 m and 1.2 m respectively and were separated by a distance of 1.6 m. The room was filled by a deposit (2016) of moderately compact yellow sand containing frequent mortar fragments with a depth of 0.2 m. It is not clear if this deposit was formed during the demolition of the building or was placed during its construction as a base for a floor.

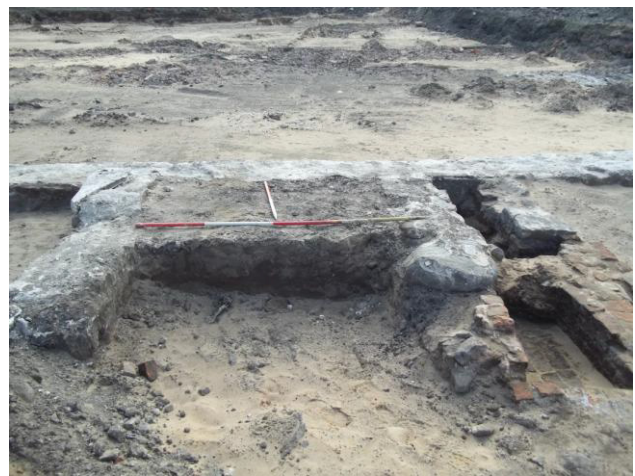
Plate 15: Structure formed by (2017-2020)

- 4.4.4 The next structure (Plate 15) encountered extending from the wall consisted of three stone walls (2017), (2018), (2020) with a brick component (2019). All the walls were built from roughly faced stone laid in random courses, bonded with lime mortar and tied into wall (2011). Wall (2017) was the furthest west and extended for a distance of 1.2 m. It was separated from wall (2018) to the east by a distance of 0.5 m which in turn extended for a distance of 2.0 m and was separated from wall (2020) by 2 m. Wall (2020) was 2.4 m in length. Brick structure (2019) consisted of two brick-built walls tied into (2017) and (2018) with a brick floor. The resulting structure therefore took the form of a room flanked to the west by a channel.

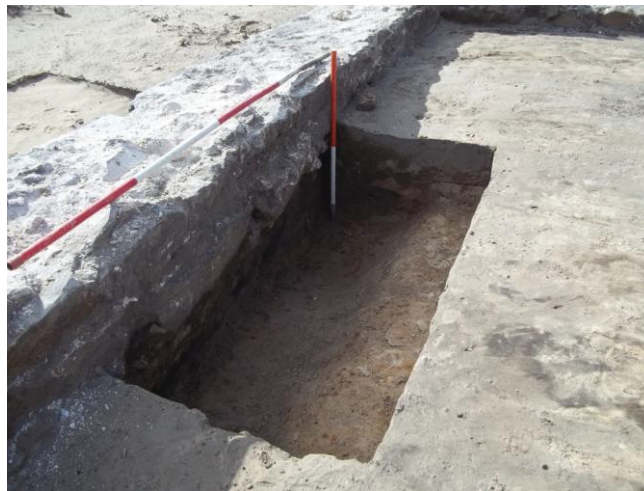
Plate 18: East-facing section of ditch (2022)

- 4.4.10 Finally what appeared to be a buried soil (2021) was located surrounding the eastern extent of (2011). A test-pit dug through this deposit found 19th/20th century pottery (not retained) showing it to be of recent origin. However the test-pit revealed the presence of a ditch (2022) sealed by this deposit which ran directly below the foundations of the wall (2011) which also cut (2021). This ditch had a depth of 0.25 m and was 1.8 m wide. It contained fill

(2023) of moderately compact grey sand from which large fragments of worn brick were recovered (not kept). Due to the depth of the ditch below the wall it is not believed to be associated with the walls construction.

2021	<p>Buried soil</p> <p>Moderately compact dark grey sand. No inclusions. Finds of 19th 20th century pottery (not kept). Depth 0.3 m. Abuts east end of wall (2011) and east of wall (2020).</p>
2022	<p>Cut of ditch</p> <p>Linear cut aligned NW – SE. Full extent unknown. Concave sides and base. Cuts natural sand and sealed below (2021) and (2011). Filled by (2023)</p> <p>Depth 0.25 m, width 1.8 m</p>
2023	<p>Fill of 2022</p> <p>Moderately compact dark grey sand. No inclusions. Very occasional worn brick fragments (not kept). Only fill of (2022).</p>
2024	<p>Stone wall</p> <p>Stone size up to 0.5 m x 0.35 m x 0.15 m. Stones are roughly faced, randomly coursed and bonded with lime mortar. Cuts natural sand but no construction cut seen. Abuts brick work (2025) to south.</p> <p>Dimensions; 7.6 m x 0.7 m x 0.4 m.</p>
2025	<p>Brick wall</p> <p>Brick size 240 mm x 110 mm x 70 mm. Mix frogged and unfrogged red and yellow fire bricks Bonded with lime mortar. Remains form L shape and abut wall (2025) to north. Surrounded by Heat exposed sand (2026).</p> <p>Dimensions; 4.0 m x 0.7 m (width west end), 1.9 m (East end) x 0.14 m.</p>

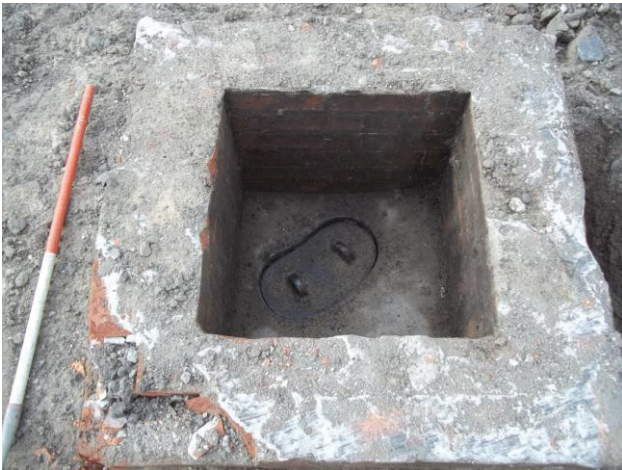
Plate 18; Manhole (3005)

respectfully. Of the two (3005) was more complete surviving up to 0.69 m in height. The bases of both structures were constructed from a layer of lime mortar into which a kidney shaped lid covering an opening into a pipe was embedded (Plate 18). Both had been back filled with compact dark grey/black sandy silt containing frequent ash and cinders and brick rubble (3002) and (3006). It is not clear if these structures are associated with the rope works or are with later development of the site.

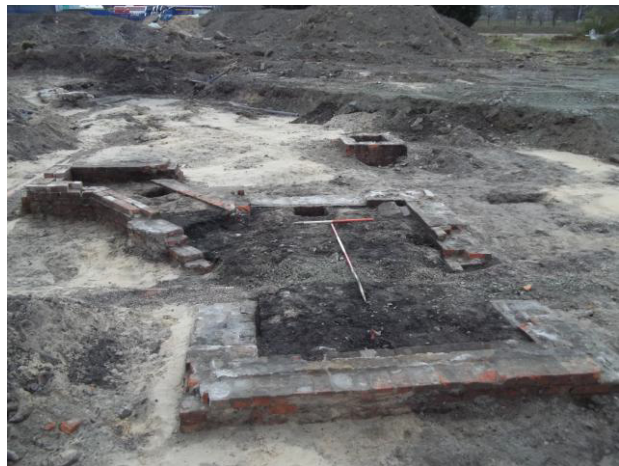
Plate 19; Building (3003)

- 4.5.2 The third structure (3003), built from the same brick type, comprised a large rectangular building with an off shoot running diagonally towards the east from the NS corner (Plate 19). The back-fill (3004) was a similar deposit as the man-holes and excavation showed the structure to have a concrete floor. No function can be attributed to this building but it is likely to be of a similar date as the manholes.

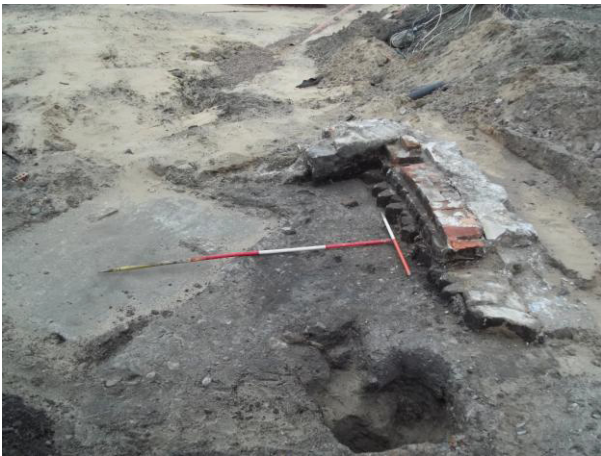
Plate 21: Wall (3011)

- 4.5.4 The final structure within Area 3 is likely to relate to the rope works that once occupied this part of the site. It took the form of a single stone built wall (3011) aligned NW – SE. It was built from roughly worked stones up to 0.5 m by 0.25 m by 0.16 m in size and was bonded with lime mortar (Plate 21). The remains extended for 4.0 m with a width of 0.6 m and stood to a height of 0.2m. These features are likely to be related to the concrete raft/foundations (1019) seen in Area 1 and together form the southern wall of the Leith Ropery.
