Mayflower Plaza, Commercial Road, Southampton, Hampshire: An Archaeological Evaluation Report

Planning Reference : 12/00294/SCO

AOC Project No: 32110

Date: July 2012

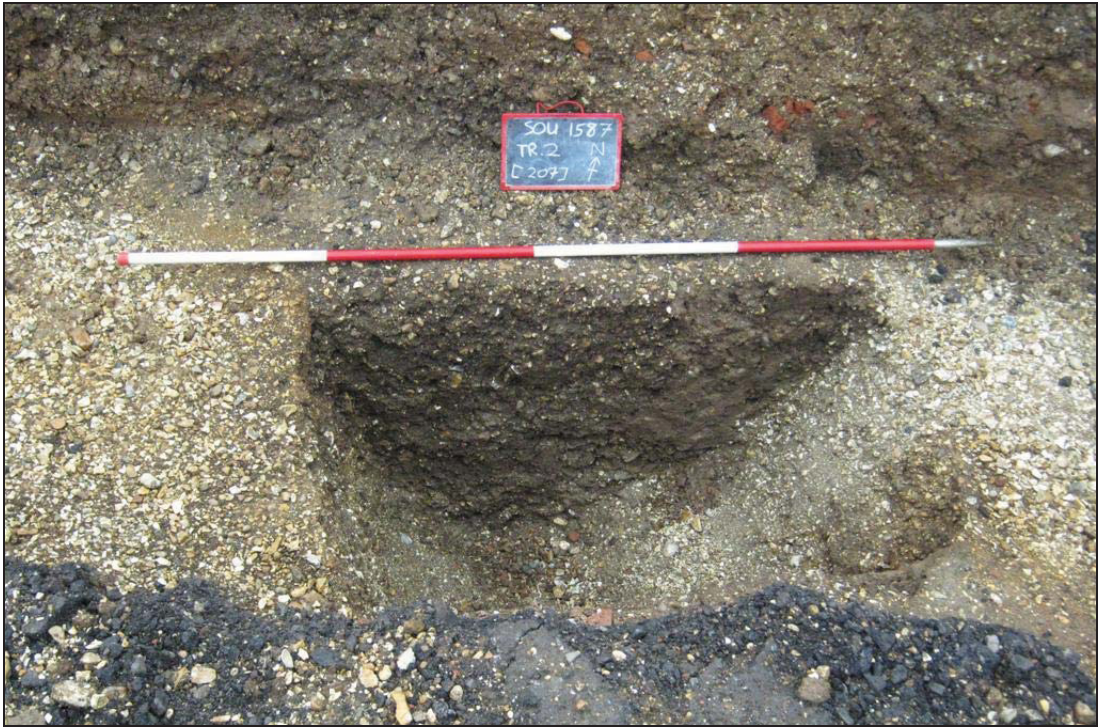
Plate 1: Ditch 207. Looking North

- 6.2.3 The earliest cut feature in the trench was a ditch running north-south [207]. This was 1.70m wide, and had a rounded base. . The top of the ditch lay at 12.05mOD and was present to a depth of 0.96m. The two sides were of different form. The western side of the ditch was near-vertical, while the eastern side sloped more gently at around 45°. The steep side is a surprising element, given the potential looseness of the terrace gravel it was cut through. There were two fills. The lower fill dominated the east side of the ditch, and was soft dark yellowish brown sandy silt (208) with occasional rounded gravel inclusions It may have derived from upcast material from the ditch digging, or possibly a bank on the eastern side. The upper fill appeared to have filled the ditch as a

single event, and was strong brown sandy silt (206) with frequent small-medium varied gravel. The fill can only be generally dated to between 1500 and 1900: one piece of fragmentary brick and two pieces of grey slate were noted.

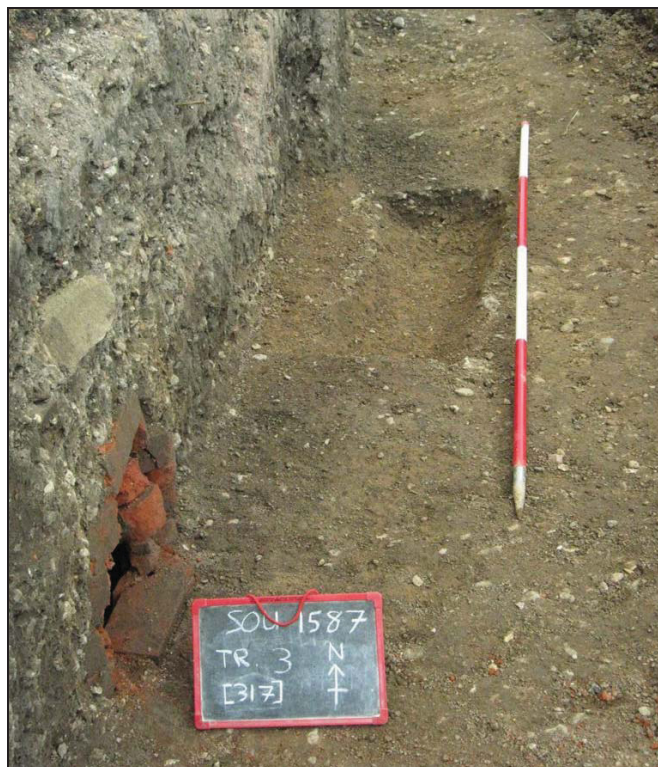
Plate 2: Feature 317, Looking North

- 6.3.3 The earliest event apparent in the trench was a short, curving length of a narrow ditch [317], just 0.22m deep with a rounded base. It was 0.50m wide and had a sharp interface with the layer above. The fill was dark yellowish brown sandy silt (316) with moderately frequent rounded gravel. Two pieces of pottery from the trench come from domestic vessels, and date from the 15th century. There was no occupation horizon associated with this feature, so its function is unclear. The top of the feature lay at 7.71mOD.

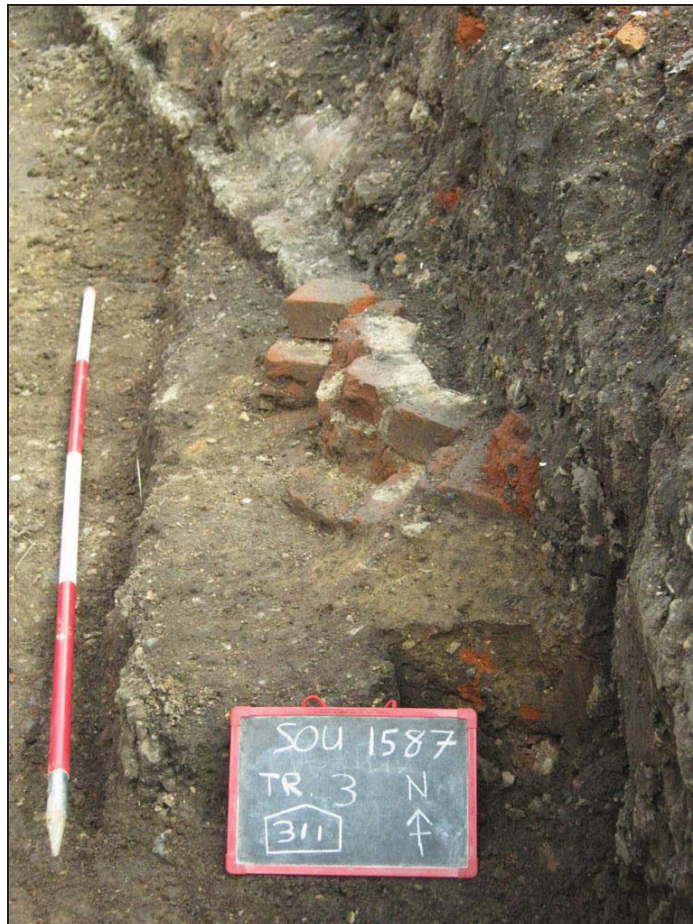
Plate 3: Pipe in Trench 3

- 6.3.5 Both soakaways were constructed of soft red bricks and held together with cement-rich sandy mortar. The bricks measured 230mm by 110mm by 70mm, consistent with a late 19th or early 20th century date. That on the west side of the trench was hardly seen [314], and lay within a cut [315] backfilled with soft dark yellowish brown sandy silt (313). The second soakaway [311] was seen to have a domed top, and also lay within a backfilled (310) cut [312]. The top of this lay at 8.07mOD. Of note was a ceramic pipe (308) that appeared to feed into the soakaway. This was present for 10m in the trench, entering from the direction of Commercial Road and Conduit House. It was mostly encased in concrete (308), and was manufactured by Kinson Pottery Ltd, Poole. This company has been in business since 1858. An additional pipe appears to feed into this (309). The major pipe was recorded at 8.16mOD at its northern point, exiting the trench southeastwards at 8.11mOD.

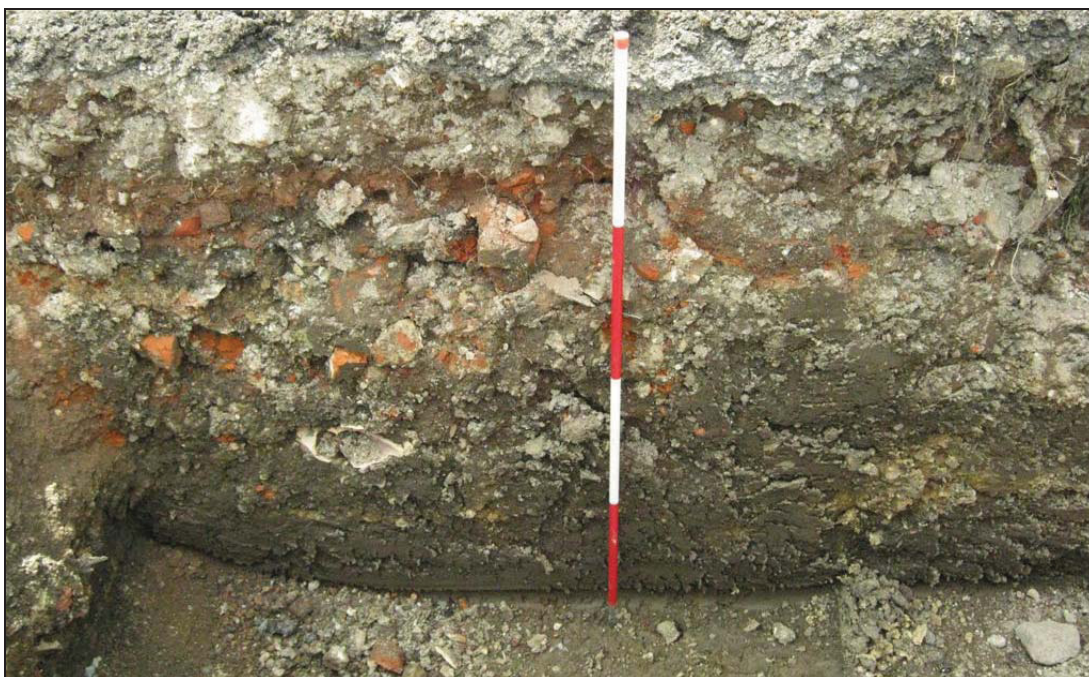
Plate 4: Sample Section of Trench 4

- 6.4.4 Above the services and the topsoil, the ground was made up by a maximum of 1.40m by a series of 19th and 20th century deposits. The first was a dump of redeposited terrace gravel (405), with a dump of dark greyish brown topsoil above (404). This lay at 9.81m at the northwest of the trench, to 9.30m at the southeast. Occasional fragments of porcelain, and building material proved it to post-date 1850, and probably represents upcast material from basement digging, forming garden soils contemporary with the former housing on site.

6.4.5 The topsoil was sealed by a dump of demolition material dominated by brick rubble (403), up to 0.70m deep, higher at the northwestern end of the trench. This represents the demolished 19th and 20th century houses from the site. Above this, 0.50m depth of made ground (402), again concentrated to the northwest was present, and was a mix of brown/ yellowish brown soil with building material, plastic, metal and general debris. This formed the subsurface to tarmac (401). The tarmac lay at 11.56m at the northwest end of the trench, dropping to 9.89mOD at the southeast end.

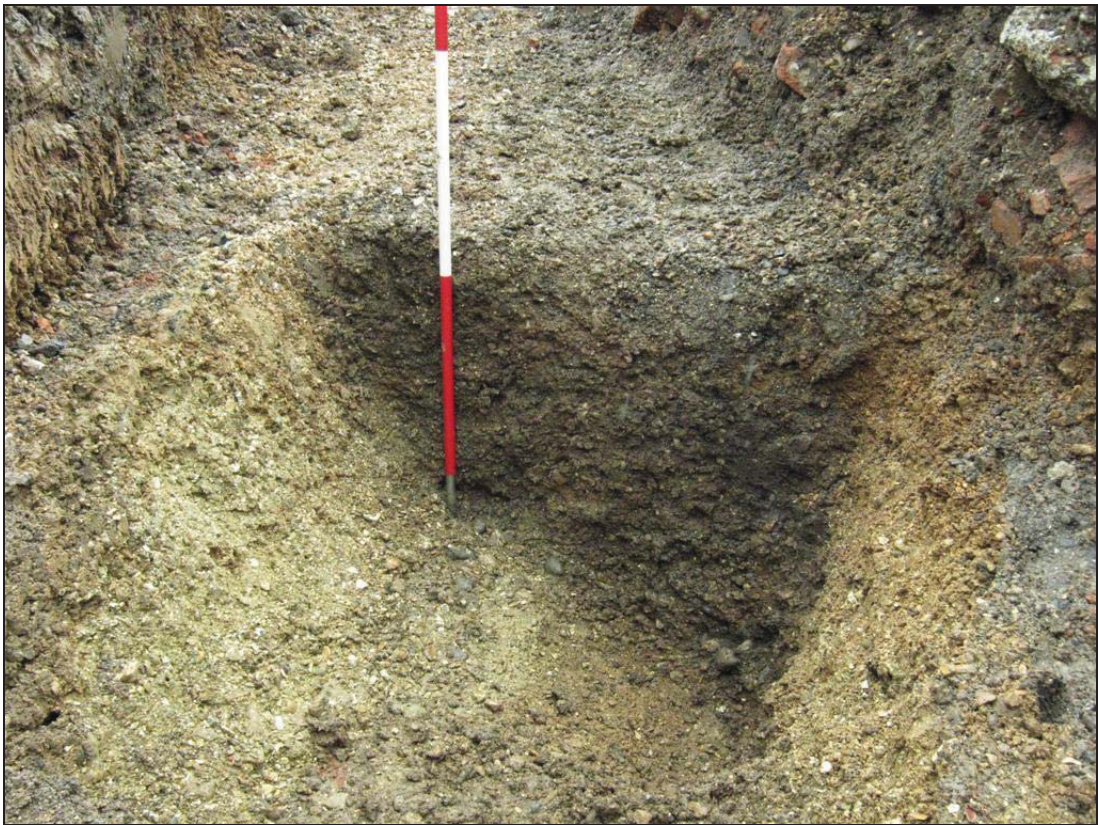
Plate 5: Ditch 513, Trench 5

6.5.3 At the northern end of the trench, and running more north-south was a ditch [513]. This had one near-vertical edge on the western side, and the eastern side had a 50° slope. The base was almost flat, lying at 10.75mOD. This profile strongly resembles that of a ha-ha; a hidden boundary suitable for keeping livestock enclosed. The ditch was present for 5.5m in the trench, and a slot 1.5m wide was excavated. The ditch was 0.98m deep, its surface at 11.79mOD. The primary fill was brown silty clay (512), and lay at the bottom of ditch to a depth of 0.08m. This was partially sealed on both sides by yellowish brown mottled sandy gravel (510 and 511), that most likely derived from slumping of the sides through erosion. These slumped deposits were sealed by a fill of mid brownish grey sandy silt (509) with occasional gravel inclusions and rare oyster shell. Pottery from this layer was collected; although small and few, a date of the late medieval period is suggested. In the absence of later finds, this 15th century date is considered the most likely. This fill was sealed by a deposit of dark brownish grey sandy silt (508), with small rounded gravel the only inclusions. A thin lens of mottled yellowish brown silty clay above this may represent further erosion of the sides (507). The top fill of the ditch was dark brown sandy silt, with small gravel inclusions (506). This was virtually identical to the topsoil.

found in Trench 5. The top of the ditch was identified at 11.79mOD where truncated by a crater, but probably lies as high as 12.19mOD beyond the truncation. The top of the same ditch lies at 12.05mOD next to Commercial Road, where the plans for Block A show a finished level of 12.75mOD.

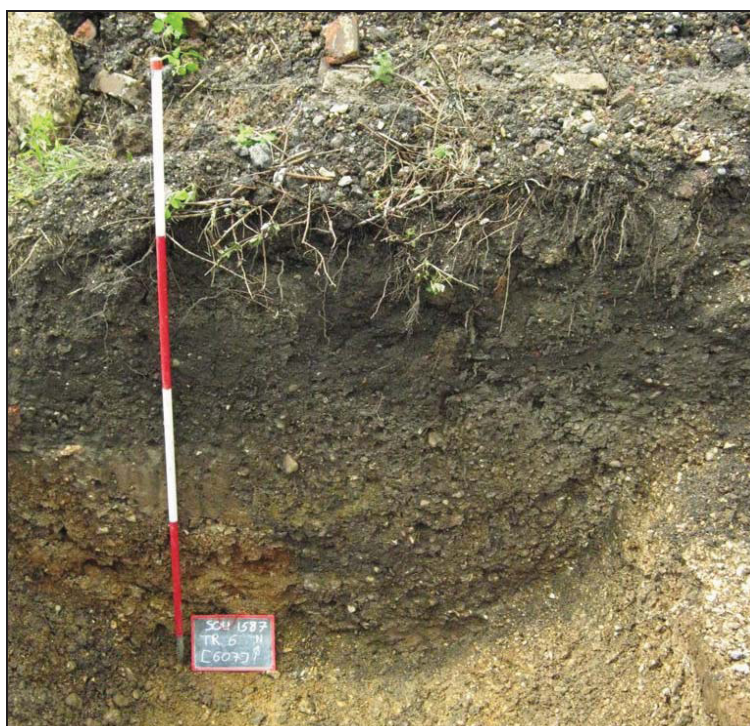
Plate 6: Ditch 607, Trench 6

6.6.2 The lowest deposit encountered was naturally-lain terrace gravel (614), lying in bands across the trench, as it sloped downhill from 13.65mOD in the northeast, to 10.00mOD at the southwestern end of the trench. The gravel was sealed, very patchily, by a thin layer of yellowish brown sandy clay subsoil (617). It is likely that this was most truncated by later construction events and reworking of topsoil. Two cut features were present across the trench. One was a continuation of the ditch seen in Trenches 2 and 5. This ditch [607] had one near vertical side, to the west, and a more sloping edge at the east. The base was rounded. It was 0.80m deep, lying between 10.25m and 11.05mOD. It appears that the western side had slumped in whilst the ditch was being established, since a deposit of mid brown clay (613) formed the upper part of the western edge, rather than the local terrace gravel. The lowest fill was mid brown clay (610), to a depth of 0.12m. The upper fill was dark brown silty clay (606) with high gravel content. Pottery within the fill suggests a medieval date.

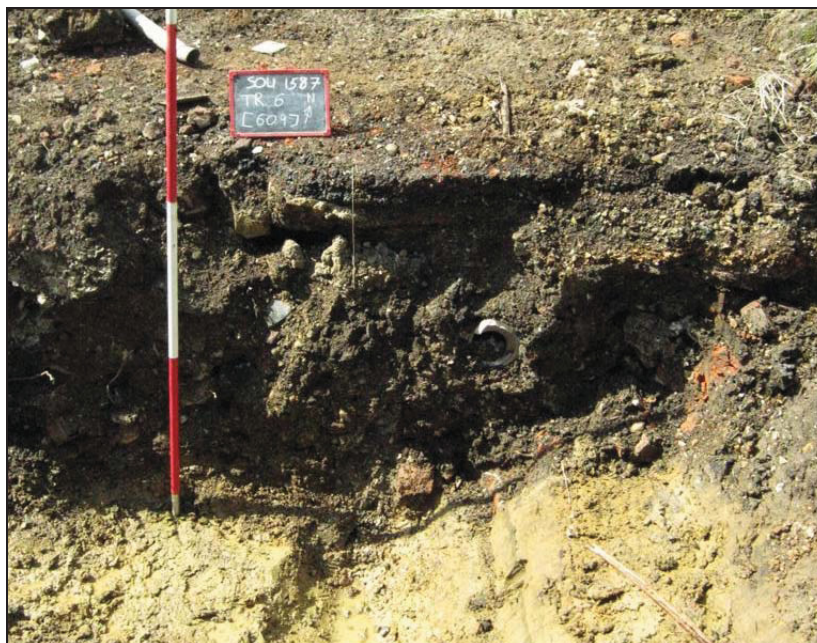
Plate 7: Feature 609

6.6.3 The base of second feature, running more southeast-northwest, oriented towards Conduit House on Commercial Road, was located 5.5m west of this boundary. The base of this linear cut [609] was bedded on, or possibly lined with, yellow clay (618). The cut had a rounded base, and was filled with sticky yellow silty clay with occasional charcoal flecks and gravel components (608). This feature was truncated to only 0.20m maximum depth, at 9.92mOD. The same truncation was seen to the northwest, in Trench 8, over the same feature.

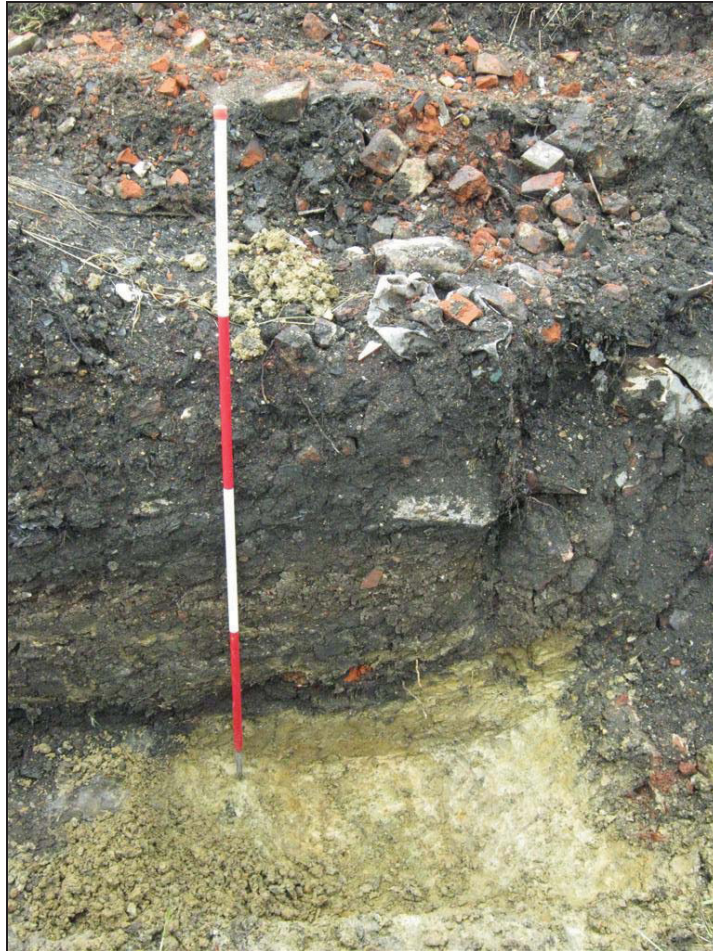
Plate 8: Feature 808

- 6.8.2 The earliest deposit, in common with all trenches, was terrace gravel, dropping from 10.70mOD in the northeast end to 8.80mOD at the southwest (804). The gravel was sealed by yellowish brown silty clay subsoil of 0.08m depth (803). One linear feature, oriented southeast-northwest, oriented towards Conduit House was revealed, [808]. The cut was 1.760m wide, and survived a maximum of 0.50m deep. At the base of the feature was solid yellow clay (809): it was unclear whether this was a naturally-lain band of clay within the terrace gravels, or added. This feature was filled with sticky yellow silty clay (807) with occasional flecks of charcoal within it. The function of this feature was compromised by a later intrusion into it [806], with an irregular edge, which was backfilled with dark brown sandy silty clay (805) with notable rubble components within it. This seems to be a deliberate robbing event into the feature.

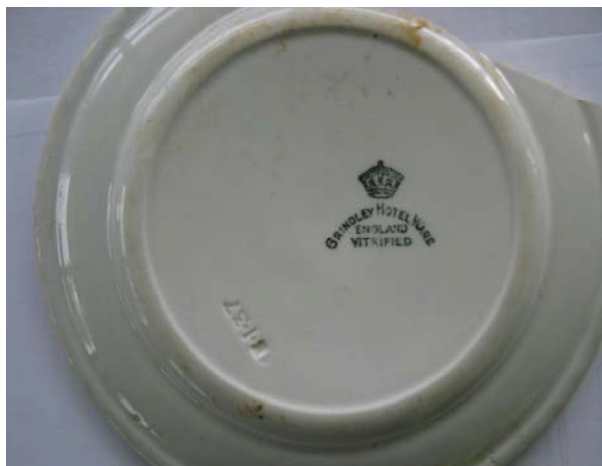
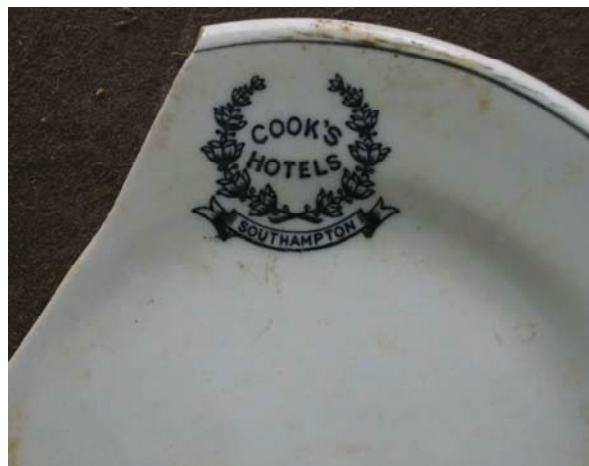
Context (404) has a two-thirds complete transfer printed white glazed earthenware side plate (232g). It's diameter was 160mm and it was produced by Grindley's potters of Tunstall, Staffordshire. Its base side has external black transfer of a crown with 'GRINDLEY HOTEL WARE, ENGLAND, VITRIFIED', and a batch number impressed stamp - B.1.37. The face has a thin black edging band around the rim and the words 'COOK'S HOTELS' surrounded by a floral wreath and below that, in a ribbon design 'SOUTHAMPTON'. These plates were popularly produced post 1946.
