1 Church Road, Kingston-upon-Thames

Historic Building Report

Planning Application Number: 08/12724

AOC Project No: 32097

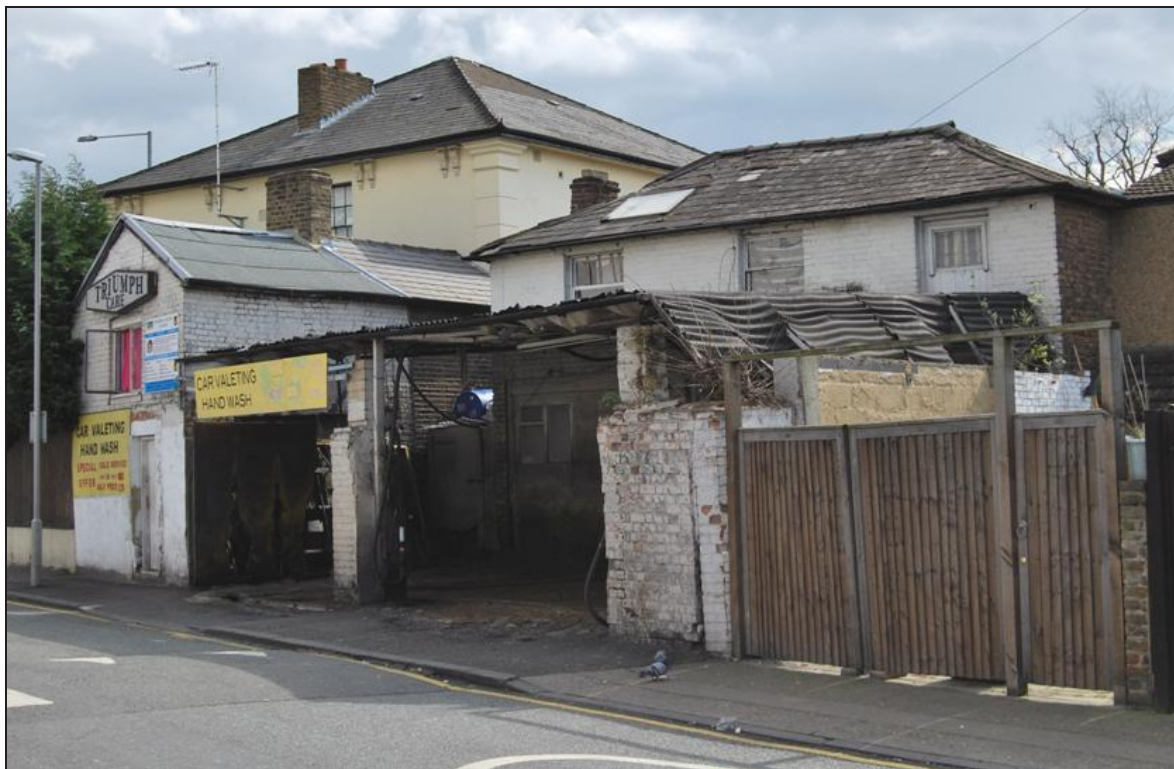
Plate 1: Overview of site, Looking East

- 6.1.1 There are two buildings on site. The smaller of the directly abuts 4, Cambridge Road, and only half falls within the site. This is defined here as Block A. The second building is a two storey block with a small courtyard in front, and currently houses a car-wash business. This is defined here as Block B (Plate 1).

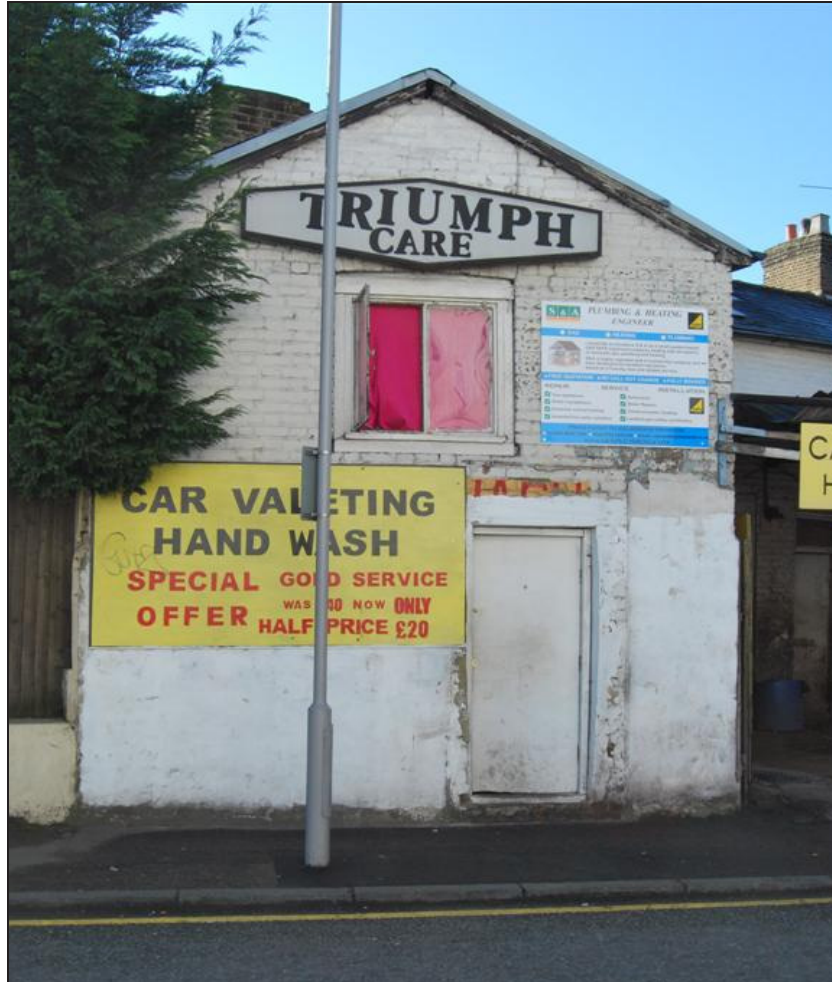
Plate 2: Gabled End Detail, Block A

- 6.2.1 Block A is a two storey building with a gable end facing Church Street. It abuts 4, Cambridge Road, and has a frontage lying at 70° to the side walls, giving the block an irregular shape in plan. Only half of this building lies within the site: the rear part abuts, and is now considered part of 4, Cambridge Road. The rear section has slate roof. The front half, subject of this report, has a pitched roof with a asphalt sheets. The entire block measures up to 9.6m long and is 4.15m wide, oriented north-west southeast. The walls are constructed of yellow stock brick (224mm by 104mm by 69mm) laid in English bond, with cement rich-mortar.
- 6.2.2 The entrance to Block A is directly off Church Road, through a door with a low storm step. The doorway has a wooden lintel, and the door is mounted on a simple frame set within the opening. The

door does not appear to be original to the building. The first floor window in this northwest-facing end of the building is constructed with a segmental brick arch. If the ground floor doorway were original, a similar form would be expected. The lower part of the front wall is rendered, which obscures evidence for construction details. The gable end is 6.83m high, and the chimney rises for a further 0.6m above the ridge. Clear and obtrusive signage obscures much of the façade (Plate 2).

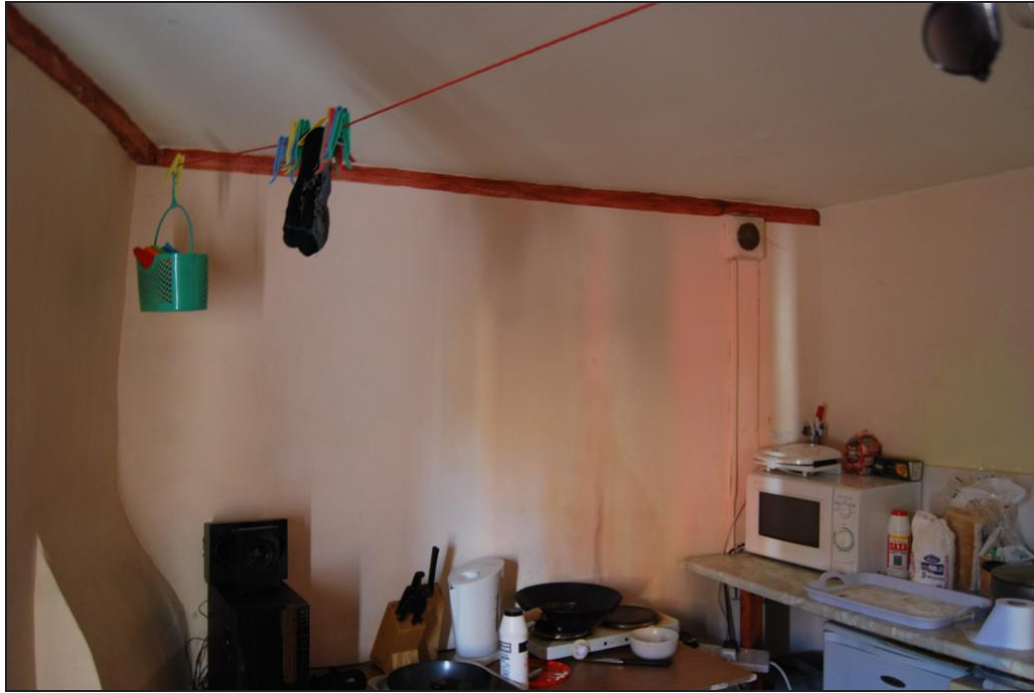
Plate 3: Ground Floor Block A: Room G1 Looking East

- 6.2.4 Internally, the spaces are trapezoidal, as dictated by the shape of the building. The ground floor has modern finishes on the walls, and is furnished as a kitchen diner (**Room G1**) with a partitioned shower room beyond (**Room G2**). A brick buttress supports the southwestern wall, and there is an angled buttress in the north corner. A chimneystack rises up the rear wall, effectively the middle of the whole building (Plate 3). The shower area partition is lightweight and very modern in date. The modern finishes include painting modern coving in wood effect paint, and also painting a partially visible midrail in the northwestern wall. This midrail is visible at the edge of a hinged hatch to the first floor, accessed via a set of open wooden stairs.

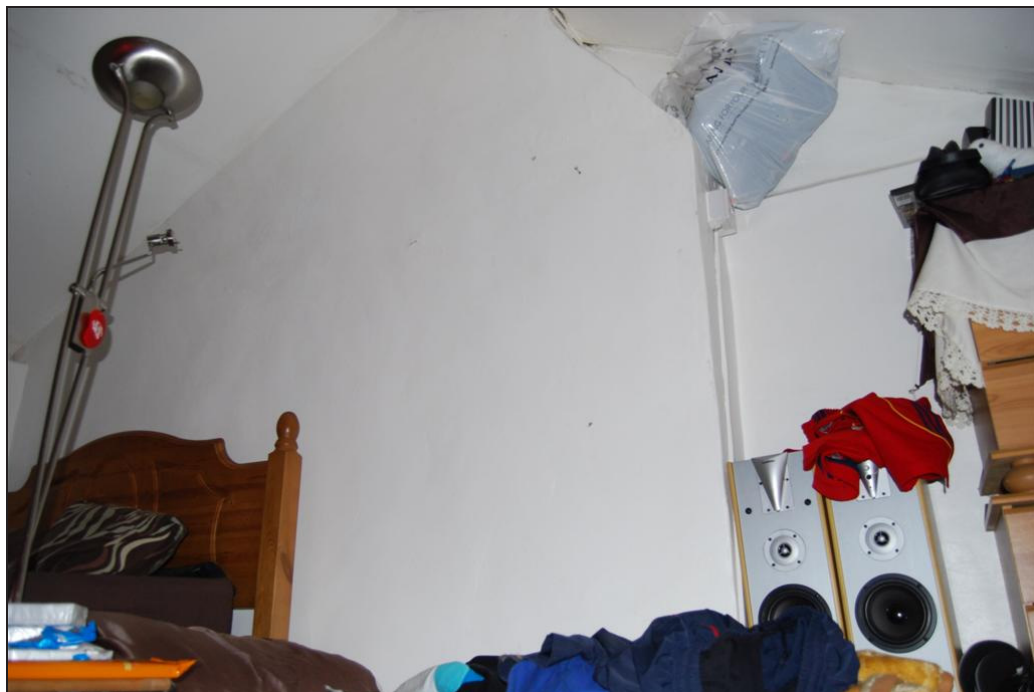
Plate 4: First Floor, Block A: Room F1 Looking Southeast

- 6.2.5 The first floor comprises a single space, furnished as a bedroom (**Room F1**). The chimneystack rises up the end wall and out through the ridge (Plate 4). Only three structural timbers are visible in this roof: two wall plates and one ridge piece. These have been painted white, effectively obscuring potential details of sawmarks or axe marks on the timbers. The inner faces of the pitched roof are clad in plasterboard. The window is a casement window.

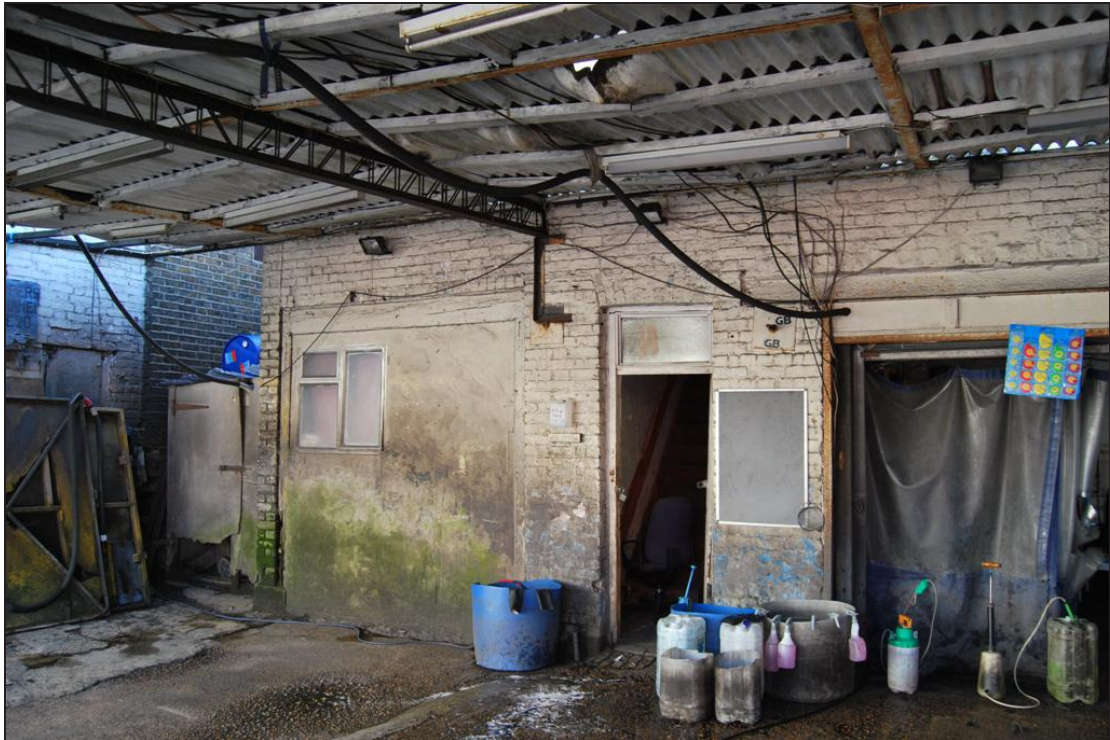
Plate 5: Ground Floor of Front of Block B

- 6.3.2 The ground floor had three openings (Plate 5). Just two are extant now the third is blocked. In the centre of the northwest wall is a doorway with a stone threshold. This leads to stairs and two ground floor rooms off a short hall. To the west of this is a wide opening spanned by an I-beam. To the east is a wide opening with a wooden frame, since blocked and rendered over. A window has been inserted into the blocking.

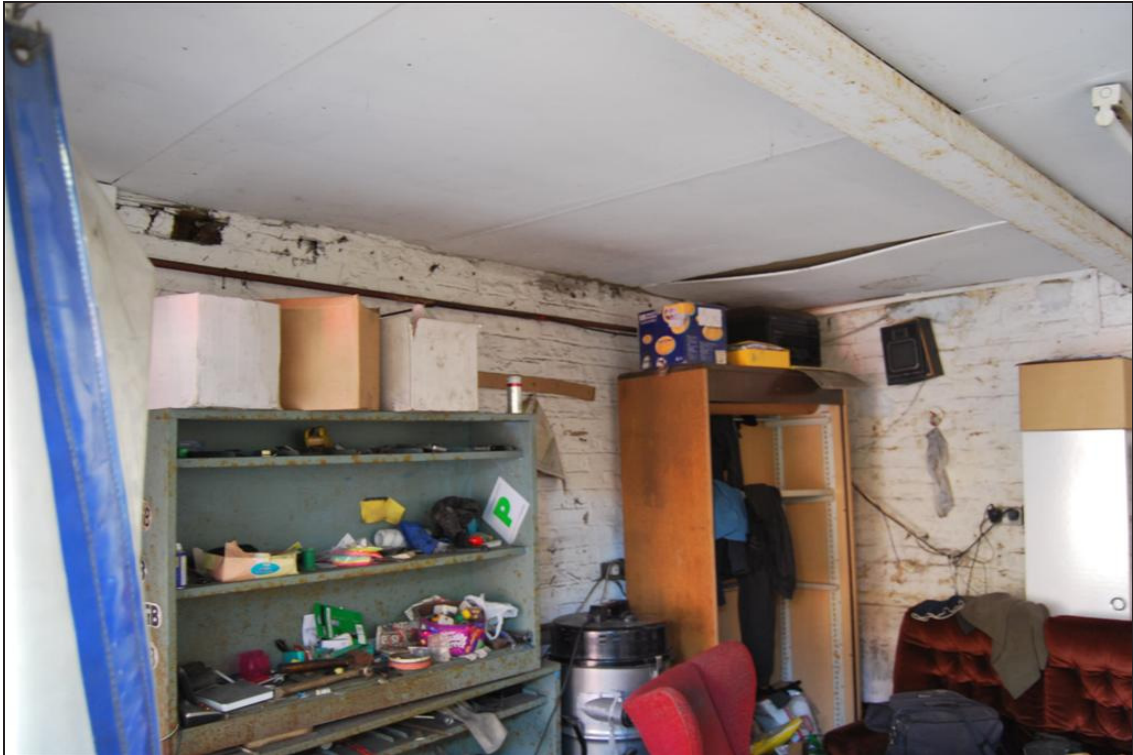
Plate 6: Room G4, in Use as Office

- 6.3.3 The wider, western opening leads into the largest room on the ground floor (**Room G4**). This is currently in use as the office for the car-wash business, and has unplastered brick walls painted white (Plate 6). The floor is concrete. There is little evidence of prior form or function in this room. A principal joist spans the ceiling. The northeast wall of this room, an internal wall, is built in stretcher bond.

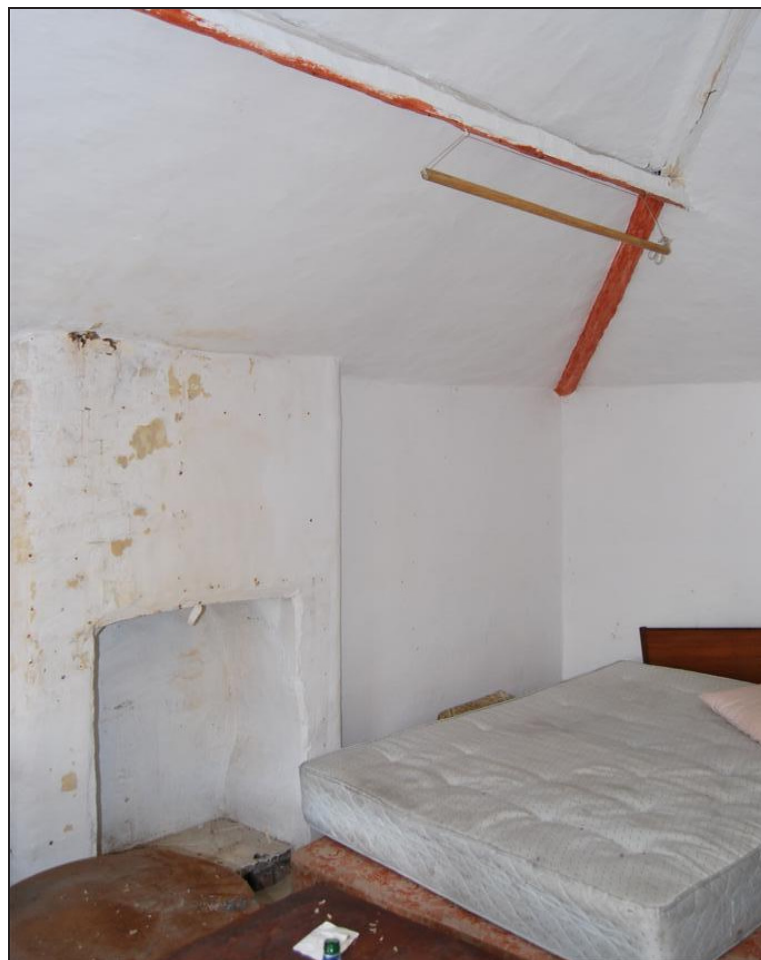
Plate 7: Coachman's Room with Fireplace – Room F3

floor lie either side of this staircase. The stairwell is brick. To the northeast is the smaller of the two rooms (**Room F3**). The room is lit by a sash window in the front wall, while in the northeast wall is a chimneybreast 1.25m wide, with a fireplace 0.77m wide within (Plate 7). The hearth is stone, and the main structure remains, with an arched opening. The current décor of the room is plain paint over plaster, which obscures potential historic detail. The wooden sash window frame and the hip beams of the roof and an end tie-beam have also been painted over, then repainted with wood-effect paint, effectively obscuring structural details which may have been apparent. This room may have been a living space for the groom/coachman.

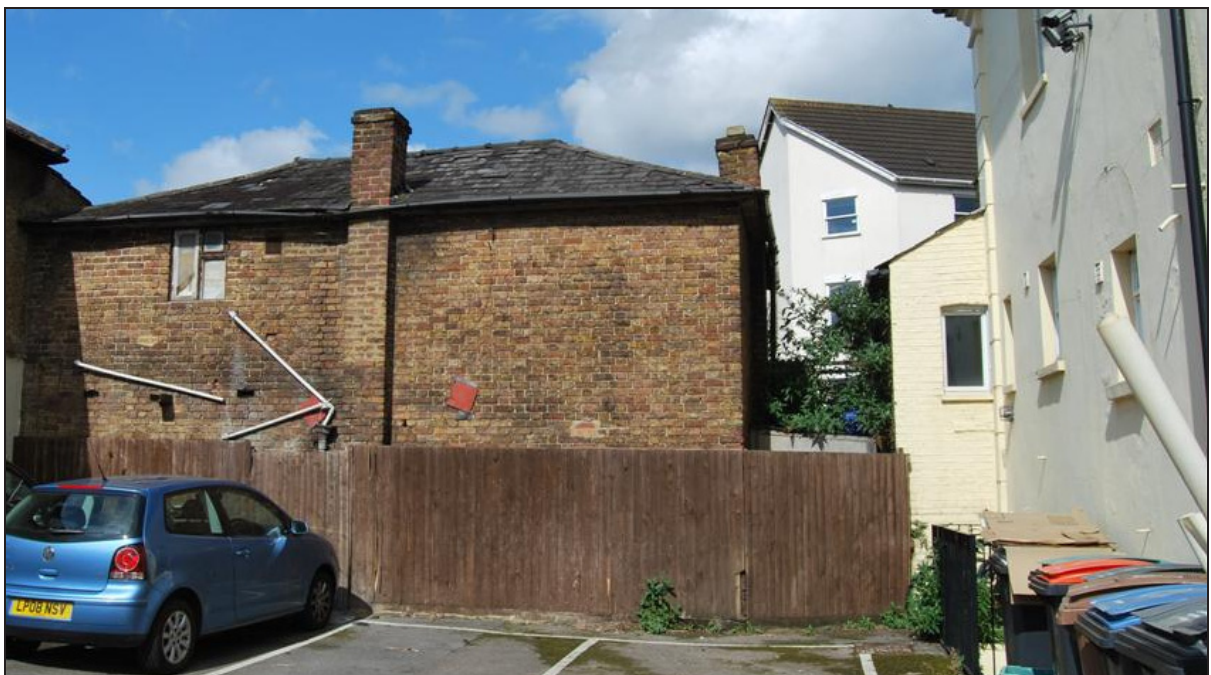
Plate 8: Rear of Block B: Block A on Right

- 6.3.8 The roof of Block B has one central pair of principal rafters with a tie beam. The roof is pitched, and if purlins were used, they are hidden behind plasterboard ceiling panels which also hide the common rafters. A rustic effect has been created by the addition of false hip beams in the roof. The slate roof is beginning to fail (Plate 8).

- 7.3 The two properties are also beginning to become dilapidated. This is not due to neglect so much as structural failure of buildings which are now 150 years old, and which appear to be constructed of brick walls just 0.24m wide, and quite slender timbers for the roof assemblies.

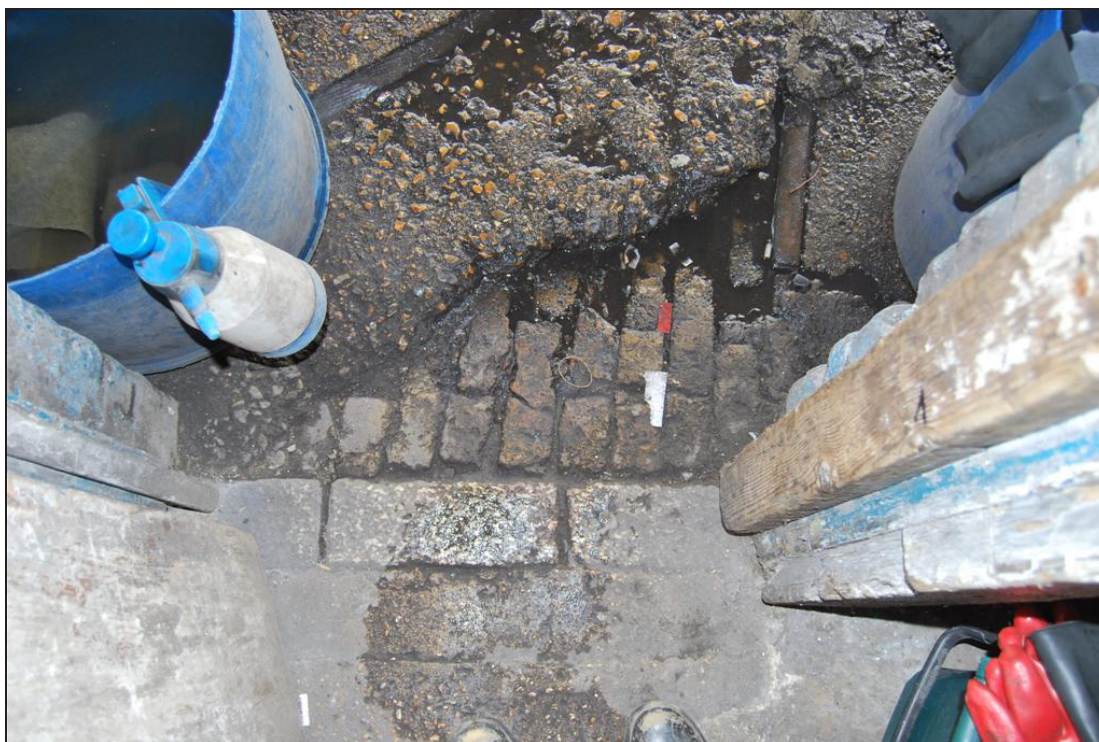
Plate 9: Brick Surface Below Concrete.

- 6.3.9 Outside the front, northwest, face of the building is a small courtyard currently used by the car-wash business. It is crossed by service trenches and manholes, but there are patches eroded in the current concrete surface which reveal edge-laid brick surface, effectively brick cobbling that is probably original to the building (Plate 9). The yard is covered by a lightweight open sided frame with a corrugated iron roof.
