Hermitage of Braid, Edinburgh:

Archaeological Works Data Structure Report

AOC Project 22061

30th March 2012

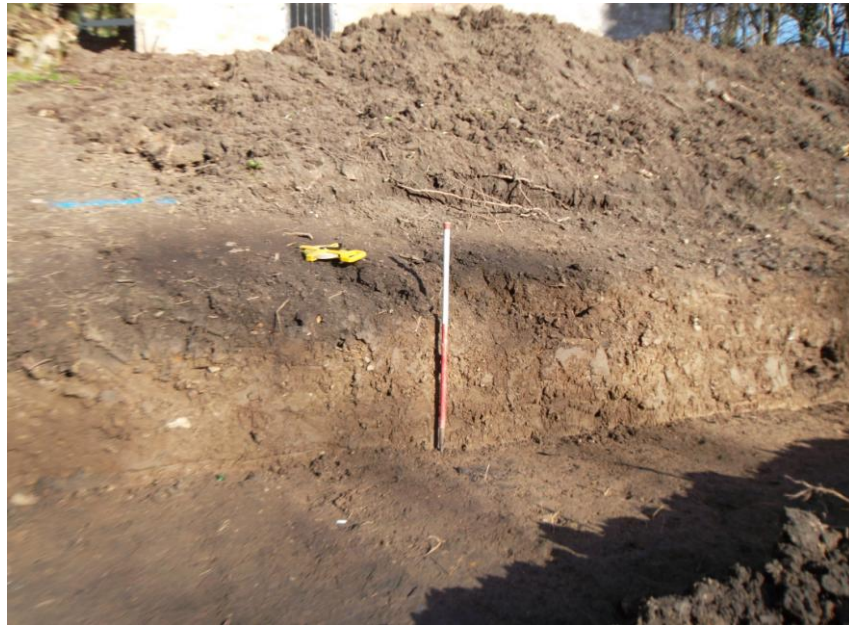
4.2.1 Three trenches (measuring 20 m by 2 m) were positioned east to west on the south-facing slope of the walled garden across the frontage of the Doocot (Figure 2). The trenches formed the footings for revetments of the slope in the creation of a new garden layout. All three trenches were excavated to a depth of 0.75 m. These excavations revealed a surprisingly thin top-soil up to 0.20 m in depth, which in turn overlay a heavily bioturbated natural subsoil of pale brown sandy silt. A single rubble field drain aligned north to south was observed in Trench 1. No archaeologically significant material was observed.

Plate 1: Trench 1 from South-west

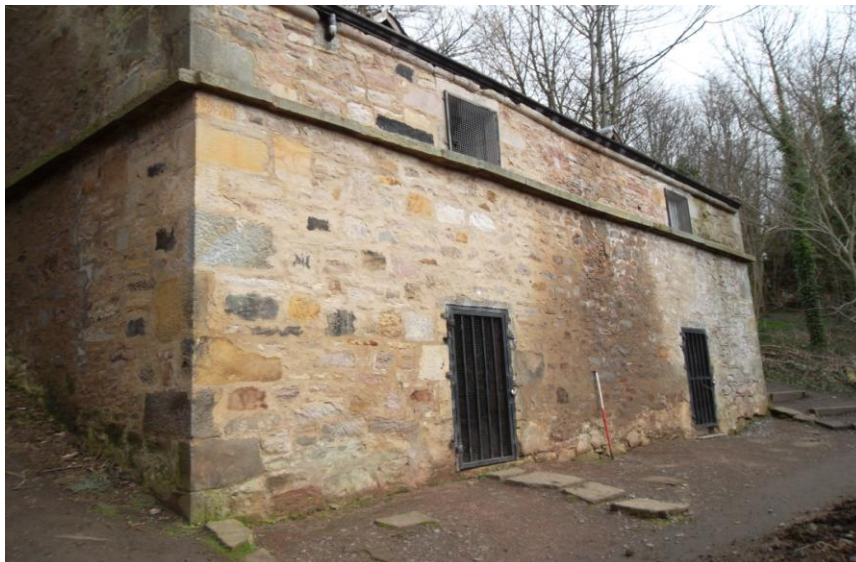
As shown in Appendix 1 the Doocot is constructed of fashioned sandstone blocks mortared with limestone. Modern repairs were visible to the south-west corner of the building with obvious re-pointing of the stonework on both the frontage and western side of the building.

Plate 2: Doocot Front Elevation from South-west

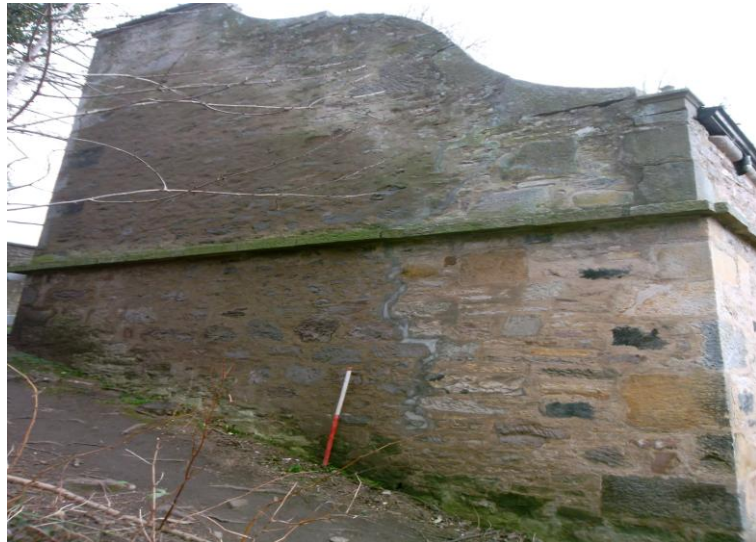
Plate 3: Doocot Western Elevation from South-west

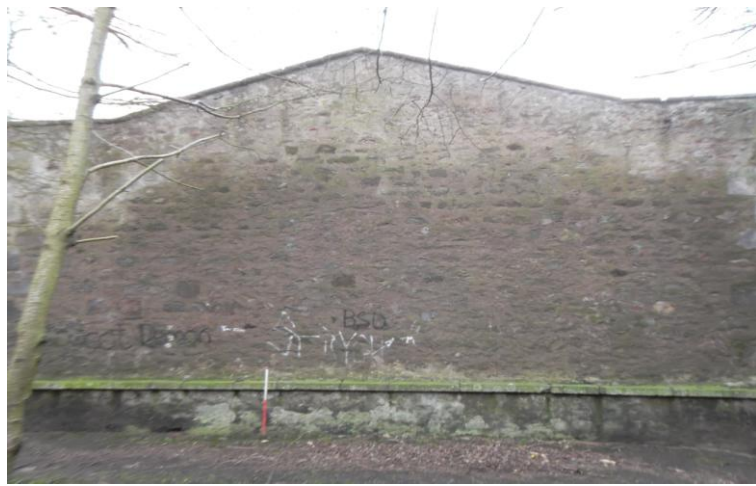
Plate 4: Doocot Rear Elevation from North

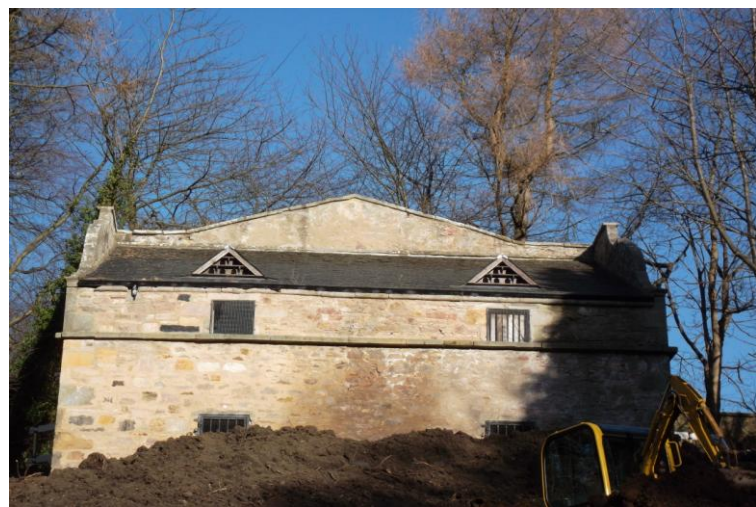
Plate 5: Doocot Roof from South

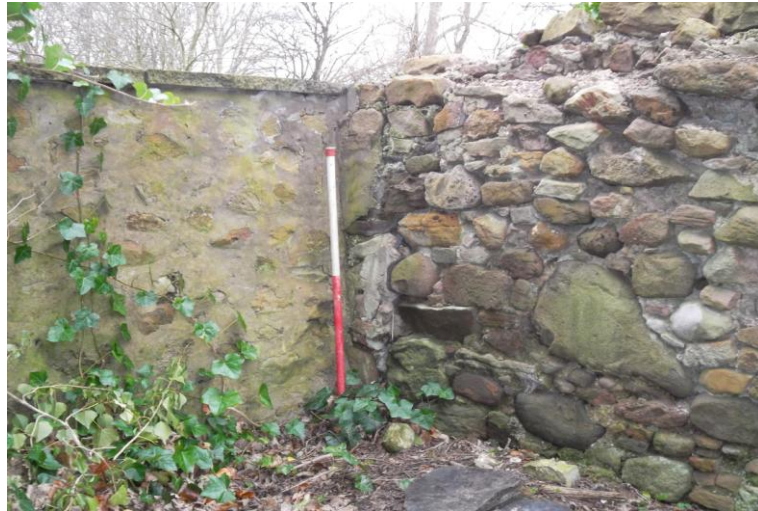
The original wall surrounding the garden has undergone significant modifications over time. Across the northern boundary of the site the wall has been largely replaced by Victorian walls (Walls 2 & 3). The wall reaches a maximum of 2 m in height along the eastern boundary and is constructed of roughly fashioned irregular sandstone blocks with some sub-angular elements. The wall is lime-mortared and a rubble core is visible in areas of significant truncation.

Plate 6: Wall 1 north-east corner from South-west

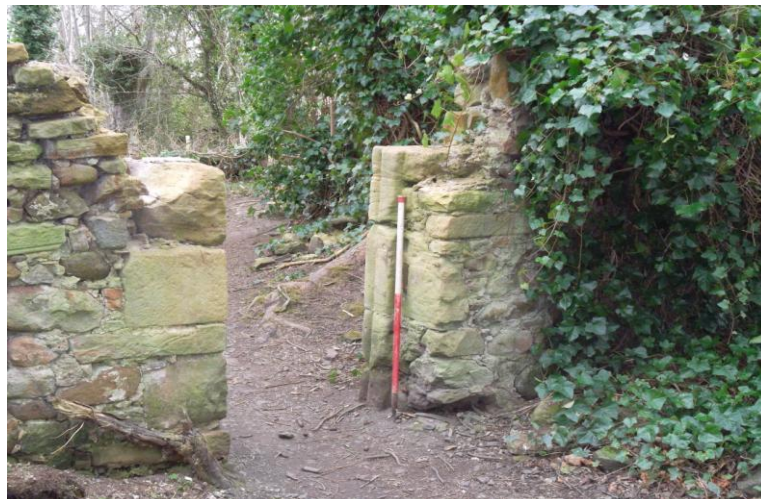
In the north-eastern corner of the wall there survives a 1.0 m wide entrance four courses in height (1.25 m), constructed of well fashioned sandstone blocks (0.30 m by 0.50 m in size). Some decorative detail survives.

Plate 7: Wall 1 Remains of entrance from west

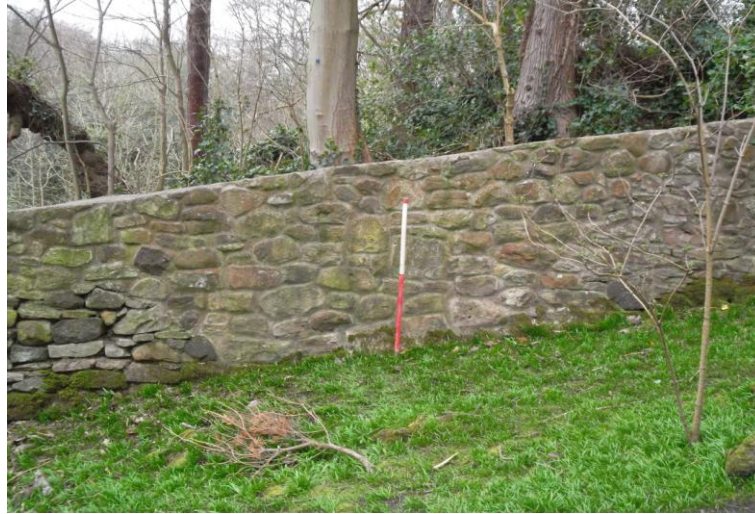
It is likely that the wall along the southern and western boundaries has also been extensively refashioned as capstones have been added. The wall here only reaches 1.25 m in height.

Plate 8: Wall 1 Western Boundary

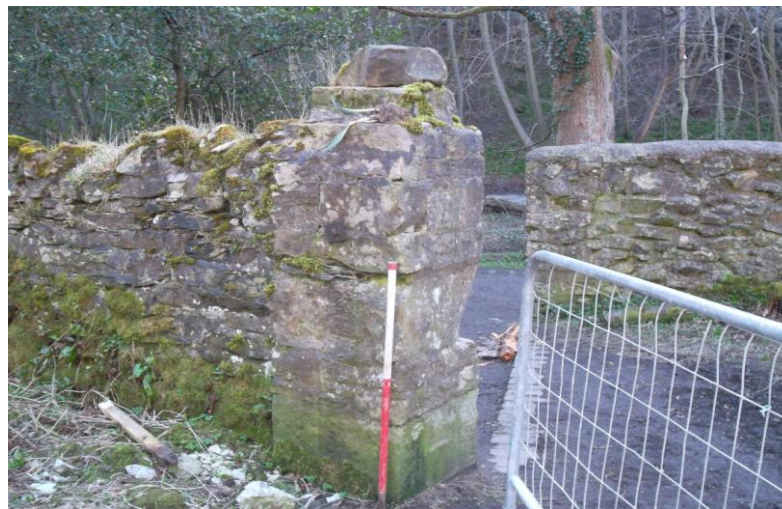
Plate 9: Wall 1 Main Entrance from North

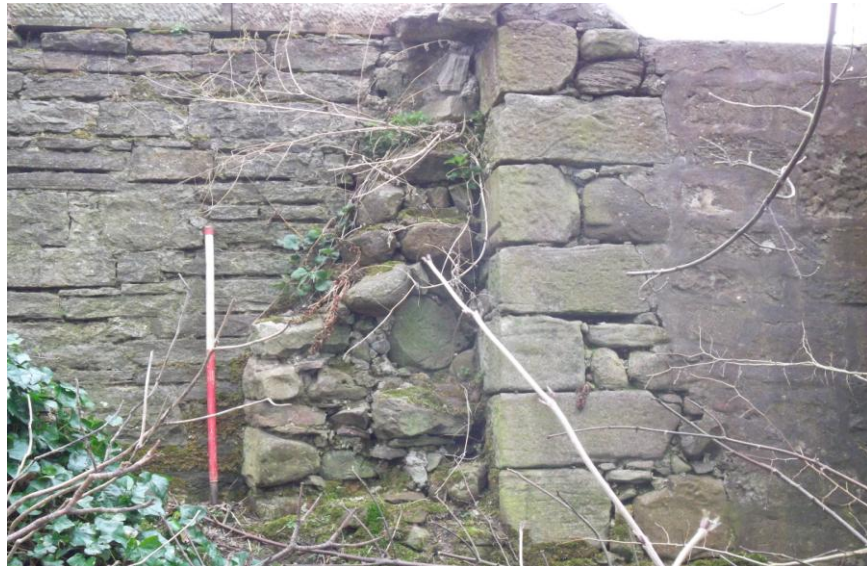
The original wall surrounding the garden has undergone significant modifications over time. Across the northern boundary the original wall [Wall 1] has been largely replaced by a large Victorian wall 3.30 m in height. This consists of large regular sandstone blocks (0.40 m by 0.25 m). The wall is buttressed every 4.5 m. Though the buttresses do not appear keyed in to the wall. Wall 2 abuts fragments of Wall 1 in both the north-west and north-east corners.

Plate 10: Remnant Wall 1 abutting Walls 2 & 3 from South
