# Canmore Linen Works, Dunfermline: Archaeological Watching Brief Data Structure Report

AOC Project 21576  
OASIS ID: aocarcha-123200  
27<sup>th</sup> April 2012

**National Grid Reference (NGR):** NT 08971 87731

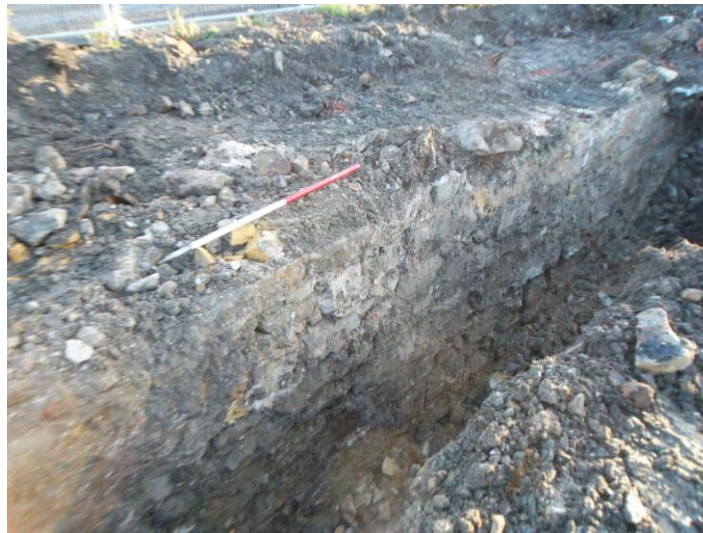
- 4.2.2 Within the mill dam area shown on earlier maps (Figure 3) the only archaeological find was a curving sandstone Wall [007] that was revealed on the inside of Winterthur Lane (Plate 1). It was exposed for approximately 45m, following the line of the road for some of the eastern loop of the lane and is probably the remnants of the dam retaining wall. It consisted of large sandstone blocks and was up to 2m deep, but had been heavily disturbed by modern services in places and completely removed along the northern edge of the reduced area.

Plate 1 - Sandstone dam Wall [007]

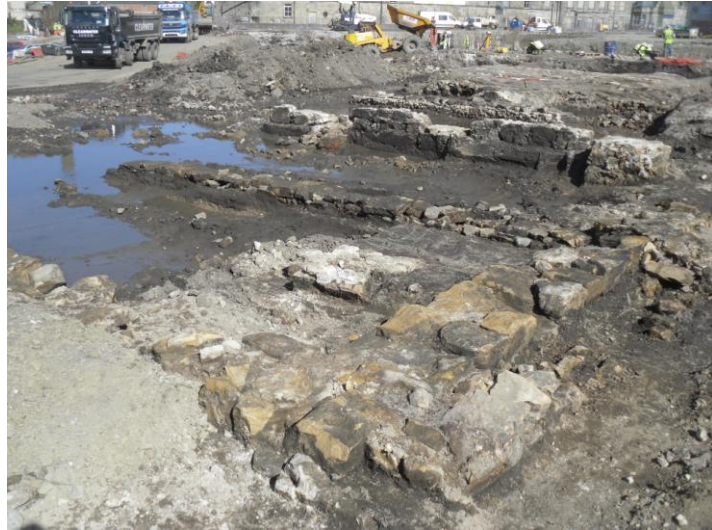
- 4.2.3 On the south side of Winterthur Lane, outwith the mill dam area, a number of walls and drains were revealed. The south-west corner foundation Wall [017] of a large sandstone building (Structure [032]) was revealed, along with sandstone Column Bases [018], [020], [022], [023] and [024]; internal Wall [020], with a possible doorway, and sandstone Drains [016], [019] and [025], which would all appear to relate to the same structure (Plates 2-4). From map evidence it is possible to say that the walls and column bases relate to the easternmost handloom weaving shop producing 'damask linen' shown on the Ordnance Survey map of 1856 (Figure 3).

Plate 2 - General shot of Structure [032] with external Wall [017] in the foreground

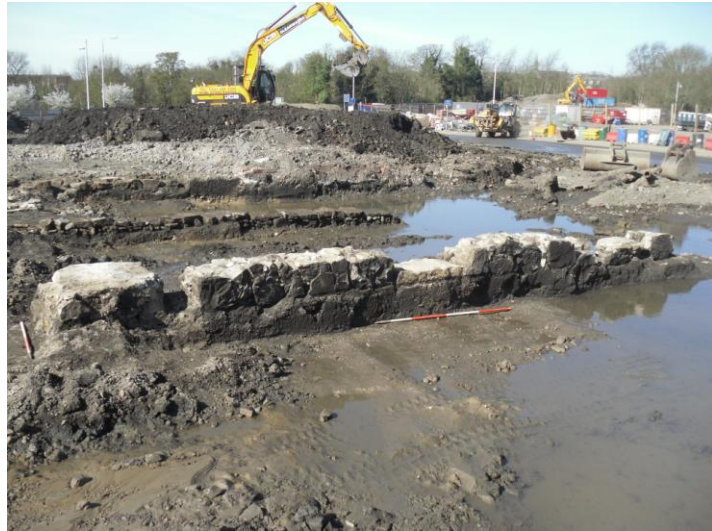
Plate 3 - Internal Wall [021] and Column Base [020]

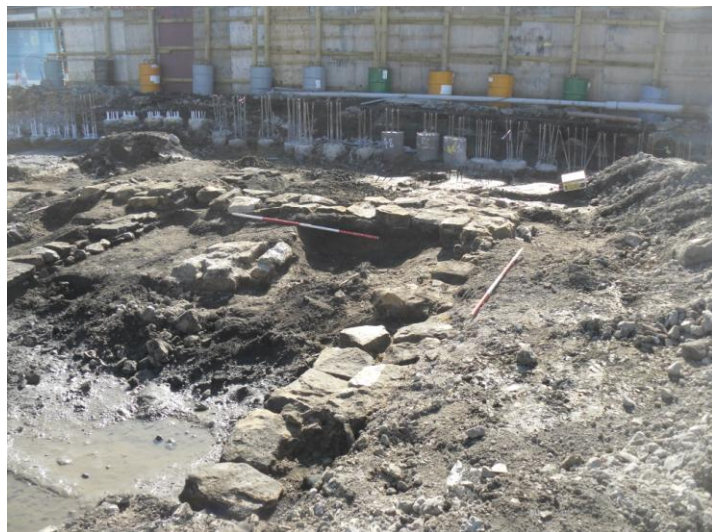
Plate 4 - External Wall [017] and Column Base [018] forming the south-west corner of Structure [032]

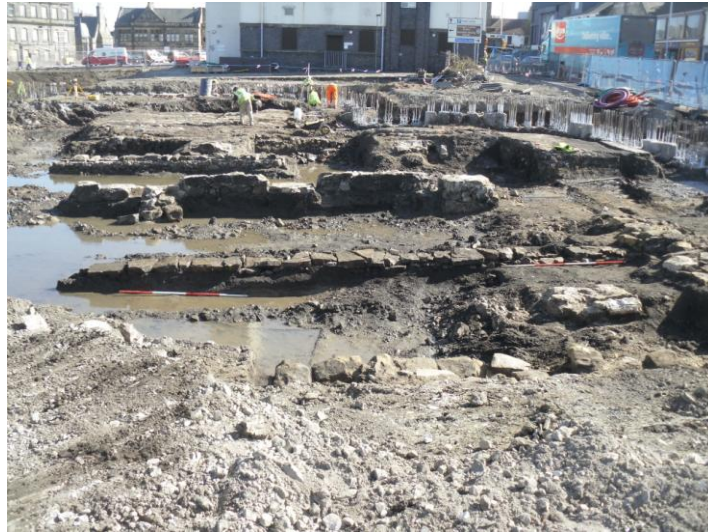
- 4.2.4 Sandstone Drain [015], of different construction to [016] and [019] and predating Structure [032] was also revealed (Plate 5). It was cut lower into Buried Soil [029] than the later walls of Structure [032] and it was also truncated by Drain [019]. The drain survived for 11.76m. It ran N-S underneath Wall [017] and a few fragments of red ceramic were found within its Construction Cut [027]. Additionally, a small shard of green glazed reduced ware was found in Buried Soil [029].

Plate 5 - Drain [015]

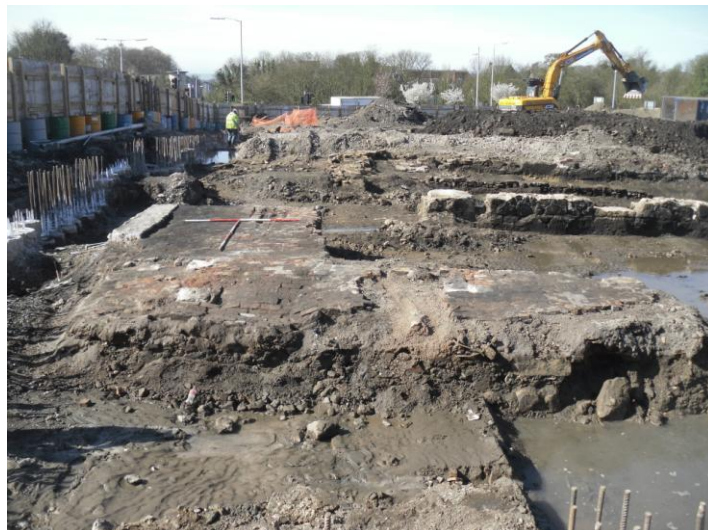
- 4.2.5 At the eastern edge of Structure [032], the column bases and drains relating to it are covered by later brick Floor [026] (Plate 6), and are also truncated by a group of sandstone structures, strip Foundations [034]-[042] (Plate 7), most likely for a wooden floor. Given that the earlier features of Structure [032] relate to the handloom weaving shop, these later features are most likely part of the larger complex of the Caledonia Works (Figure 6). These later features were themselves truncated and destroyed by modern services and walls relating to the fire station construction.

Plate 6 - Brick Floor [026]

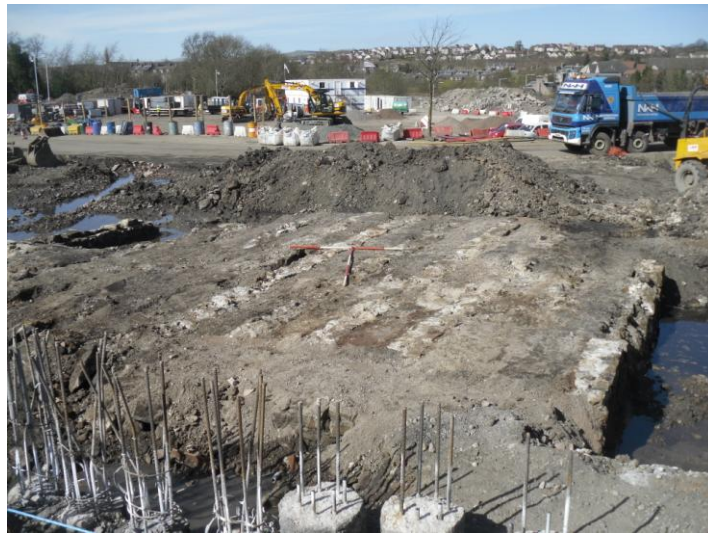
Plate 7 - Sandstone strip Foundations [034] - [042]

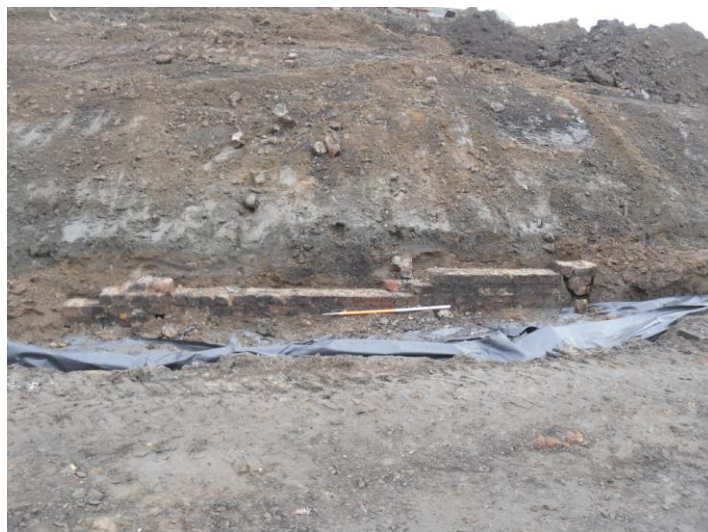
- 4.3.3 The other two walls on this side of Bruce Street were red brick Walls [011] and [012], which relate to a now-demolished residence in this area according to map evidence (Plate 8). Due to the presence of a 'time capsule' sealed within a milk bottle, the wall's construction can be precisely dated to May 1875; map evidence indicates that it was built as part of an extension to a house on "Wooers Alley" (see Figures 3 & 4).

Plate 8 - Extension Wall [011]

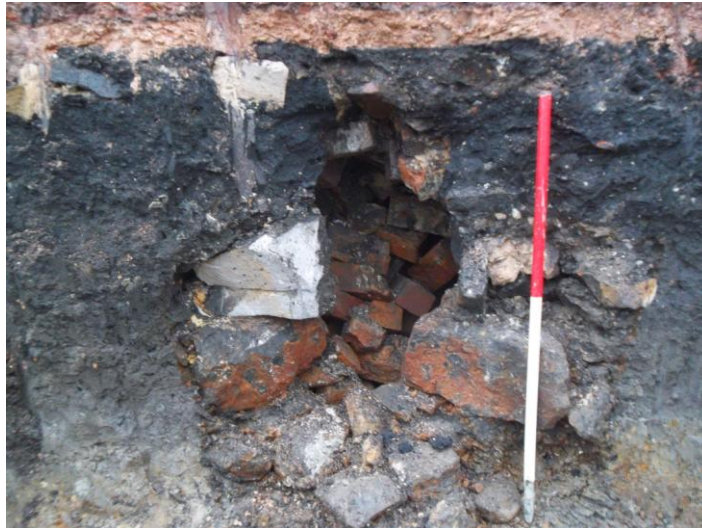
- 4.3.4 Wall [006] and two other features, Well [004] and Culvert [013], are located around Pilmuir Street. Wall [006] is a heavily truncated sandstone structure running N-S for 2.3m. Well [004] was partially revealed in section; it was constructed of dry sandstone and had an internal diameter of 0.7m (Plate 9). In spite of disturbance by construction works, it was possible to largely preserve the well *in situ* to the east of Pilmuir Street on the very edge of the development area. Culvert [013] was revealed within a service trench that crossed Carnegie Drive at the junction with Pilmuir Street and related to the sewage and drainage works of Dunfermline (Plate 10). It was constructed of brick with a sandstone cap and was heavily mortared with sand and lime. None of these features could be dated accurately using artefactual evidence, but they are most likely related to 19<sup>th</sup> century buildings and structures in this area.

Plate 9 - Well [004]

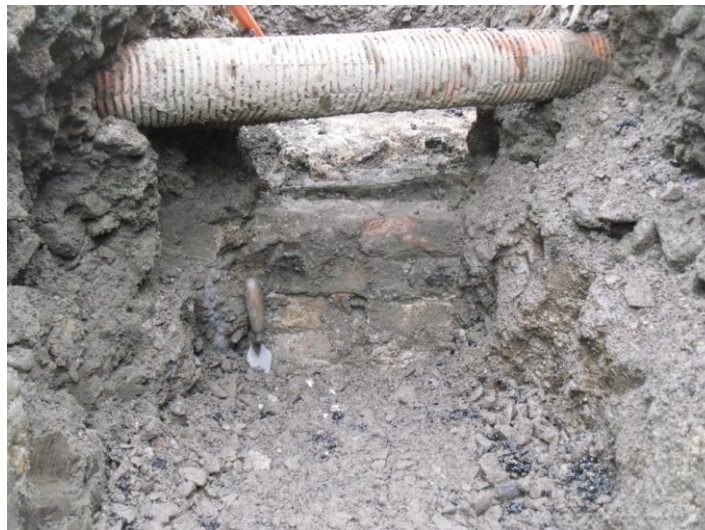
Plate 10 - Culvert [013] under the road

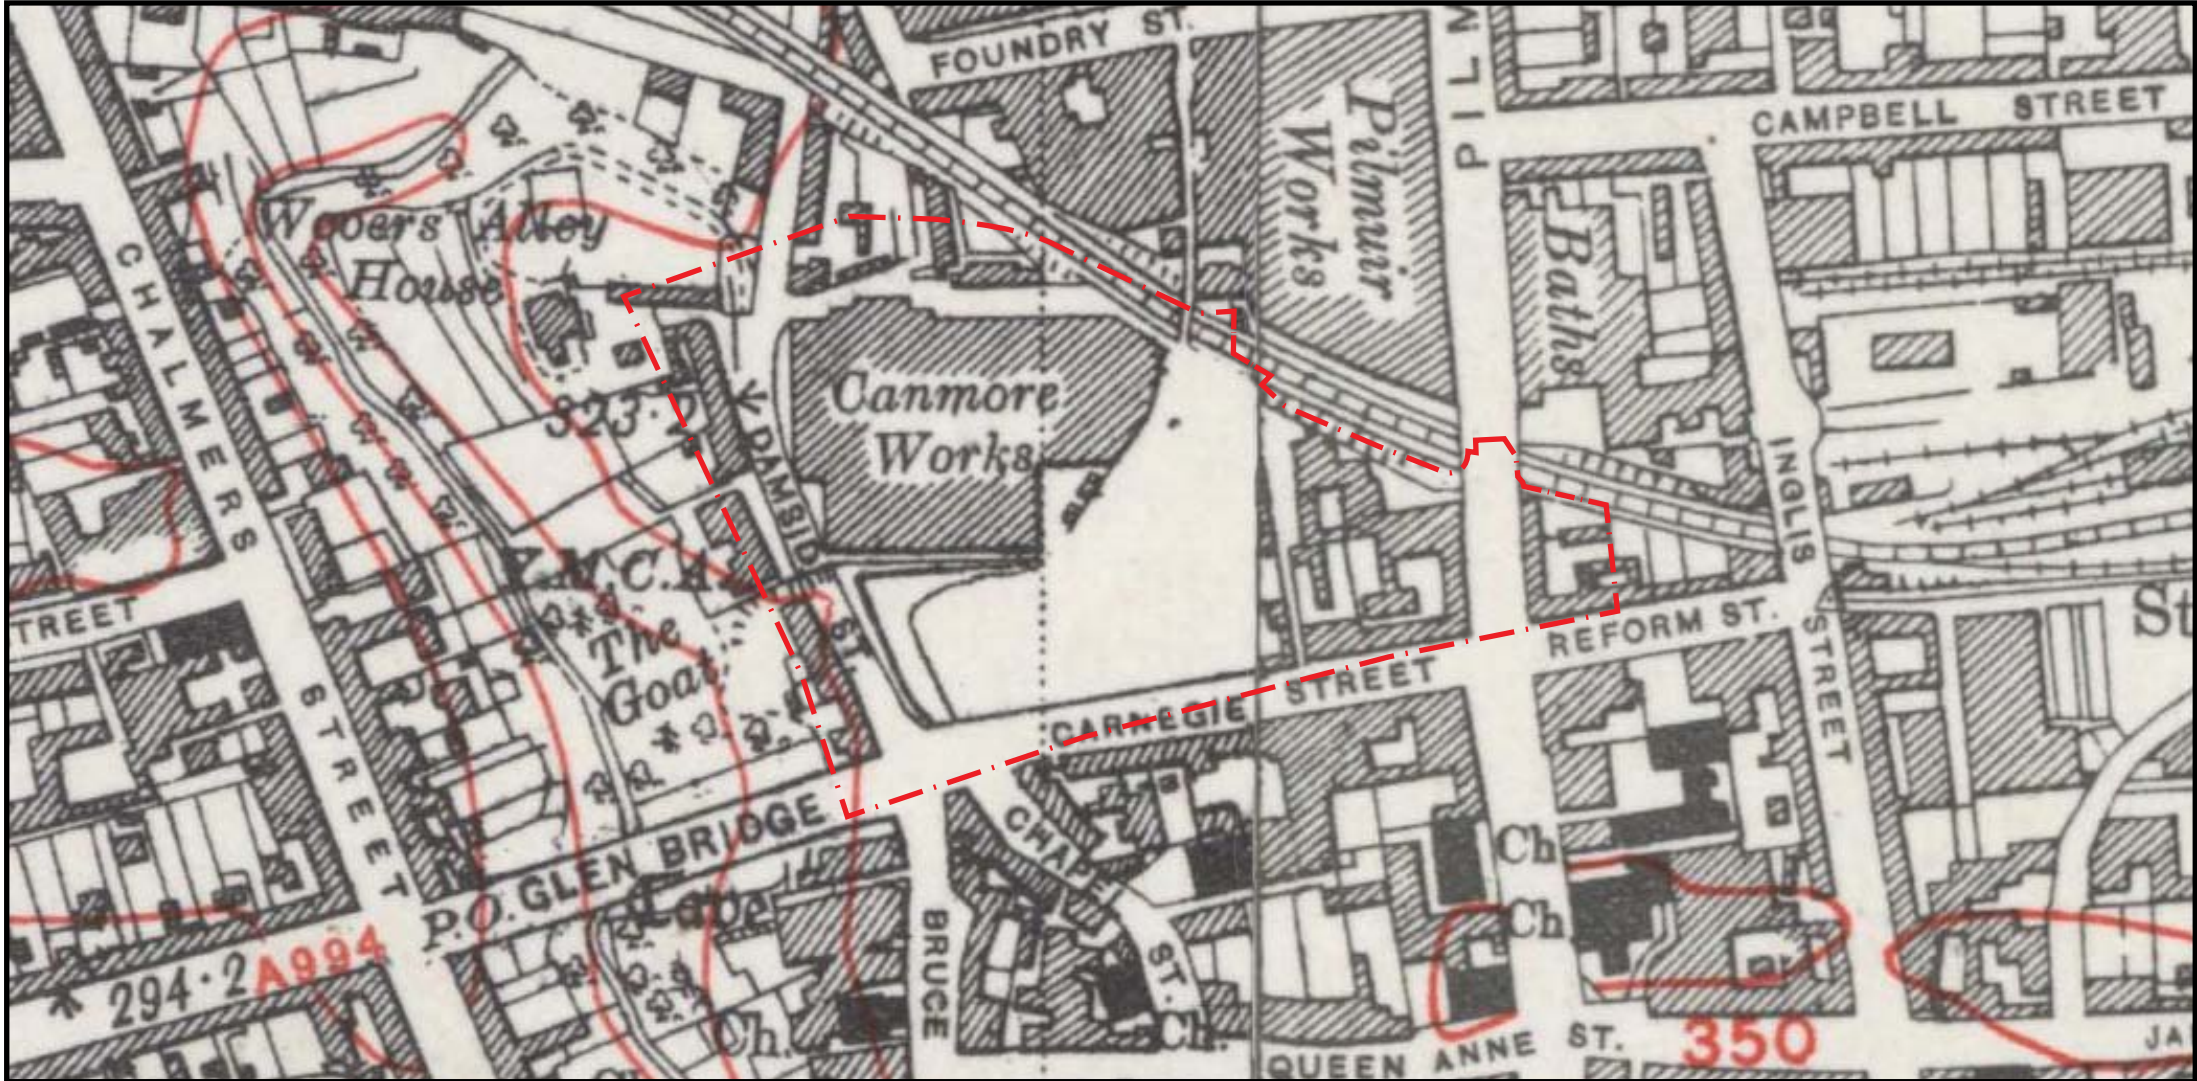
Figure 6: Extract from Ordnance Survey map, 1947

Caledonia Works had been demolished by that time and the mill dam removed with the mill lade completely covered over (Figure 6).

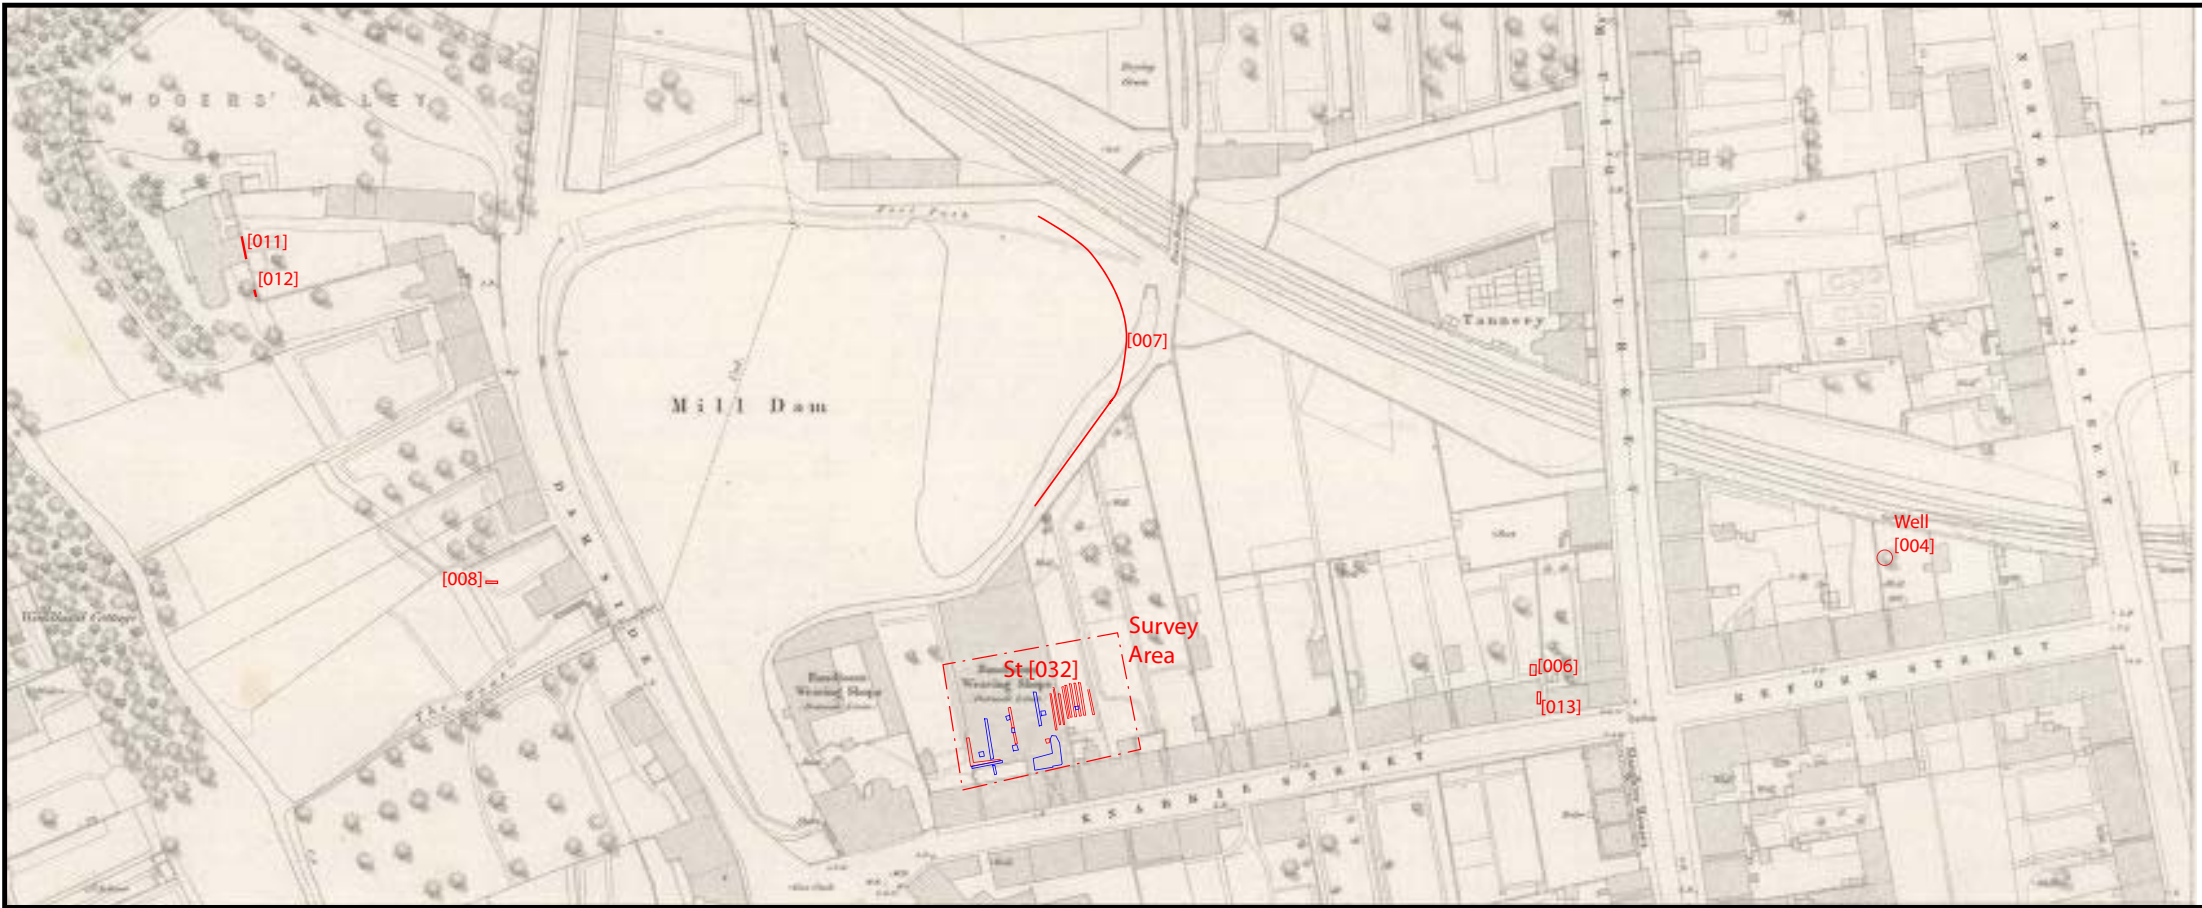
Figure 8: Overlay of features onto Ordnance Survey map, 1856
