# 2 Market Gate, Arbroath: Data Structure Report

AOC Project 22199  
Oasis ID aocarcha1-132533  
27<sup>th</sup> August 2012

### Data Structure Report

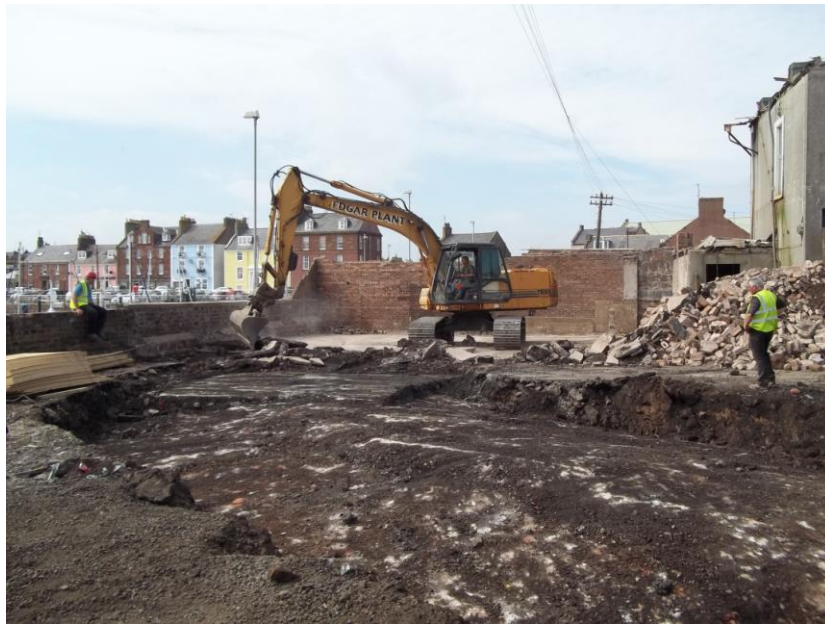
Plate 1 - Work in Progress at 2 Market Gate

- 3.1 The watching brief was undertaken on the 8<sup>th</sup> and 9<sup>th</sup> of August, 2012 in fair weather conditions yielding good archaeological visibility. The groundworks involved the excavation of made ground along the line of the culvert, and one test-pit over the slipway to investigate the potential for contaminated ground. Excavation was undertaken using a 25 tonne tracked 360 excavator equipped with a toothed bucket.

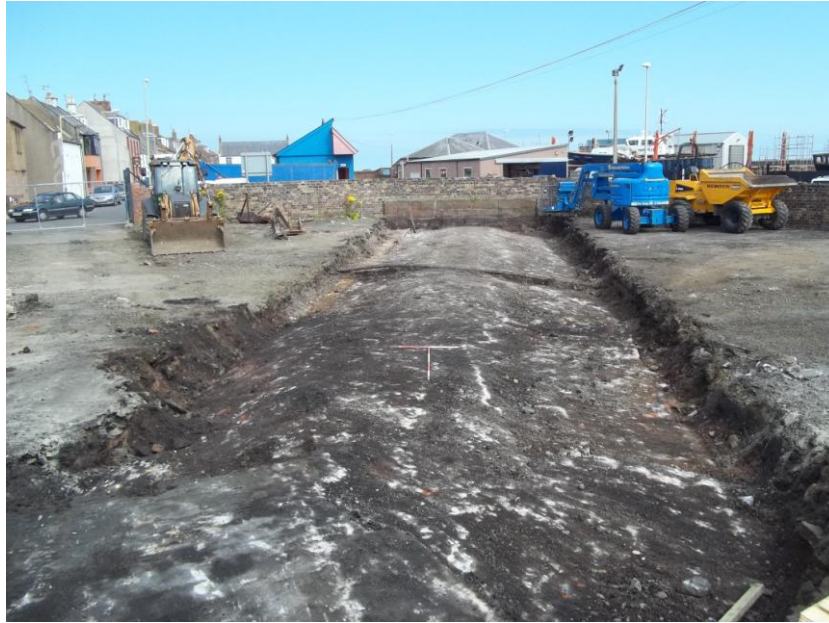
**Plate 2 - Concrete Culvert Exposed**

- 4.1.2 On inspection the culvert was found to have been constructed in one phase, without reinforcement, or any form of internal frame. The most likely method of construction is thought to have involved the assembly of a timber mould, insinuating the interior surface of the arch, which was then filled with wet concrete, and removed when the structure had set. The concrete arch abutted the bridge on the east side of the site (see Figure 4), and also the outer wall of the pre-existing slipway on the north bank of the burn. On the south bank the concrete arch was set against a stone structure which could be a retaining wall or sea wall consolidating the land on which the 18<sup>th</sup> century naval battery was constructed.

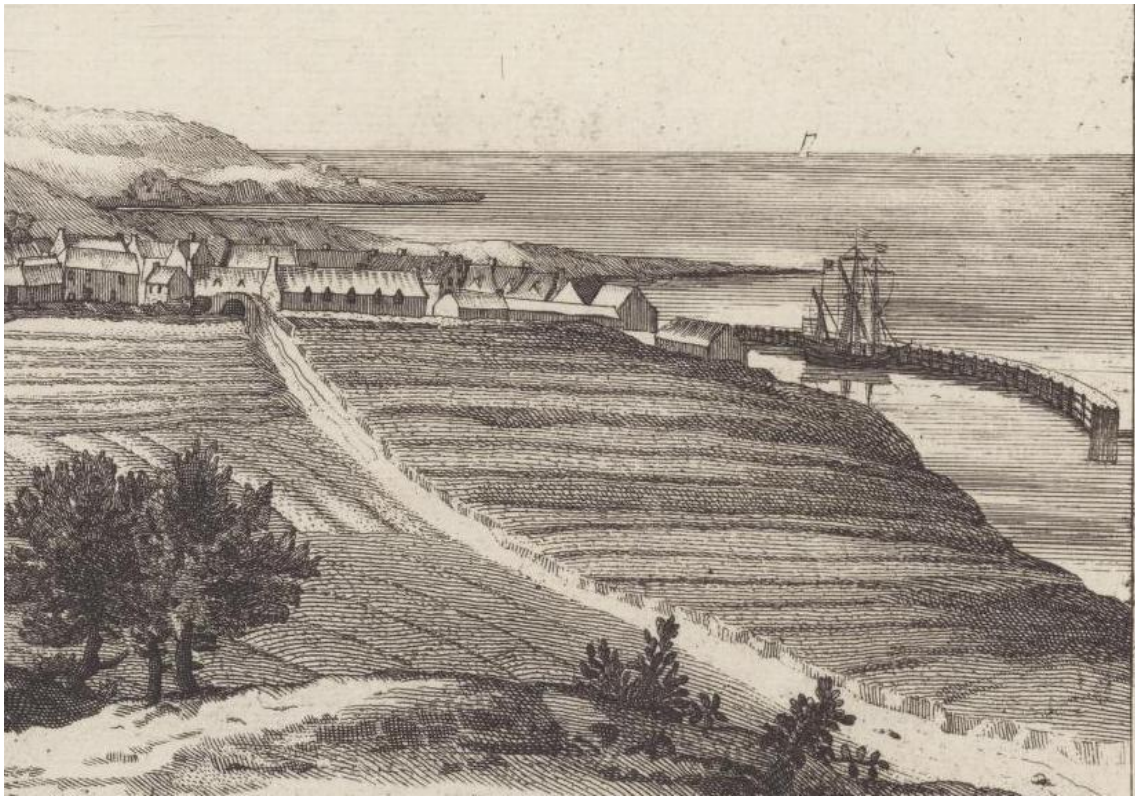
**Figure 3: Detail from John Slezer's Etching *The Prospect of ye Town of Aberbrothick***  
(By kind permission of the trustees of the National Libraries of Scotland)

- 1.3.1 The site at 2 Market Gate is located on the site of two successive harbours. The first, of monastic origin dating to the late 14<sup>th</sup> century (Figure 3), consisted of a breakwater starting at Danger Point, with an entrance to the south. This was destroyed in the early 18<sup>th</sup> century and replaced by a rectangular dock and breakwaters, gradually developing into a tidal harbour and wet dock with substantial slipways and boat building facilities. Military surveys in the 18<sup>th</sup> century of the site record the location of a battery of naval guns protecting the approaches to Arbroath and this structure survived until at least 1822, when it was recorded by John Wood (Figure 4). The development plot is depicted on the 1865 25 inch OS sheet being bisected by the Borthock Burn (Figure 5), with a slipway and smithy on the north bank, and winding gear for a patent slip on the south bank. By 1921 the burn is recorded as having been covered over, and the plot levelled, to provide a flat yard or working area (Figure 6). During 20<sup>th</sup> century, the Fisherman's Association occupied the plot, and a large warehouse and ice factory dominated the site, with the buildings on the street frontage providing space for offices and a chandlery.
