Southbank Road, Kirkintilloch: Archaeological Watching Brief Data Structure Report

AOC Project 22218
OASIS ID: aocarcha1-132590
21st August 2012

Southbank Road, Kirkintilloch:

Archaeological Watching Brief

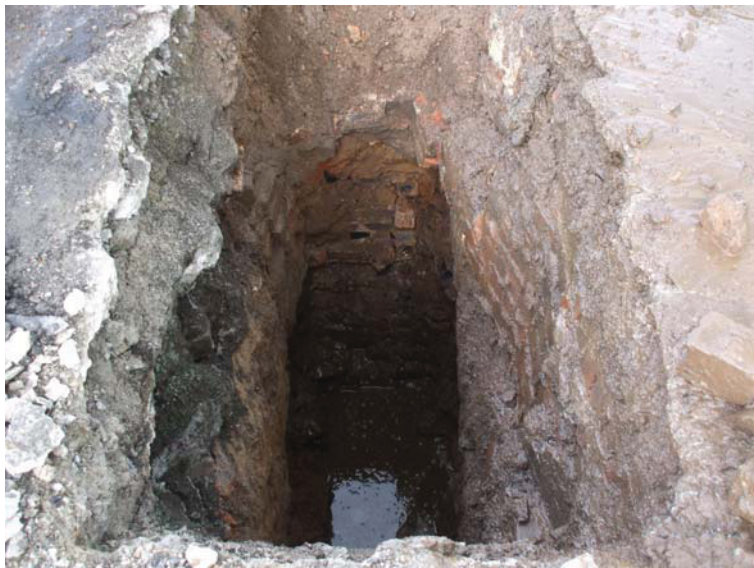
- 4.2 Test pits 3 in the eastern half of the site revealed a possible brick feature at a depth of 0.6 m below the current ground surface and a substantial brick wall at a depth of 1.4 m below the current ground surface. The brick feature was only seen in the test-pit section, but it may have been curved indicating a feature of greater functional complexity than a simple linear wall. The remainder of the test-pits in this area revealed made ground of mainly dumped ash deposits to depths of at least 2.3 m. The bore holes in this area indicated natural soils were not found until 2.7 m deep.

Plate 1 - Test Pit 3 showing wall and possible feature

- 5.1 Despite the limited scope of the test-pits excavated, it was possible to determine that features and structural elements of the nickel works do survive in the western half of the site. As for the eastern half it was not possible to fully interpret the wall(s) found in Test-pit 3 to indicate if they are structural elements of the nickel works or of modern re-use of the site. Given the marked difference in height between the eastern and western halves of the site and the presence of a modern retaining wall to stabilise the upper half (see Figure 8) it is possible that the eastern half of the development area has been completely truncated by later activities.

<i>Dimensions</i>	3 m by 0.8 m by 3.5 m
<i>Orientation</i>	NE-SW
<i>Deposits and Depths</i>	Concrete slab on Type 1 hardcore to 0.3 m overlying a second concrete layer with brick inclusions to 0.6 m. Sandy rubble layer to 1.4 m then an orange sandy clay deposit to 1.9 m covering a brick wall within the centre of the test-pit to depth of 3.3 m.
<i>Significant Features</i>	Brick wall 4 courses wide and 1.4 m high sitting. A slightly curved brick wall/feature on the SE side of the test-pit to depth of 1.4 m
<i>Other Features</i>	None
<i>Subsoil</i>	Fine yellowish brown sand from 3.3 m to 3.5 m.
<i>Finds</i>	None

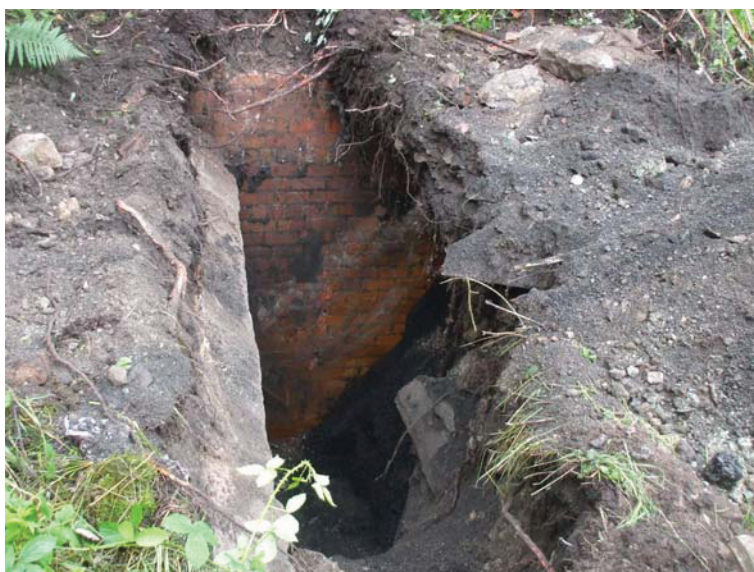
Plate 2 - Modern retaining wall and ash dumps in Test-pit 1

<i>Dimensions</i>	2.5 m by 0.8 m by 3.5 m
<i>Orientation</i>	N-S
<i>Deposits and Depths</i>	Very thin topsoil overlying a silty sand and hardcore to 0.35 m. General concrete and brick rubble to depth of 1.0 m. Layers of green and black ash (furnace residue??) to 3.5 m.
<i>Significant Features</i>	None
<i>Other Features</i>	Modern brick retaining wall running E-W, revealed just under topsoil and hardcore at the southern end. Wall continued to same depth as test-pit.
<i>Subsoil</i>	Not reached
<i>Finds</i>	None

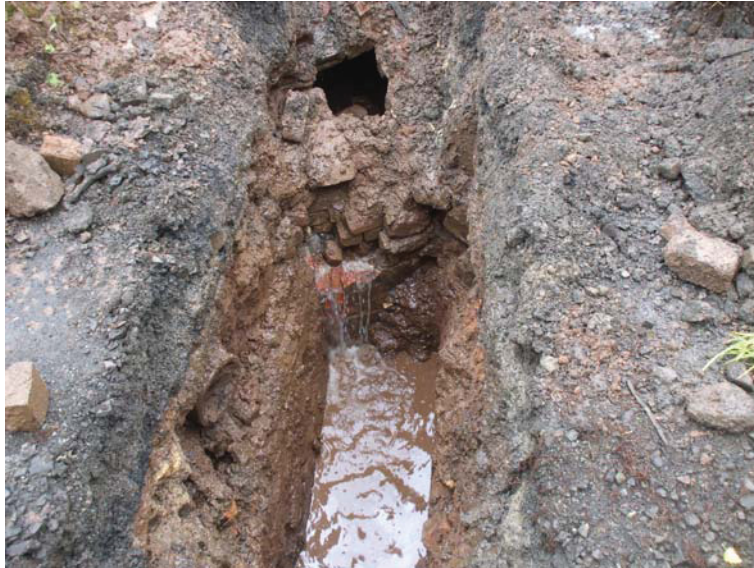
- 4.3 In the western half of the site several other built features were revealed. Three sandstone walls were revealed at depths of 0.5 m below the current ground surface in Test-pits 10, 12 and 13. Furthermore, a large brick structure with an arched brick roof was revealed in Test-pit 8 at a depth of 0.6 m. The structure was filled with water and was running N-S at the western end of the test-pit and was still seen to a depth of 2.5 m deep (water concealed the bottom of the test-pit). The other test-pits revealed modern madeground and surfaces overlying natural subsoil at depths varying from 0.6 m to 2.1 m below the current ground surface.

Plate 3 - Brick feature in Test-pit 8

<i>Dimensions</i>	2.5 m by 0.8 m by 2.5 m
<i>Orientation</i>	E-W
<i>Deposits and Depths</i>	Thin, mossy topsoil covering hardcore to 0.5 m overlying red clayey sand with brick inclusions overlying brick surface to 1 m.
<i>Significant Features</i>	Large brick built drain feature with arched brick top running N-S and abutted by brick floor at depth of 1 m. Feature (water filled) continued into natural clayey sand to 2.5 m.
<i>Other Features</i>	None
<i>Subsoil</i>	Reddish brown clayey sand with large angular stones from 1.2m to 2.5m.
<i>Finds</i>	None

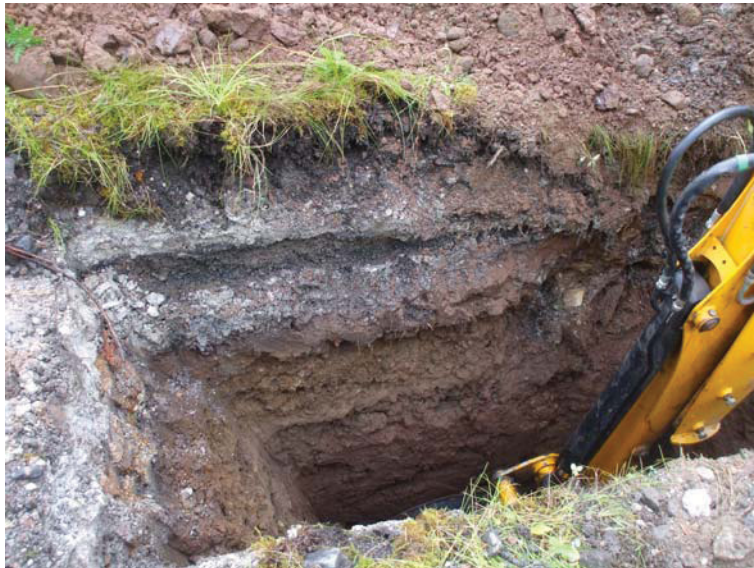
Plate 4 - Modern deposits onto natural subsoil (Test-pit 10)

<i>Dimensions</i>	2.5 m by 0.8 m by 3.3 m
<i>Orientation</i>	NW-SE
<i>Deposits and Depths</i>	Thin, mossy topsoil covering hardcore to 0.2 m overlying concrete and brick layer to 0.5 m. Black ash layer in NW to 0.7 m
<i>Significant Features</i>	Sandstone wall under concrete and brick at the NW end of test-pit.

<i>Other Features</i>	None
<i>Subsoil</i>	Orange gravel in a sandy matrix from 0.7m to 1.3 m sitting on a reddish brown clayey sand to 3.3 m
<i>Finds</i>	None

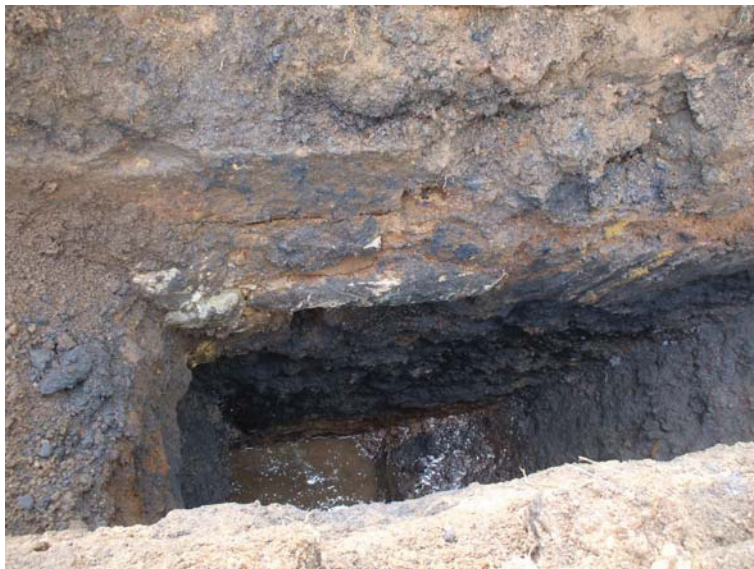
Plate 5 - Sandstone wall under cobbles in Test-pit 12

<i>Dimensions</i>	2.5 m by 0.8 m by 3.4 m
<i>Orientation</i>	NE-SW
<i>Deposits and Depths</i>	Concrete to depth of 0.2 m in SW end of test-pit sitting on grey ash and slag to 0.6 m. Re-deposited gravel and sand to 1.1 m. Dark grey clayey sand (contaminated) to 1.5 m.
<i>Significant Features</i>	Sandstone wall under cobbles running NE-SW (seen in section) - measured 1.5 m in length with a foundation course and two other courses of cut stone with a sandy concreted mortar.
<i>Other Features</i>	Cobbled surface to the NE end of test-pit overlying sandstone wall.
<i>Subsoil</i>	Orange gravel in a sandy matrix discoloured by contamination from 1.5 m to 2.8 m sitting on reddish brown clayey sand (contaminated) to 3.4m
<i>Finds</i>	None

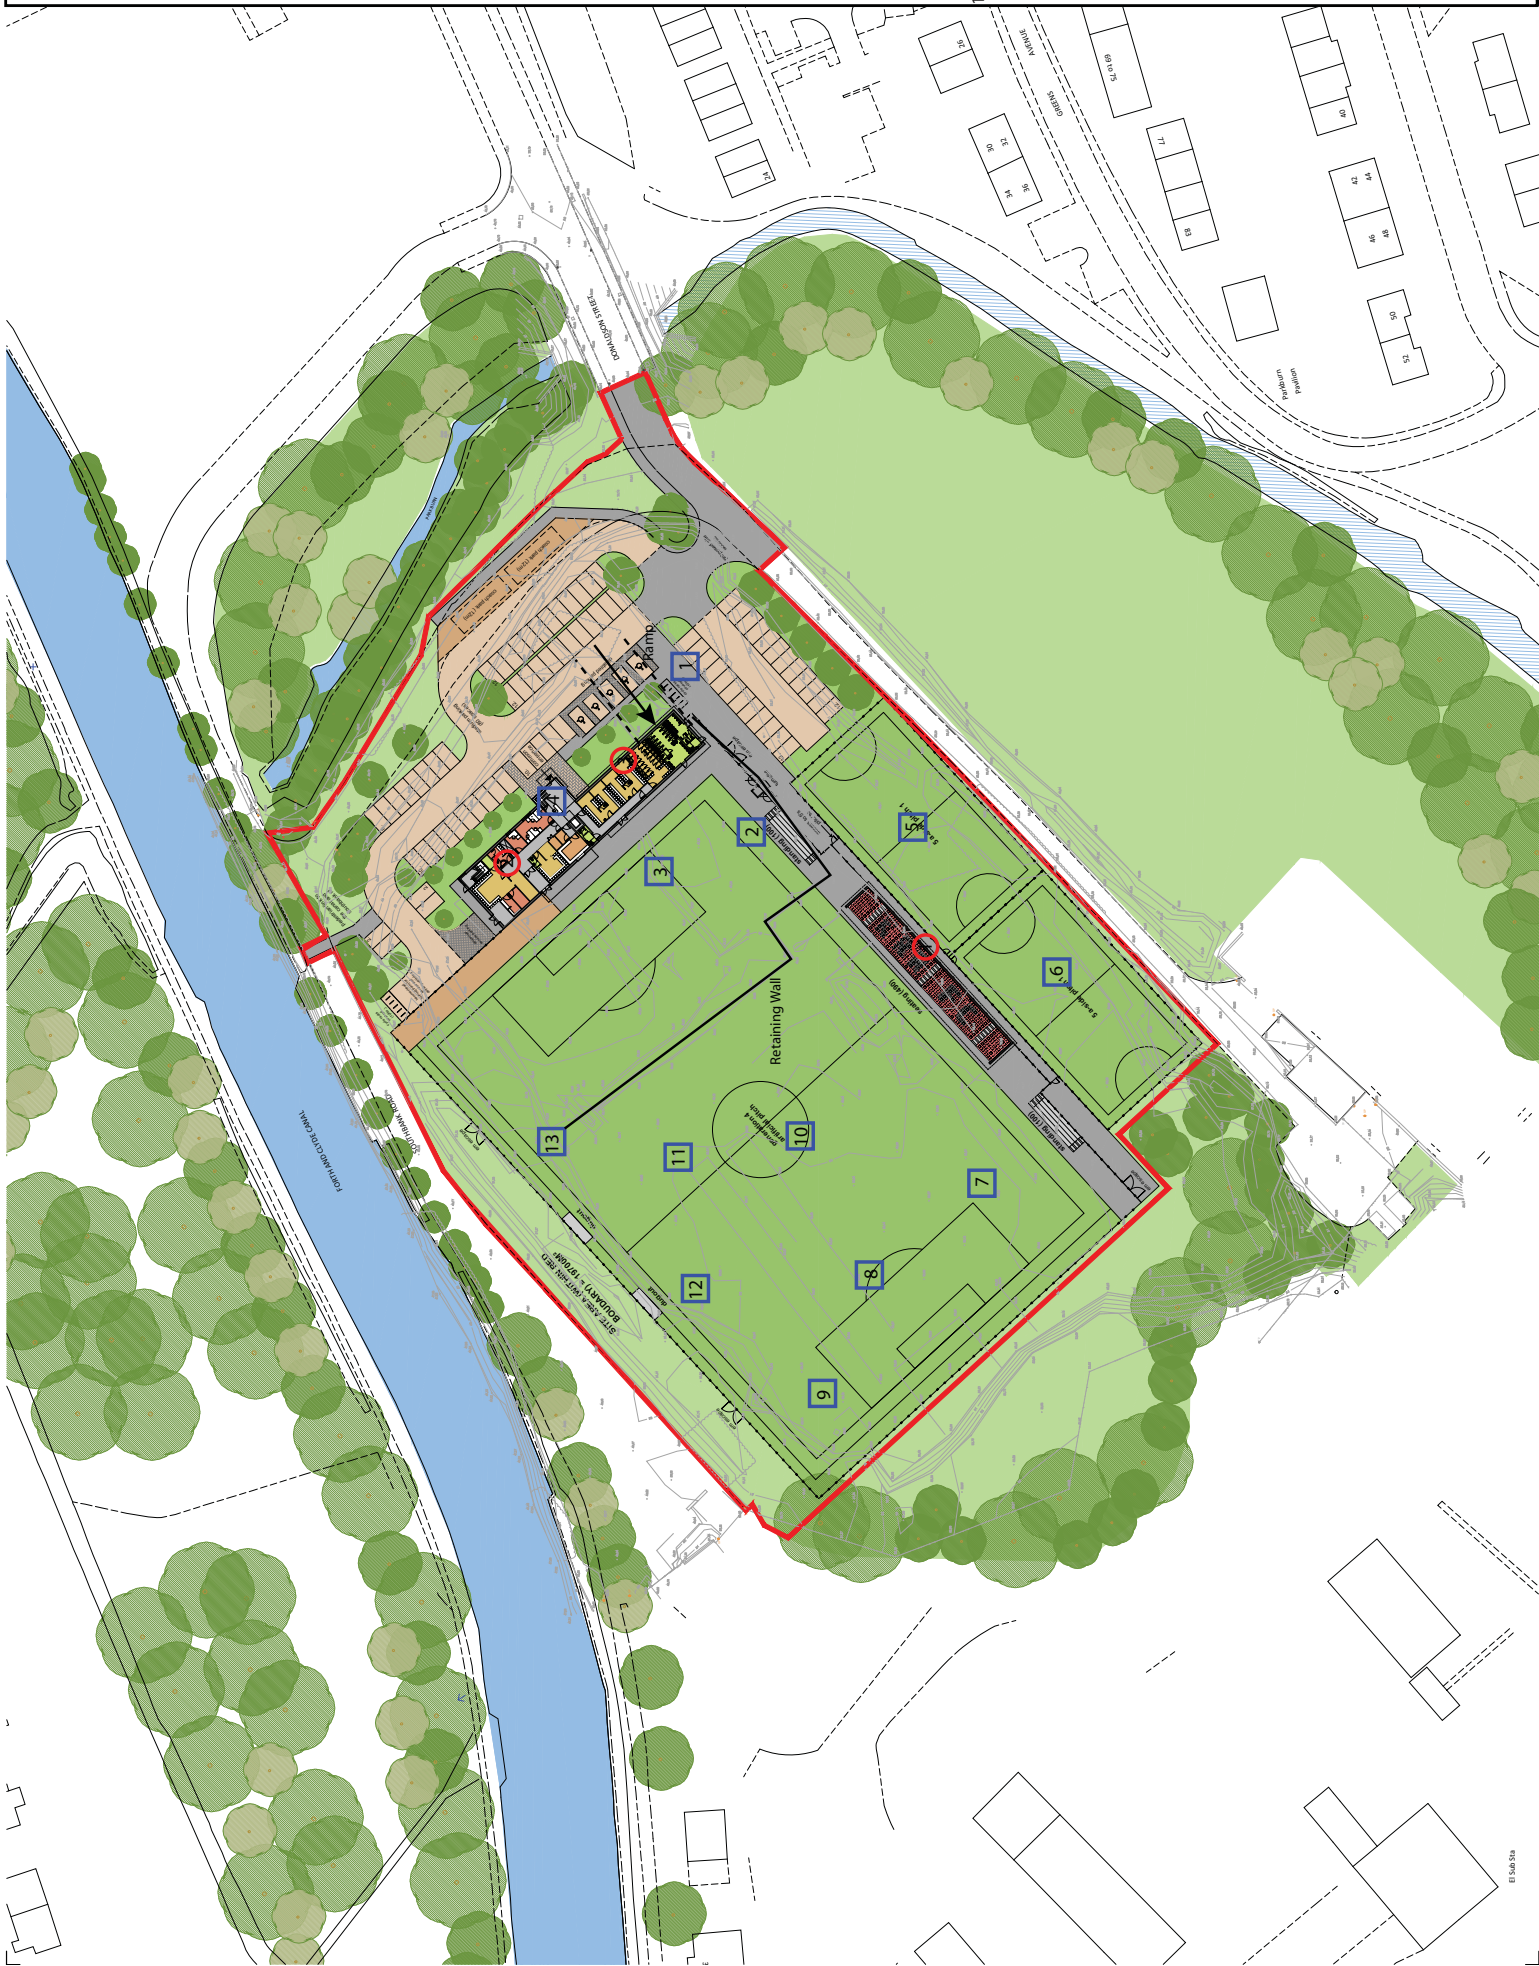
Figure 8: Location of Test Pits 1-13 and Boreholes 1-3 Adapted from a drawing provided by the Client

Figure 8b: Location of test-pits and bore-holes overlain on development plan
