Park Hill Park, Water Tower Hill, South Croydon, London Borough of Croydon: An Archaeological Watching Brief Report

AOC Project No: 32004

Date: August 2012

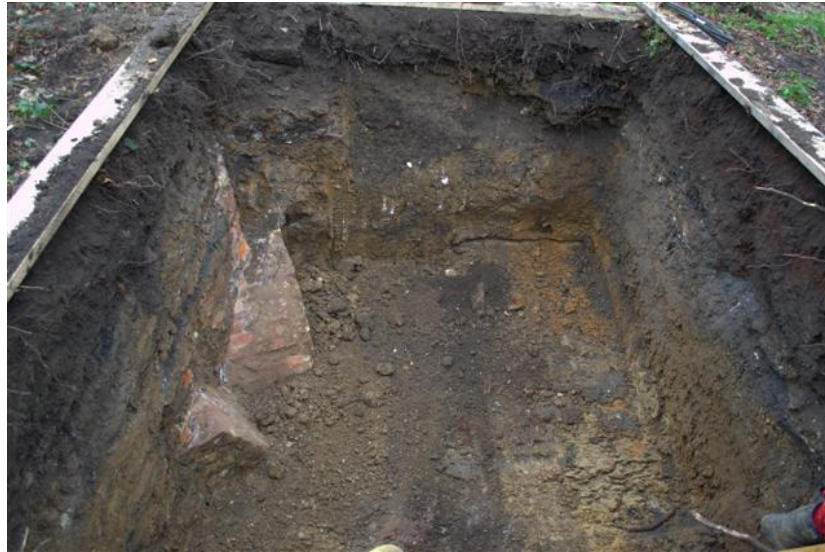
Plate 1. Test Pit 6, looking southeast.

7.6.2 Test Pit 6 was located in the south of the site (Figures 2 and 3), north of Test Pit 8; it measured 3.80m x 3.00m. Natural firm, yellow clay (609) was observed in the west of the trench, at a height of 82.95m AOD. The earliest features recorded in the eastern portion of the trench comprised a series of brick structures, probably associated with the engine house for the nearby water tower. A pair of arched features [607] and [608] were visible in the eastern section of the trench. [607] was aligned northwest-southeast, and was constructed from red bricks measuring 215mm x 110mm x 65mm in rough English pattern, bonded with sandy cement mortar; it measured 1.10m in length, at least 0.50m in width and at least 0.70m in height. Feature [608] was constructed in the same manner; it was perpendicular to [607], being aligned southwest-northeast. It measured 0.60m in visible length, 0.50m in width and at least 0.70m in height. A brick wall [606] sat directly upon [607], it was again

constructed from red bricks and sandy cement mortar in stretcher bond; it was aligned east-west and measured 0.10m in length, 0.30m in width and 0.80m in height.

7.6.3 The brick features were overlain by made ground deposit (605), a firm, mid yellow-brown sandy clay, with occasional CBM inclusions; it was 1.50m thick. The made ground was cut by water pipe trench [604], this was aligned north-south; it was a linear with vertical sides, the base was not observed. It measured 3.80m in length, 0.80m in width and 2.10m in depth. The water pipe (603) was cast iron and measured 3.80m in length and 0.50m in diameter. The pipe trench fill (602) consisted of loose greyish yellow sandy clay. The pipe trench was overlain by made ground deposit (601), a loose grey silt with frequent CBM inclusions; this deposit was 0.30m thick. The made ground was sealed by 0.50m of loose dark grey sand-silt topsoil (600).

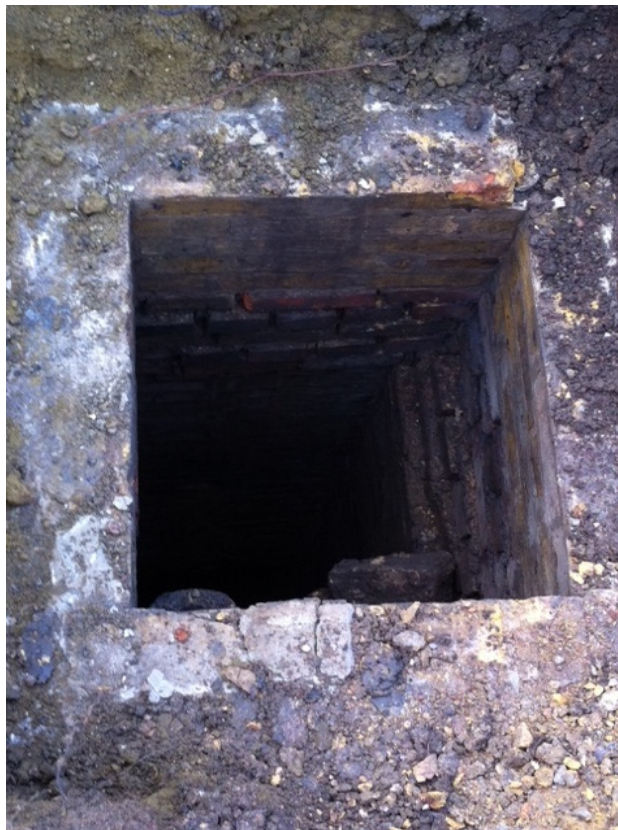
Plate 2. Inspection chamber [207], looking north

- 7.8.3 An inspection chamber [807] was found in the west of the pit; it was constructed from yellow stock bricks measuring 215mm x 110mm x 65mm, bonded with cement mortar, in stretcher pattern. The chamber was square, measured 1.00m in diameter and was 5.60m deep with an arched drain at the base. The inspection chamber cap [806] was a circular collar of yellow stock bricks bonded with cement mortar in stretcher pattern, 1.40m in diameter and 0.30m high, with an iron grate set into the centre.

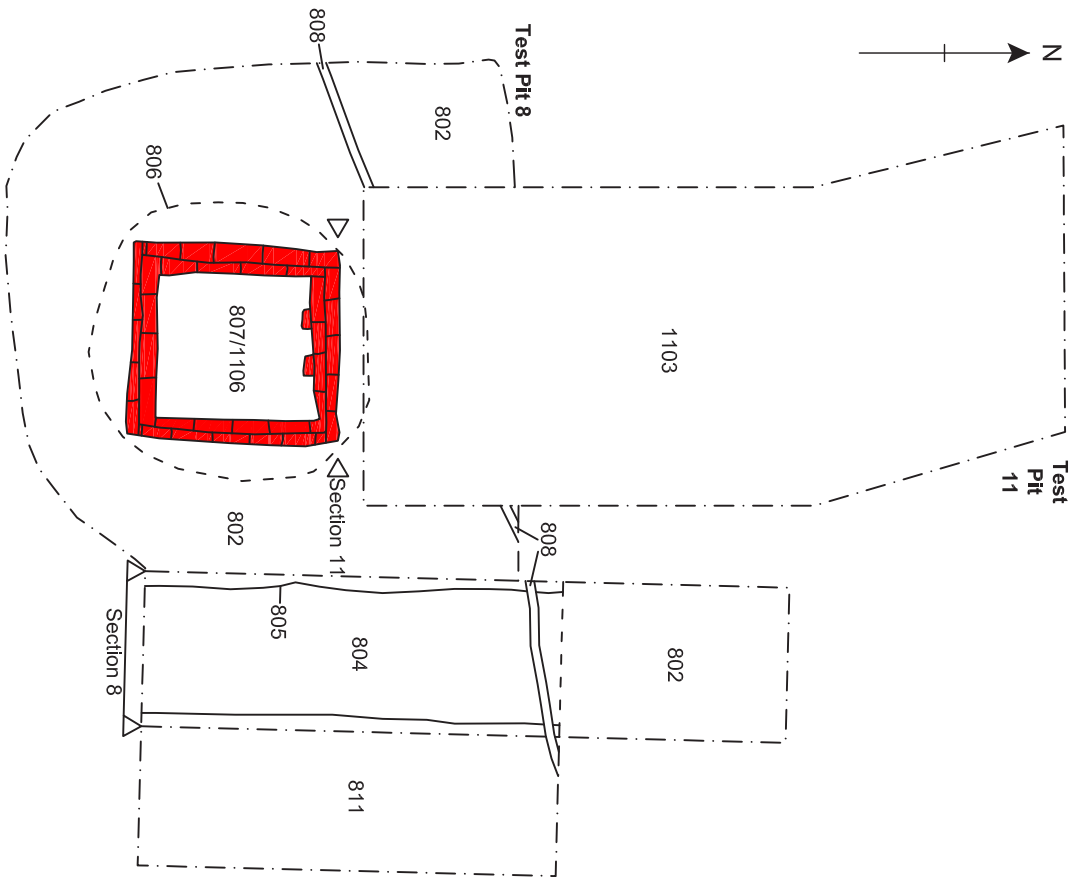
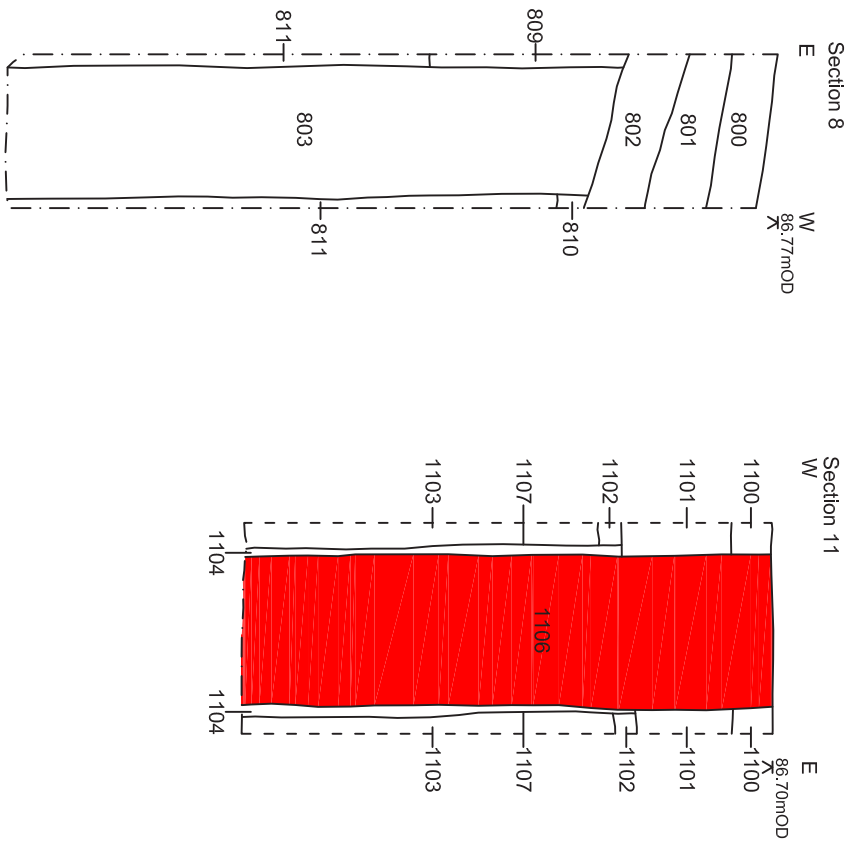
Figure 4: Test Pits 8 and 11: Plans and Sections

- 7.8.2 Test Pit 8 (Figures 2 and 4) was located in the south of the site, north of Test Pit 7 and was intended to be the intermediate pit, but the water pipe proved to be too deep for access. It measured 5.00m x 4.50m. The natural deposit (811) was observed at a height of 85.29m AOD and consisted of mid brownish orange silt-clay, it was overlain by subsoil (810) which consisted of mid brown clay-silt, 0.30m thick. A deposit of made ground (809) was visible in the eastern face of the pit; it consisted of firm chalk blocks and was 1.40m thick, this deposit is probably associated with the landscaping undertaken for the construction of the water tower or reservoir. The made ground and subsoil were cut by the water pipe trench [805]; this was linear, with vertical sides and was aligned north-south. It measured 3.00m in length, 0.80m in width and 4.15m in depth; the base of the trench was not seen. The pipe trench fill (803) consisted of soft grey-yellow sandy clay.

7.11.2 Test Pit 11 (Figures 2 and 4) was in the south of the site, to the north of, and partially overlapping Test Pit 8; it measured 5.00m x 2.00m. Natural orangey yellow clay (1103) were observed at a

height of 85.65m AOD, they were overlain by a thin subsoil deposit (1102) which consisted of mid orangey brown silty sand which was 0.15m thick. The subsoil was truncated by the cut for the inspection chamber seen in Test Pit 8 as [807]. This cut [1107] was only seen in the southern section of Test Pit 11; it was 1.10m in width and at least 2.50m in depth with vertical sides. The inspection chamber itself [1106], has been previously described as [807]. The fill of the inspection chamber cut (1104) consisted of loose dark grey sandy silt, 2.50m thick.

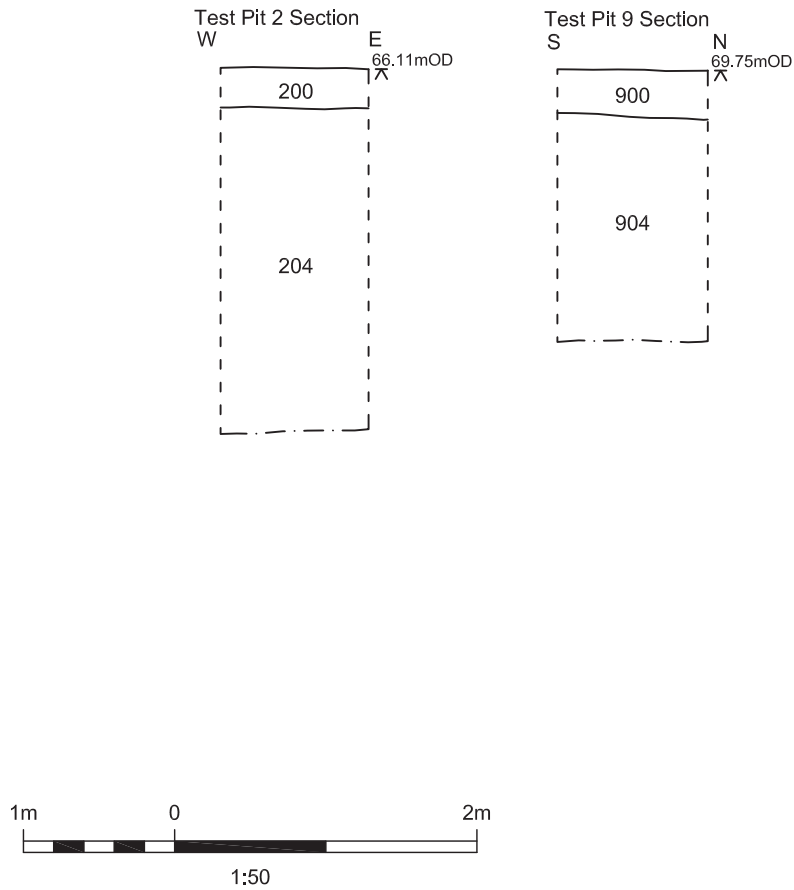
Figure 5: Sample Sections

7.2.2 Natural orange-yellow clay (203) was observed at a height of 65.86m AOD. The natural clay was cut by two water service trenches [202] and [207]; service trench [202] measured 5.00m in length, 0.50m in width and 2.40m deep; it was linear with very steep sides and a flat base and was aligned north-south. The trench contained a cast iron, bitumin coated water pipe (204), 5.00m long and 0.45m in diameter. The trench backfill (201) consisted of soft orange-yellow clay, 2.40m thick.

7.2.3 Service trench [207] was also aligned north-south, it had vertical sides, a flat base and it measured 5.00m in length, 0.40m in width and 1.50m in depth. The water pipe (206) was again cast iron and was 0.30m in diameter. The pipe trench backfill (205) consisted of soft orange-yellow clay, 1.50m thick. The services were overlain by topsoil deposit (200), which consisted of dark brown clay-silt 0.25m thick.

7.9.2 Test Pit 9 (Figures 2 and 5) was located in the centre of the site, approximately 2m south of Test Pit 3; it measured 4.00m x 3.00m. Natural orangey-yellow clays (904) was observed at a height of 69.45m AOD. The natural deposit was cut by pipe trench [903]; which was linear, with vertical sides and a flat base and was aligned northwest-southeast. It measured 4.00m in length, 0.80m in width and was 1.50m deep. The pipe (902) measured 0.45m in diameter and was constructed from cast iron; the pipe trench fill (901) consisted of soft, orange-yellow sandy-clay with occasional CBM inclusions. The trench fill was overlain by topsoil (900), a deposit of dark brown clay-silt, 0.30m thick.
