**AOC**  
Archaeology  
Group

## Advocates Library, Edinburgh

### Watching Brief Report

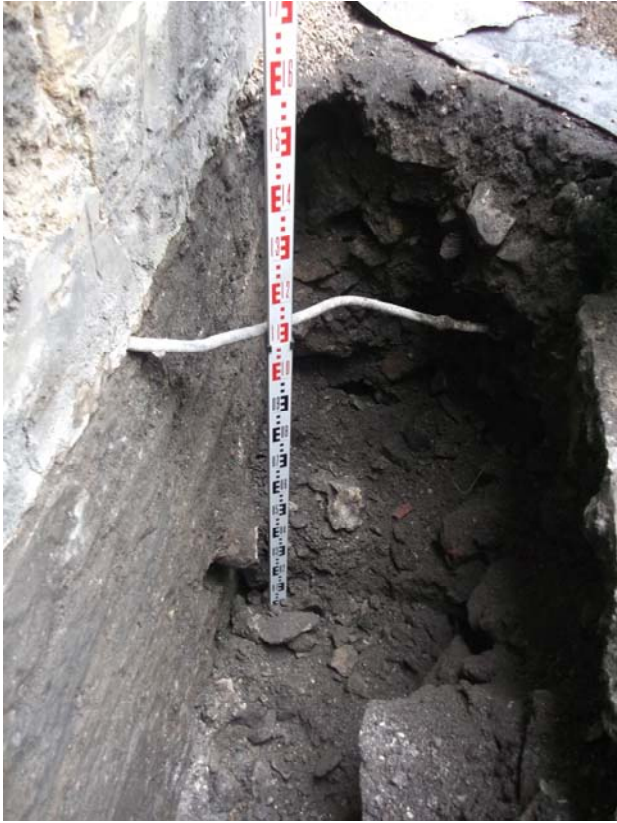
**Plate 1 Test Pit 1**

Test Pit 1 was excavated to a depth of 1.5m against the southern elevation wall of the Advocates Library (**Plate 1**). A single deposit of friable dark greyish brown sandy clay mixed with demolition rubble was encountered extending to the limit of excavation from beneath the thin spread of scalpings which form the modern ground surface. The deposit contained a mix of material including clearly 20<sup>th</sup> century recent ceramic, architectural masonry (**Plate 2**) and fragment of Glasgow manufactured chimney pots dating to around 1830-1850 (Haggerty *pers. Comm.*). Test Pit 1 measured 1.8 x 0.70m.

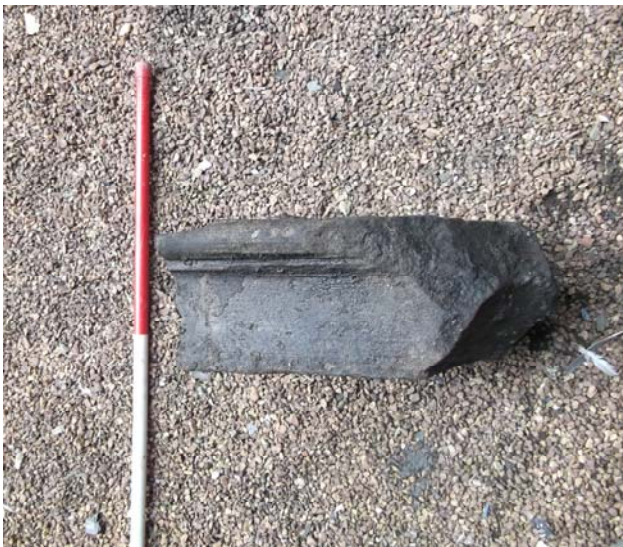
**Plate 2 Fragment of Architectural Masonry Recovered from Test Pit 1**

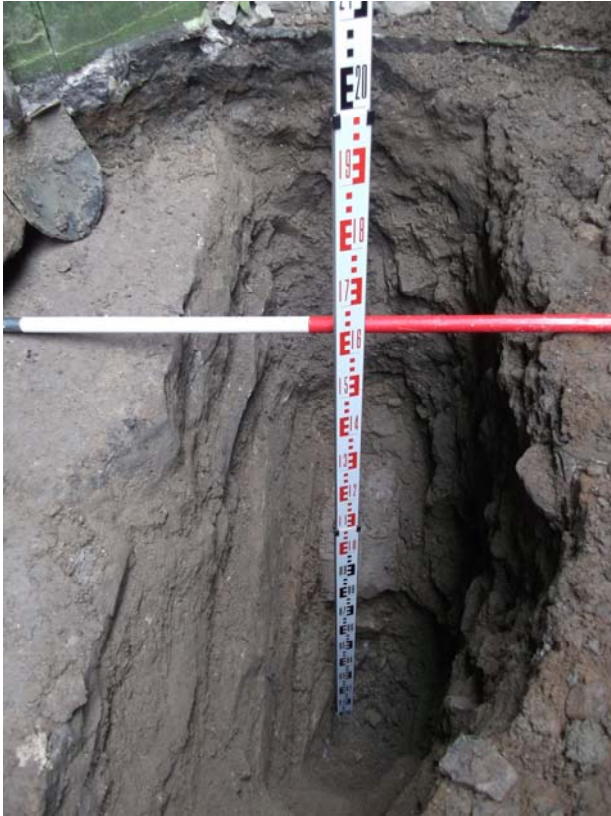
**Plate 3 Test Pit 2**

Test Pit 2 was excavated to a depth of 2.15m against the northern elevation wall of the Advocates Library (**Plate 2**). A single deposit of buff yellowish greyish brown silty sand with sandstone brash extended for 1.3m below the ground surface. The sandstone brash was sealed by a deposit of grey clayey sand containing pockets of black organic clay which extended below the limit of excavation. No finds were recovered during the excavation of the test pit. Test Pit 2 measured 1.8 x 0.70m.

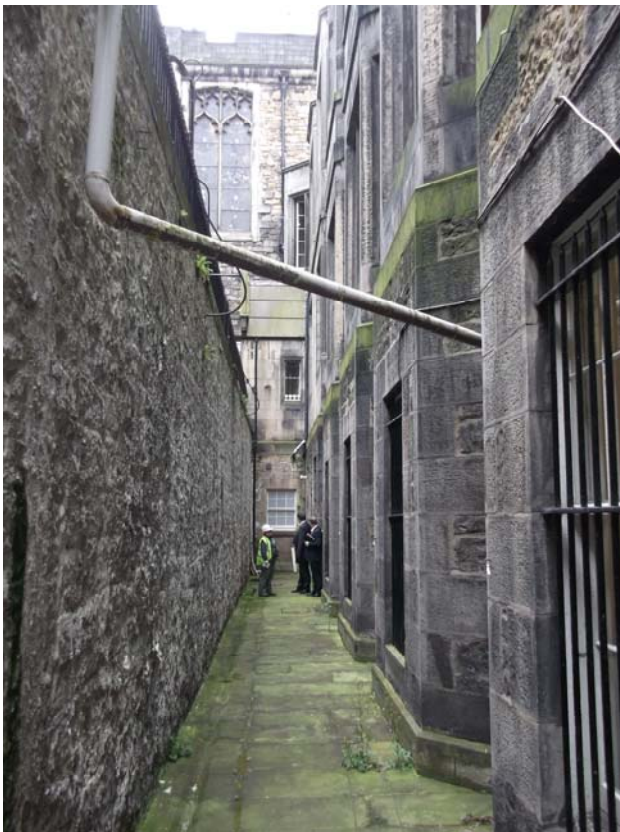
**Plate 4 East facing view along the basement court within which Test Pit 2 was excavated showing the Advocates Library (right), the courtyard's revetment wall (left) and Parliament Hall (background)**

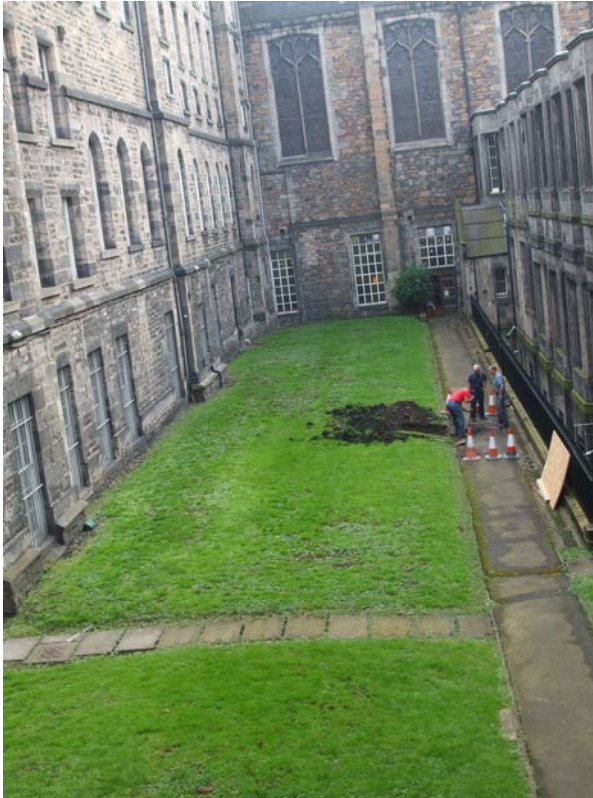
Test Pit 2 was excavated to a depth of 0.85m within the grassed courtyard which lies between the Advocates Library, the Signet Library and Parliament Hall Advocates (**Plate 5**). A single deposit of dark greyish brown sandy clay mixed with rubble extended from ground level to the limit of excavation (**Plate 6**). No finds were recovered during the excavation of the test pit. Test Pit 3 measured 3.4 x 1.40m.

**Plate 5** East facing view of Test Pit 3 showing the Advocates Library (right), the Signet Library (left) and Parliament Hall (centre)

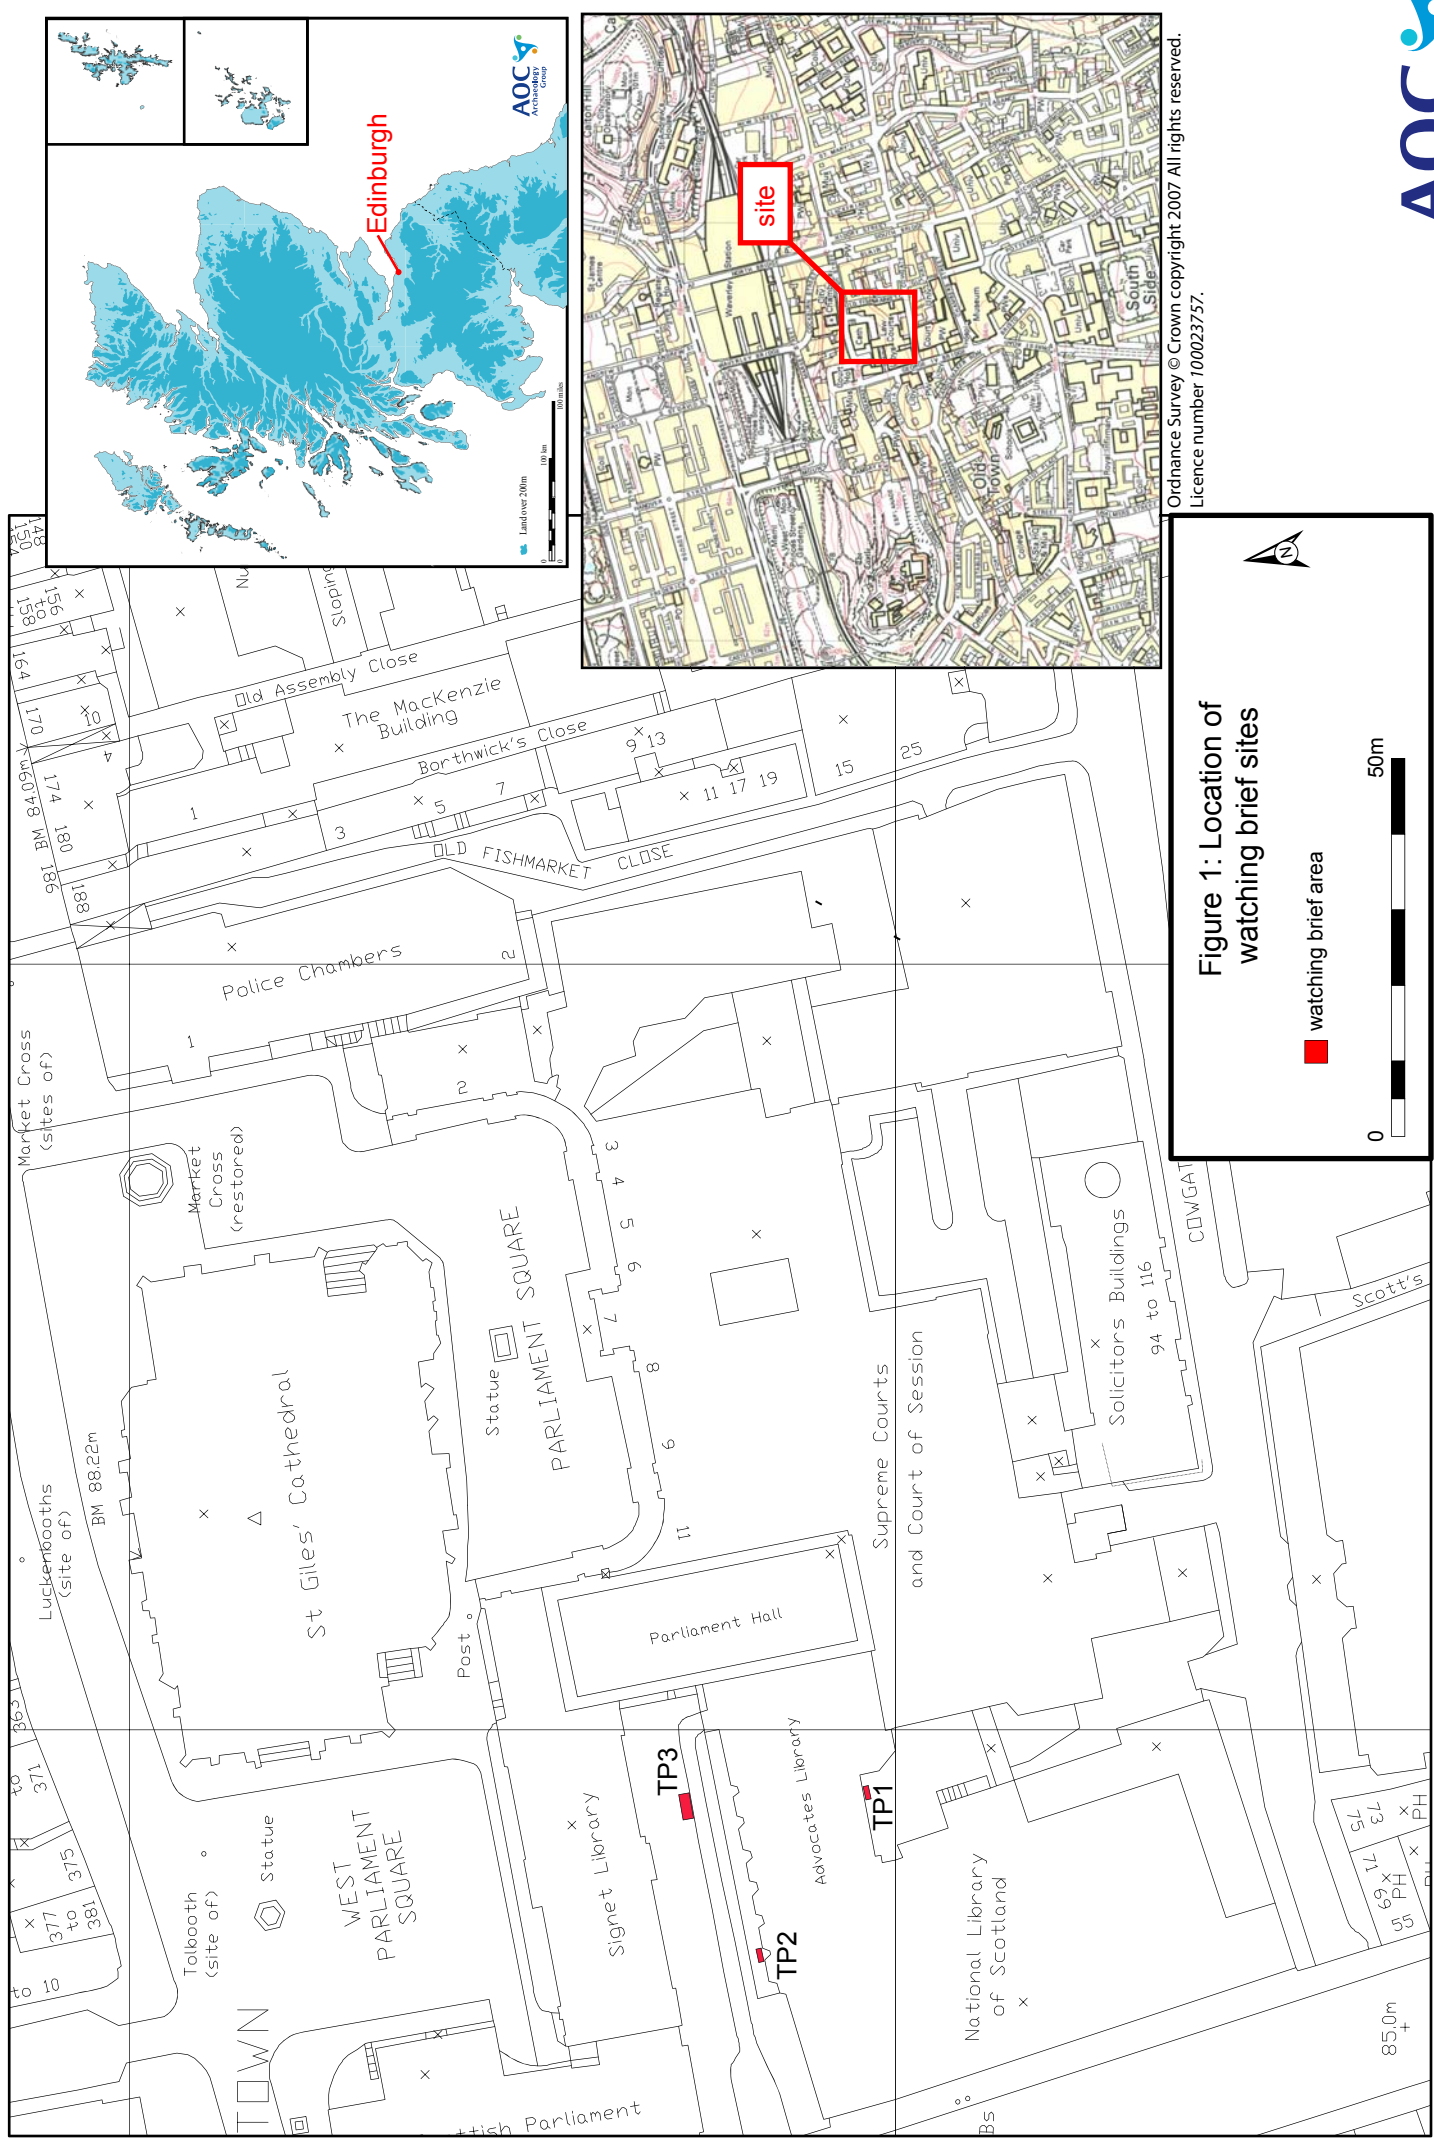
Figure 1      Location of watching brief

- 1.2.1 The three test pits were located both north and south of the exterior of the Advocates Library (NGR: NT 2568 7351, Figure 1). Test Pit 1 was excavated against the southern elevation wall of the Library within a small courtyard accessed from the Cowgate to the south. Test Pit 2 was dug against the corresponding north elevation wall, within an open basement court, several metres below the ground level of the grassed court to the north (**Plate 4**). The final test pit, Test Pit 3 was excavated within this upper grassed court.
- 1.2.2 The individual grid references for the test pits were:
