Flimby Wind Farm Watching Brief Data Structure Report

AOC Project 21676
OASIS ID – aocarcha1-136458
30th October 2012

Flimby Wind Farm: Watching Brief Data Structure Report

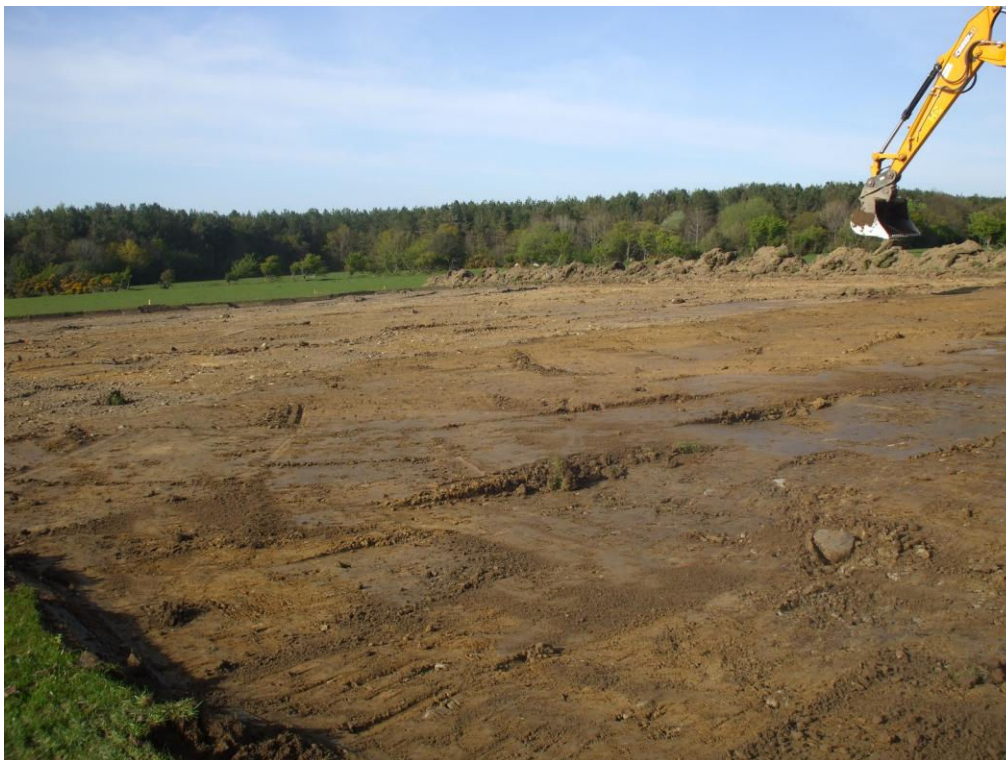
Plate 1 - Turbine 1 crane pad stripped

- 4.2 The topsoil across the watching brief area was a mid brown clayey silt ranging from 0.2m to 0.4m deep, sitting on a natural subsoil of mottled orange clay. An abundance of modern ceramic tile field

drains were noted within all areas of the excavations. A modern sewer cut was revealed in the crane pad of Turbine 1, and the disturbance from mining activity was present around Turbine 2.

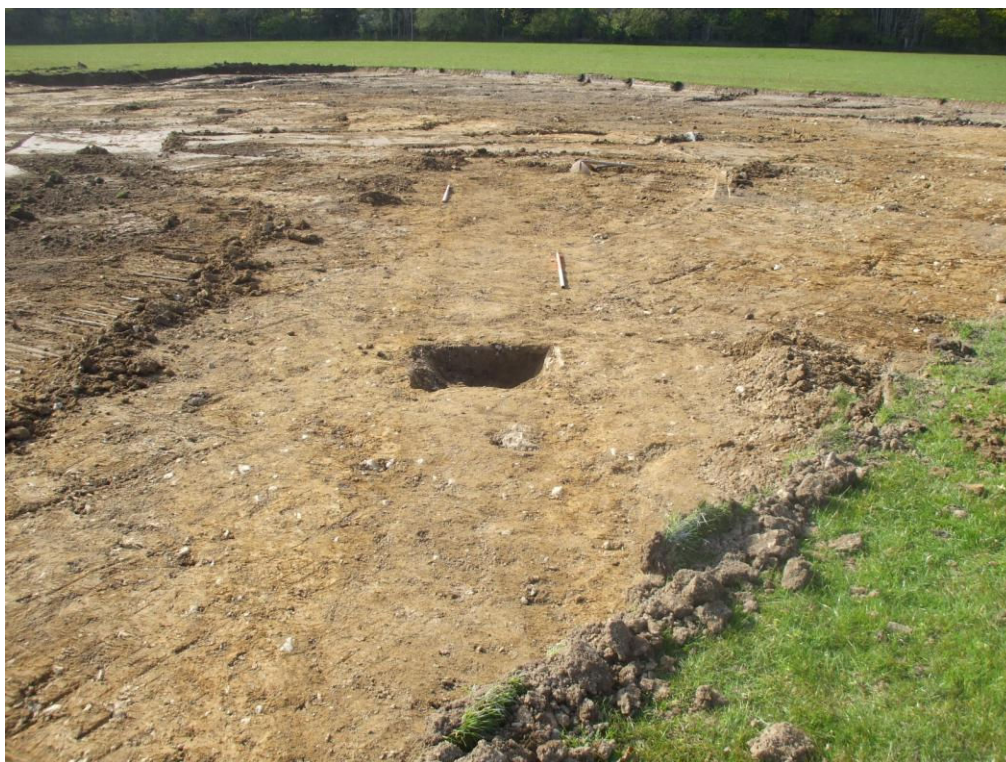
Plate 4 - General shot of ditch [004]

4.3 A linear feature [004] running SE-NW, terminating 11m from the eastern edge of haul road 2 was revealed and recorded (Figure 3). It measured 11.24m by 0.69m by 0.15m, with the fill [005] containing one small fragment of 18th century clay pipe stem. The NW terminal was very shallow (0.04m) and there

were clear indications of plough truncation throughout the field. The ditch [004] was also cut by a field drain running NE-SW.
