# St Peter with St Paul Church Hall, Plough Road, London Borough of Wandsworth: Historic Building Record

Planning Application: 2009/0716

AOC Project No: 32322

Date: December 2012

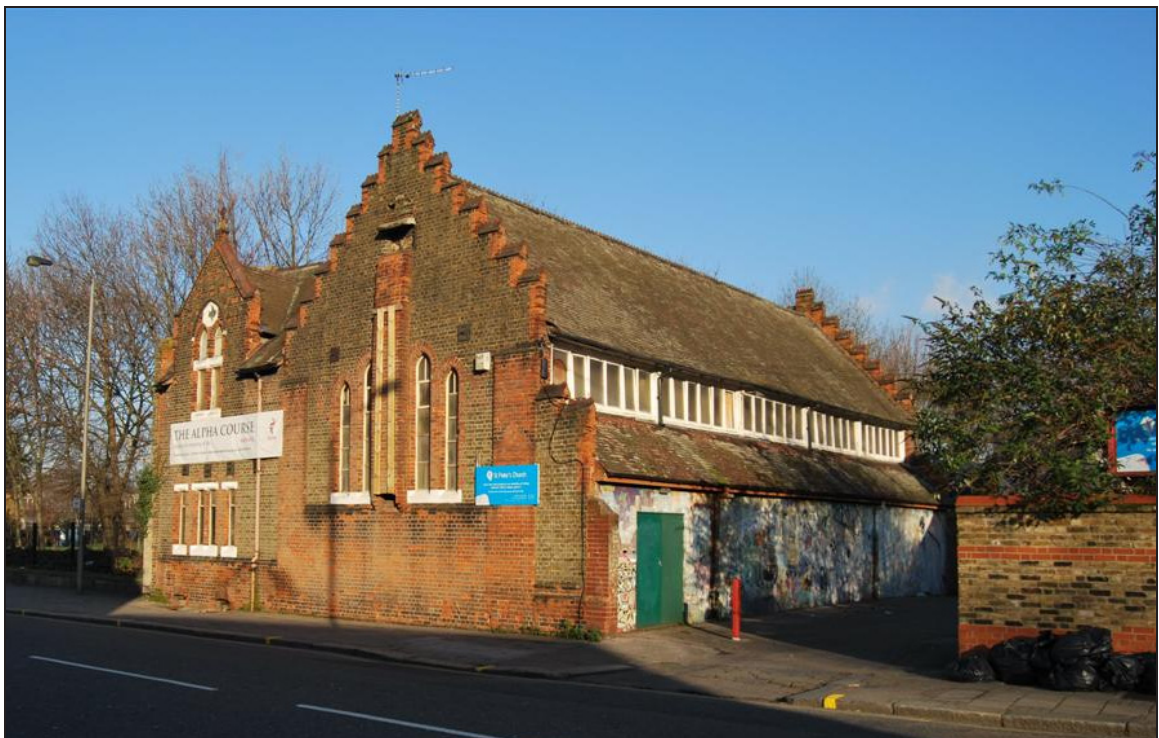
Plate 1: External View Of Hall

- 6.1.1 The building comprises a rectangular hall measuring 19.3m by 9.3m in plan, oriented east-west, in free Gothic style. It has a pitched tiled roof, with windows in each end and a high-level clerestory along each side with projecting side aisles. Additions have been built on the north side, comprising a two-storey block with twin gables and a later, flat-roofed extension. More modern buildings have been appended to the east end, providing community spaces over the footprint of the burned down church.

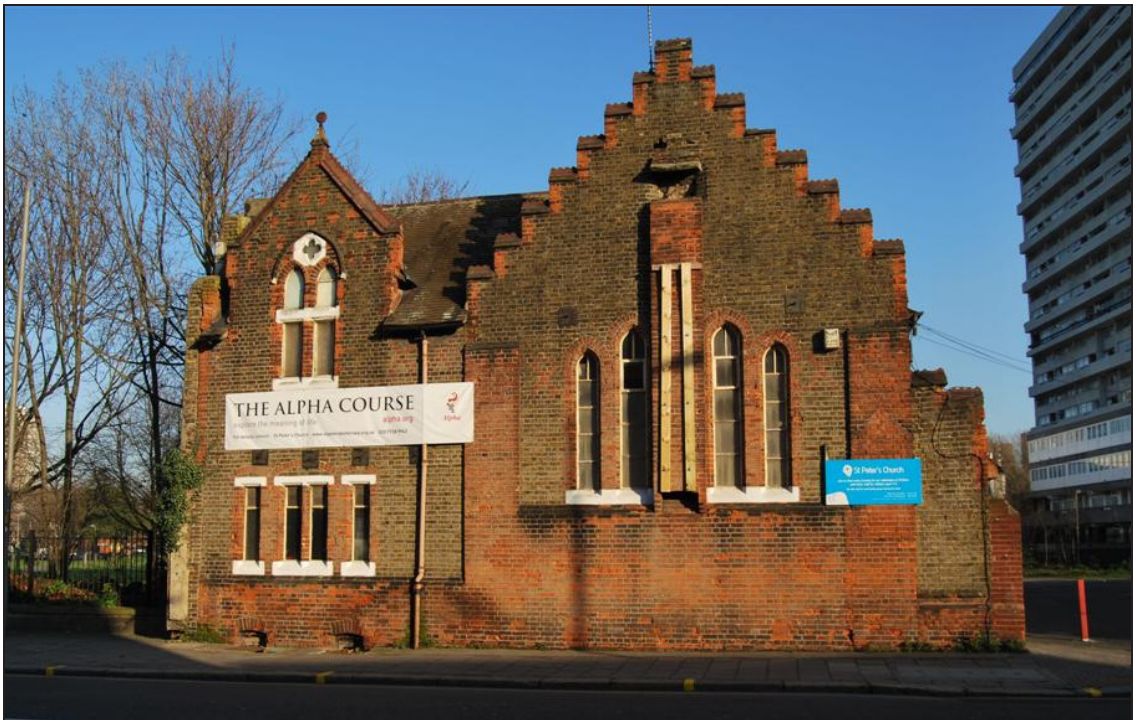
Plate 2: West Elevation, Church Hall

- 6.2.1 The principal room in the building, and the main function, is the hall (**Room 1**). This is constructed of yellow brick with red brick and stone dressings. The bricks are laid in English Bond, and the stonework is limited to the sills of the windows. The north side of the hall has later additions concealing much of its face, and the south side is painted with a mural, the Battersea Puzzle, dating to 1981 (LMPS 2012).
- 6.2.2 The west end of the hall is 0.5m thick and faces directly onto the street, and has a gable end with windows, the peak standing 8m high. The red brick dressings outline the body of the hall, and angled

bricks form the window reveals. A central hollow brick panel has wooden braces bolted to it, which are preventing this end wall from collapsing. Above the panel is stone hood. There are two windows each side of the central panel, each with lancet arches. The glazing is clear glass, set in wooden frames. Each window has an upper bottom-hung casement that opens inwards. An additional brick buttress has been added on the south side of the front, probably contemporary with the modern supports. The gable of the hall church has some of the more interesting and decorative elements of the whole building, being a crow-stepped gable, each step adored with a peak and trough ridge tile. Each step is red brick. The east end of the hall is similarly constructed. The join between the main hall and the northern extension is well coursed, and the upper levels are obscured by a large advertisement for 'The Alpha Course', hiding the brickwork. This reflects the fact that since the church burnt down, the hall has been a religious focus.

fashion, with a quatrefoil spandrel. However, the west wall has suffered subsidence and movement which has required bracing and tying in order to prevent the wall from buckling outwards and collapsing onto Plough Road. Externally, this is manifest by a pair of applied upright posts which are designed to prevent this west wall from moving, and a series of iron plates which have been added, bolting the end roof truss to the wall. Internally, the repair bracing is formed of wooden beams bolted between the western end truss and the next truss in, which is likely to have stressed the second truss also. The crow gables above the ends of the hall do not appear to have been affected by the movement below.

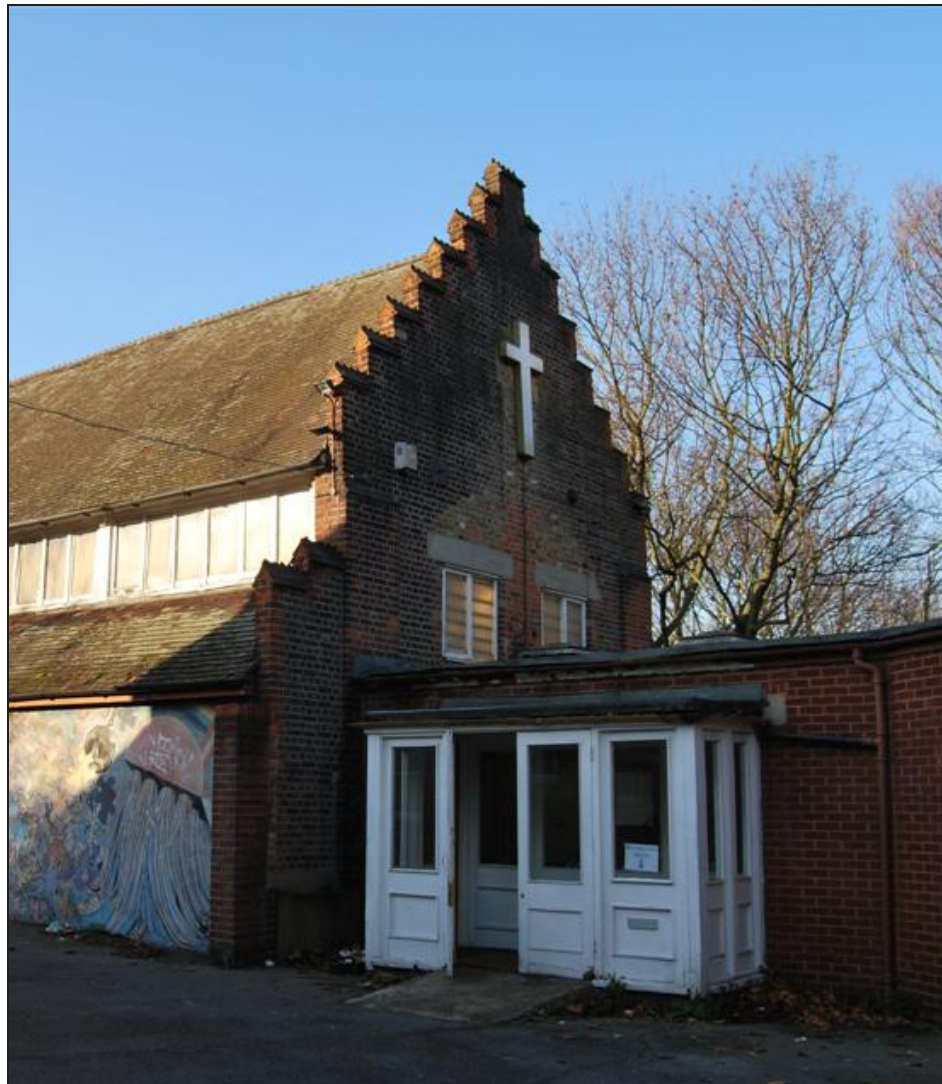
Plate 3: East End Of Hall, Showing Repairs

- 6.2.4 The east wall of the hall shows noticeable evidence of repair, and rebuild, although the cause of structural failure is unknown. The yellow bricks that form the main body of the hall around the windows have been replaced with a mix of much paler bricks and red bricks. Two casement windows in the end wall have concrete lintels. The lower parts of the end wall are concealed by modern additions to the structure. The main entrance to the hall is now through this modern addition: a set of double doors lead northwards from here. A large white Latin cross has been applied to the gable.

- 7.2 There has also been movement in the north wall of the early extension, with a crack in the brickwork of the stairwell (**Room 3**), and at the east end of the hall, the main window in the gable has been rebuilt using concrete sills in the post-war period. It is unproven whether this is blast damage or caused by structural weakness.

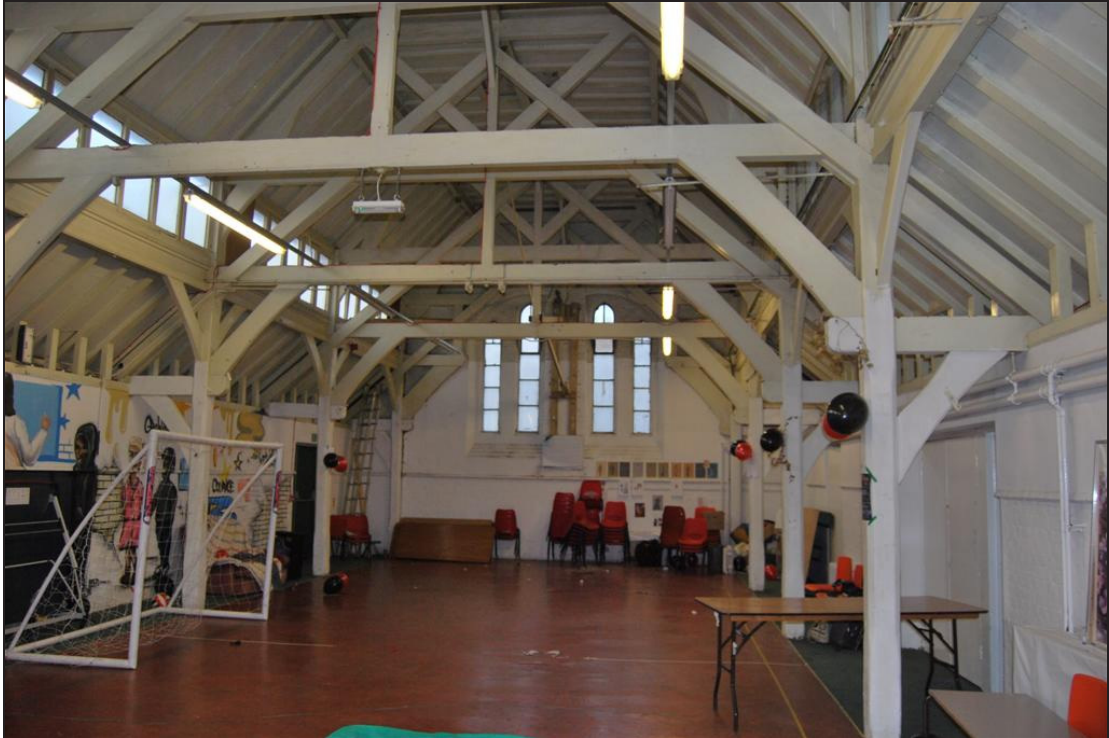
Plate 4: View Of The Hall, Looking West

- 6.2.5 Internally, the hall is a single open space divided into five bays by six timber trusses (**Room 1**). The two end trusses are partially inset into the brickwork of the walls. Each truss is constructed identically, apart from the ends, which have open tie-beams, to allow for the windows. Each truss is based upon a pair of posts, which rise from floor to eaves level, two parallel tie-beams span the width of the church, tying the posts together at eaves level and at the level of the top of the side aisles. All of these elements have chamfered edges with stops. A collar-beam spans the roof at purlin level.

- 6.2.6 The roof is a king post roof with struts and each tie-beam is braced with arched braces. Trenched purlins on each side carry the common rafters. At 2.50m height, short tie beams run between the principal posts and the outer walls of the side aisles. These are braced with struts, and the open end is effectively a corbel for the lowest braces. The principal rafters of the side aisles rise from the outer ends of the beams, to the king post of the main truss, at the same angle as the main roof. Each principal rafter associated with the side aisles is formed of a pair of timbers bolted on the outside of each principal truss.

- 6.2.7 The end trusses both have open tie beams, and the king posts end in points. This allows the windows to be uninterrupted by the timber framing. However, there is evidence for structural failure and repair at each end of the hall: the principal trusses that rise from the side aisles have been clasped with iron bands. This is assumed to be a preventative measure to stop splintering as the

outer walls deform. The western truss (Truss A) is tied to the second truss (Truss B) by large beams that span the bay, a second measure to prevent the wall moving. They are attached to a pair of upright beams on the outside of the hall. The brickwork of the west end is however, largely intact. This shows that the four lancet windows have potential weight above them relieved by a pair of semi-arches that meet at a central pier. At the eastern end, the arches have been damaged by the repairs to the brickwork, and the insertion of concrete lintels apparent on the exterior.

- The trusses that support the roof appear cluttered and at first a peculiar admixture of a king post roof with a complex bracing and supports. However, it is quite a simple and basic construction, with the principal side-aisle rafters largely cosmetic. Effectively, the roof is a king post roof with braces, the king post rising from the upper tie beam of the clerestory. A parallel lower tie beam at the base of the clerestory has a post spanning the space, but is subsidiary to the main support. Each principal rafter and collar beam is secured with braces, which is typical of a mid to late Victorian hall.

- The side aisles are supported with another principal rafter assembly, the rafters bolted in pairs to the main assembly and meeting at the collar beam of the kingpost. The side aisles would have structural cohesion without these long rafters, being supported by braced side collars. The extension of the principal rafters of the aisles provides an attractive architectural detail, they run parallel with the principal rafters, reflecting the tie-beams above and below the clerestory, and having the same proportions.

- Overall, although the king post assembly is very common, the unnecessary parallel rafters provide an attractive line, and enhance the hall's internal appearance, by focussing the perspective, in two stages. The History Building Company Report (Leadsom 2009) describes the roof assembly as typical of a cluttered Victorian structure. Whilst it may be described as busy, there is a space of 3.4m between trusses, and their height, in association with the clerestory windows, has resulted in a well-lit building that is typical of, perhaps, the 1870s rather than the heavier, darker framing later in the century.

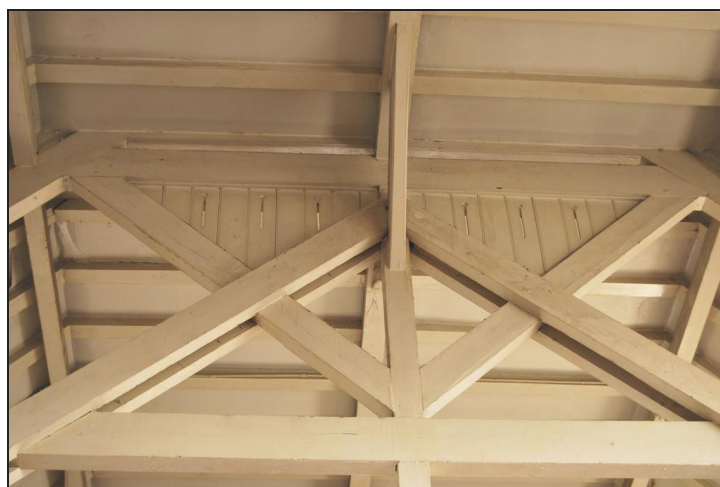
Plate 5: Boards At Truss 'E'.

- 6.2.8 Two of the inner four trusses shows minor additions or losses. The second truss (Truss B) is missing its southern lower brace below the aisle tie-beam and the south aisle. Also, a new section of timber has been added to one the lower principal rafters. The fifth truss (Truss E) has lost the head of the inner corbel. Of note, however, is a partial pierced screen beneath the collar beam.

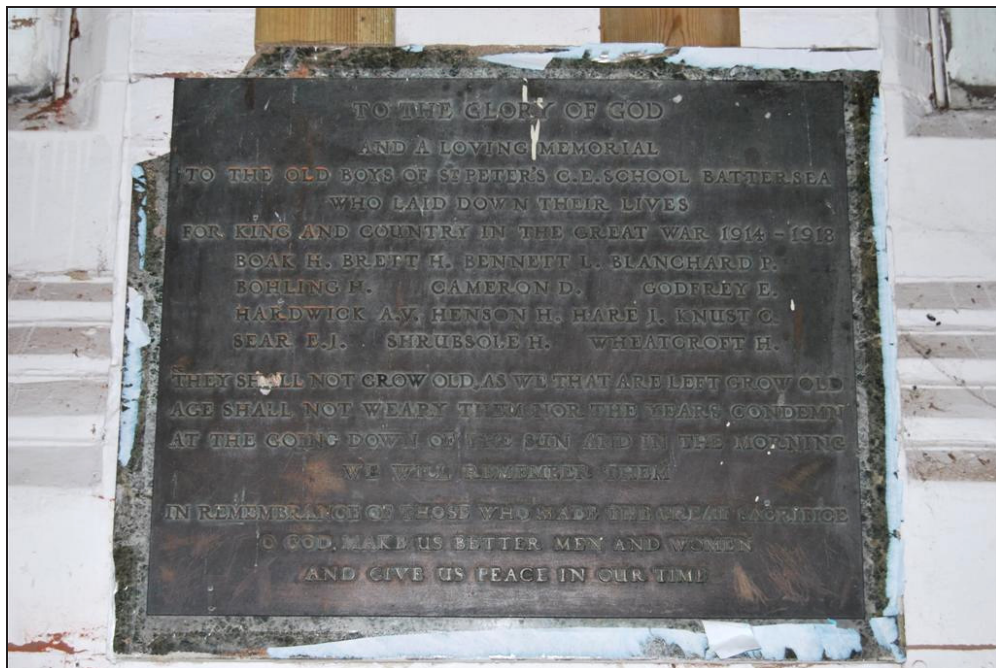
Plate 6: Memorial Plaque

- 6.2.10 Of note is a plaque mounted on the west wall of the hall, below the window. It is bronze, and mounted on a slab of green marble. This reads: "To the Glory of God and a Loving Memorial to the Old Boys of St Peter's C.E. School, Battersea who laid down their lives for King and Country in the Great War 1914-1918". It gives their names and the famous Ode of Remembrance. This is taken from Laurence Binyon's poem, "For the Fallen", which was first published in September 1914 (Binyon 1914).

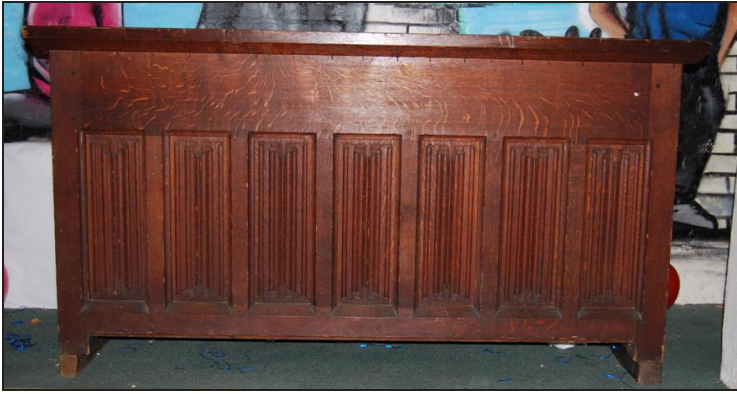
Plate 7: Altar

- 6.2.11 The plaque finishes with a prayer: "*In remembrance of those who made the great sacrifice, O God, make us better men and women and give us peace in our time*". This is typically the opening prayer in Remembrance Day Services.
- 6.2.12 The floor of the hall is linoleum, and the walls are painted. There are no other visible signs relating to the use of the hall as a school, due to modern finishes.
- 6.2.13 The hall also has an altar stored against the south wall (Plates 6-7). This is oak, with a simple table frame, and a front panel with seven incised panels with vertical fluting. The altar top has an incised symbol of a cross in a circle in each corner, and a fifth in the centre. This is a typical altar top, with the location for the sacrament during the Eucharist marked by the central symbol.

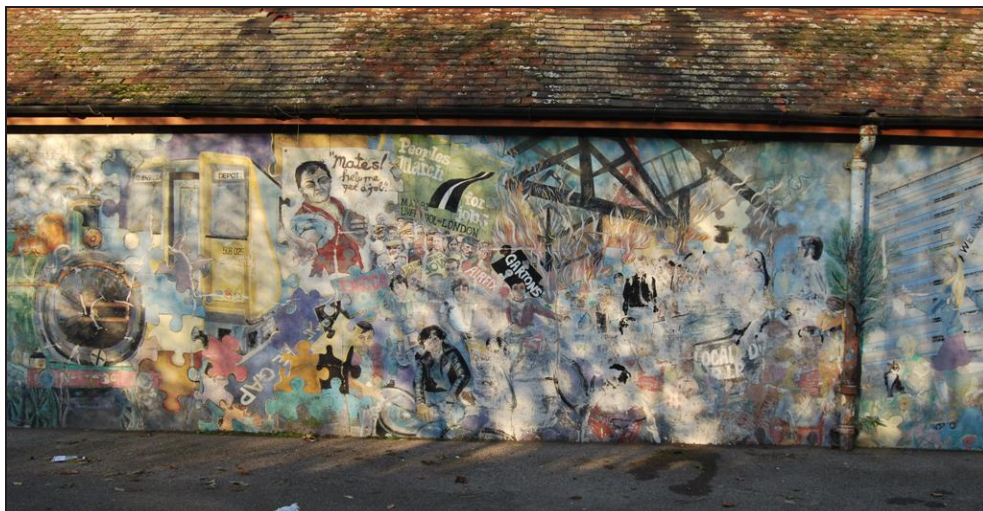
Plate 9: Part of the 1980s Mural

- 6.2.15 The mural on the outside wall is the Battersea Puzzle. It was started in September 1980 when the Rev Michael Wimshurst of St Peter's, asked the Wandsworth Arts Resource Project (WARP) to paint a mural. Christine Thomas of WARP created a scene of local history events. The mural was begun in April 1981 and measures 3m high and 18m long. It starts with German bombers flying over Battersea Power station and an image of a large tiger from the local funfair. It leads onto a Victorian house being repaired by a man on a ladder representing the gentrification of the area. An old steam train is portrayed next to a new train showing the changes to the Clapham Junction station. After this is a march for jobs, showing marchers from Jarrow representing the loss of industry in the area, the closures of 'Morgans', 'Airfix', and 'Gartons' and 'Decca' factories. There is an image of a burnt out church showing what happened to the original St Peter's building. Interestingly, the timber frame that is depicted is that within the hall.

- 7.3 Of interest to students of the more modern streetscape and mural art is the 'Battersea Puzzle' on the south side of the south aisle of the hall. This was painted in 1981 by the Wandsworth Arts Resource Project, and is beginning to peel and flake as the underlying surface deteriorates. Part of the mural has already been lost when a set of doors at the west of the south side were painted over or replaced.

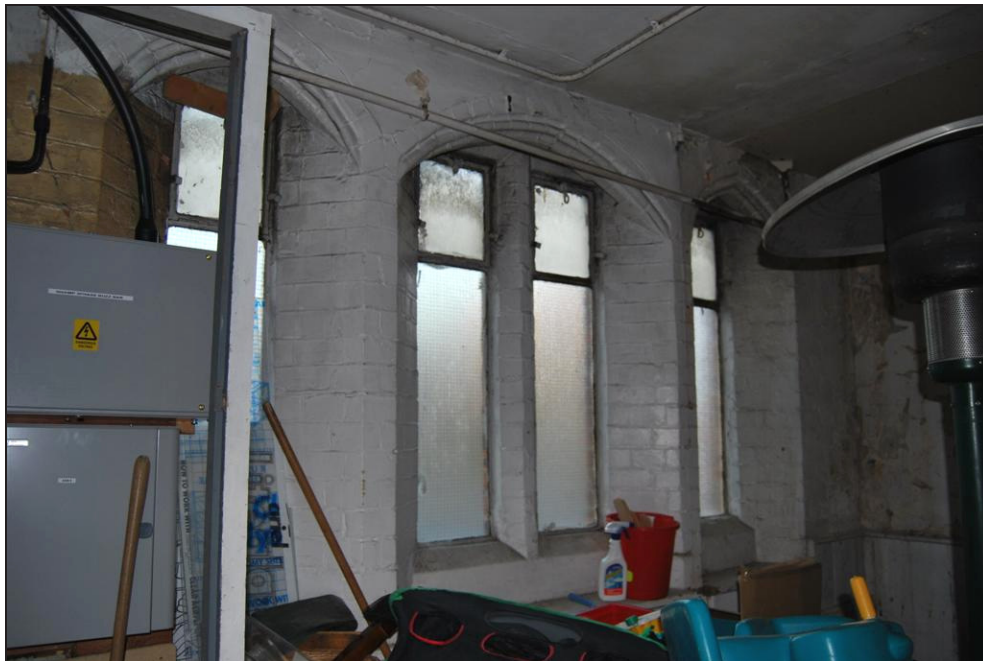
Plate 10: Room 2 Windows

- 6.3.2 The lower part of the west wall is red brick, rising to a sill course, and the majority of the build above here is yellow stock bricks in English bond, again with red brick dressings around the windows and forming the northwest quoin of the building. The roof of the block is a pitched roof running north-south, its gable facing north. A second pitch runs west, with a gable above the west front. A projecting course of brick acts as a hood mould around the gable peak.

- 6.3.3 The sills and lintels of the ground floor windows are stone, as are the sill, transom and a quatrefoil of the first floor window. The ground floor windows have flat lintels on the outside, but shallow lancet arches internally. The ground floor windows comprise a central pair, with two flanking windows. The reveals are angled brick. The first floor window is a lancet arch, subdivided into three elements: two lancet windows with a stone transom, with the stone spandrel above pierced by a quatrefoil.

- 6.3.4 The brickwork of the additional structure to this hall is tied in well to the original coursing. An additional blind piece of brickwork fills the space between the edge of the clerestory and the first floor, built of yellow brick decorated with a diamond pattern of overfired headers. At the rear of the block, the pitched roof slopes down over a stairwell that provides access to the first floor, the northern face of the additional block contains the back of a chimneystack and part of the rear wall of the demolished adjacent property 19 Plough Road. The face is rendered and painted.

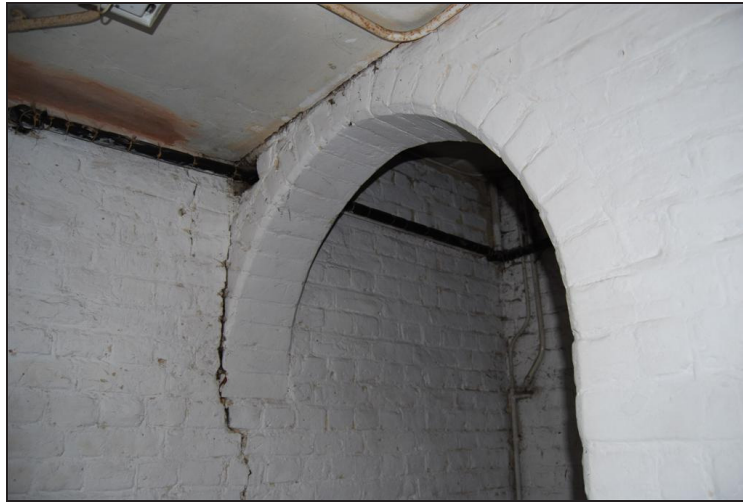
Plate 11: Structural Crack

- 6.3.6 The other ground floor room of the block is a short hall running north south with a winding dog-leg staircase to the first floor (**Room 3**). The stairs have 0.21m high risers and 0.2m wide treads. At the turn of the dog leg, a brick arch supports the stairwell. This has a significant crack where it joins the outside, northern, wall, before turning south. The stairwell is decorated with a skirting board with a roll mould on the upper surface. This is a rare piece of architectural detail in the interior of the building. On the east side of the hall is a door which leads to a partial cellar. No access could be gained to the cellar, but it is reportedly in poor condition, and contains a boiler.

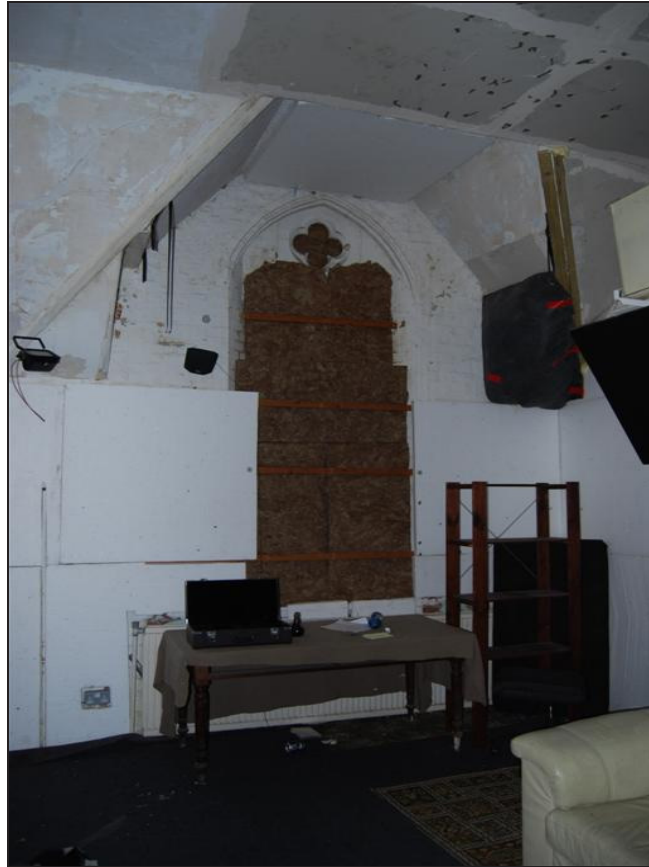
Plate 12: Room 9. General View

- 6.3.7 The stairs rise with a winder at the top, with a water tank installed behind a wooden panel in the upper stairwell (**Room 8**). The stairs lead directly to a single room on the first floor (**Room 9**). This features the window with the quatrefoil spandrel, a chimneystack with an extant fireplace, and there is a small window overlooking the hall. This is currently used as a music room. The window is boarded over internally, and each wall is clad with expanded polystyrene sheets, presumably added as sound-proofing. The fireplace is tiled and overpainted in grey paint. It may be an original fixture, but such a narrow, square form is unusual for the 1870s. The fireplace has no grate nor decorative scheme surviving. The only structural evidence in the room is a beam supporting the valley of the two gables, and a purlin running along the east side of the roof. This implies that the common rafters are laid on the purlins, and that there is no need for a structural roof truss, due to the smallness of the building.

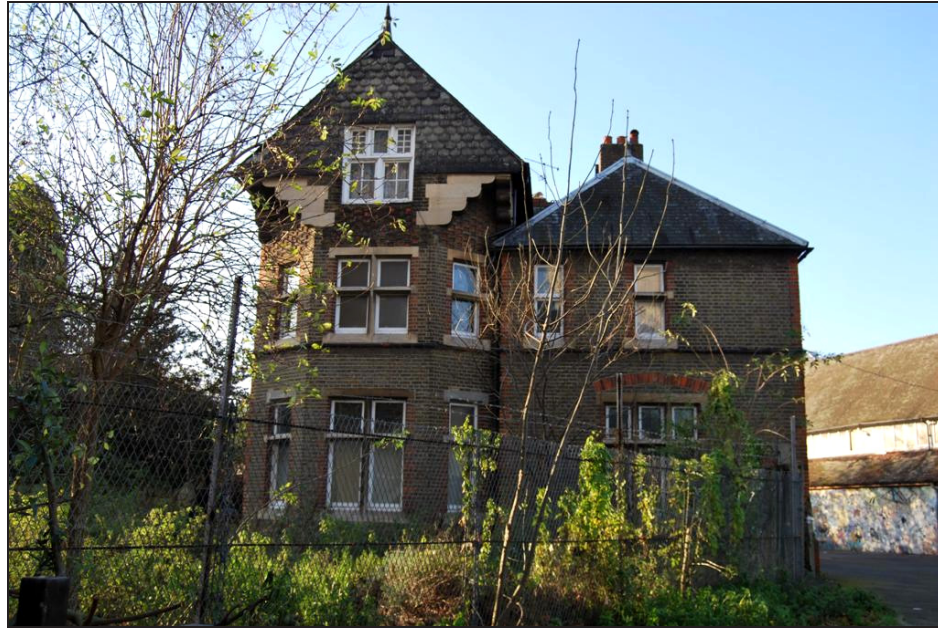
Plate 13: The Vicarage, Looking West

6.4.1 To the south of the hall is the vicarage, dated to 1911 by previous investigations (Leadsom 2009), and described as of low historic value, due to changes to fabric and fittings. This is a two and three-storey yellow brick building with stone and red brick dressings. The principal aspect faces east, and has two bays; the southern has a polygonal bay surmounted with a tile-hung gable. The vicarage is partially enclosed by a brick yellow brick wall and a doorway with the address onto Plough Road. It stands within its own gardens, now overgrown.

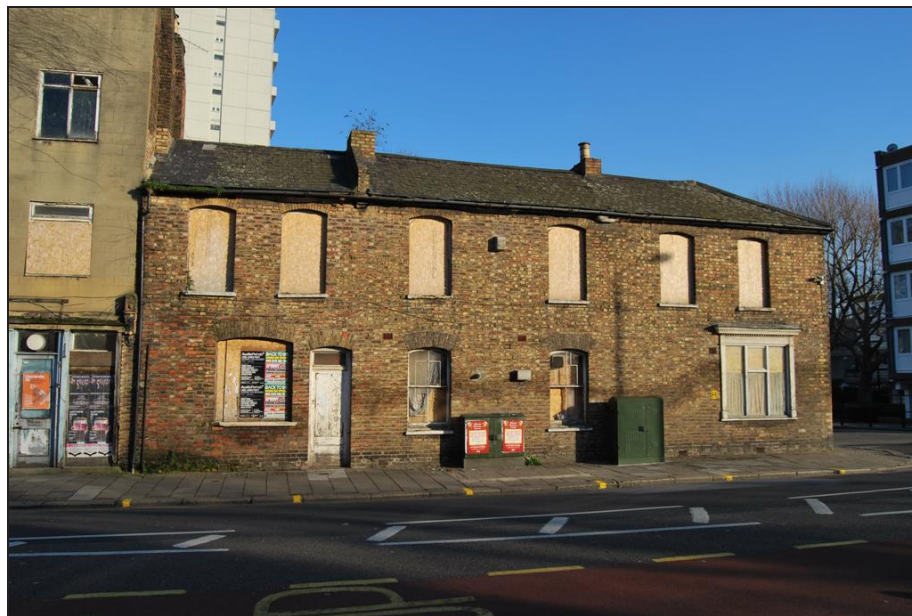
Plate 14: 29-31 Plough Road

6.4.2 The loss of contemporary housing stock in the immediate area has altered the setting of the site, and the loss of the church itself has resulted in a vicarage and hall without an associated focus. The only other buildings of contemporary date are a group of shops with dwellings above at 23-31 Plough Road, that are now boarded up. Nos 29-31 are an irregular triangular shape, fitting into the angle created by Plough Road and the northeast-running Winstanley Road. All these buildings are derelict and boarded up.
