# West Bowling Green Street, Leith:

## Archaeological Evaluation & Excavations Data Structure Report

On Behalf of: **J Smart & Co. Plc**  
28 Cramond Road South  
Edinburgh  
EH4 6AB

AOC Project No: **21982**

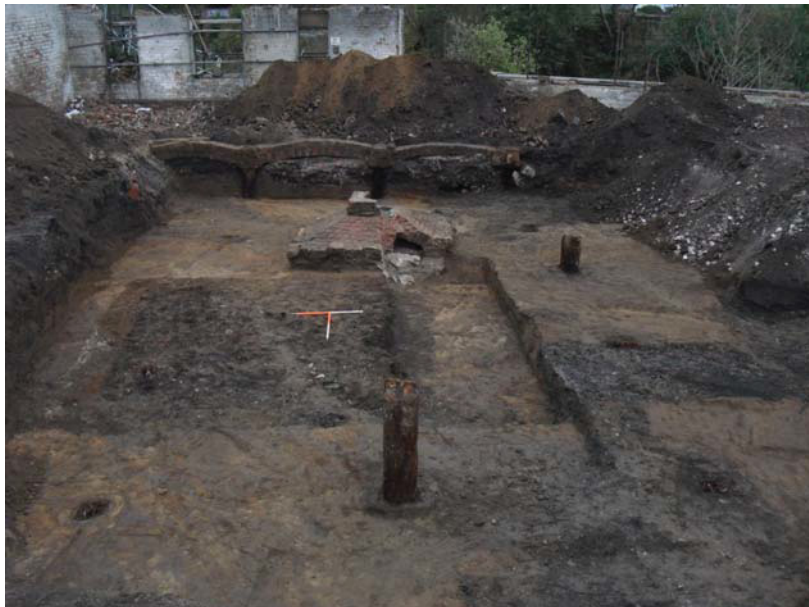
Plate 1 - General shot showing Area A features

5.2.1 The evaluation in this area consisted of three trenches (see Figure 8 and Appendix 1 for details). Trenches 1 and 2 revealed over 1.0 m of made ground onto natural sand [036] with no archaeological features revealed. However, Trench 3 revealed the corner of a brick and sandstone feature [009] as well as a linear feature [010] nearby. An area measuring 12.0 m by 10.5 m was then opened around these features (Figure 9; Plate 1).

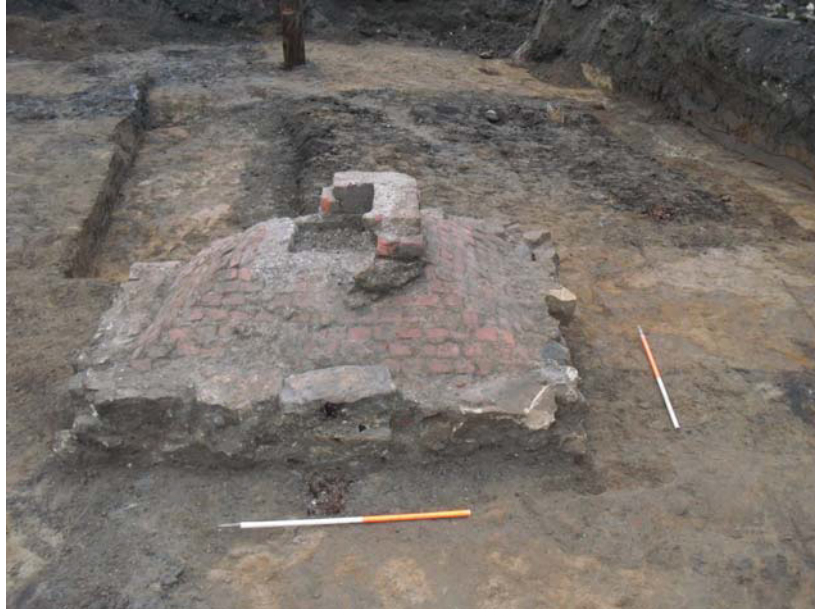
Plate 2 - Detail shot of Structure [009]

5.2.2 The brick and sandstone structure [009] is within cut [007] and survived to a height of approximately 1m above the natural subsoil level. The upper part of the structure consisted of a pyramid shaped brick vault, some 0.7 m high which sat on top of a sandstone base that itself was cut 1.0 m deep in

the natural subsoil [036] (Plate 2). A service track [014] runs into the structure from the north and another service track [012] runs through the structure east to west. Both linear tracks contained ceramic pipes, [037] and [014] respectively. Internally, structure [009] was rectangular in plan (0.92 m by 0.78 m) and was floored by flagstones [047]. Pipe [037] would have emptied into the structures interior. Access to the internal space would have been through a square hole in the top of the brick vaulting.

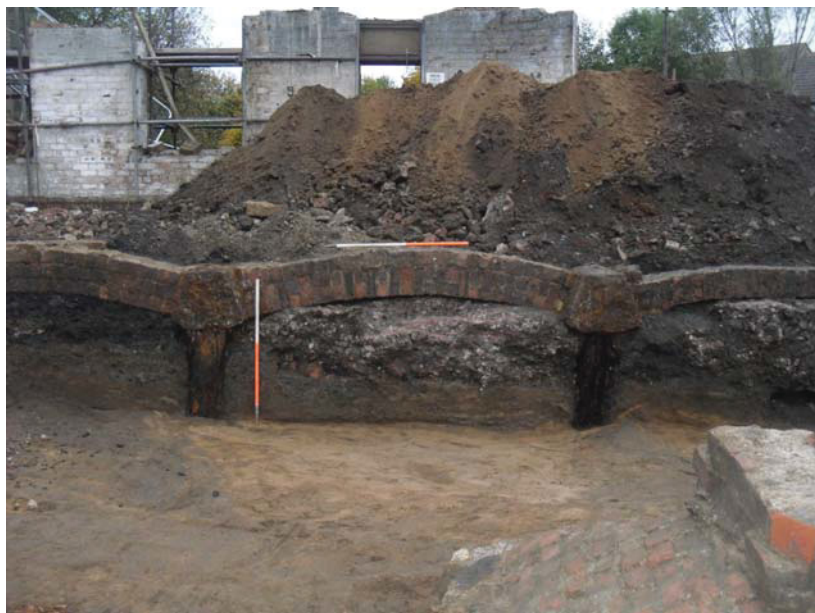
Plate 3 - South facing elevation of brick arches [001]-[003]

5.2.3 The remains of a later building in the form of brick foundation arches [001], [002] and [003] (Plate 3; Figure 10) and several timber piles ([004]-[006] and [016]-[028]) was revealed around structure [009]. This later structure truncated the service tracks [012] and [014] and appears to line up with the remaining upstanding walls around the excavation area.

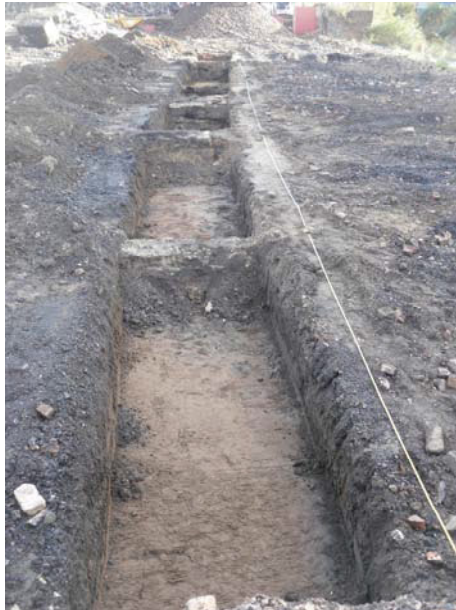
Plate 4 - Trench 6 showing walls [054] to [059]

- 5.3.1 The evaluation in this area consisted of 6 trenches (see Figure 8 and Appendix 1 for details). Trench 4 at the western boundary of the site contained no archaeological features, but did indicate that the natural subsoil changed from orange gravel [053] in the north to a reddish brown sandy clay [060] in the south, which sloped quite steeply down to the rivers edge. Trenches 5 to 8 revealed a number of features and structures that required further investigation. This led to a larger excavation area being stripped measuring 35.0 m by 25.0 m encompassing the features from Trenches 5 and 8 (Figure 11). The walls and structural features in Trench 6 ([054]-[059]) and Trench 7 were interpreted as being part of the latest phase of building on site and so were not investigated further.

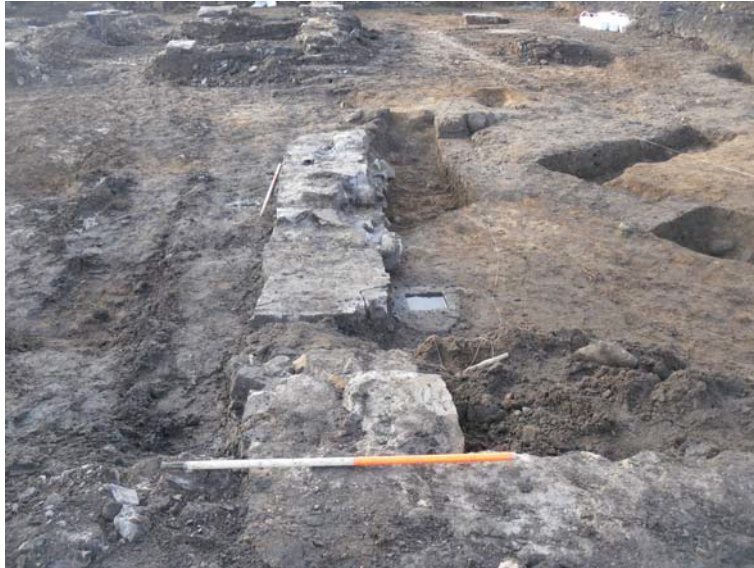
Plate 5 - General shot of wall [095] abutting [096]

- 5.3.2 The main structural features in the excavation area were the large sandstone walls [086], [089], and [092] to [096], and the fourteen sandstone foundation pads [097] which relate to the 19<sup>th</sup> Century warehouse structure (Plates 5 & 6). The walls [089] and [096] relate to the external walls of the 19<sup>th</sup> Century warehouse whereas walls [086], [094] and [095] relate to the courtyard walls. The sandstone foundation pads would have been internal features for supporting the roof, and walls [092] and [093] were internal walls of the same structure. Re-deposited natural [079] may also relate to the warehouse construction, used as a levelling layer placed over demolition deposit [078].

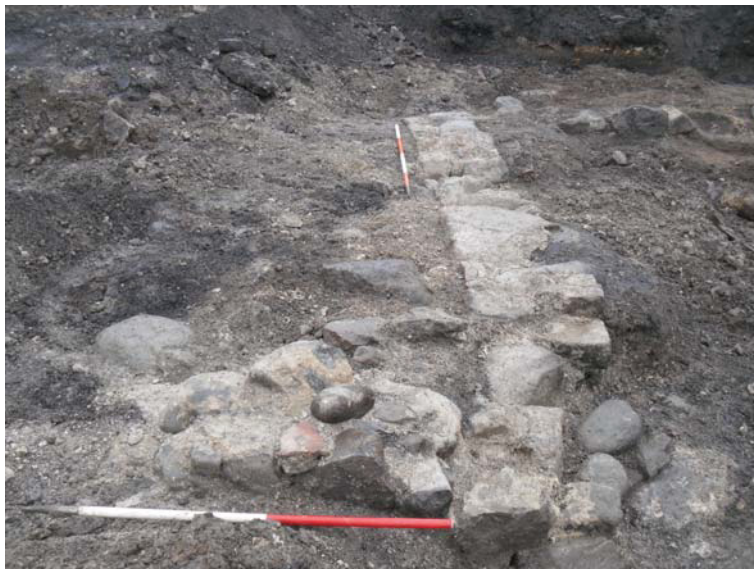
Plate 7 - General view of walls [075] & [076]

- 5.3.3 The demolition deposit [078] truncated by the warehouse construction, relates to an earlier structure, surviving in part in the south east area of the excavation. This structure consisted of two cobble and sandstone walls [075] and [076], which most likely formed the NW corner of a building (Figure 12; Plate 7). Only 1.5 m of wall [075] survives which is aligned SW-NE and abuts the NW end of wall [076], surviving 5.3 m in length and aligned NW-SE. Both walls are truncated by modern activity; [075] to the NE and [076] to the SE. They both sit on the natural sandy clay [060] and are probably cut into possible soil horizon [077] which contained a number of red tile fragments. The NW end of wall [076] and wall [075] appear to be abutted by the demolition layer covering collapsed wall [084]. Another small fragment of a sandstone wall [085], measuring 1.47 m by 0.55 m, is also constructed into this demolition deposit to the NW of [075] and [076].

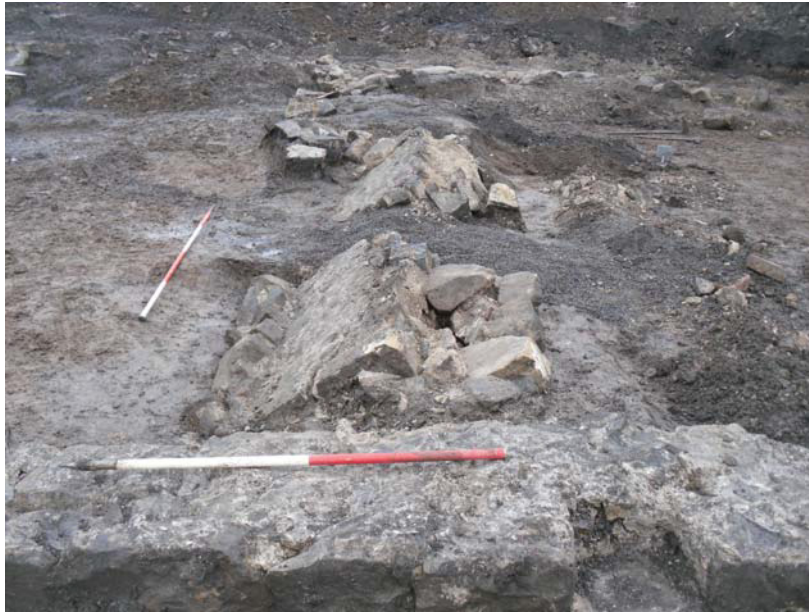
Plate 8 – East facing view of collapsed wall [084]

- 5.3.4 The collapsed wall [084], measuring 10.5 m by 0.6 m is constructed of whinstone bonded with a cemented sand and lime mortar and is aligned approximately E-W (Plate 8). The eastern end may have abutted the corner of wall [075] as it does not continue underneath. The wall survives lying at an approximate 60 degree angle having collapsed to the south into ditch [098] (Figure13; Plate 9). From the evidence on the ground it appears that the wall foundations subsided into the north edge of the ditch causing the wall to topple backwards, capping the southern half of the ditch. The ditch is visible cutting natural [060] for 10.5 m and is 1.44 m wide, filled by deposit [100]. As the wall has collapsed into this ditch it can be assumed to be at least to some extent contemporary with the ditch as the ditch although partially infilled was still an open feature when the wall collapsed into it as shown in Plate 9.

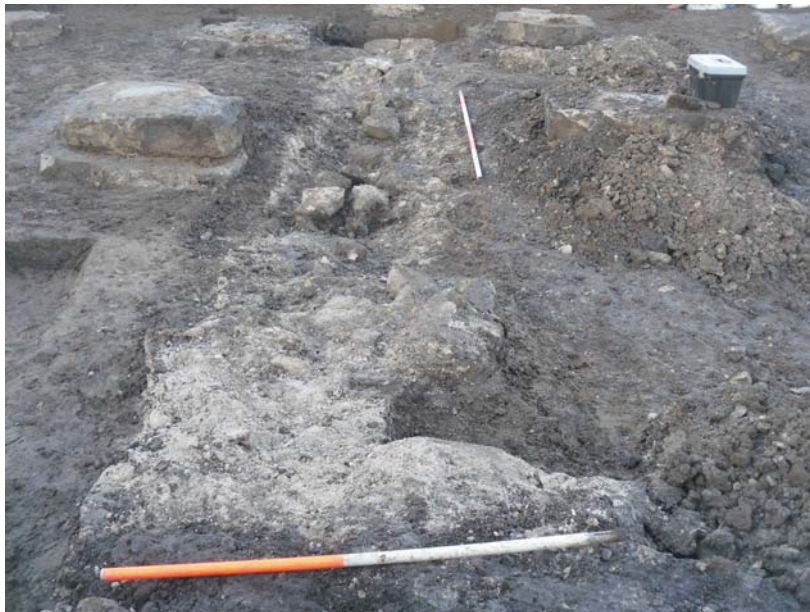
Plate 10 - Rubble wall [064]

- 5.3.5 To the west of the collapsed wall [084] and aligned with it, is another whinstone wall [064] (Plate 10). Heavily truncated by the later warehouse construction and situated between four of the pillars [097], this wall may have been the western part of [084]. It was not possible to determine if this was the

case as warehouse wall [086] is between them and there is evidence that [064] heads to the north just prior to being truncated by this wall (see Figure 11). It only survives to one course high and is almost rubble in condition, with the western end surviving only as a mortar spread in the east facing section of the excavation edge.

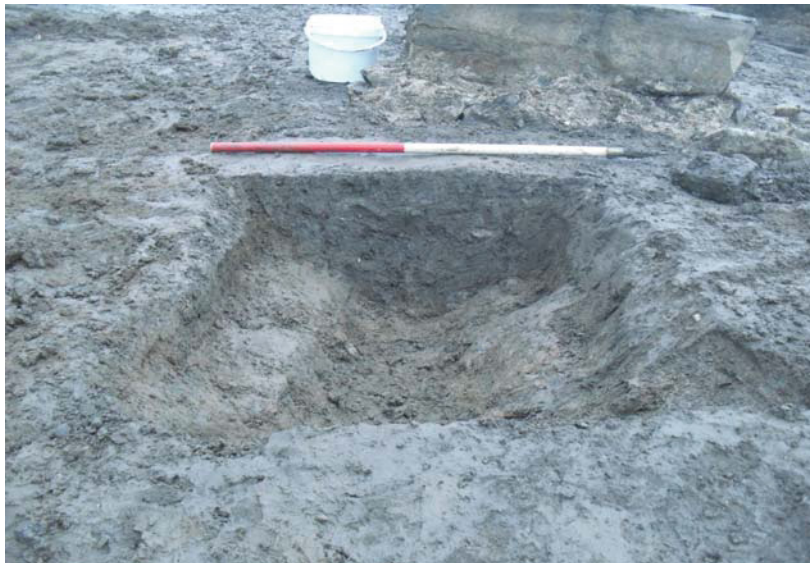
Plate 11 - NNE facing section of ditch [080]

5.3.6 Pre-dating the structures on site, a number of negative features were also revealed throughout the excavation area. Four of these features were linear in nature and were situated to the south and west of the excavation area. From the ceramics found within them (a mixture of Scottish medieval reduced wares and late white gritty ware – George Haggerty pers comms) it is possible to provide a late medieval date for most of them, however ditch [080] contained material ranging from the late medieval and the post-medieval period suggesting it was in use for much longer. This ditch was revealed at the southern edge of the excavation area running SSW to NNE and measured 15.2 m by 0.84 m by 0.43 m (Figure 13; Plates 11 & 12), terminating at its NNE end, just beyond wall [086]. The fill [081] of this ditch contained red tile, green glazed medieval reduced ware, fragments of

animal bone, and also part of a human jaw bone and vertebrae. As human remains were found within the ditch it was fully excavated but no further human remains were encountered.

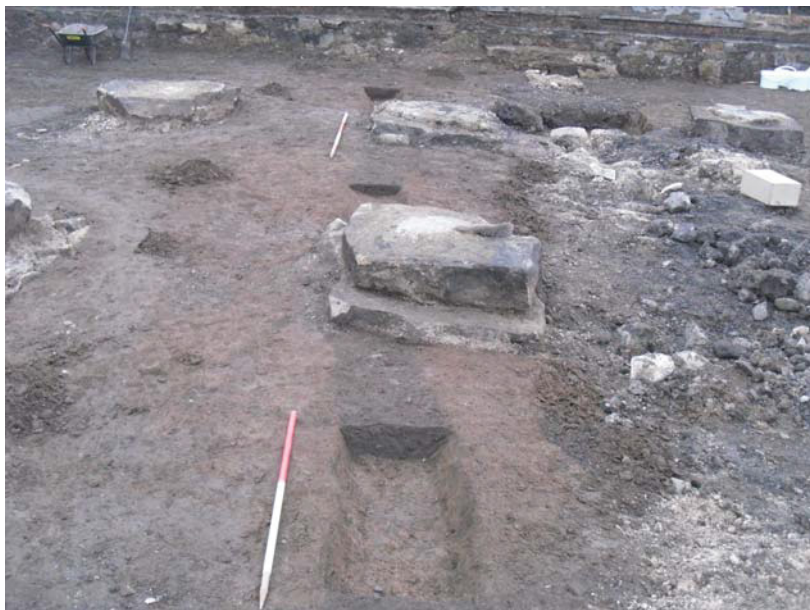
Plate 13 - General view of ditch [071]

5.3.7 Parallel to ditch [080] and approximately 4.0 m to the north of it was narrower ditch [071] which measured 11.9 m by 0.48 m by 0.18 m (Figure 13). This ditch was truncated by wall [089] to the west, wall [086] to the east and by foundation pads [097] in two places along its length (Plate 13). This ditch cut the SSE terminus of another ditch [051], which runs SSE to NNW and out with the excavation area. It was also truncated by wall [089], wall [064] and by a modern manhole to the west of wall [089]. It measured over 16m long and was 0.76 m wide at its widest point and 0.62 m at its deepest (Figure 13; Plate 14). West of this ditch and running parallel to it was the remains of another ditch [049] which was much shallower (only 0.1 m deep; see Figure 14) and did not survive well throughout its length. It measured 12.13 m by 1.25 m with a similar fill [050] to that of ditch [051].

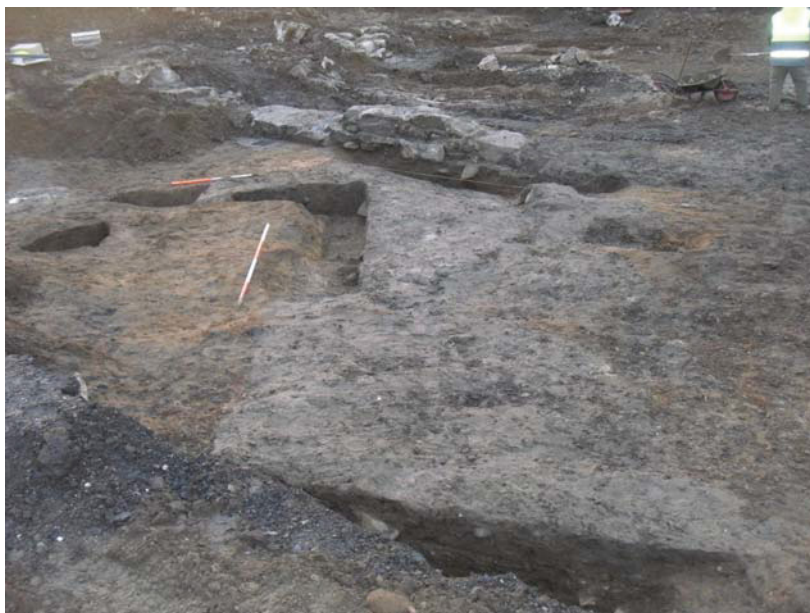
Plate 15 - General view of features [061], [090], [073] and [087] in NE corner

5.3.8 To the north east corner of the excavation area, a further series of negative features [061], [090], [073] and [087] were revealed and once again these contained fragments of Scottish medieval reduced ware (Plate 15). The two largest features [061] and [090] could be interpreted as ditches or large elongated pits. In plan and in section they are clearly two separate features (Figures 14 & 15) however after excavation it was obvious that one was an extension of the other, combining to form a ditch or trench running NNW to SSE measuring approximately 14.0 m by 2.6 m and surviving up to 0.45 m deep (Plate 16). The other two features [073] and [087] were smaller and created a narrowing ditch (narrowing from [087] to [073]) running SW to NE at approximate right angles to the larger features (Plate 17). The widest of these was ditch [087] which measured 4.63 m by 1.02 m by 0.38 m, with ditch [073] extending the ditch by 1.40 m but only being 0.47 m wide and 0.23 m deep (Figure 17).

- 6.9 The other ditch features [061], [073], [087] and [090] most likely relate to this late medieval period as well given the ceramics found within them, however it is probable that these features relate to a more specific event at this period, the siege of Leith in 1560. It is known from the Petworth map of the siege that ditches, batteries and gun mounts related to the third approach of the siege were located just to the west of the development area (Harris 1991). The features found, being too small to be part of the main siege ditches are most likely smaller forward movements from the main siege works and may be further gunning placements related to Mount Falcon.

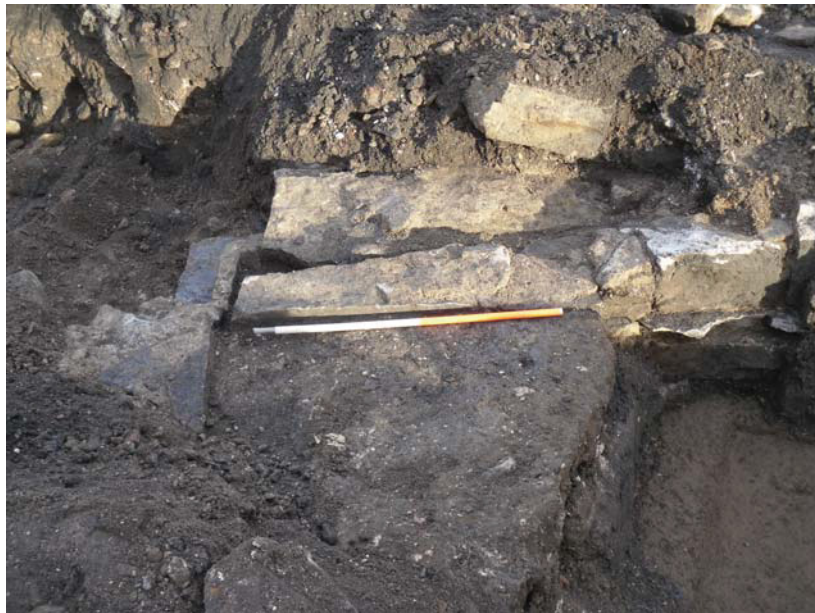
Plate 18 - Walls [069] and [070] within Trench 9

- 5.4.1 Evaluation Trench 9 revealed the remains of two sandstone walls [069] and [070] forming the corner of a possible structure (Figure11; Plate 18). Wall [069] was aligned N-S and abutted the south face of wall [070] which is aligned E-W. Both walls were constructed on top of a made ground similar to [078]. Further excavation to reveal the extents of the structure showed that both walls had been truncated by modern activities leaving a surviving structure measuring 3.0 m by 2.3 m.

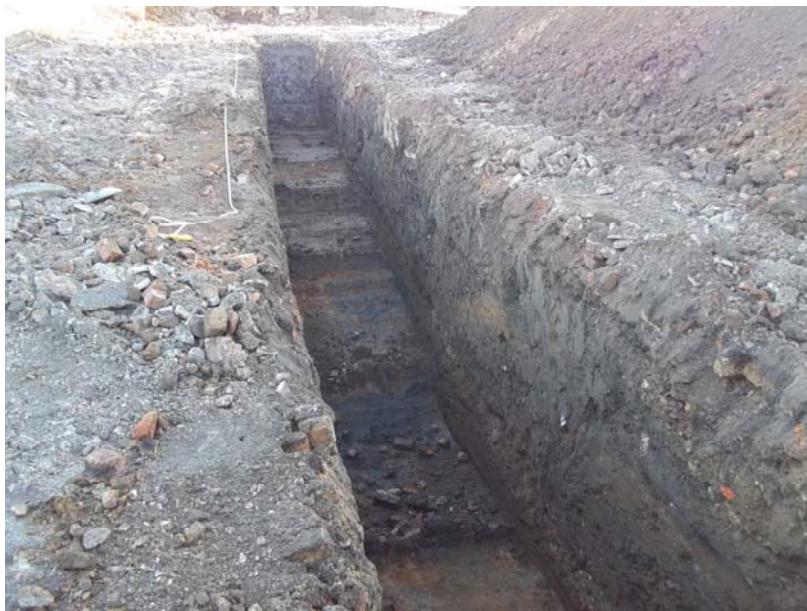
Plate 19 - Post excavation view of Trench 10

- 5.5.1 Area C relates to the area south of West Bowling Green Street and to the east of the main entrance into the site. Three trenches were placed in this area (Trench 10, 11 and 12; see Figure 8) aligned east to west revealing modern made ground to depths of up to 3.0 m sitting on top of orangey brown sand with lenses of grey clay: the same as [036] in Area A (Plate 19). A number of large concrete blocks and brick walls were removed in the top half of the made ground but no significant archaeological features were revealed.

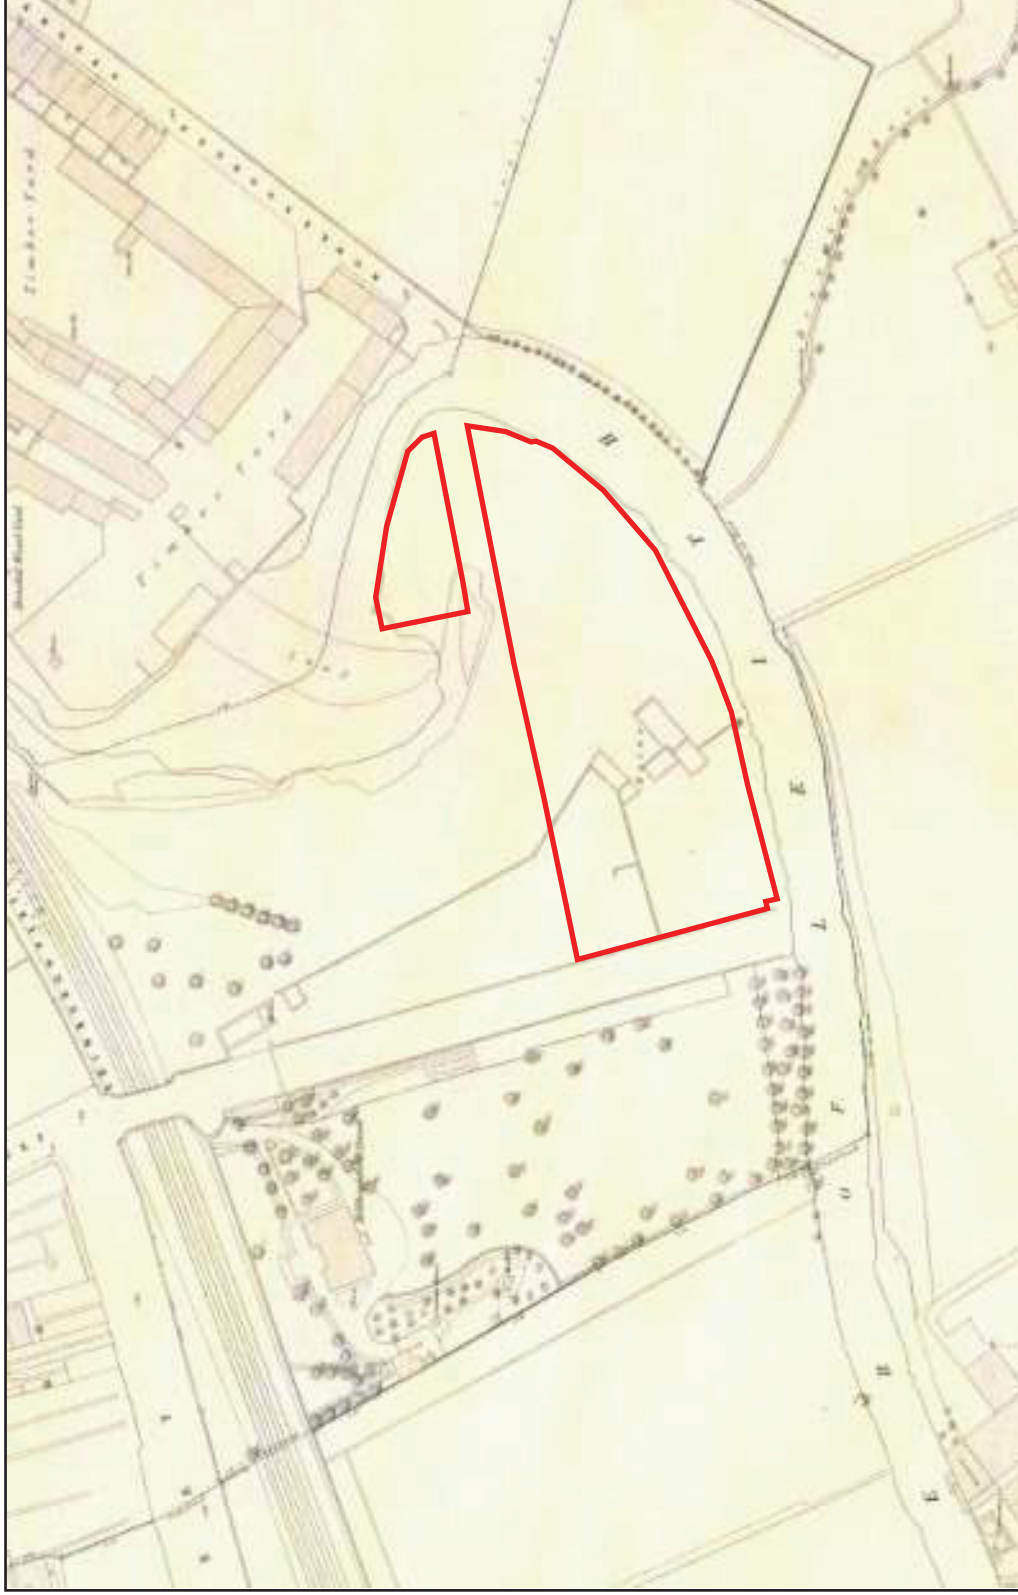
Figure 6: Extract from Ordnance Survey Map, 1852

Approximate Site Location

- 2.3.4 Stevenson's map of 1837 shows that there has been little change, with both the L-shaped block and the two small buildings, likely still washing houses, shown. Changes are seen in Johnston's plan of 1851 (Figure 5) as this does not show the L-shaped block, though a group of walls on a reverse L-shape appears in a similar location. These may correspond to a rough northwest/southeast boundary apparent on maps as early as Ainslie's of 1804. A group of walls are also marked to the south. These are again visible on the Ordnance Survey map of 1852 (Figure 6), which labels them as 'Ruins'. It is possible that these are actually remains of the washing houses which are no longer extant. The Ordnance Survey map of 1852 also depicts the walls to the north.

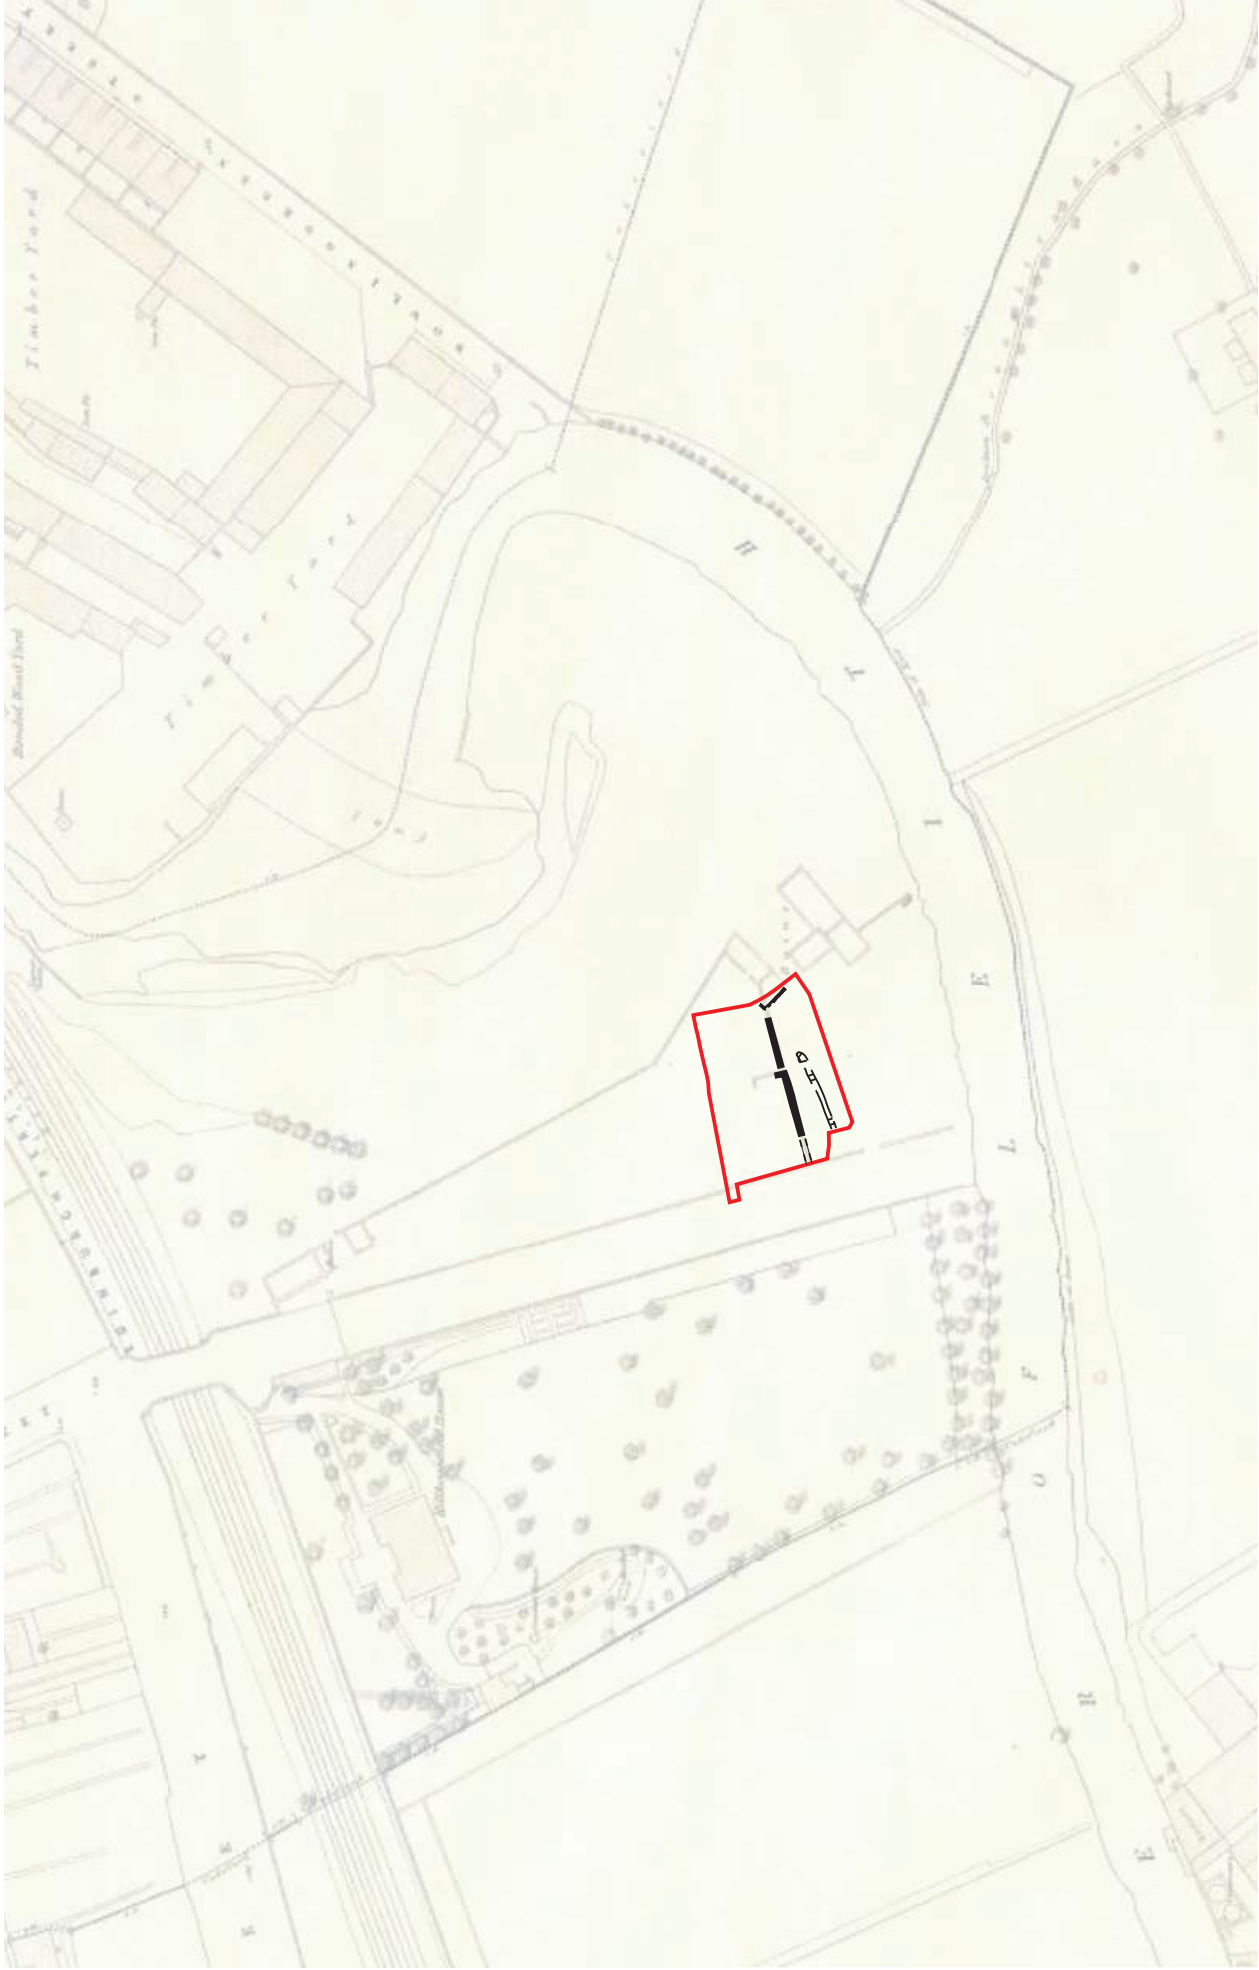
Figure 17: Extract from the 1852 Ordnance Survey with excavated features overlain

- 6.4 Looking at the earlier structures in Area B – walls [064], [084], [075], and [076] – alongside the 1852 Ordnance Survey (Figure 17), a link can once again be made between the structures found on the excavation and the structural remains mapped. Wall [064], which begins to form an L-shape, along with wall [084] match up with the ruins marked on the 1852 map. Furthermore, the corner formed by walls [075] and [076] can be seen to relate to the northernmost building depicted within the development area. Given that the structures at the time of the 1852 map are depicted as ‘Ruins’ we have to look at earlier plans and maps of the area to attempt to date them.
