# Fort House, Leith: Archaeological Watching Brief Data Structure Report

AOC 22187

15<sup>th</sup> February 2013

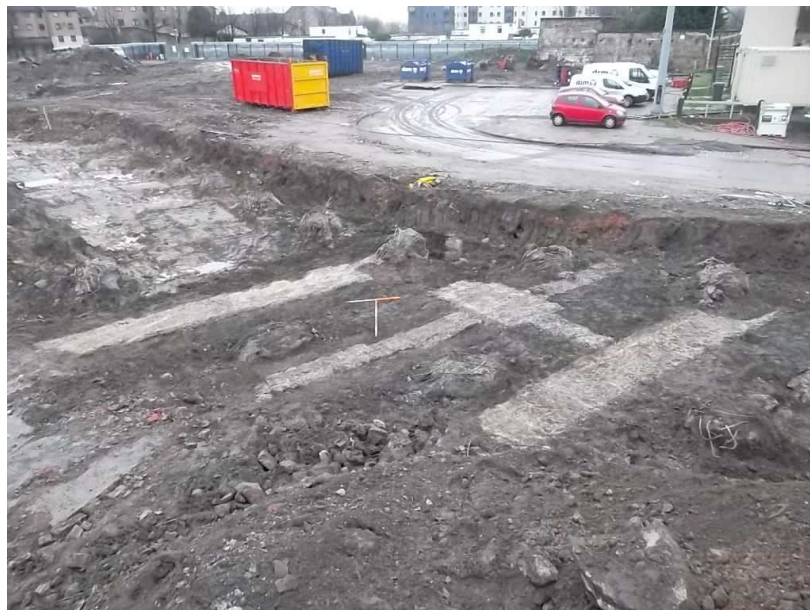
Plate 1 - NE end of Structure 1 with wall [007] through centre

5.2.1 After removing the modern concrete foundation beams, a modern made ground consisting of light brown sand with abundant sandstone brick and red blaes inclusions measuring 0.6m to 0.9m thick in places was removed. This modern made ground layer covered several concrete foundations [003], [004], [008], [010]-[013], [015], [022] and [026] throughout the building footprint. These foundations could be seen to form parts of at least three structures: Structure 1 consisting of [003], [004], [008], [010]-[013] and [015] and measuring 32m by 8m; Structure 2 consisting of [022]; and Structure 3 consisting of [026] (Plate 1-4). These three structures were mainly aligned NE-SW and given there similar construction would most likely be contemporary with one another. These foundations were abutted by demolition deposit or levelling layer [006] throughout the excavation area.

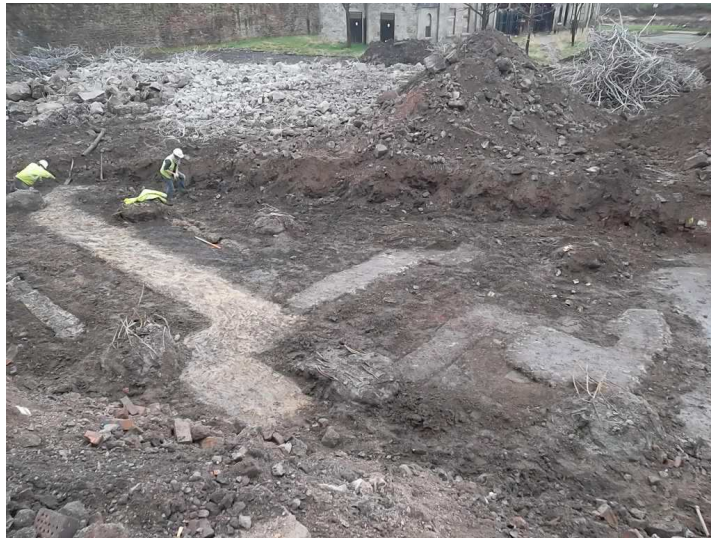
**Plate 2 - SW end of Structure 1 foundations**

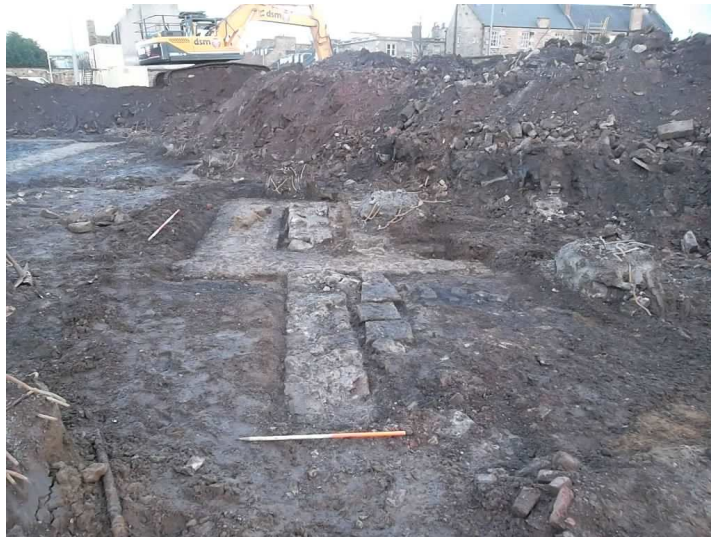
**Plate 3 - Structure 2 truncating wall [023]**

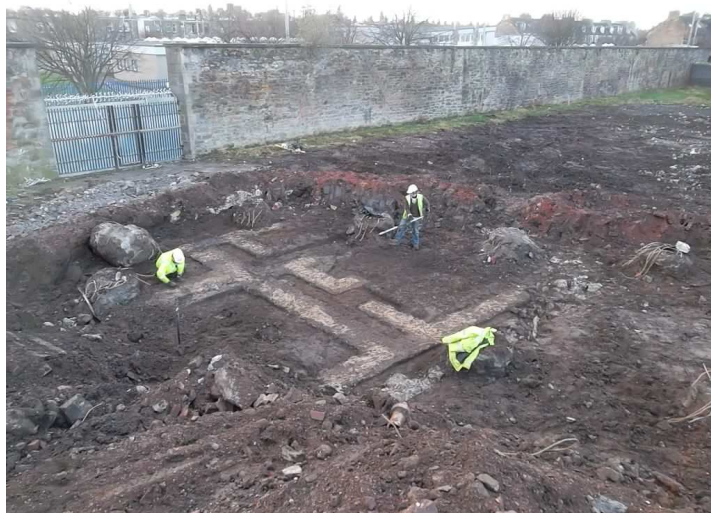
**Plate 4 - General view of Structure 3**

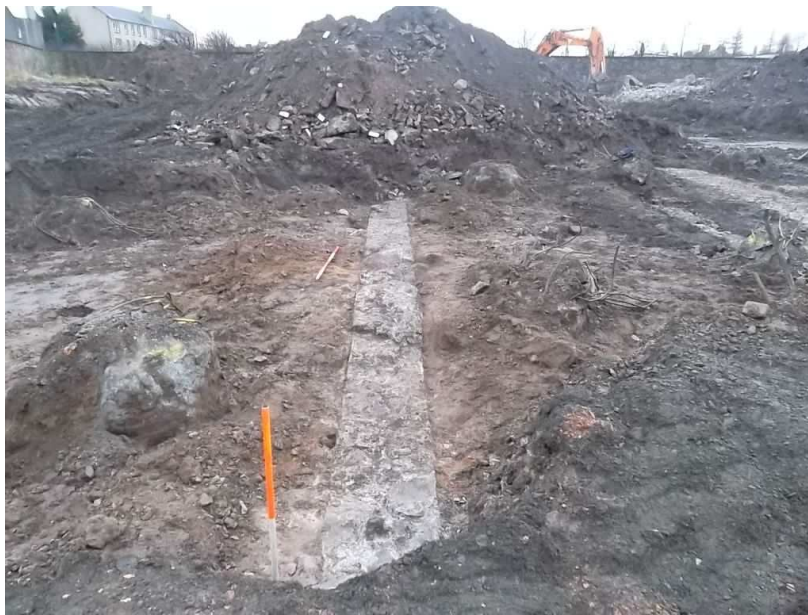
Plate 5 - Detail shot of wall [001]

- 5.2.2 Truncated by the later foundations in places, and covered by deposit [006], several earlier sandstone walls with ash and lime mortar were also revealed, [001], [002], [007], [016], [018], [023], [024], [025], [027], and [028] (Plate 5-7). Apart from walls [025], [027] and [028] which were aligned SE-NW all of the walls were aligned NE-SW and appear to form one structure. Two other sandstone walls with a sand and lime mortar [014] and [017] were also revealed adjacent to the main cluster of features found (see Figure 2). These walls were also aligned NE-SW with [017] forming part of an entrance to a building (Plate 8). As well as the walls, three post pads [019]-[021] were revealed within the main cluster of features aligned similarly to the walls found (Plate 6).

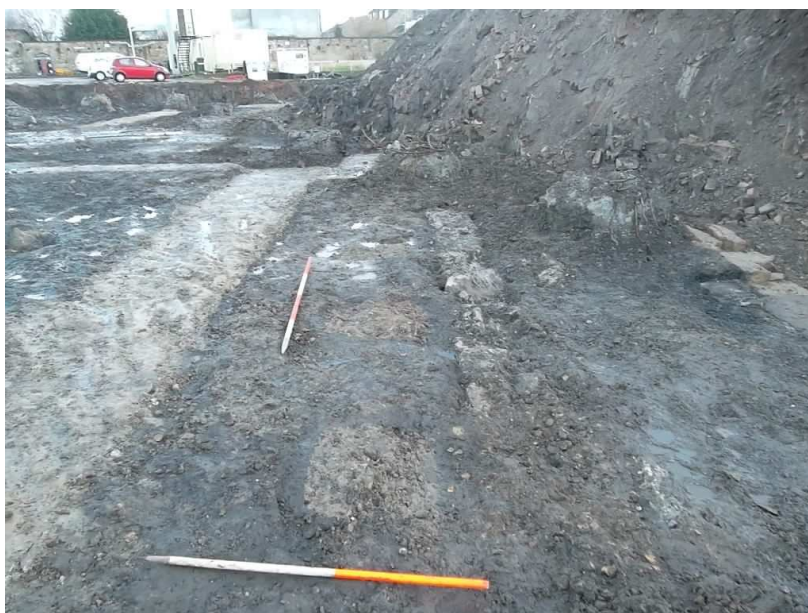
Plate 6 - Wall [016] with post pads [019]-[021] adjacent

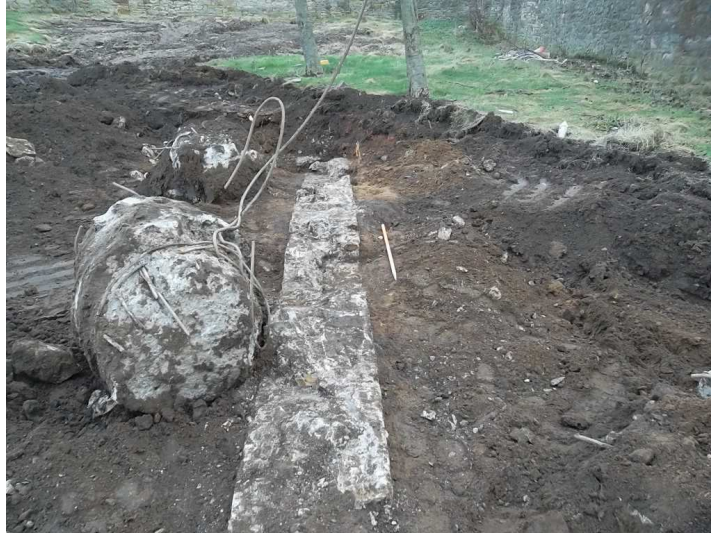
Plate 7 - Wall [028]

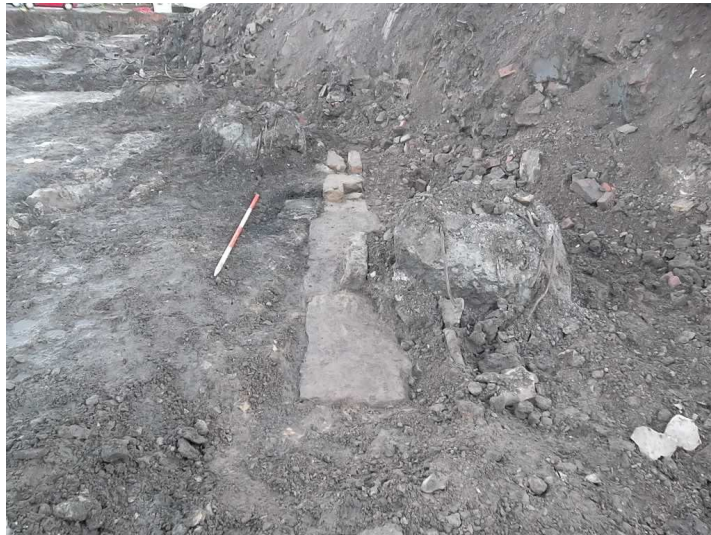
Plate 8 - Wall [017] with possible entrance

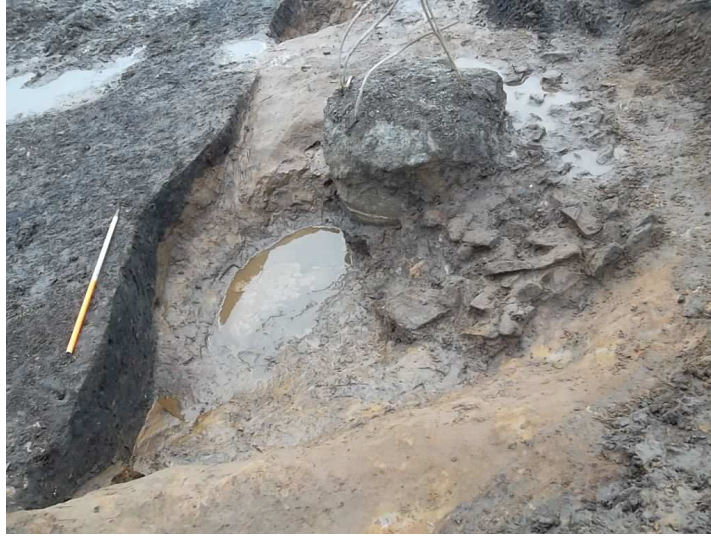
**Plate 9 - Pit [037] and stone deposit [040]**

- 5.3.1 Excavations in this area revealed a similar made ground to Area A, covering a light brown sandy clay natural. The works failed to identify a well recorded on maps of the fort, and capped in advance of the Fort House council estate being constructed. Close to the possible location of the well, a large amorphous pit [037] was revealed which had a possible stone lining [040] (Plate 9). The upper fill of the pit [039] contained several fragments of post-medieval ceramics as well as some animal bone and a cork (Small Finds 5, 6 and 7).

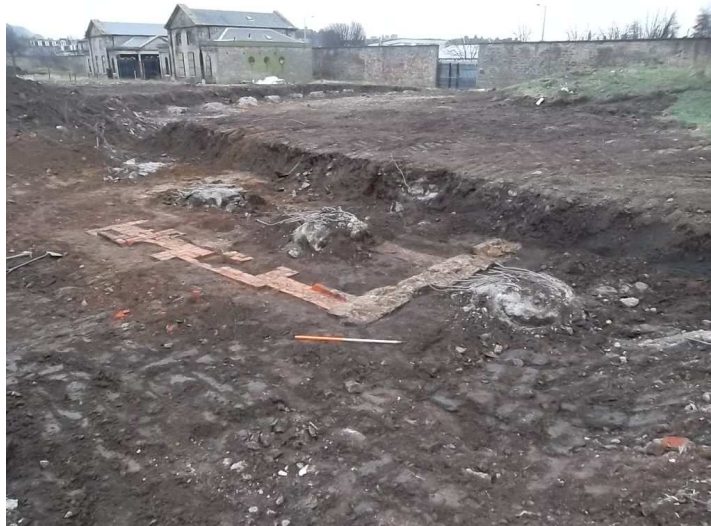
**Plate 10 - Structure [033]**

- 5.3.2 Close to the NW boundary wall, a brick and sandstone structure [033] was revealed (Plate 10). The structure consisted of two sandstone walls aligned NE-SW, a brick wall aligned NW-SE and a concrete foundation [032] aligned NW-SE. Some modern concrete was also noted attached to the SW end of wall [029] indicating that it was in use throughout several changes to the forts layout. The full extent of the structure was not revealed and it seems likely the building continues SW beyond the limit of the excavation.

- 6.3 However, looking at the construction of the other walls of Structure [033] it would have been logical to assume that this structure was earlier than the 1906 constructions. The use of hand made brick (which are usually considered to pre-date 1850) in wall [030] and the sandstone walls [029] and [031] are indications that this structure may date from an earlier period of fort occupation. Considering the cartographic evidence it is clear that this structure does relate to the buildings in the 1906 OS map (Figure 6), and was not recorded as part of the fort in 1895. The different method of construction may indicate the buildings along the NW wall pre-date the new SE buildings by a few years, prior to the use of concreted materials in construction, or it may simply indicate the structure was not as important to the forts development and therefore not built using the latest construction techniques in order to save expense.

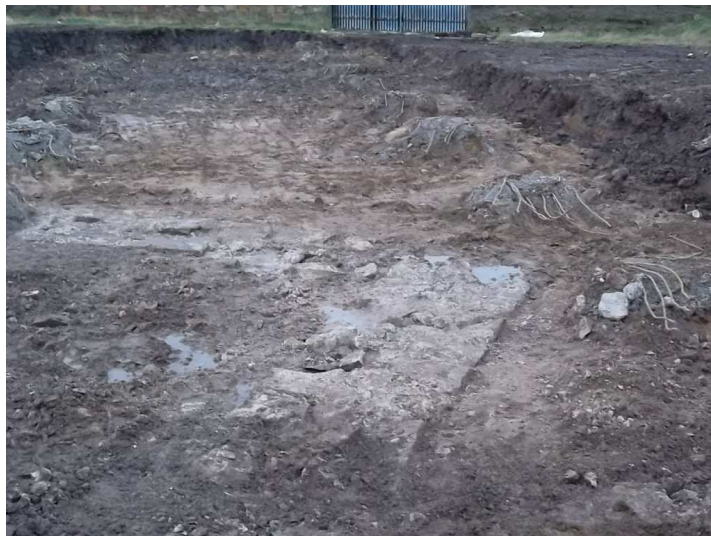
**Plate 11 - Foundations [036]**

- 5.3.3 To the north of the gate houses, two more sandstone wall fragments [034] and [035] and a sandstone foundation [036] were revealed (Plate 11). Walls [034] and [035] only survived at the edges of the excavation area, having been removed during the construction of the council estate.

They possibly formed a boundary wall surrounding foundation [036] which forms the NW corner of a structure.

- 6.4 Comparing the 1822 map (Thomson) with walls [034]-[036], it is clear that these walls relate to the powder magazine (labelled on the 1852 OS map) and depicted with a boundary wall around it. The storing of munitions and gun powder within the fort would have been a health and safety risk as accidental explosions could cause serious damage to the surrounding buildings, courtyard and anyone nearby. It was due to these safety concerns that the structure had thick outer walls (1.5m) as well as a boundary wall surrounding it so that any explosion would be buffered as much as possible. Given that the building is no longer depicted on the 1906 OS Map there could be a case for suggesting that such an accident happened and the building destroyed, but it may simply have been removed during the reconstruction of the fort during this period.

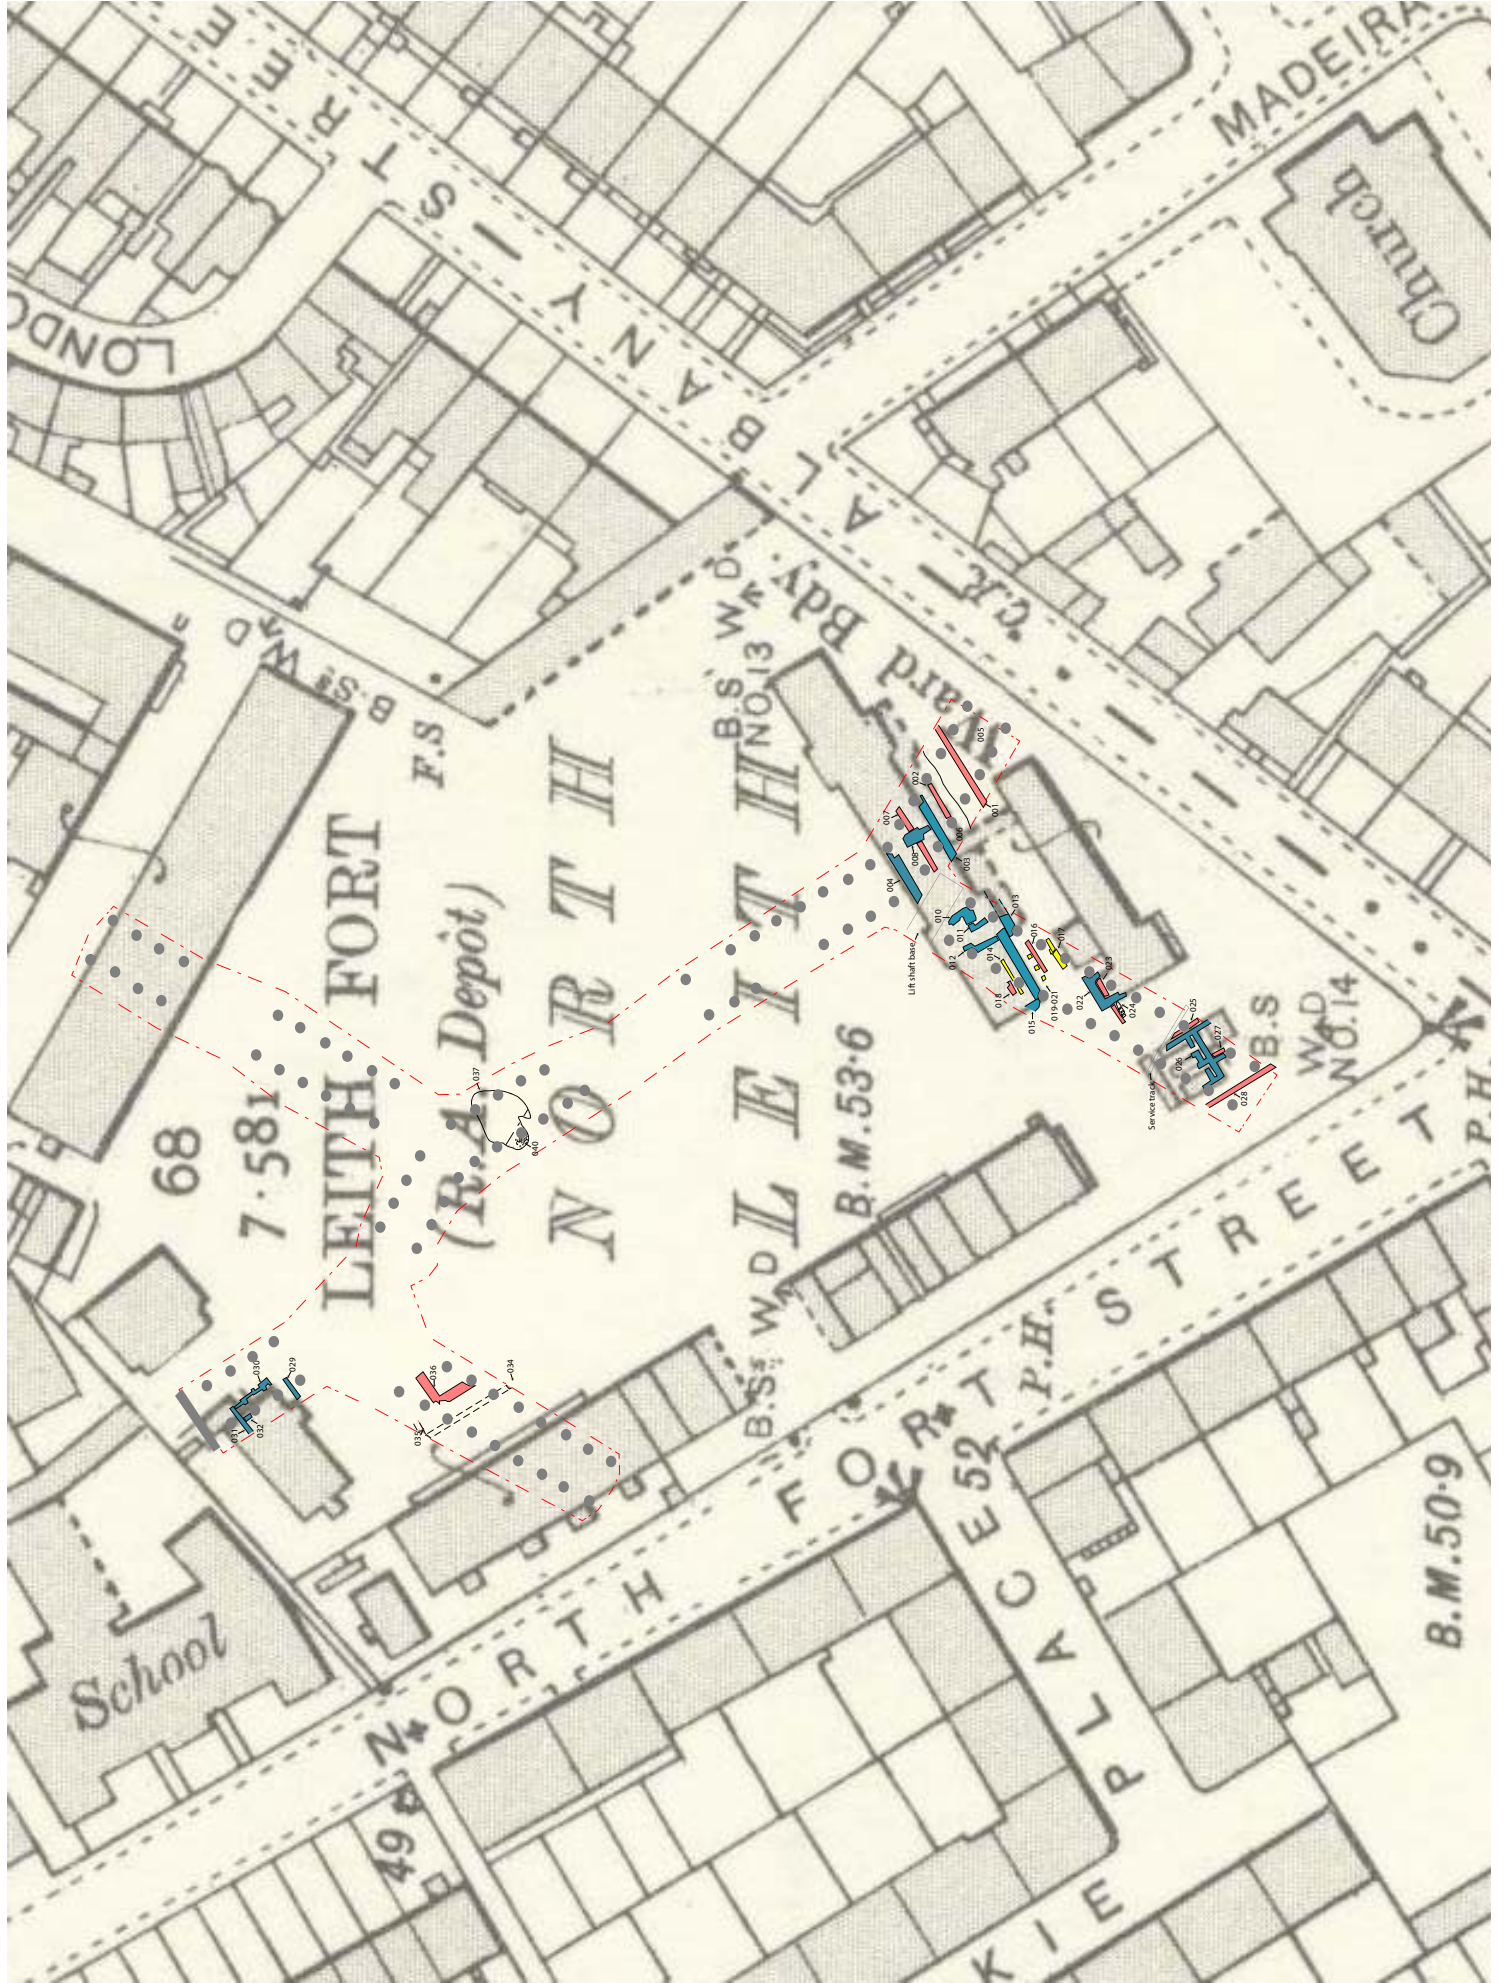
Figure 6 - Overlay of archaeological features onto 1906 OS Map

- 6.2 Comparing the excavation results with the map evidence it is clear that the walls and structures revealed tie in to the different phases of the fort buildings. Furthermore, the maps indicate that the majority of reconstruction to the fort layout was conducted between 1895 and 1906. Looking firstly at the concrete foundations [003], [004], [008], [010]-[013], [015], [022], [026], and [032], it can be shown from the 1906 OS Map that this type of construction material was used from the late 19<sup>th</sup> and early 20<sup>th</sup> century within the fort. Structure 1 is identified as the building that replaced the original stable block in the SE of the fort. Furthermore, Structures 2 and 3 can also be related to buildings at the time of the 1906 OS map and given how contemporary these structures all are it can also be assumed that the similarly constructed foundation [032] within structure [033] also relates to this period.
