Seton Hall, Berwick Upon Tweed: Archaeological Evaluation Report

AOC Project 22354
Oasis No. aocarcha1-145931
26th March 2013

On Behalf of:	Berwickshire Housing Association Limited 55 Newton Street Duns TD11 3AU
National Grid Reference (NGR):	NT 988 526
AOC Project No:	22354
Prepared by:	Kevin Paton
Illustration by:	Kevin Paton
Date of Fieldwork:	7th March 2013
Date of Report:	26th March 2013

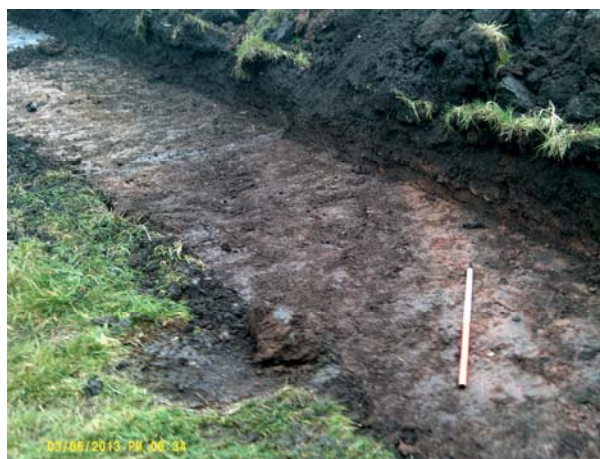
Plate 1 - Shot of furrow in Trench 3

- 5.3.1 Despite extensive plough scarring in most trenches furrows from a post medieval field system were encountered throughout the evaluation area. The furrows were aligned NW-SE and were seen to be around 1.7 m wide, 0.2 m deep and 3-4 m apart (Plate 1). They were filled with light brown clayey silt with abundant coal fleck inclusions, containing clay pipe stems and white ceramic fragments. One of the furrows in Trench 4 had ditch [001] cutting through the centre of it which has been interpreted as a drainage channel running into a small hollow.
