# James Gillespie's, Edinburgh: Phase 2 Archaeological Evaluation, Watching Brief & Excavation (cont.) Data Structure Report

AOC 22383

16<sup>th</sup> Dec 2013

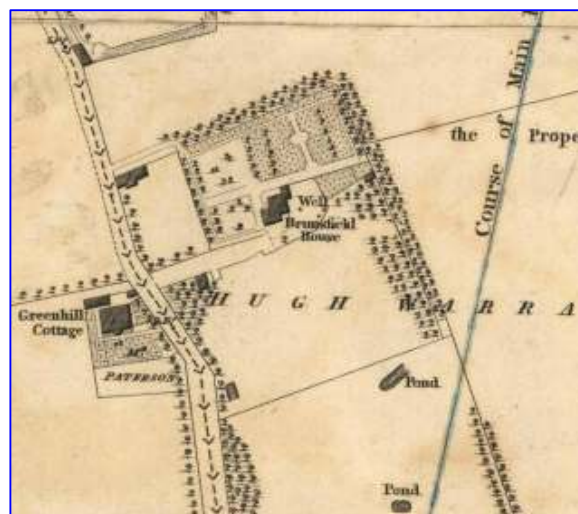
Figure 2: Extract from Kirkwood's map of the City of Edinburgh and Its Environs, 1817

- 2.3 Until the development of the school in the 1960s, the house stood within private grounds, as can be seen by the detailed historic mapping from the early 19th century to the mid-20th century (Figure 2 – 4).
- 2.4 A previous phase of archaeological works were completed between February and March 2013 (Humble 2013).

5.2.2 The Ice House and associated structures were excavated using a combination of machine and hand digging. This revealed a substantial circular Ice House chamber with double skinned walls and a corbelled roof. A projecting flag floored entrance ran to the north of the structure leading to an ancillary paved area formed by a combination of existing boundary and blocking walls. The northern wall of this structure can be seen on the Kirkwood map of 1817 (Figure 2).

5.4.1 The heavily truncated remains of a well [029] were observed during on-going ground-works within the area to the north-west of the well. This probably relates to the feature shown on the Kirkwood map of 1817 (Figure 2). The remains of the well consisted of a 1.0 m deep segment of curving sandstone wall. The well appeared to have been largely removed and the remains in-filled with type 2 hardcore. Unfortunately ground conditions prevented any further investigation.

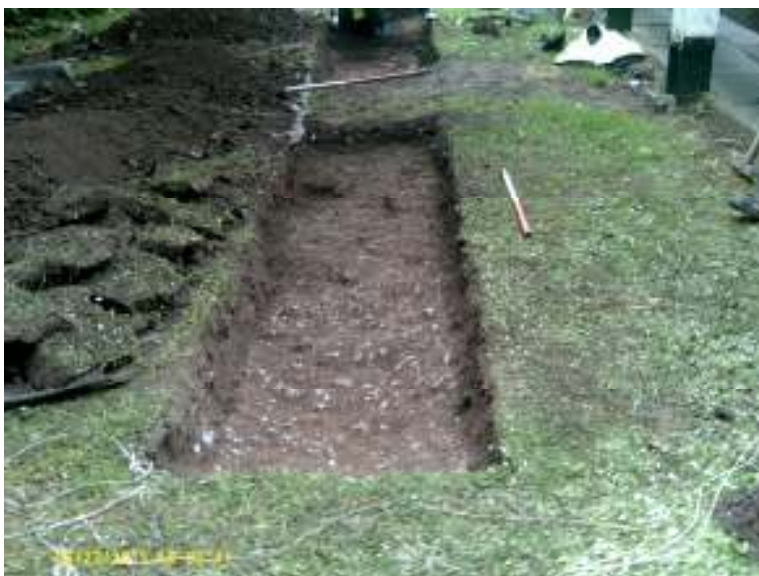
Plate 1 - General view of Trench 5

- 5.1.1 The archaeological evaluation was conducted between the 15<sup>th</sup> July 2013 and the 2<sup>nd</sup> August 2013. Weather conditions were generally dry and bright and archaeological visibility was good.
- 5.1.3 The evaluation in Area 5.1 (Figure 5) comprised five trenches with total basal dimensions of 43.6 m<sup>2</sup> (see Appendix 1 for details). Topsoil in the area consisted of a medium brown loam over a deposit of made ground consisting of re-deposited natural and frequent shattered sandstone fragments. The natural subsoil of pinkish brown clay and stone was typically at depths of 0.4 m below current ground surface (Plate 1). Trenches 1 and 3 contained modern pits and several fragments of Scottish post medieval reduced ware were found within the topsoil. No archaeologically significant features were revealed.

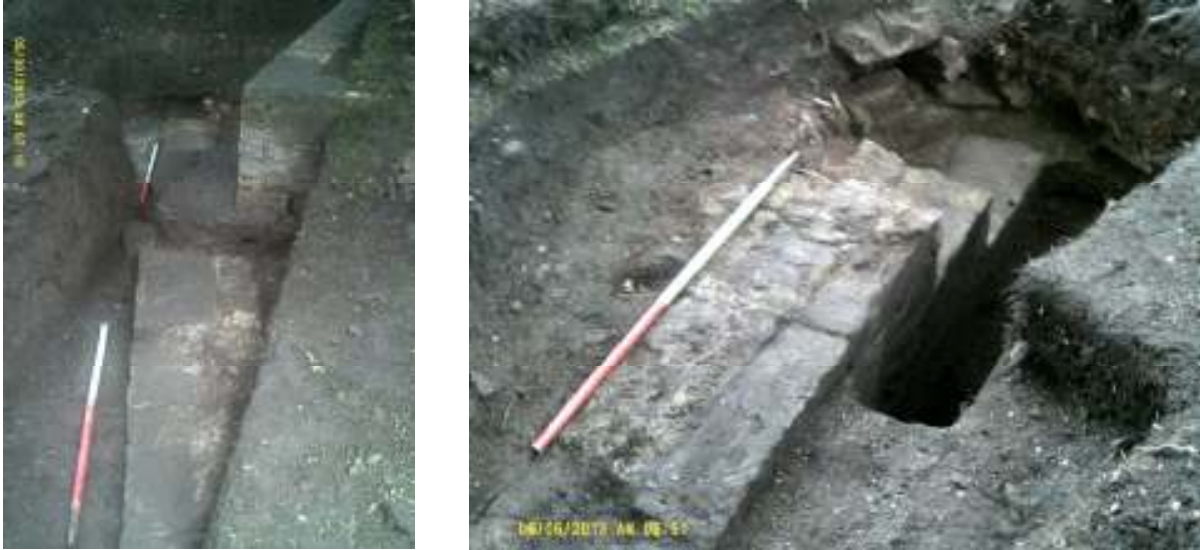
Plate 2 - Ice House retaining wall [604]

- 5.1.5 Underneath the made ground, a retaining wall [604] aligned approximately E-W was revealed in Trench 6 that was abutted to the south by a compact deposit of re-deposited natural [609] (Plate 2). To the north the made ground was over 1.2 m deep and consisted of dumped deposits of loose ash [608] underlying modern demolition and made ground [602] to [606] with a capping layer [607] immediately on top. In Trench 7, to the south of Trench 6, a curving sandstone wall [707] supporting a corbelled sandstone dome [708] was revealed that continued west under the excavation edge (Plate 3). These features were underlying a very compact re-deposited clay [705].

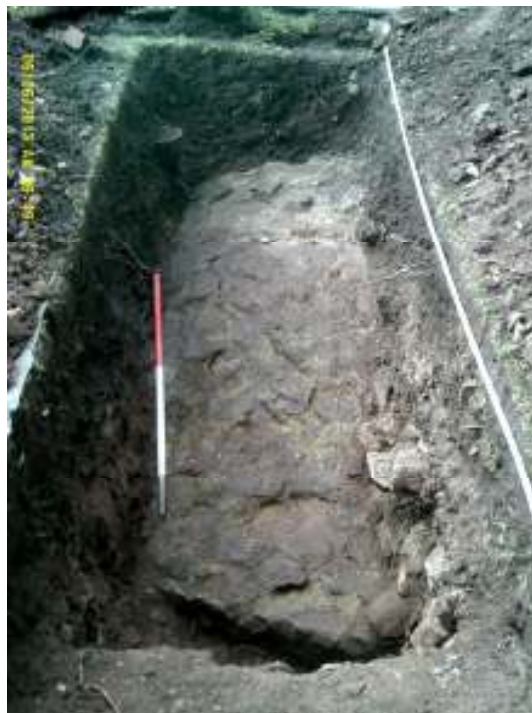
**Plate 4 - Corbelled roof of Ice House**

- 5.1.6 Trench 8, to the south of Trench 7 revealed more of the corbelled roof [801] of the Ice house underlying a very compact re-deposited natural clay with abundant whole frogged bricks [802] (Plate 4). The supporting wall expected to the east of the dome was not revealed due to the depth of the made ground exceeding 1.2 m.

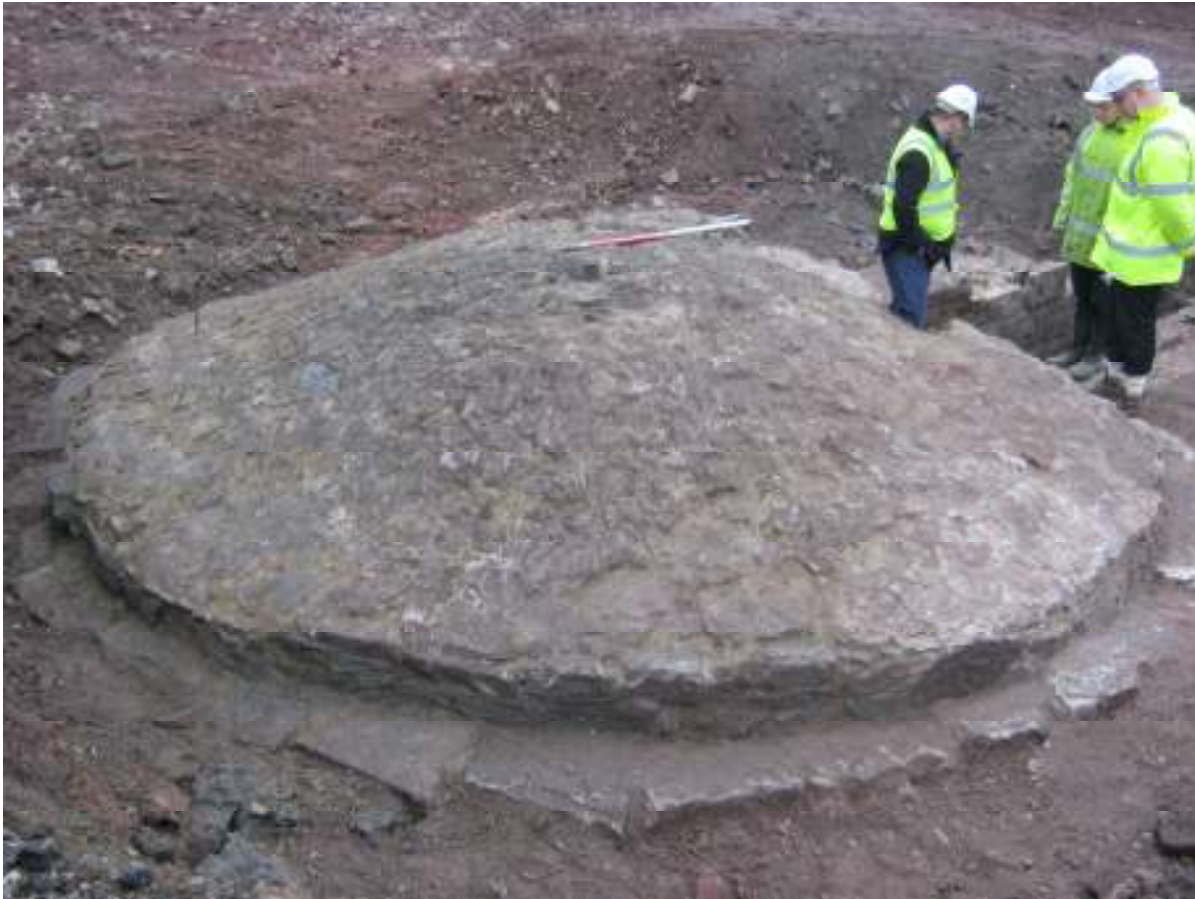
Plate 5 – The Ice House chamber [101] pre-excavation from south-east

5.3.1 The main structural component of the Ice House was a substantial circular chamber 5.5 m in diameter. The chamber was constructed of lime mortared rectangular sandstone blocks and consisted of a double skinned wall separated by a 0.25 m wide void [008]. The outer wall [007] was cut into the natural and was 0.30 m in width. The inner wall [009] was more substantial at 0.50 m in width and supported the corbelled roof [002]. The roof was relatively intact with the exception of a portion overlying the threshold [004]. This had been removed to allow the in-filling of the chamber with demolition material [025], probably during the construction of the present school buildings. This material was found to fill the chamber almost to roof level. The substantial roof measured 4.5 m in diameter and 0.30 m to 0.40 m thick. Once the roof was recorded it was removed to wall level to allow the removal of the demolition material. This revealed the chamber to be 4.0 m in depth with a sloping sandstone flag floor [024] and a centrally placed metal drainage grate [024]. No stairs or other internal features were present.

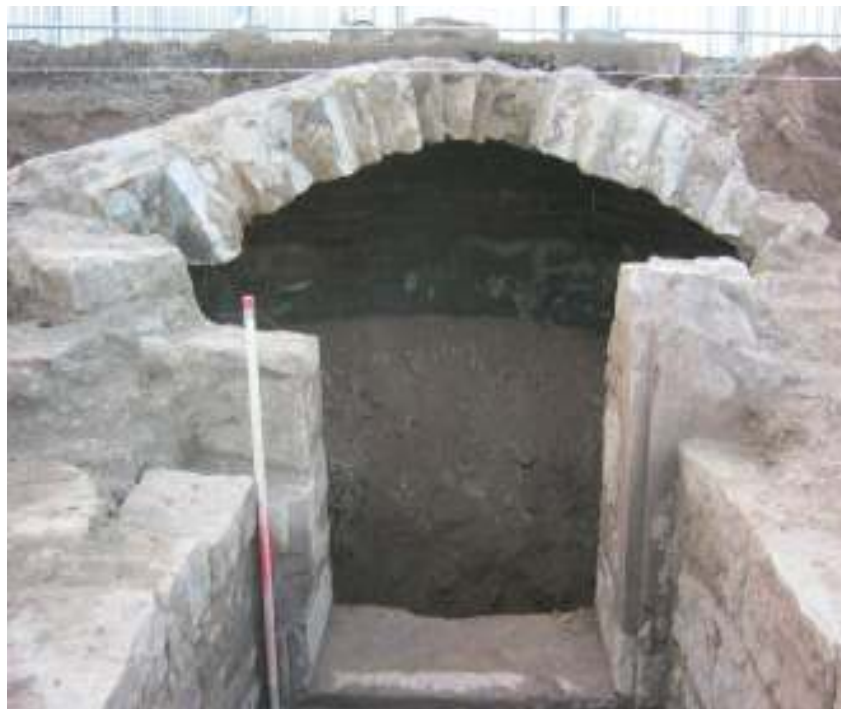
Plate 6 – North facing section through the Ice House roof [002]

[002]	Structure	<b>Corbelled roof</b> of Ice House (see evaluation contexts [801-802]). Formed by lime mortared blocks of rectangular sandstones. The roof is 4.5 m in diameter and is set on top of the inner wall [009] of the structure. The roof is 0.30 m – 0.40 m thick. Severe truncation is visible to the northern portion of the roof

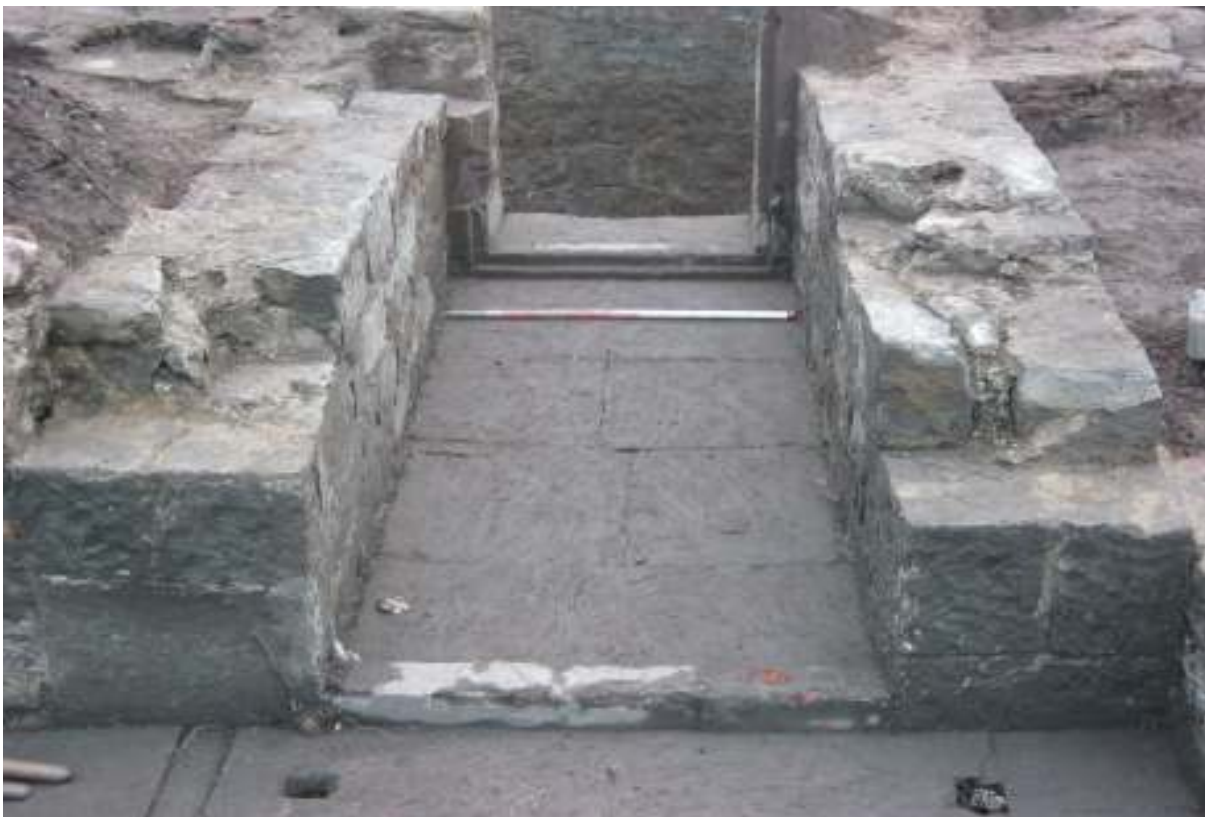
Plate 8 – The entranceway [017] showing both thresholds [004-011] from north

5.3.2.1 The immediate entrance to the Ice House chamber was situated to the north and consisted of two pink sandstone door jams [003] flanking a large worn sandstone threshold [004]. The entrance had undergone significant truncation during a previous removal of the roof to allow in-filling. The

threshold was 1.0 m in width and survived to a maximum elevation of 0.75 m. The door jams were decorated with simple horizontal chisel lines.

5.3.3.1 The threshold [003-004] led out into a narrow projecting entranceway 3.0 m in length by 1.0 m in width. The entrance way was flanked by the sandstone walls [005-006] which were keyed into the outer wall [007] of the Ice House chamber. The walls survived to a maximum elevation of 0.90 m and were both 0.60 m in width. The floor of the entranceway was composed of large flat mortared sandstones [010]. A threshold comprised of concrete covered bricks [011] was recorded across the northern end of the entrance. The entrance was filled to the existing ground level with deposits of top-soil and demolition material [015-016].

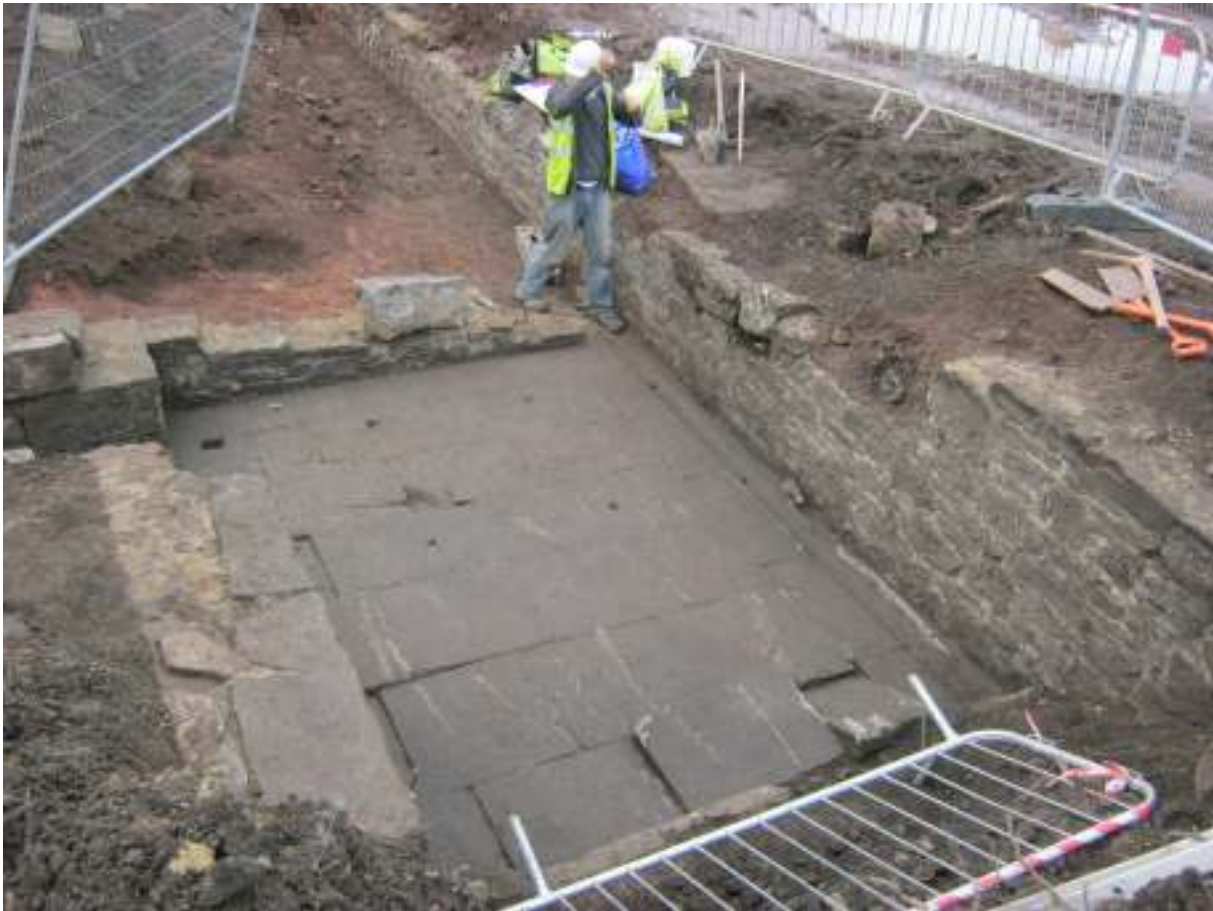
Plate 9 – The ancillary area showing the walls [013-021-014] from east

5.3.4.1 The excavation of the projecting entrance saw the continuation of the flag floor for a further 3.0 m until it abutted the boundary wall [013]. A rectangular floored area 3.0 m north to south by 4.0 m east to west was then revealed enclosed by a further sandstone wall [014] recorded during the evaluation. This is identified as a retaining wall for the deposits covering the Ice House chamber. A blocking wall [021] 3.20 m in length by 0.40 m in width had been added on to the western entrance wall [005] and was aligned north to south. This also abutted the wall [013]. The eastern end of the area was open, however the flooring here was edged with a single course of upright sandstone blocks [012] creating a boundary of sorts.

5.3.4.2 The flag floor of the ancillary space included four pairs of equally spaced small square cut settings [018] aligned north to south and set in line with the entranceway to the Ice House. The settings were spaced 1.10 m apart east to west and 0.75 m apart north to south. The northern pair of settings were cut into the carved drain gully [020] which is incorporated into the floor and runs east to west along the southern face of the boundary wall [013]. The gully ends in a metal grate similar in size and form to that set within the floor of the Ice House chamber. It is likely that the settings are the probable remains of a wooden arbour scaffold or similar garden feature.

5.3.4.3 Given that none of the walls associated with the ancillary space were keyed into the structure of the Ice House it is probable that the ancillary space represents a later, possibly 19th century, alteration of the area between the Ice House and the existing 18th century garden boundary wall shown on the Kirkwood map of 1817 (Figure 2). This is reinforced by the large amounts of plant pots, glass bottles and ceramics recovered from the immediate infill [025] which date to the 19th and early 20th centuries.

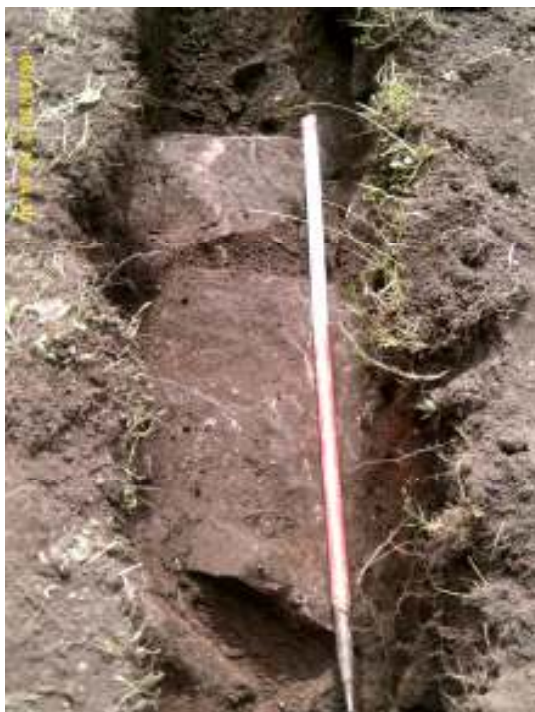
Plate 11 – General view of wall [1000]

- 6.1 The watching brief of the electrical service running from the boiler room to Bruntsfield House uncovered two archaeologically significant features (Figure 6). The first was a sandstone wall [1000] that probably relates to a boundary wall within the estate of Bruntsfield House (Plate 5). The small section of wall revealed in a 0.5 m wide service track measured 0.65 m wide and consisted of red and beige sandstone aligned approximately east to west. The second feature was the continuation of the Bruntsfield House foundations to the east of the current building footprint. Recorded as foundation [1001], it consisted of large sandstone blocks measuring 1 m wide and tied into the foundations under the current tower house (Plate 6).
