# Rachan Woods House, Rachan, Broughton Archaeological Evaluation Data Structure Report

# Rachan Woods House, Rachan, Broughton Archaeological Evaluation

## Data Structure Report

**Planning Ref No.** 10/01419/FUL

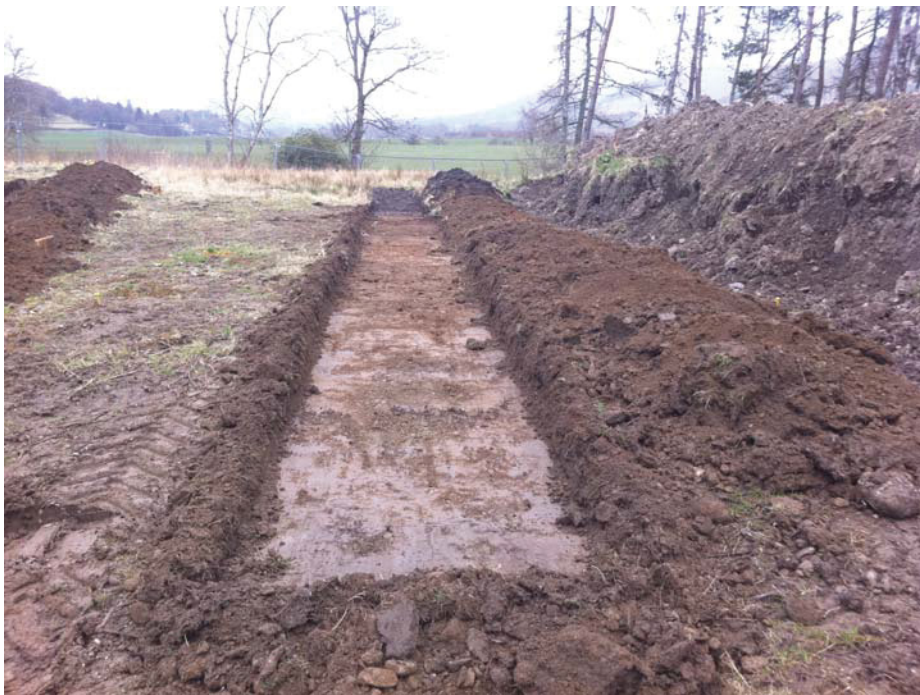
Plate 1 - Trench 1 Post-excitation showing topsoil bund to east

- 4.3 On arrival it was evident that the site had been partially stripped with subsoil visible in patches and a large bund of predominantly topsoil lying along the eastern edge of the house plot (See Plate 1). Where the original topsoil profile survived it appeared as a dark coloured sandy organic rich topsoil lying over a subsoils consisting of arrange/brown coloured sands and gravels. The topsoil varied in depth from 0.05 m to 0.25 m in depth.

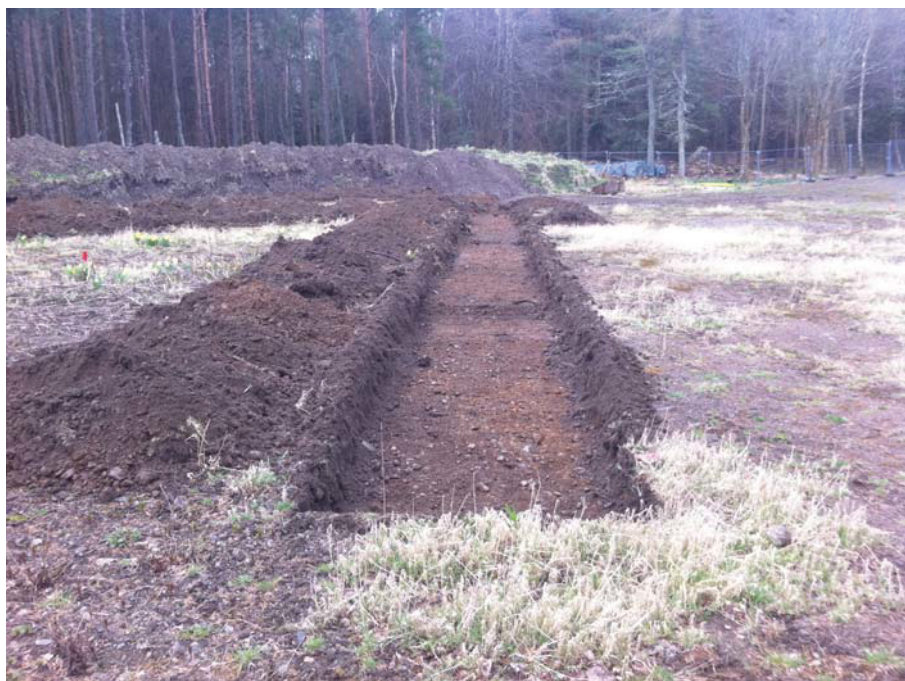
Plate 2 - Trench 3 Post-excavation

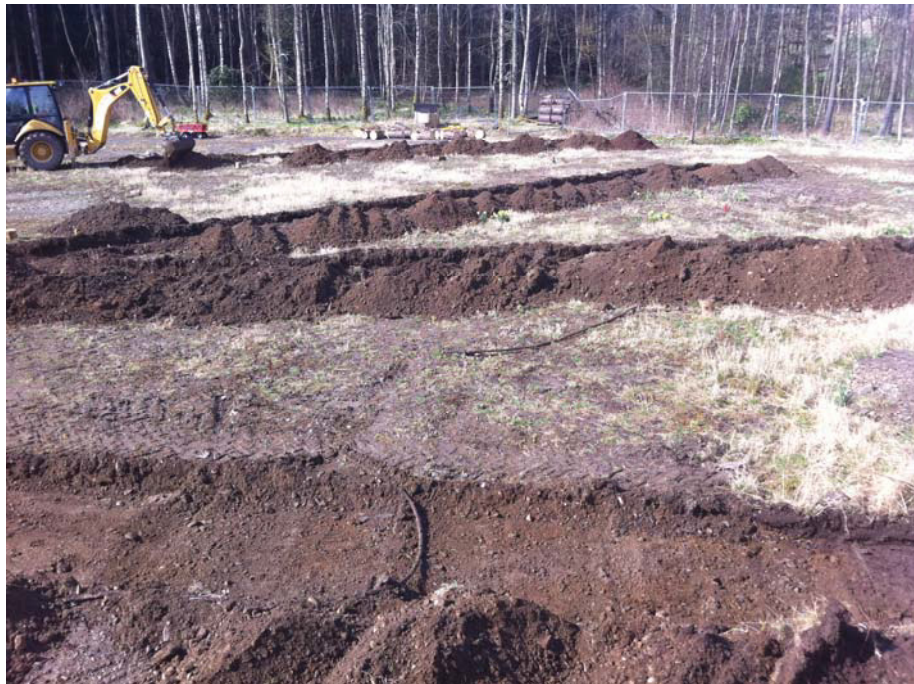
Plate 3 – General view across the site from the East
