Beaverhall Road, Edinburgh: Archaeological Evaluation Data Structure Report

AOC Project 22011

Beaverhall Road, Edinburgh Archaeological Evaluation Data Structure Report

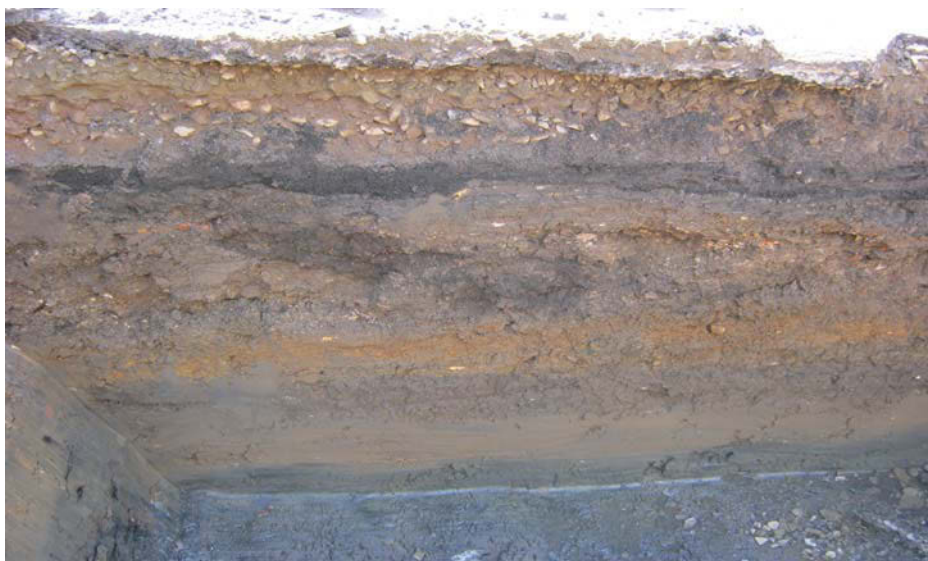
Plate 1: Trench 1 Post-excavation south-west facing section showing depth of made ground

- 4.3 Trenches 1-3 were located in the north-eastern half of the car-park (Figure 2). This portion of the site had been previously truncated. Made ground was removed to a depth of 2.10 m. This deposit was heavily contaminated with diesel in its upper half. The made ground directly overlaid a natural of orange brown boulder clay. No *in situ* original deposits or archaeologically significant material was revealed.

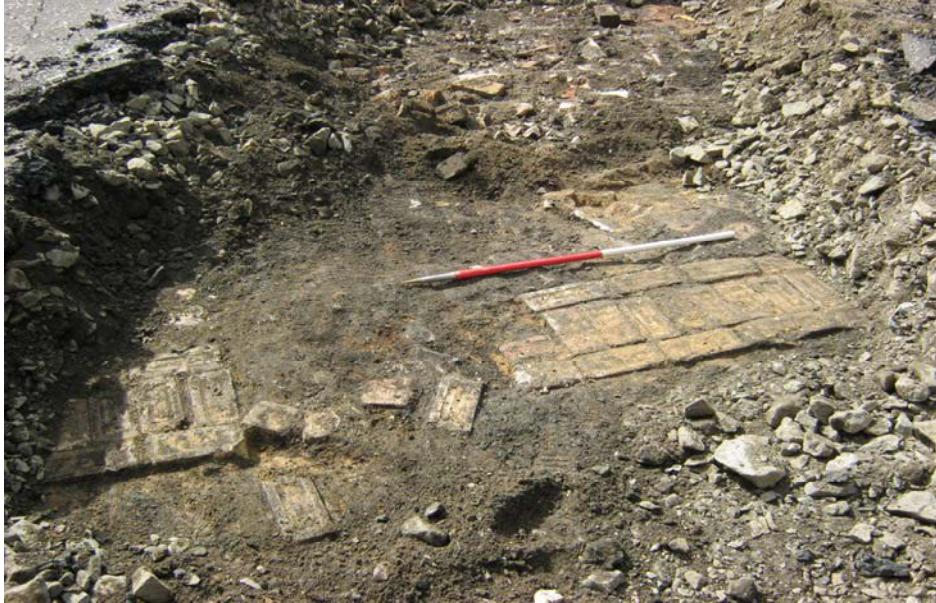
Plate 2: Trench 4 showing brick features [401] & [402]

- 4.4 Trenches 4-9 were excavated along the southern boundary of the site. Trench 4 revealed a small section of loosely mortared brick setts [401] which relates to a now demolished section of this building (Figure 3). The structure was formed by a single course of fire-bricks stamped 'Whitehill'. These bricks were also visible within the aforementioned upstanding building to the east of the trench. The bricks most probably represent the remains of a wall foundation. This foundation was 0.50 m wide and aligned north to south across the trench. A further small area of bricks [402] 0.50 m in diameter is the probable remains of an associated floor surface. Both structural remains directly underlie a 0.20 m thick demolition layer of brick and mortar [403]. This deposit probably relates to the demolition of the building.

Context	Trench	Description
[401]	4	Brick structure consisting of a single course of loosely mortared fire-bricks stamped 'whitehill'. The structure was 0.50 m in width and ran north to south across the trench. The structure was a possible setting for a wall foundation and is overlain by the demolition deposit [403]. The structure is probably associated with [402]. It is cut by modern services.
[402]	4	Remnant of a single course brick surface or floor 0.50 m in diameter. This is possibly related to [901]. The floor is directly overlain by the demolition deposit [403]
[403]	4	Deposit of demolition/ brick rubble probably related to [401] & [402]. The deposit is very mixed and consists of fire-brick, red-brick, mortar and clay.
[901]	9	Single course of 'whitehill' stamped bricks set in herring bone pattern. The bricks are directly overlain by a 0.10 m thick layer of concrete. The bricks and concrete form a deposit of hard-standing capping a deposit of made-ground. The bricks measured 0.24 m by 0.11 m by 0.08 m individually and were visible in both trench sections.

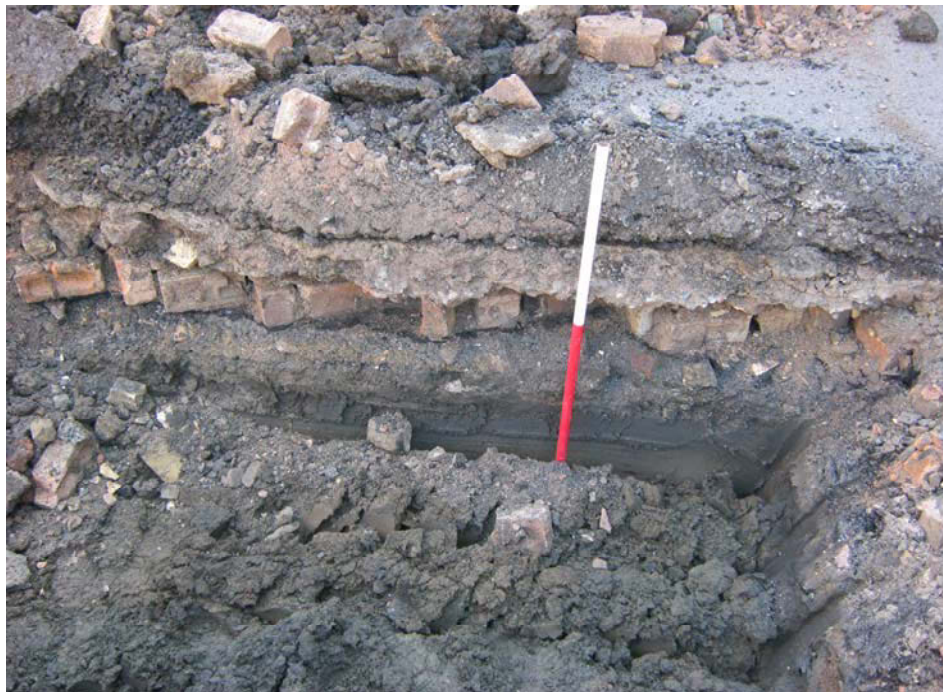
Plate 3: Trench 9 south-west section showing brick surface [901]

- 4.5 The demolition layer [403] is also present within Trenches 5 – 8, directly overlying the natural. In Trench 9, the fragmentary remains of a brick surface [901] set in a 'herring bone' pattern was recorded capping a 0.20 m thick deposit of made ground (Plate 3). The bricks forming the surface were again stamped 'Whitehill'. The brick surface was directly overlain by a 0.20 m thick layer of concrete.
