Tenbury Workhouse, Teme Street, Tenbury Wells, Worcestershire: Historic Building Record

Planning Application Refs: MH/11/0887/FUL and MH/11/01466/CON

AOC Project No: 32426

Date: September 2013

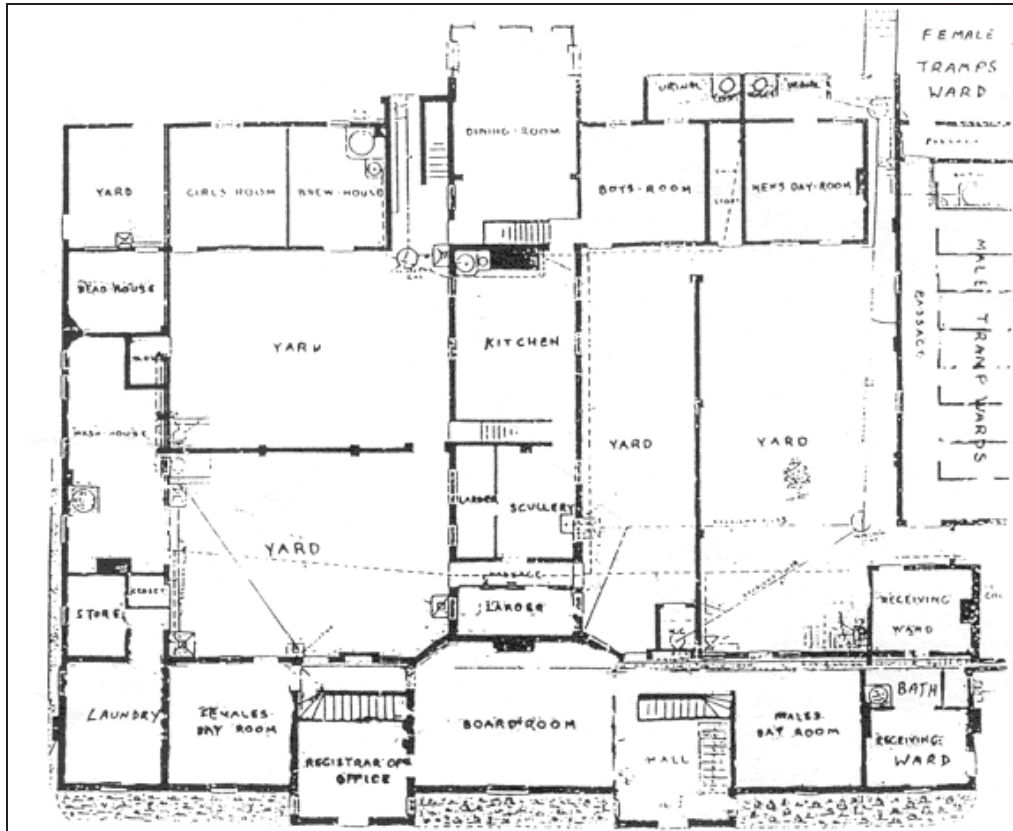
Plate 1: Plan of Tenbury Workhouse (from Higginbotham 2013). North is to the left.

This was funded by public subscription and loans (Trouteaud and Bevis, 1993). The layout (Plate 1) shows that the central range had a kitchen and scullery, with a boardroom facing Teme Street. Girls and 'females' rooms were around the north courtyard, with boys and 'males' on the south side (Plate 1). That part of the workhouse subject to this report comprised a 'Males Day Room', and two receiving wards and a bath on the ground floor for tramps (Higginbotham 2013). The Tramps wards are planned as a slightly separate unit to the main structure. The other principal building on site, and subject to this record is a two-storey brick building, purpose built as an infirmary in 1871. This lies c.70m east of Teme Street (Plate 3), and was most recently occupied by Russell, Baldwin and Bright.

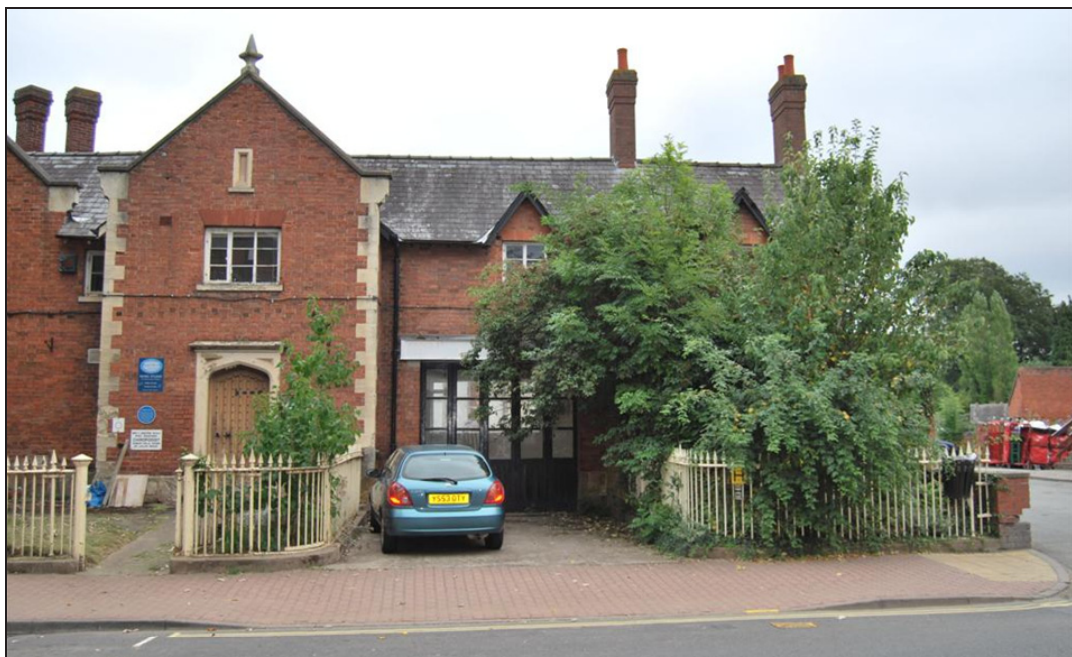
Plate 5: Workhouse West Elevation.

- 6.7 The first floor of the block has two original casement windows with original furniture; these have stone sills and flat-arched lintels. They lie within gabled dormers. The pitched roof above is a purlin roof, with brick chimneystacks rising 1.9m above the ridge, surmounted by ceramic chimney pots.

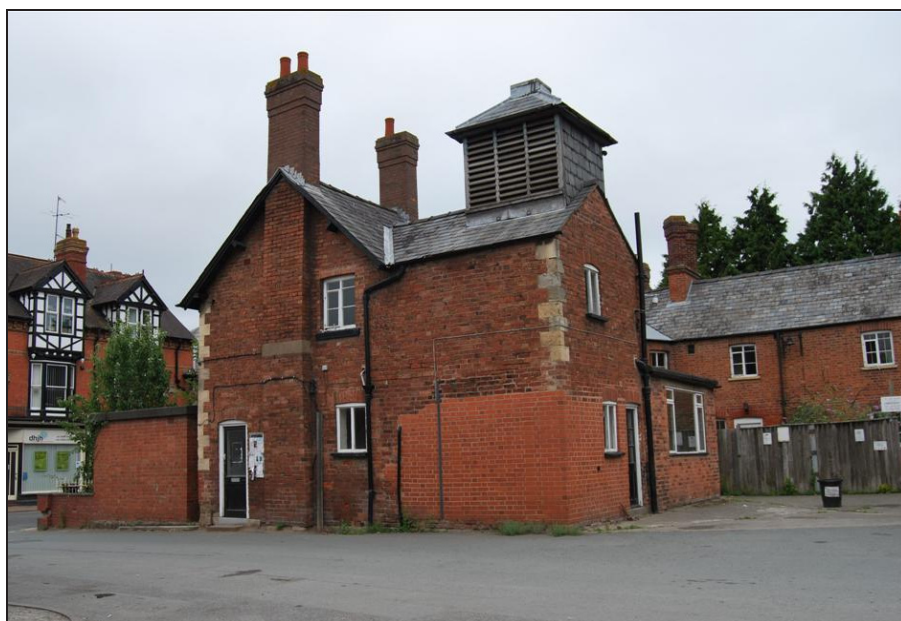
Plate 6: South End of Workhouse, Looking Northwest

- 6.8 The south wall comprises a door and window on the ground floor, and just one first floor window. The southern of two chimneystacks projects 0.12m from the wall and has a block of dressed stone half way up. The purlins and wall plates of the roof project under the eaves in the gable end. There is also an undecorated bargeboard. The windows in this face differ from the front, having segmental arched brick lintels, but the sills are still stone. The southeast corner of this block as it turns and runs eastward on the ground floor has been fully rebuilt in modern brick, with no openings. The rebuild continues across a window to a back door to the property; the window has been rebuilt. A window above, on the first floor is a fixed window with central glazing bar. The pitched slate roof has a shallower slope than the front range, the ridge 1.10m lower. There is also a window on the first floor of the north face of this part, and one other first floor window on the rear of the front range, facing east. The ground floor is obscured by a flat-roofed extension of the fire appliance garage space.

- 6.9 There is a square tower on the rear range of the block, with a hipped roof (Plate 6). The north and south sides are fitted with three panels of horizontal wooden slats, while the east and west faces are hung with slates. The roof is surmounted by a low square lead cap. This tower was used to hang fire-hoses up to dry.

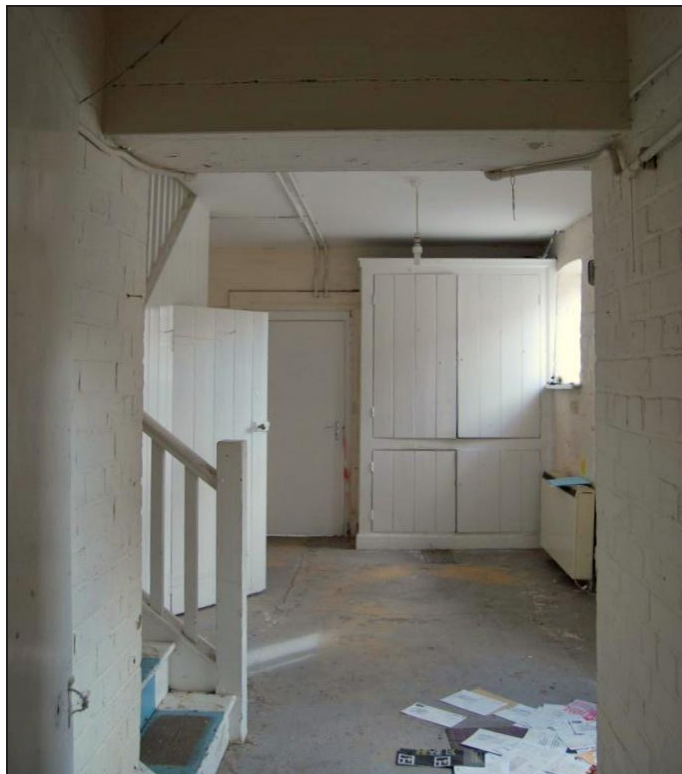
Plate 7: Room 2 Looking East

- 6.10 Internally, there is a notable paucity of evidence for the function of the building as a workhouse, and few clues of its use as a fire station. There is no plaster on any internal wall: all have painted brickwork. The principal access to the building is the door in the south wall, and although the opening is original, the door more recent. The doorway has a segmental arched brick lintel, in common with the windows. The door has a high threshold, possibly to guard against flooding. The first room beyond the door (**Room 2**) is rectangular in plan with a wooden stair rising to the first floor (Plate 7). There is a blocked fireplace in the south wall, a drainage grill in the floor, and two other rooms. The floor is concrete. The room has no decorative touches: there is no skirting nor picture rail or cornice. A built-in cupboard is most likely to be an addition from the fire brigade's occupancy. The back of a chimneystack in the north wall is associated with fireplaces in rooms to the north. The plan of the workhouse (Higginbotham 2013, Plate 1) shows this to have been one of two receiving wards, and that it contained a bath. It was separate from the rooms of the workhouse to the north. Its proximity to the tramps wards suggests that this was a tramps receiving ward, with the bath a necessary feature to wash off the dirt from the road. The grill is probably an original feature; enabling swabbing down of the ward after the tramps had been processed. The grill has simple diagonally-set square piercing with no decorative scheme. The stairs are not an original feature. They are a quarter-turn stair with a landing, but are notably clean wood, with new supporting struts. The banister is plain, with no turned features. There is storage space beneath the stairs, which is panelled with plain boards. The door to the space has strap hinges contemporary with the stairs. The built-in cupboards have two large upper doors and two small lower doors, simply formed of boards. The top of the cupboard frame has a convex moulding to a square stop.

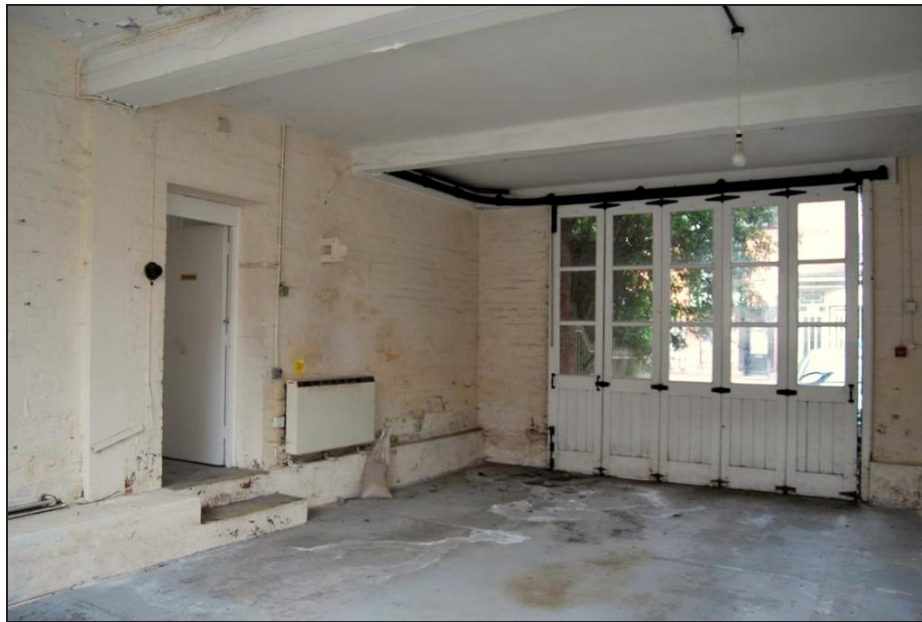
Plate 8: Room 1 Looking West

- 6.12 The second door from Room 2 leads north into the enlarged room used for the fire appliance (**Room 1**). This room is 7.90m long and 4.75m wide. The floor has been excavated down a further 0.42m from its original floor level, and is concrete. This is part of the conversion to being an appliance garage from its original use as a Males Day Room when a workhouse. These changes also include the loss of the east and west walls, both now spanned by steel I-beams. The west wall has a five-part sliding door on a pair of curving runners (Plate 8). The east wall is now open to an expansion with a casement window that spans almost the whole width of the room. A ledge around the edge of the room represents the stepped-out foundations of the block. Two fittings in the room date to the firestation: a thermometer manufactured by GEC and a bracket formed of a pair of angle-irons. The only original structural elements are the sidewalls and a principal joist supporting the floor above.

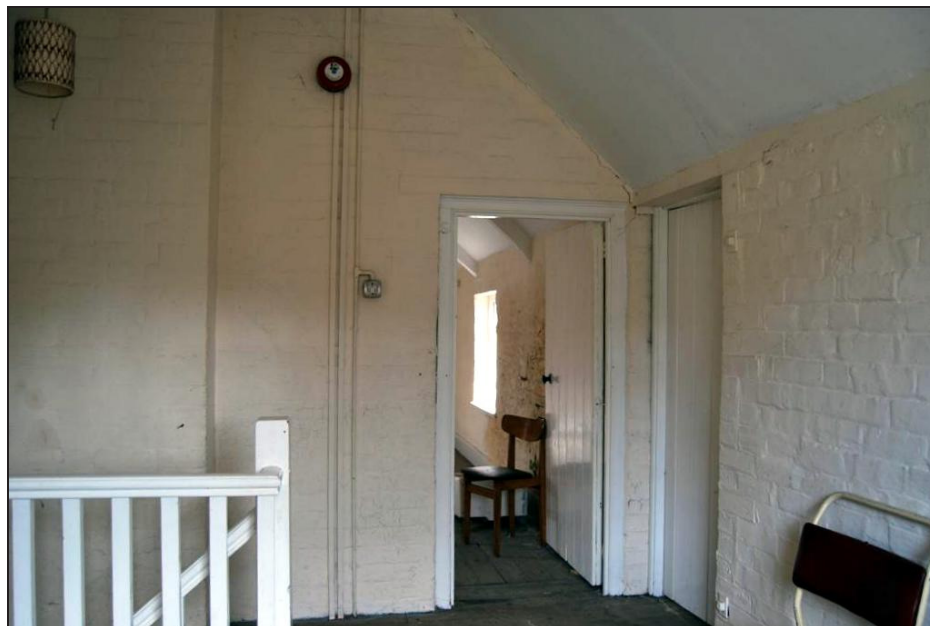
Plate 9: Room 5 Looking North

- 6.14 The stairs lead upwards to an open area (**Room 5**), with the stairwell guarded by the same plain banisters used on the stairs (Plate 9). The room is well lit by a window in the south wall, which is a metal casement, a later addition to the original opening. Three doors lead from the room, two are boards with three rails and strap hinges, the other, leading west, is a panelled door and therefore more recent. The floorboards are 5" boards, laid east-west over common joists orientated north-south. In the south wall is a blocked fireplace, fully bricked up. This would have heated the room, and suggests that Room 5 and Room 7, currently beyond a partition to the west, was originally one space. Skirting around the room has a slight stepped roll mould.

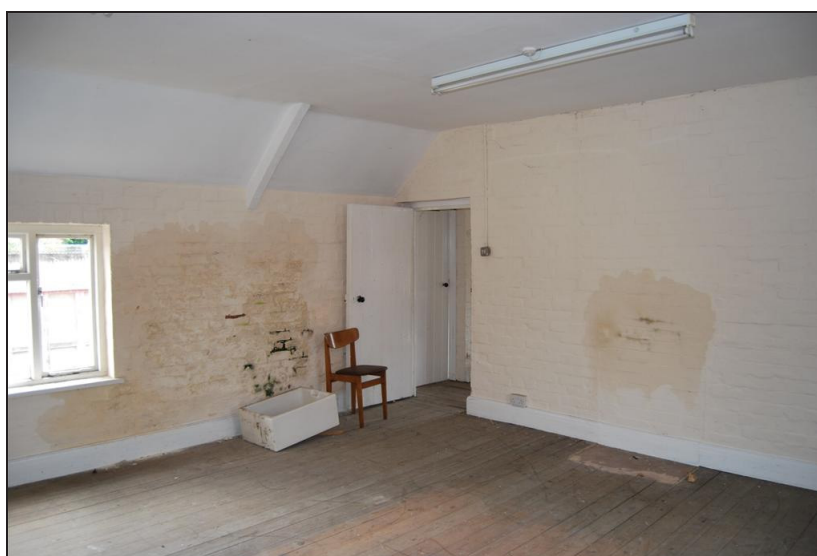
Plate 10: Room 6 Looking Southwest

- 6.15 The largest room on the first floor lies in the north of the block (**Room 6**) (Plate 10), measuring 5.15m by 4.75m, lit by a window in each side. The windows are metal casements with a wooden central post. The window overlooking Teme Street has its original furnishings: the window swings open onto a curved quadrant stay, sprung so that the window wedges open (Plate 11). The window is furnished with a spiral handle and the fastener has a wide flanged catch. The room is almost bare of detail: the fireplace has been removed and bricked up: only the skirting remains, which has a lightly moulded stepped roll mould. The ceiling has been constructed at collar beam level, with the lower parts of the principal rafters visible. The roof is a laid-on purlin roof, with the common rafters over the purlins. This room was part of the male accommodation in the years of the workhouse, and may have been a recreation room for the fire brigade staff.

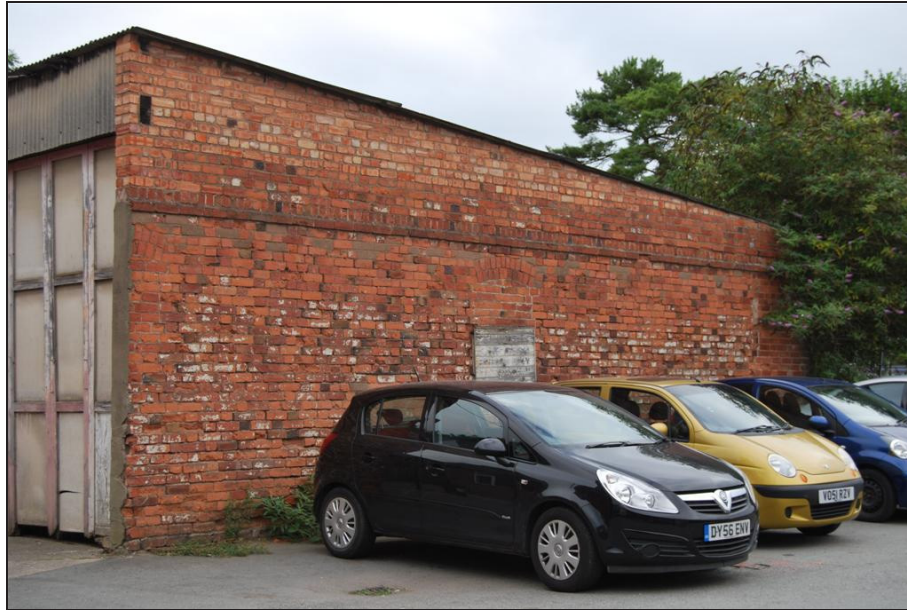
Plate 12: Tramps Ward.

- 6.18 The tramps ward exists now as a length of red brick wall measuring 11m east-west and standing 2.85m high, just a single brick wide (0.23m) (Figure 5 and Plate 12). The bricks measure 9 or 9¼" by 4½" by 2¾" and are generally laid in Flemish bond. A plinth of three courses are stretcher bond, and are stepped out slightly before two courses of headers provide the base for the rest of the wall. The top of the remaining wall is finished with a row of stretchers that projects slightly with a row of headers laid on edge above. Modern bricks above this form a gentle pitch sloping down westwards. This wall is the only surviving part of the Tramps block, and was its north wall.

- 6.19 The north side of the wall is now an internal wall of a pair of storage sheds of modern date with corrugated iron roofs. It is supported by two brick buttresses each 0.59m wide that project 0.1m from the wall, and are structural supports for the tramps ward. The wall also features one and a half blocked window reveals. Each has a segmental arched lintel over the window formed of two courses of headers. All window furniture has been removed and no sills remain.
- 6.20 It cannot be proved whether the Tramps Ward was one or two storeys, but the plan of room uses (Higginbotham 2013) indicates that this is the edge of a passage along the edge of the Male Tramps Ward. An example of a Tramps Ward at Ripon workhouse, now a museum, has individual cells not much bigger than a bed, off the passage.

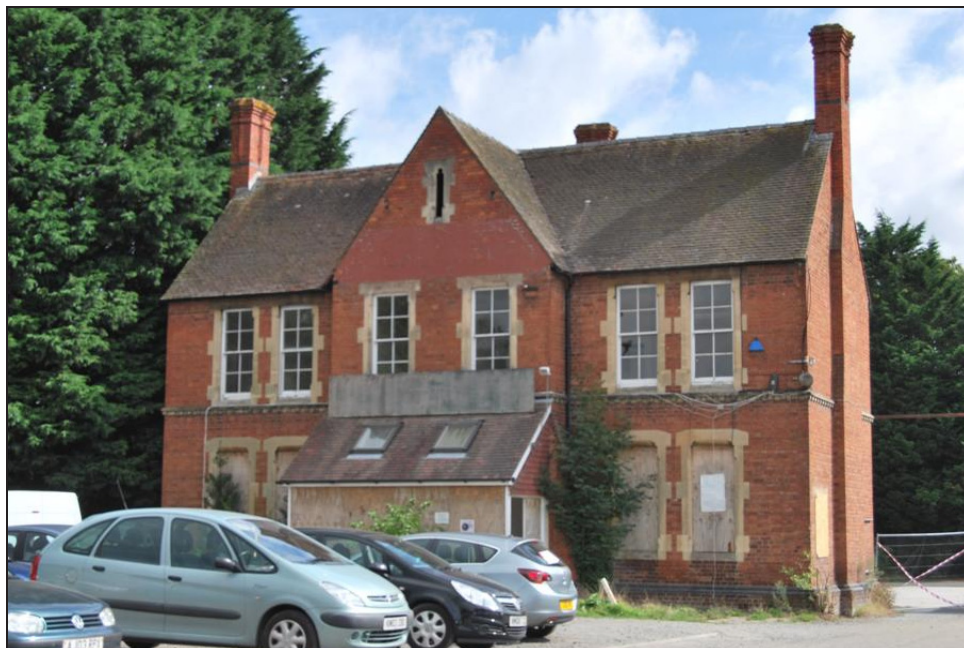
Plate 13: Infirmary West Elevation

- 6.21 The infirmary building stands 70m east of the workhouse, and is a tall two-storey building with three bays oriented north to south (Figures 6-8). It is designed with external symmetry with a central projecting bay on each side. The layout of each half and on each floor is closely mirrored, barring the central staircase bay. There is a twin entrance in the west side, now obscured by a modern lean-to porch (**Room 1**) (Plate 13). The building is constructed in red brick (9¼" x 4" x 2¾") laid in English Bond. A stepped chimneystack rises at each end with acute moulded brick projections, and there is a third stack in the centre of the rear wall. The roof is tiled, with quite a steep pitch, with wall plates purlins protecting beyond the wall line to the eaves.

- 6.22 Each window is dressed with stone. The sills are carved with a 70° pitch, whilst the reveals rise square to a triangular stop, then up at 45° to a second stop. The lintel has a central carved rebate. The stone sides are ashlar blocks providing an alternating pattern. A horizontal band of pale buff bricks forms a dentil course beneath the first floor windows. The windows themselves are sash windows, where original, with slender glazing bars, which maximise natural daylight to the wards. The central bay on each side has windows with curved relieving arches built into the brickwork. This structural support aids the integrity of the gable above.

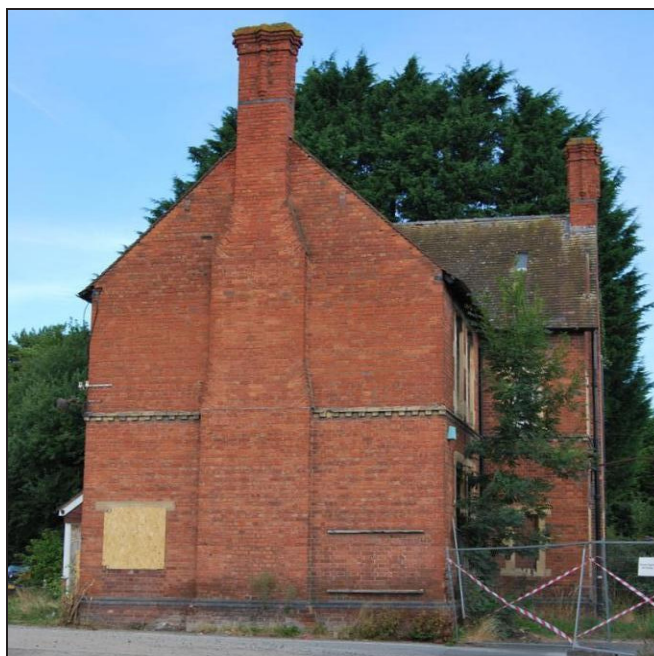
Plate 14 : South End of Infirmary

- 6.23 The end walls are mostly blind, except for a later window inserted into the south wall on the ground floor (Plate 14). Five windows in the east-projecting bay on the ground floor have been bricked up. The central of each side has a gable end. In the west-facing gable is a stone lined narrow slit window with an upper cusped foil.

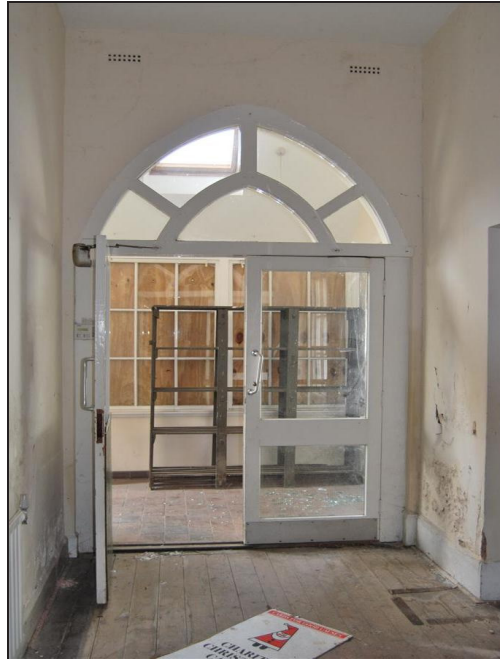
Plate 15: Doorway between Porch (Room 1) and Hall (Room 17)

- 6.26 There are two arched openings in the wall of the main building next to the new porch, and these represent two original doorways into the building. That to the south is boarded over but otherwise complete; the northern has been modified, leaving only a fanlight in the arch (Plate 15). The original elements indicate a doorway 1m wide with a panelled and semi-glazed outer register. The panelling is wood, and comprises a single rectangular panel with stopped rebates; one on each side. A narrow window spans the space between the panel and a rail that divides the door from the fanlight. The outer register continues around the edge of the arch, with three curved glass sections, whilst the centre of the fanlight is a single pane with a slight lancet effect. The southern doorway leads to a hall running east (**Room 6**) that also contains stairs to the first floor. The space under the stairs would

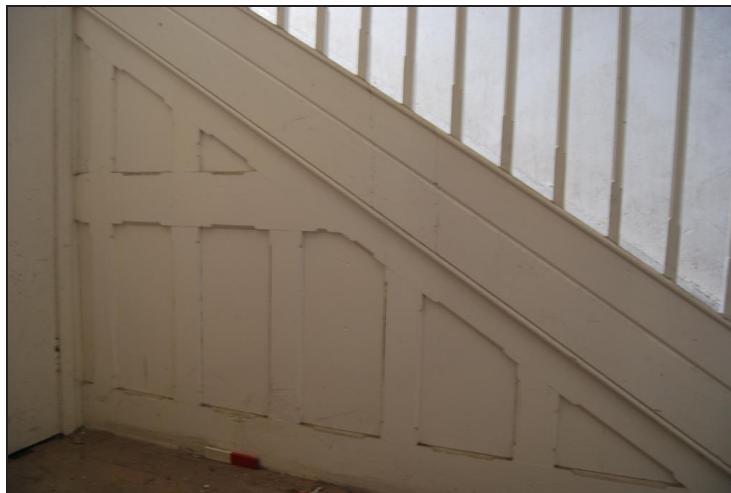
Plate 16: Panelling Around Staircase

have been used for storage. The side of the stairway are enclosed with panelling identical to that used in the doorway (Plate 16). The northern doorway leads to another, parallel hall (**Room 17**). The hall has a skirting board with only a slight chamfer to the top edge, and this is present in most rooms.

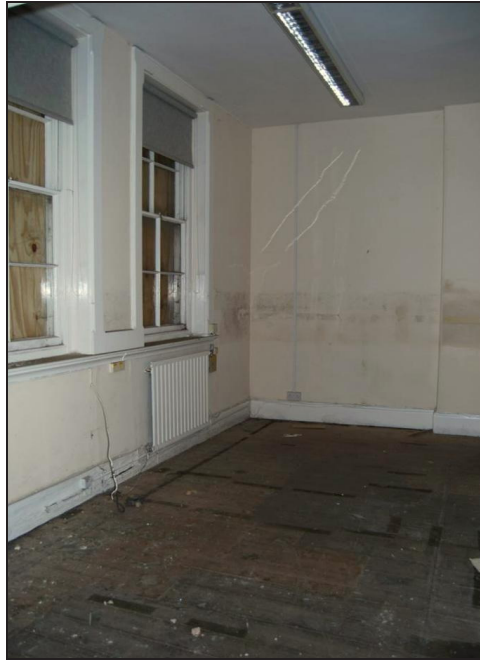
Plate 18: Room 2 Looking Northwest

- 6.30 To the north is a former ward with a blocked up fireplace, now divided into two rooms (**Rooms 2 and 3**) (Plate 18). The skirting and the windowsills have a concave mould on the underside. Apart from this, the rooms are plain. The south wall of one of the rooms (Room 2) has been almost fully removed, leaving it open plan from the hall. The eastern room has a serving hatch cut through its south wall. The new partition is semi-glazed at high level.

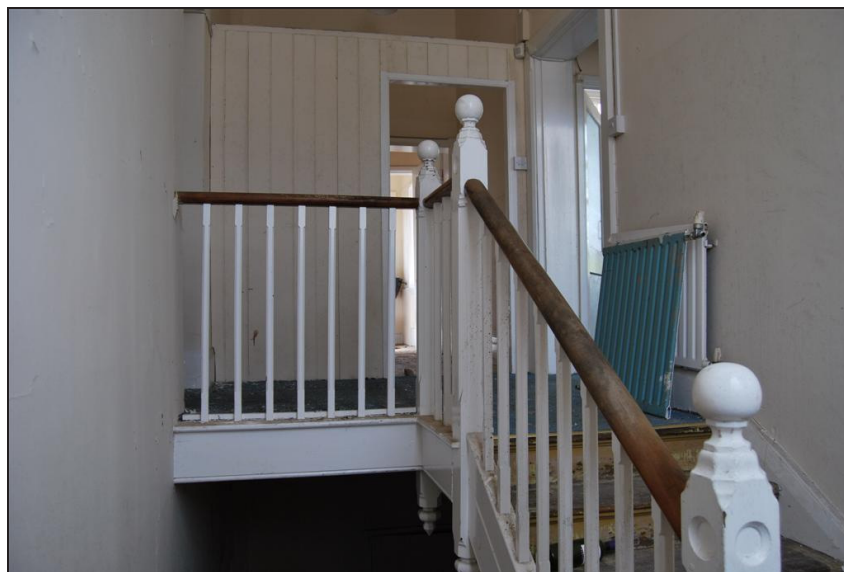
Plate 19: Room 9 From Stairway

- 6.33 The stairs land on a generously lit landing (**Room 9**), with wards to the north and south, washing and toilet facilities to the east and a nurses station behind a semi-glazed wooden partition next to the stairs. The banisters from the ground floor continue around the stairwell, and across the front edge of

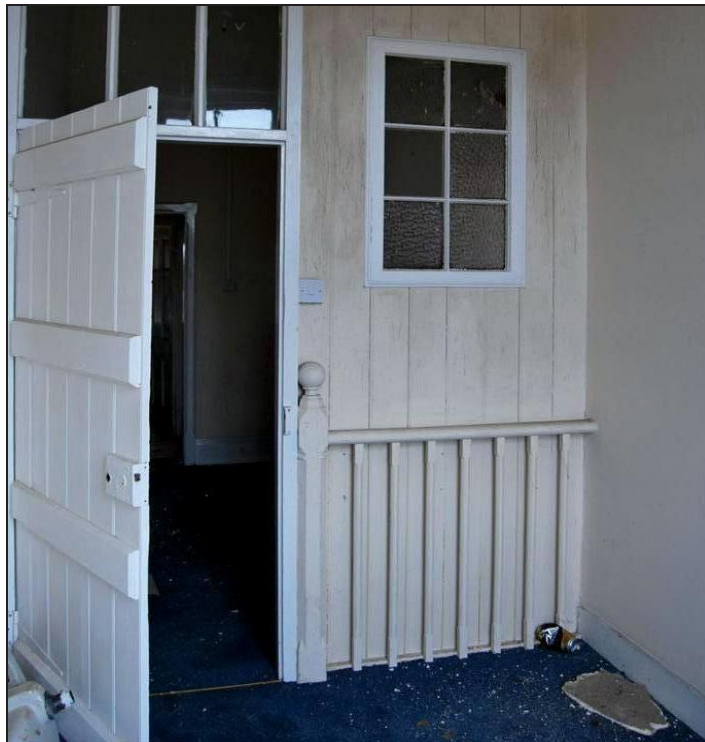
Plate 20: Nurses' Station

- 6.35 The room next to the staircase in the central west bay (**Room 12**) has an external window, and an inner wall constructed of vertical boards with a six-pane window erected over a stud frame which is additional to the build (Plate 20). The original space appears to have been an open, more approachable room, partitioned from the landing by a simple extension of the banisters and rail. There is no heating in this room, or signs that this was ever present. The only detail in the room is the skirting. The interpretation of this as a nurse's station is a deduction from similar hospital layouts found, including West Middlesex Hospital, High Wood Hospital Brentwood, and the form and function of the pavilion wards that developed out of the style of workhouse infirmaries. The door is boarded with four rails and strap hinges.

- 7.6 It was noted that the only other room in the infirmary with a fireplace is centrally located in the east side, and this is likely to have been the medical officers room. There may not have been a permanent medical officer: it is perfectly feasible that visits only every other day were carried out. Also of interest in the room above the entrance on the west side, which has been now enclosed, but was formerly open. This is likely to have been the nurses' station for the first floor, since both wards could be monitored from this central position. Opposite the nurses' station are two groups of bathroom facilities. Only one retains its partition: the other has been re-erected to enclose the former nurses station.

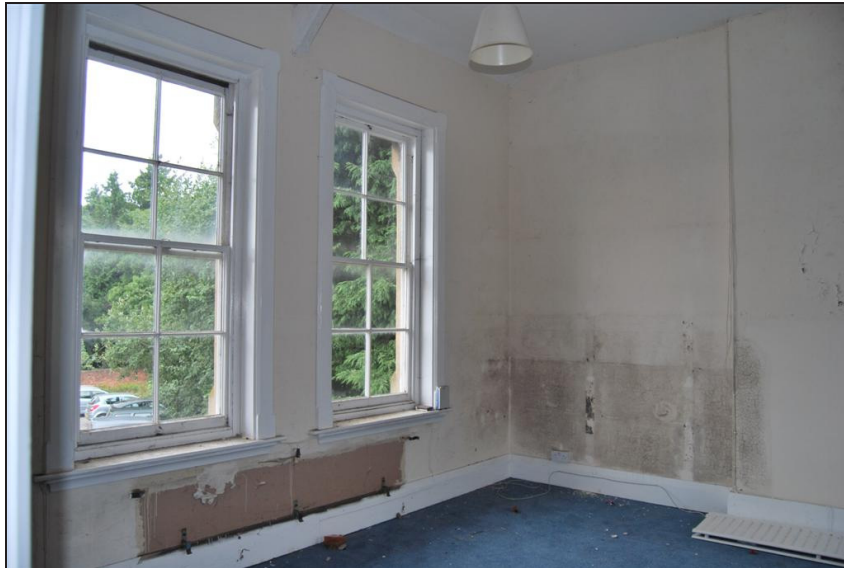
Plate 21: Room 13, Ward

- 6.36 The northern end of the first floor comprises a single large room (**Room 13**), which was clearly a patients ward (Plate 21). The ward measures almost 6m by 5m, with a chimneystack rising in the north wall: the fireplace is long gone and bricked up. The room is lit by two windows in each side, all four being large sash windows, which are remarkably efficient windows for air circulation. The underside of the internal windowsill has a narrow concave mould. The principal rafters rise from

slightly below the line of the ceiling, allowing space for common rafters laid on purlins to be jointed to a secondary wall plate. The typical skirting of the building is present here. The door is panelled, and the frame has a 45° chamfer with stops on each corner and lintel. This is common to all original doorways on the first floor.

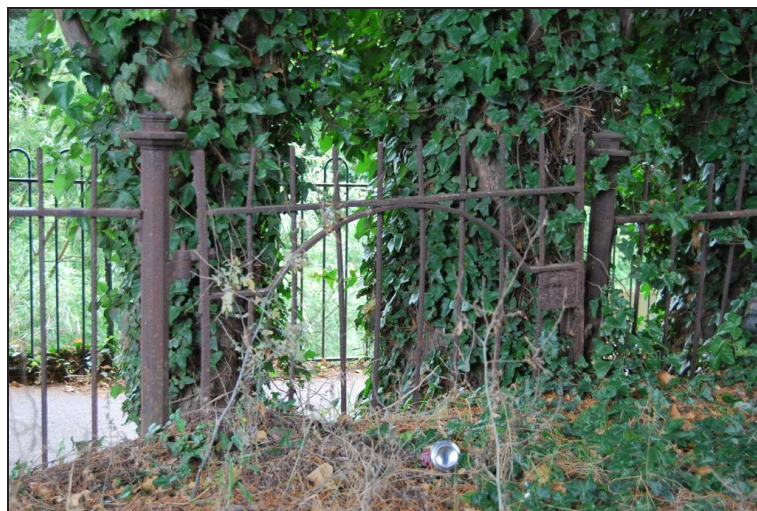
Plate 22: Fencing and Gate

- 6.38 One possible original feature is an iron fence along the northern edge of the workhouse grounds, next to a footpath adjacent to the River Teme. This survives in varied condition. The fencing is formed of panels between upright posts. The posts have an octagonal profile with a flaring cap and a

- 6.39 The iron fencing at the street front is in better repair, and of different style. These have spear-headed rail finials. The posts have an octagonal profile, and the top has a subtly stepped capital with a low peak above.

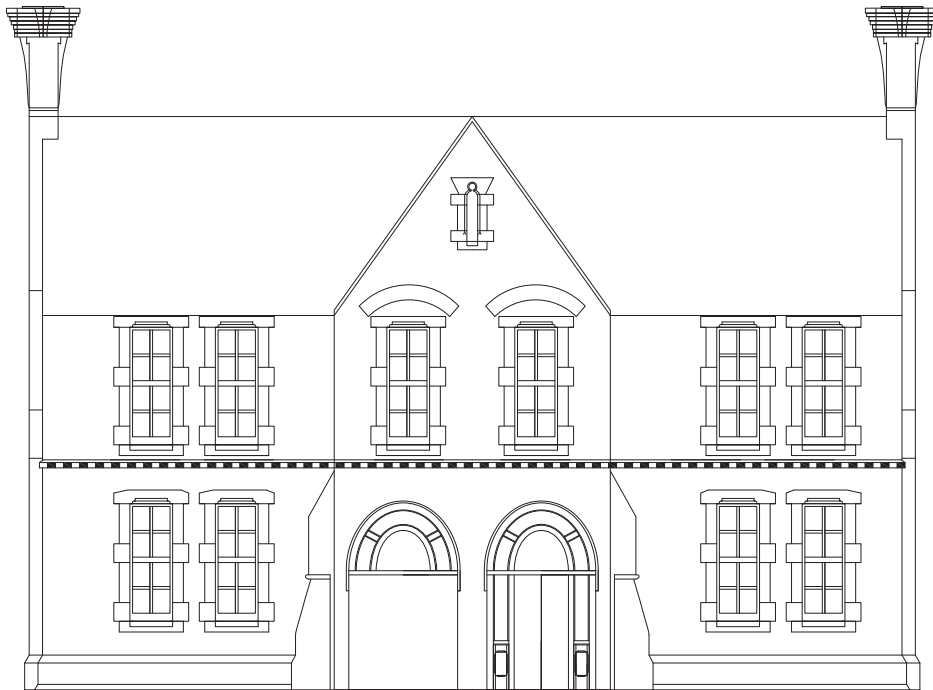
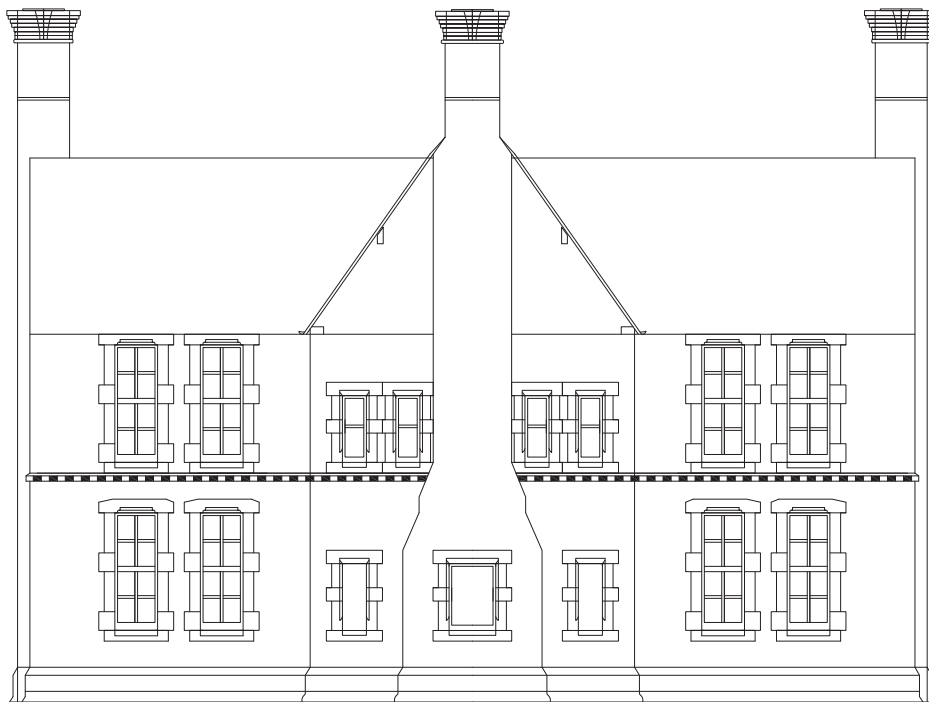
WEST FACING ELEVATION

EAST FACING ELEVATION
