Elgin Flood Alleviation Scheme

Watching Brief

Data Structure Report

AOC Project 21942

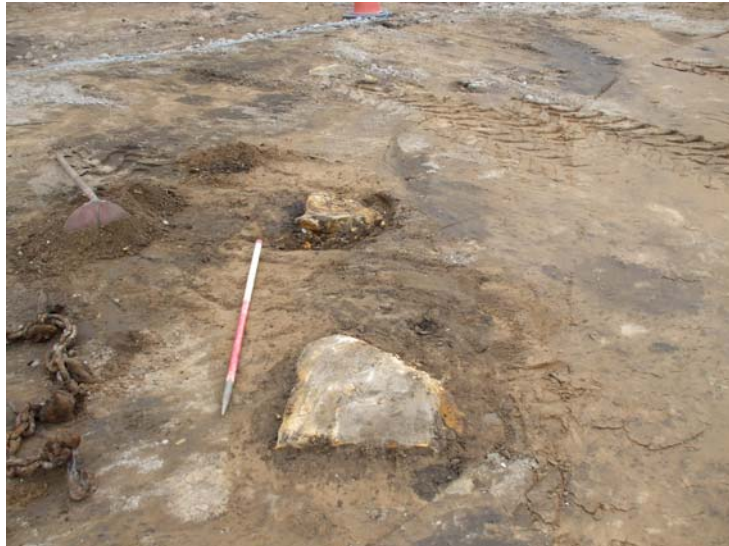
- 4.1.1 The topsoil stripping in this area was conducted intermittently between the 13th June 2012 and the 26th September 2012. Overall weather conditions were good yielding good archaeological visibility. Topsoil in the area was between 0.3 m and 0.6 m thick and consisted of a dark brown sandy silt sitting on a light brown clayey sand subsoil. Two parallel series of paired sandstone blocks [006] were placed into the subsoil running NE-SW towards the river. One of the pairs of blocks had a large iron chain within the cut around the stones (Plate 1).

Plate 1 - Paired sandstone blocks [006] with chain on the left

- 5.4 Further post medieval activity was noted in the Kingsmills area by the presence of paired sandstone blocks [006] running towards the river from the direction of the Iron foundry or Newmills (or vice versa). These blocks were most likely the foundations for a couple of long pipes running from the mills or foundry structures to the river. These pipes could have been for drainage of sewage or waste water, or possible chemicals used within the different works.

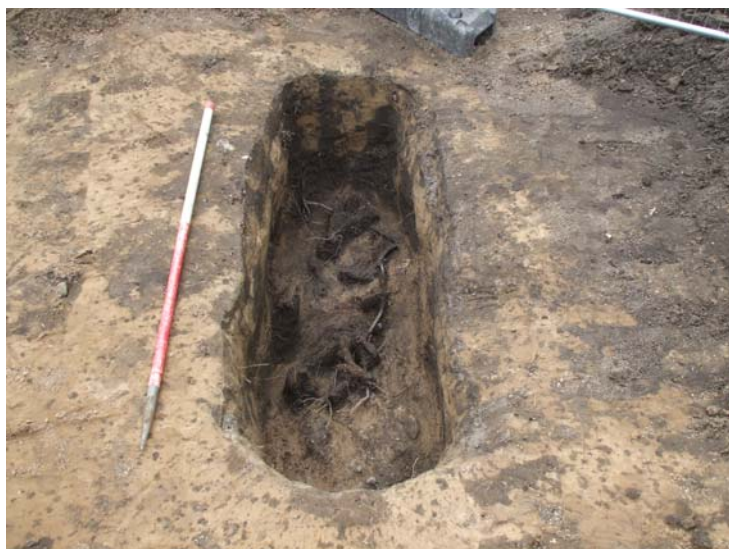
- 4.1.2 A grave cut [003] orientated SE-NW was revealed a few metres to the NE of the landscape bund at the rivers edge (Figure 2). The grave contained disarticulated skeletal remains [005] within a dark greyish brown sandy silt deposit [004]. The bones were very badly degenerated with only fragments of possible long bones surviving (Plate 2). A second cut [007] in the base of the grave suggests that the grave had been disturbed. White ceramic finds and a clay pipe stem from deposit [004] suggest that the disturbance and grave date to the post medieval period.

Plate 2 - View of grave [003] with disarticulated skeletal remains [005]

- 5.5 Moving away from the Industrialisation of the river bank, the grave [003] discovered in an isolated location out with a cemetery is an unusual find. The disturbance of the grave indicated by cut [007], suggests that the grave was of a later, post medieval date due to the ceramic finds and clay pipe stem within deposit [004].

- 5.9 In providing a date for the disturbance of the grave the ceramic finds from deposit [004] and the clay pipe stem in particular are of importance. They indicate that the disturbance of the grave was conducted at some point in the mid to late 19th Century. The stamp on the clay pipe stem fragment - "rns cutty" on one side and "'ray Aberde" on the other – refer to a Burns Cutty style pipe made by someone with the surname ending in 'ray' from Aberdeen. Using comparisons of other Burns Cutty pipes made in Scotland, this style appears to have been around from the 1840's to circa 1890's (Museum Victoria 2012). Using this evidence the burial can be tentatively dated to the mid 19th century. More detailed studies of the clay pipe stem and ceramics may help to narrow this date range further, however achieving a date for the burial would be most accurately achieved by using the skeletal remains.

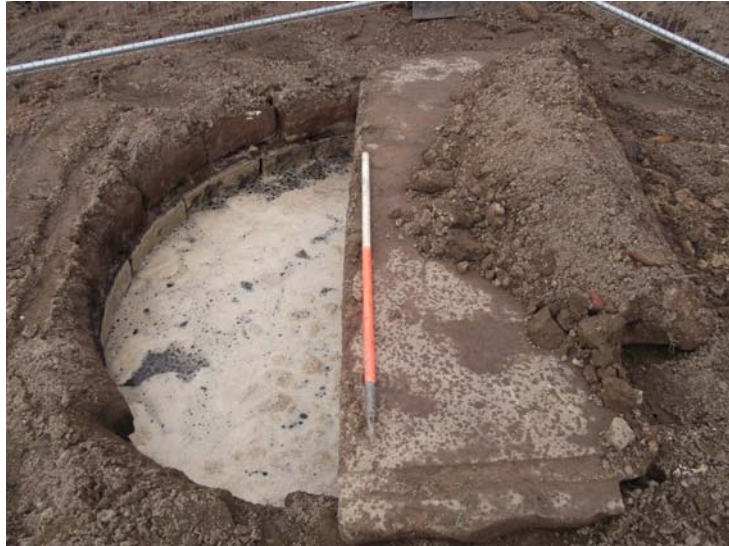
- 4.2.1 A small section of topsoil was stripped on the 26th September to the north of the previous excavation area at Deanshaugh Mill (AOC 2011). A circular stone capped well [011] (Plate 3) was revealed 2.5 m north of the previous excavations on the mill (Figure 3). It measured 2m in diameter and consisted of roughly hewn sandstone setts with two large sandstone slabs covering the top. The water level within the well was only 0.3 m below the top course of the well so further investigation was impossible. The well is to be preserved in situ.

Plate 3 - Well [011]

- 5.2 The discovery of the unmarked well [011] next to the previous excavations at Deanshaugh Mill added further information to the mill complex (Figure 3). As the well will remain preserved *in-situ* there was no requirement to investigate the feature further and due to health and safety reasons it would have proved hazardous to even attempt. Therefore how the well fits into the excavated remains and phases of the mill complex is not clear.

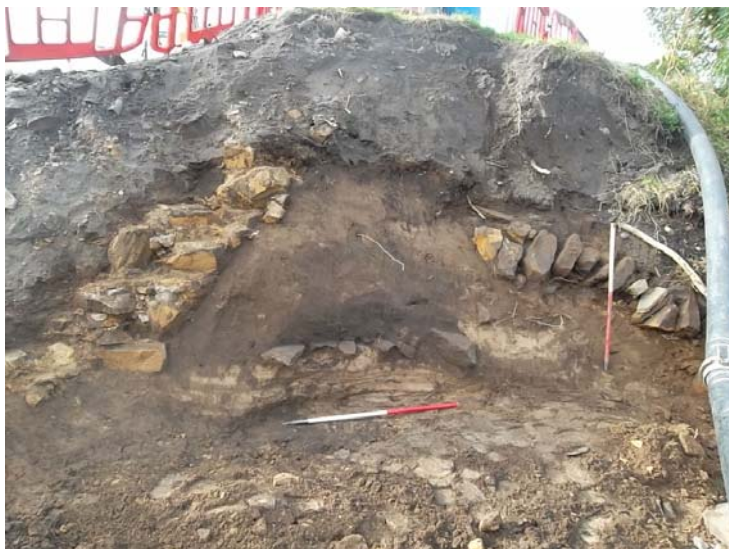
Plate 4 - Sandstone wall [012], bank [013] and stone facing [014]

- 4.3.2 Further monitoring was required when flooding in an area within the boundary of modern disturbance next to the bridge exposed some sandstone features along the river bank (Plate 4). A sandstone retaining wall [012] measuring 1.0 m high by 0.5 m wide was revealed 3.5 m from the rivers edge which was abutted by a man-made bank [013] with a sandstone facing [014]. The features would

have continued to run SE, parallel to the river if they had not been removed by the modern bridge. The features are to be preserved *in situ*.

- 5.3 Further down river, excavations and some unfortunate flooding revealed what was probably a very significant structure built in Elgin during the post medieval period: the earliest attempt at a flood alleviation scheme. The section of wall [012] and stone faced bank material [013] and [014] probably dates to around the end of the 18th century given that the Newmills mill and the Elgin brewery were constructed at this time (Hume 1967; Seaton 1983). It is reasonable to assume that when these Industrial buildings were erected that they would have required a means of restricting flooding close to their structures as well as allowing for the river to be channelled and contained for ease of use. Just as the modern alleviation scheme will do, this early river bank structure would have provided

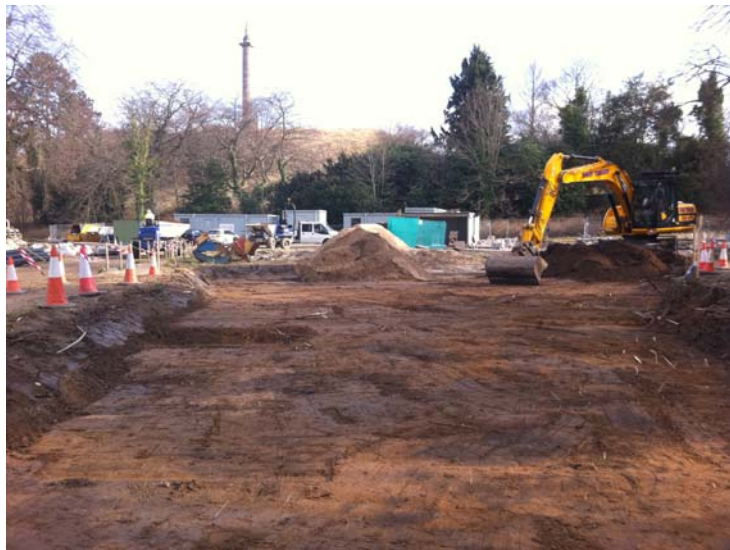
- 4.4.1 A small topsoil strip was required ahead of the construction of flood defences to the west of the Mansion House Hotel on 9th April 2013. The area had previously been covered by mature trees which had been felled and had the stumps removed. The topsoil was organic rich with lots of tree roots. The topsoil measured between 0.25 m and 0.35 m thick and lay over light orange/yellow coloured sands (Plate 5). No features or artefacts of archaeological significance were unearthed during the watching brief works.

Plate 5 - View of main area of watching brief

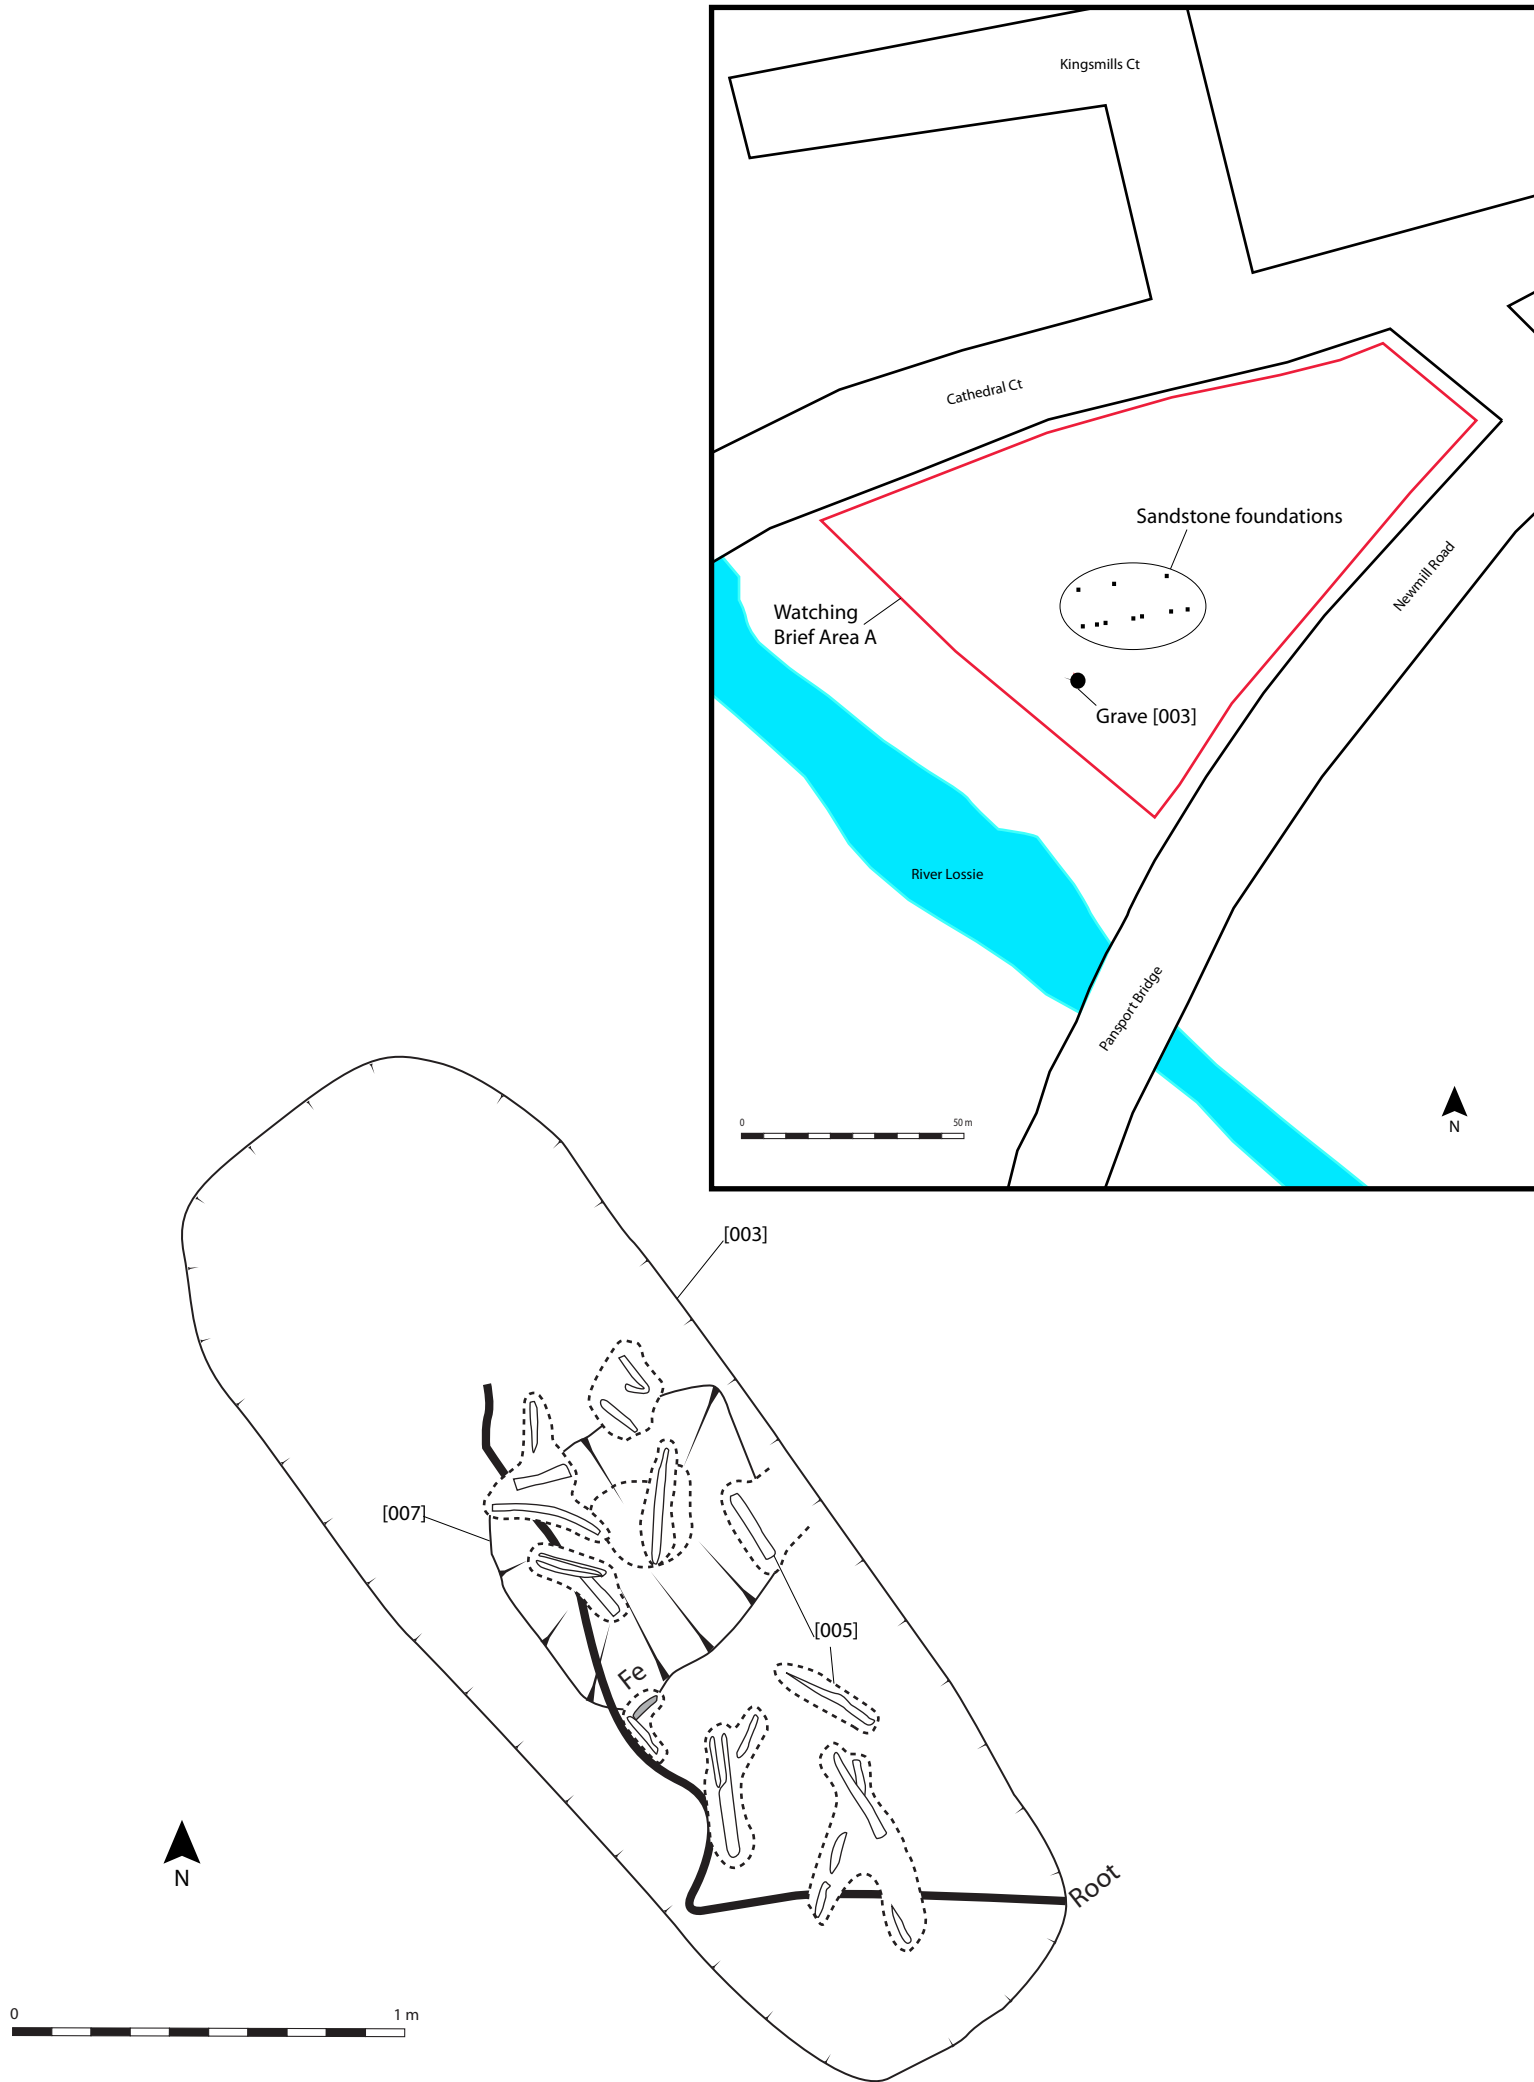
Figure 2 - Location and plan of grave [003]
