The Lamb Inn, Bilsham Road, Yapton, West Sussex: Historic Building Record

Planning Application: C3810/ A/ 12/ 2182107

AOC Project No: 32436

Date: September 2013

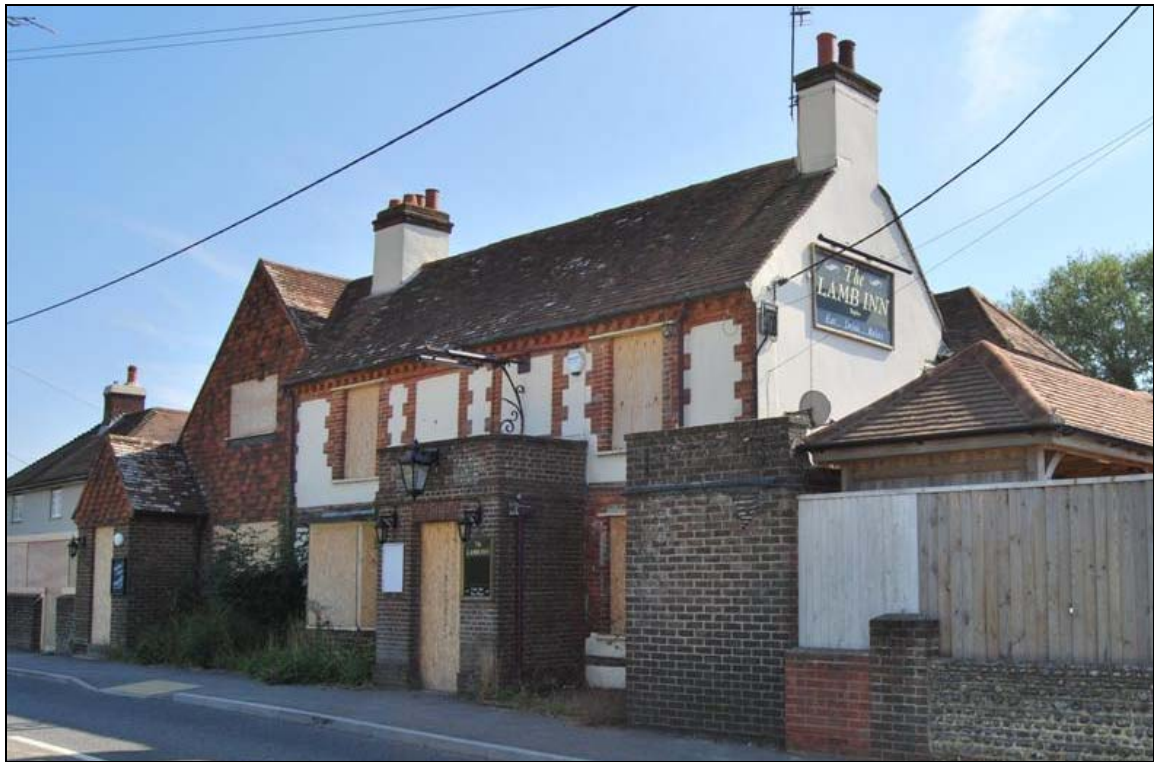
Plate 3: Lamb Inn, Looking Northeast

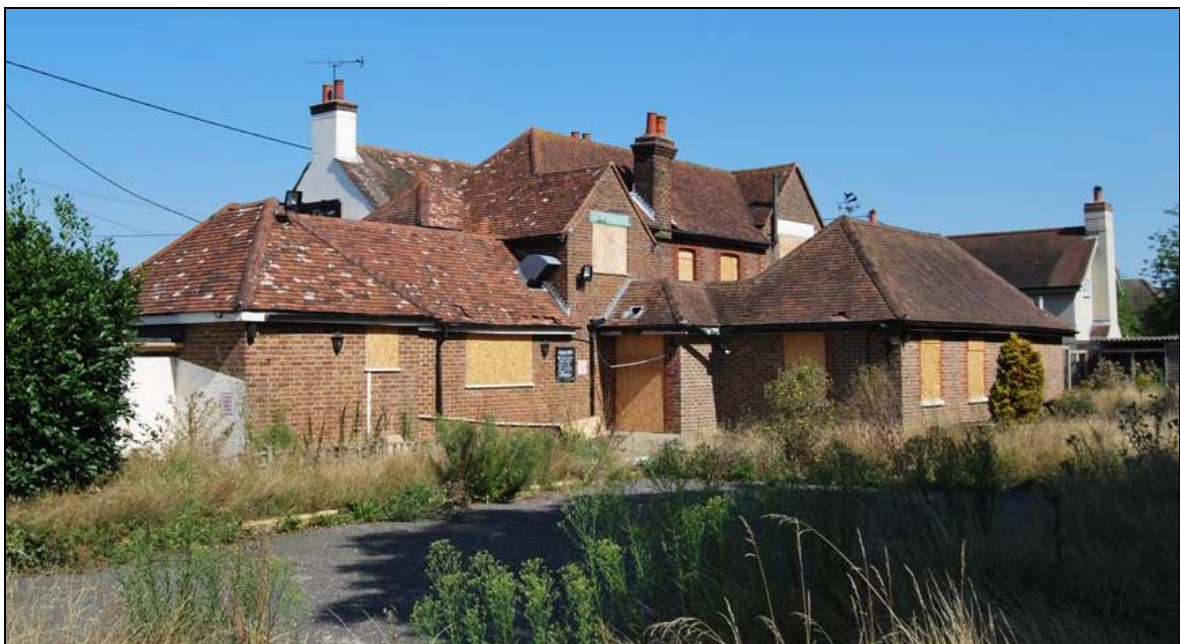
Plate 4: Lamb Inn, Looking Northwest

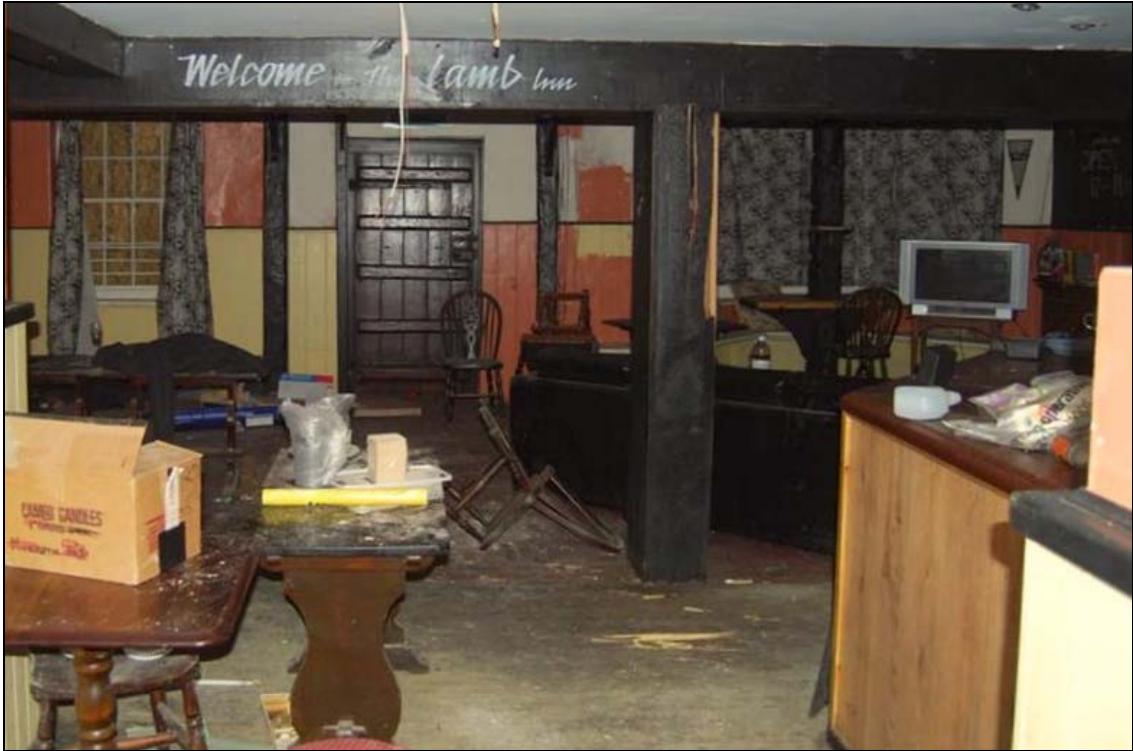
Plate 5: Main Bar, Room 3 Looking Northwest

- 6.6 Internally, the ground floor of the earliest phase (**Room 3**) is revealed by one fireplace, structural posts and beams, and a brick floor. Three upright posts along the northwest wall each support beams which span the ceiling (Plate 6). The opposing uprights have been removed, and the beams now are tied to a double steel I-beam. An additional principal rafter is visible in the northern part of the room. The posts and beams are thickly painted, but this has not obscured all detail. The posts appear sawn, and the arrises have been regularly chopped with an axe, to effect a fake aged look. The central of the three assemblies has a carpenter's incised letter V. Triangular brackets with axe-chopped edges have been added to the northwest posts, in an attempt to maximise the aged-effect.

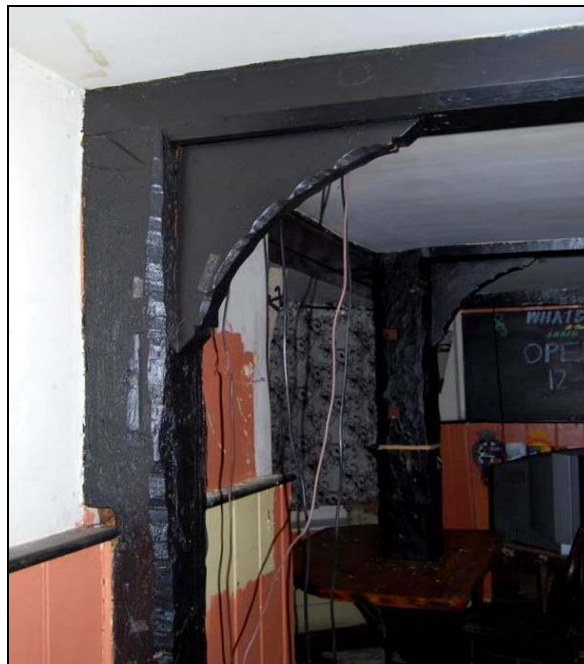
Plate 6: Detail of Post and Beam Assembly. Carpenter's Mark at Joint.

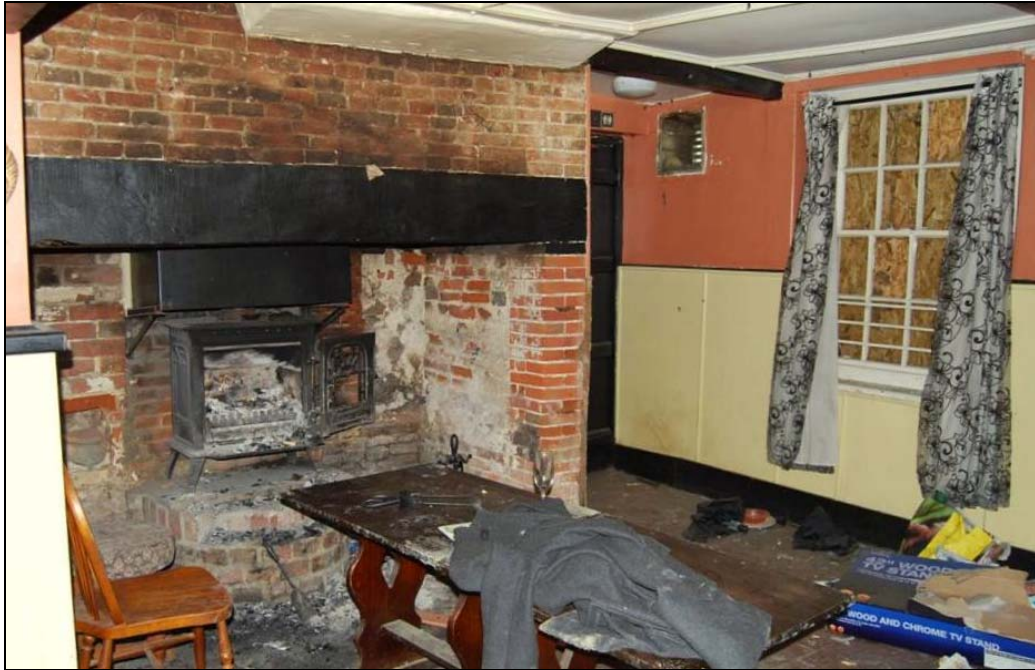
- 6.7 The room has a fireplace in each wall. That to the northeast is an early 20th century addition into the older chimneystack, and is constructed with a bullnose brick hearth and a fire surround featuring a poorly executed ogee arch. This replaces an original fireplace, which fell from use when a doorway was cut into an extension to the northeast (Room 4). One pier of the fireplace remains. The southeastern fireplace, however, shows much more historic fabric, and may indicate that this was the kitchen of the house that became The Lamb (Plate 7). The fireplace is made of thin bricks (8¾" by 4½" by 1⅞"). The opening is 2.00m wide, and spanned by a timber bressumer. To the rear of the hearth are two degraded and heat-worn recesses, which may be the remains of small domestic ovens. The current grate stands upon a later semicircular brick plinth.

Plate 7: Southern Fireplace, Looking Southwest, Room 3

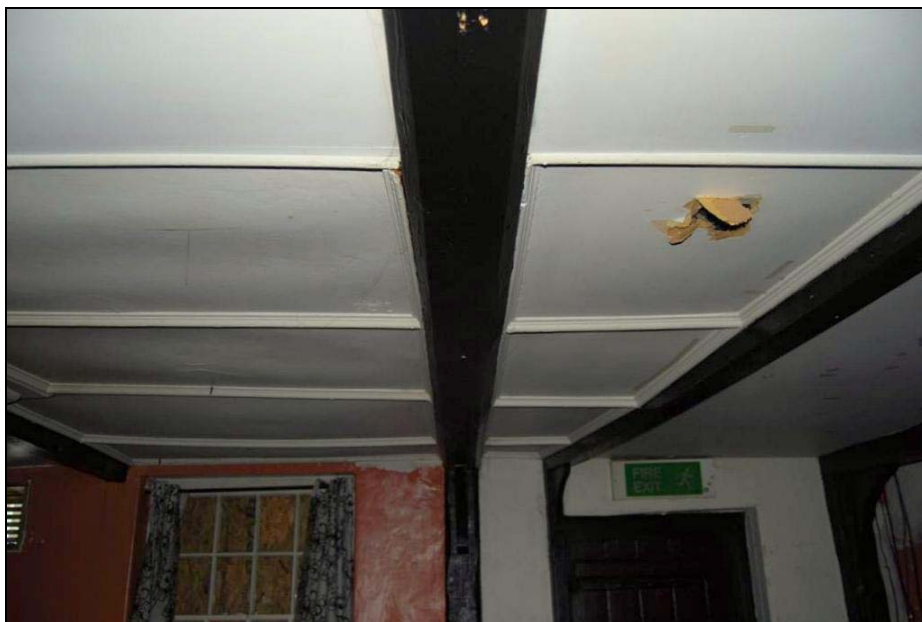
Plate 8: Ceiling Detail, Room 3

- 6.8 In the southern part of the room, a beam across the ceiling is at 10° to the angle of the main beams (Plate 8). This beam potentially marks the location of a ground floor dividing wall that has been

removed. To its south are a series of mouldings, giving the effect of a panelled ceiling. There are no signs of the location of an original staircase to the first floor.

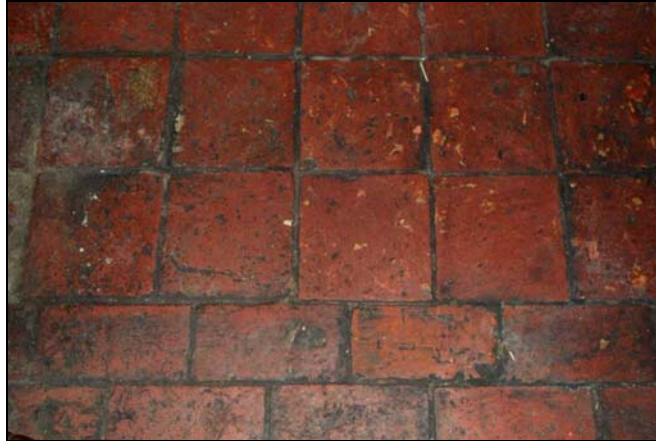
- 6.9 The floor comprises bricks of the same dimensions as the front wall. The layout of the floor varies either side of the line of the 10° angled partition. The bricks next to the supposed kitchen fireplace are laid parallel to it, whilst beyond, the bricks are laid in rows lengthways along the building. These are worn, but few show signs of being cracked. Next to the bar is an area of 6" red floor tiles, which may be a repair of an area prone to wear (Plate 9).

Plate 9: Sample of Brick and Tile Flooring

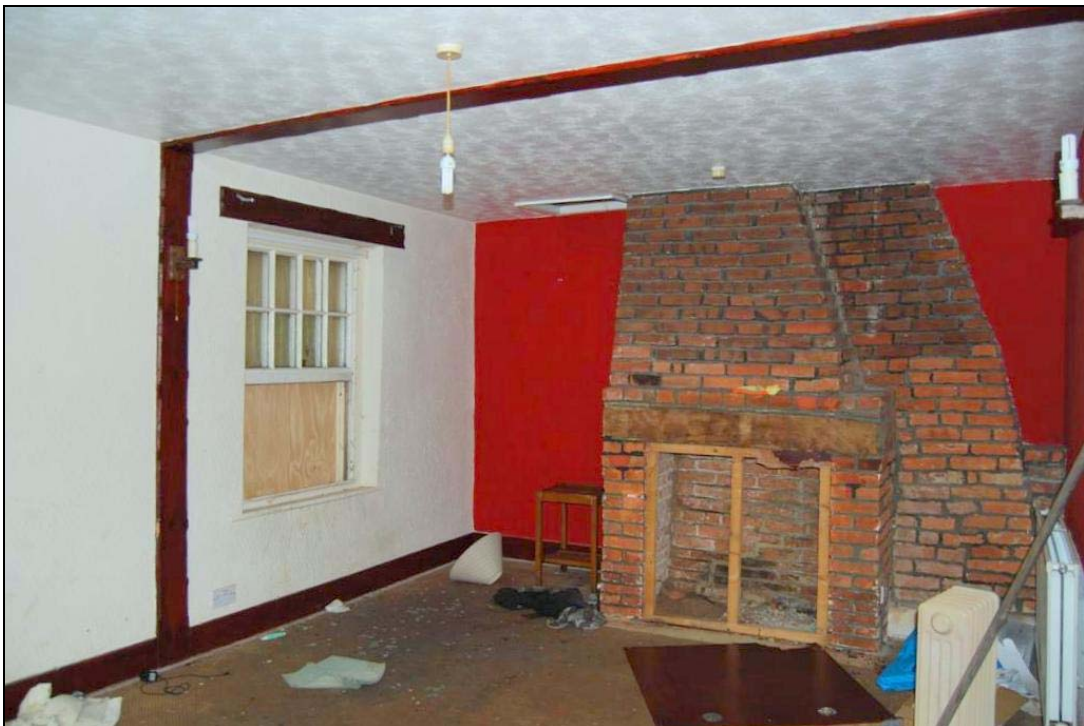
- 6.10 The first floor of the building now comprises a single room with a wide chimneystack at each end, the width created by a parallel flue rising from the ground floor in each case. The room (**Room 15**) is accessed from either of two doors from a landing along its southeast side, the landing part of the second phase addition. These doorways are also later. In the front wall of the room are two sash windows, part of the original build. In the southeast wall, next to the doorways are a pair of blocked openings, filled by studs and lath and plaster, which represent infilled windows.

Plate 10: Room 15 Overview, Looking Northwest

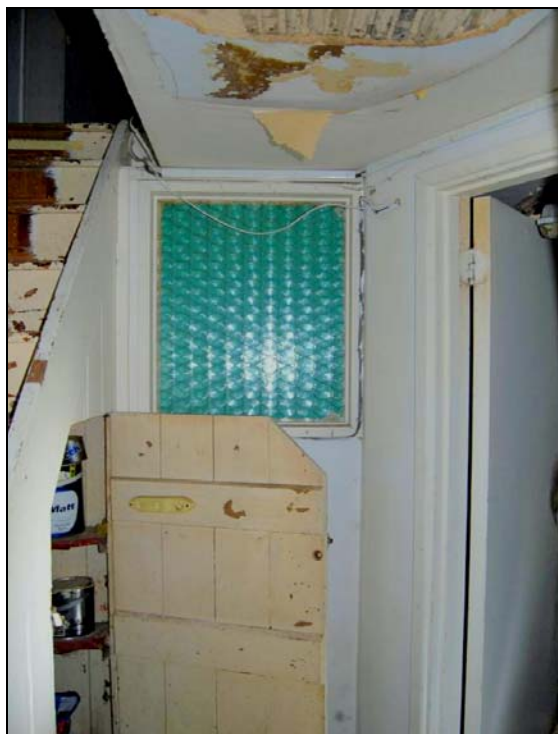
- 6.14 The new staircase is in a brick extension to the southwest, measuring 3.25m by 2.4m (**Room 6**). This room has a new external door to the southwest in a modern frame. The stairs rise to a short landing then northeastwards to the first floor. Some light is provided by a semi-glazed partition from the bar. The ceiling is lath and plaster, the staircase is enclosed behind plain boards. The east corner of the bottom of the stair hall has been removed during a later phase (Plate 11).

Plate 11: Panelled Edge of Stair, Room 6

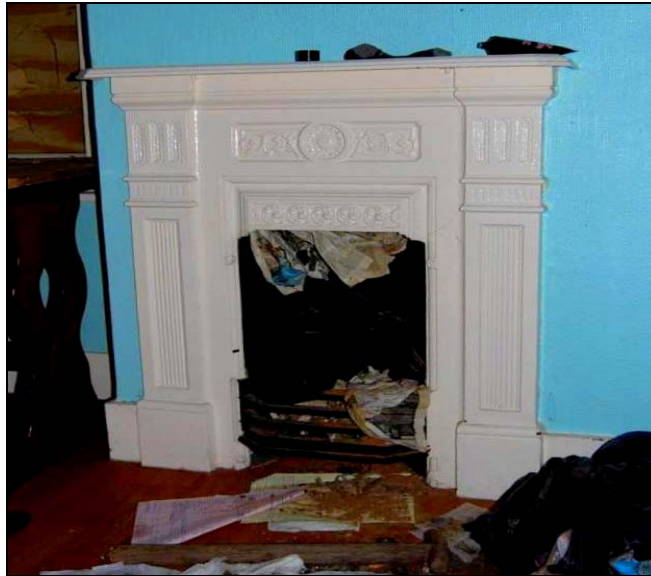
- 6.15 The first floor comprises a landing, two rooms, and a toilet above the stairs. The landing (**Room 7**) runs adjacent to the first phase block, with a recess marking the southern of two blocked windows. It has a short dogleg to a toilet, situated above the stairs (**Room 8**). The largest of the group of new rooms (**Room 11**) has a chimneystack in the external wall, flanked by two windows. Both windows are sash windows, with two panes in each section. The room has a skirting board with upper chamfer and a simple picture rail with a roll mould at the top and bottom. The room's main architectural detail is the fireplace (Plate 12). The fireplace is a typical post-1870 fireplace with classical pilasters and incised triglyphs elements and a floral motif across the mantel's frieze.

Plate 12: Fireplace in Room 11

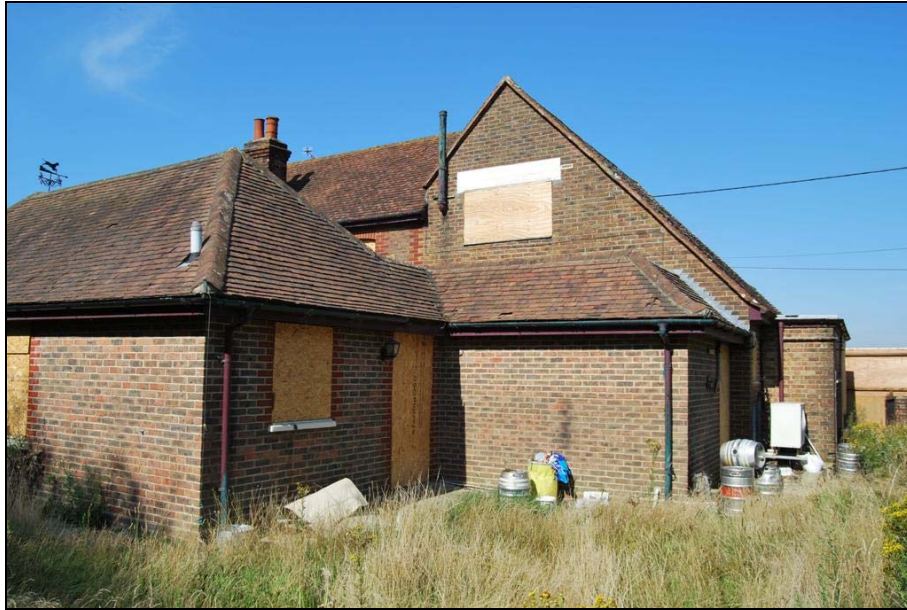
- 6.18 The building was extended northeastwards with a two-storey block containing two rooms plus toilet facilities on the ground floor, and two rooms on the first floor. Access to both floors was provided by breaking through the end walls of the previous phases. The floor levels are higher than the rest of the building, due to the natural topography rising at this end of the site. Two steps on the ground floor and three on the first floor are present. The extension has a tile-hung gable facing the road and stock brick to the rear (Plate 13). The roof is a catslide roof down to ceiling level on the ground floor. Each window is a casement window.

Plate 13: Phase 3 Extension and 20th Century Additions, Looking Southwest

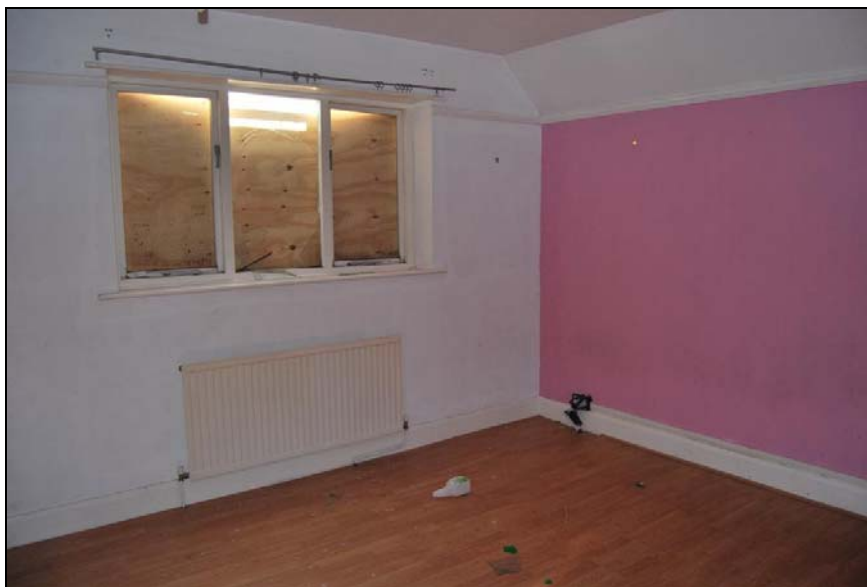
Plate 14: Room 13 Looking Southeast

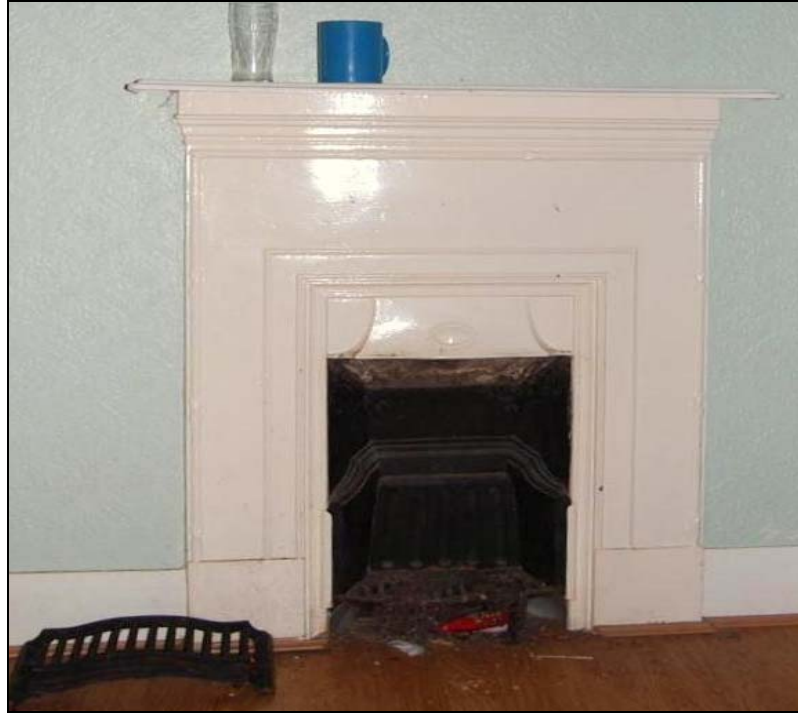
- 6.21 The first floor rooms are accessed from the end of the landing. The rooms are equal in size and both have cupboard space in the eaves. The northern room (**Room 14**) has a fireplace backing onto the chimneystack of the first phase (Plate 15). This is a late 19th century fireplace, and is quite plain in comparison with that in Room 11. It has simply moulded straight incised lines around the sides and top of the mantel, and around the opening for the grate. The hood bows out slightly with an arc incised on either side. The southern room has no fireplace.

Plate 15: Fireplace, Room 14

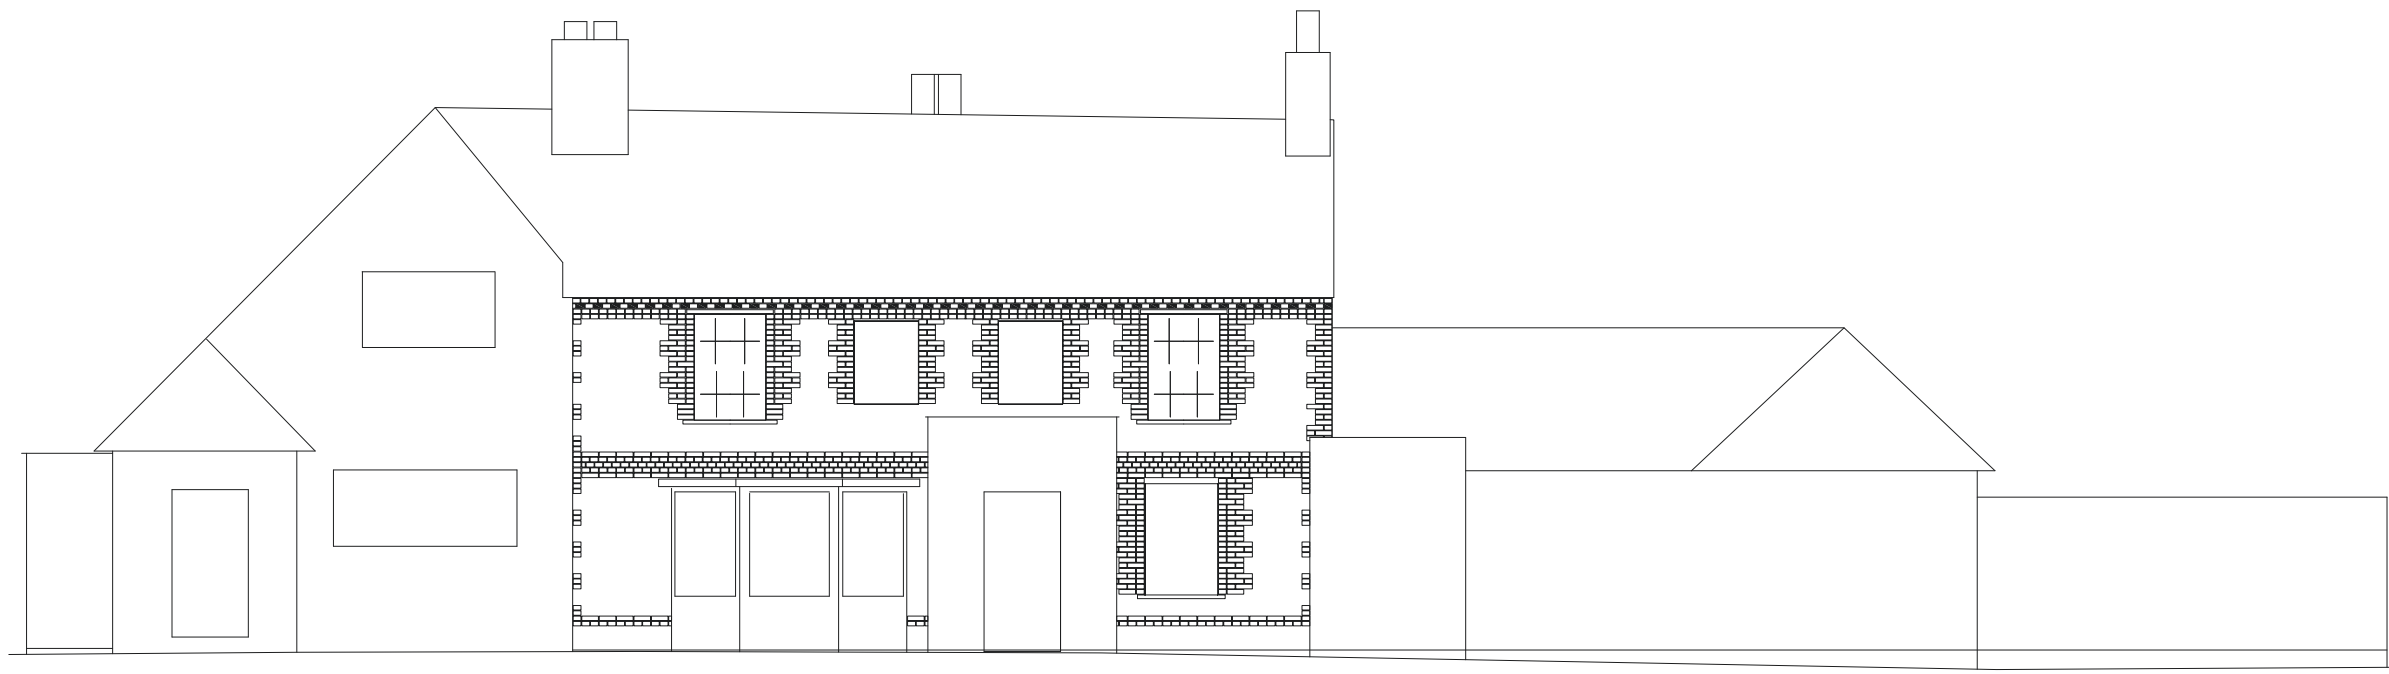
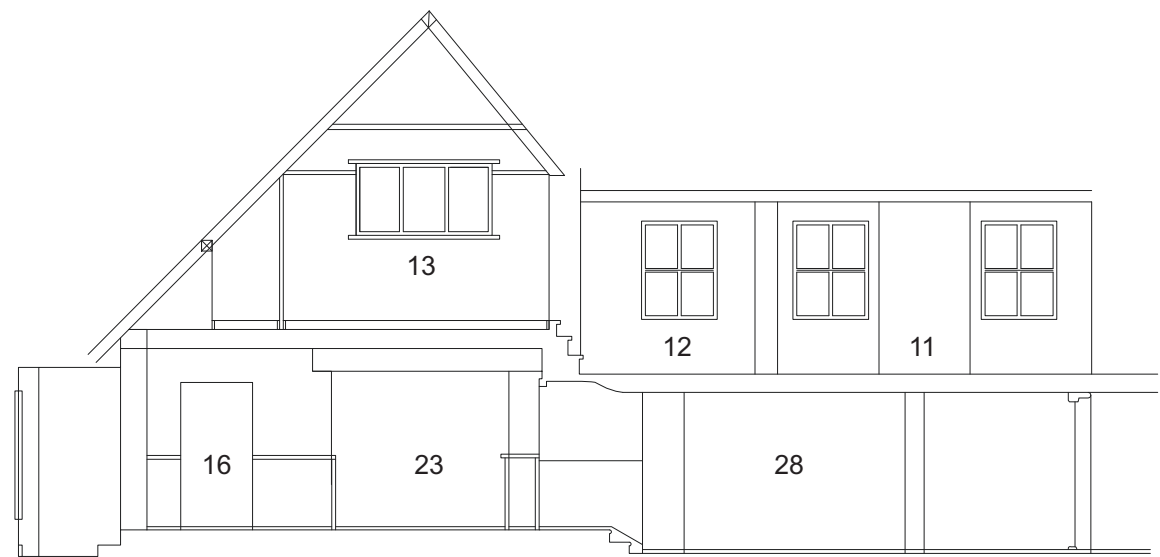
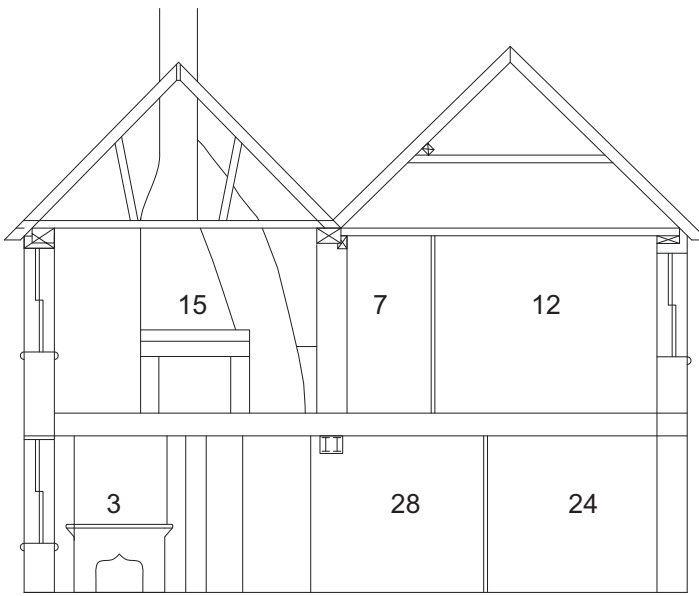
Figure 5: Northwest Elevation and Profiles through Building

NORTHWEST ELEVATION: Phase 1 in Detail

PROFILE 1

PROFILE 2
