Nos 157 – 159 Lanark Road West, Currie,  
Edinburgh

Historic Building Recording  
& Archaeological Evaluation Report

AOC 22510  
23<sup>rd</sup> October 2013

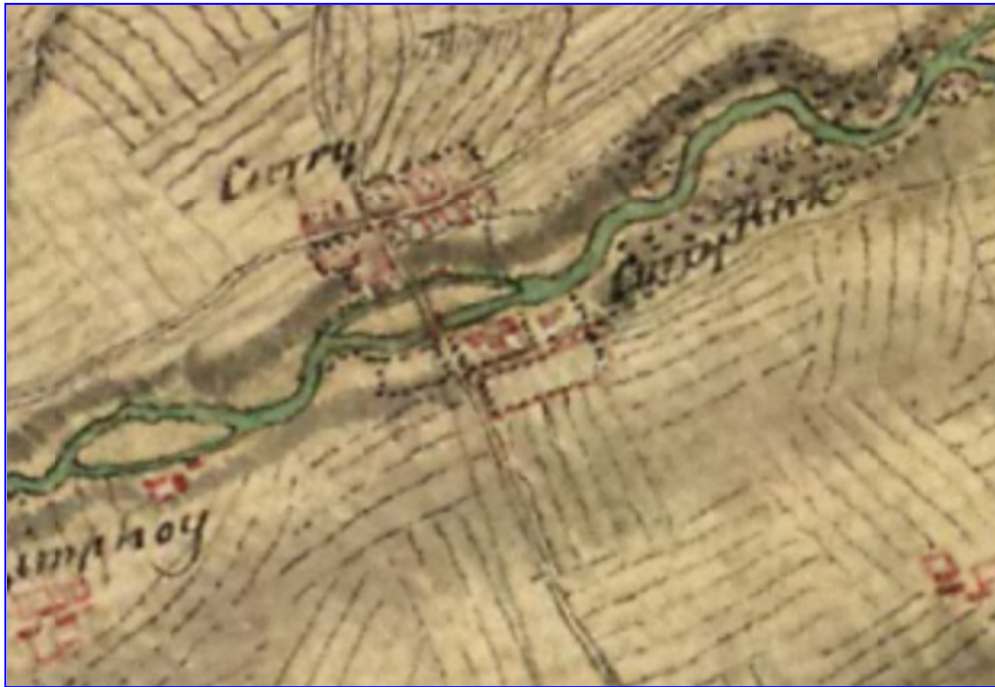
Figure 2: Extract from William Roy's Military Map of Scotland, ca 1747 - 55

- 4.2 By the early 17<sup>th</sup> century, Currie had established itself as a small farming community. William Roy's Military Map of Scotland dating to 1747 – 55 also details the settlement at Currie in the mid-18<sup>th</sup> century ([Figure 2](#)). Currie has been established around the main east/west thoroughfare (to become Lanark Road West) with Currie Kirk to the south in enclosed land.

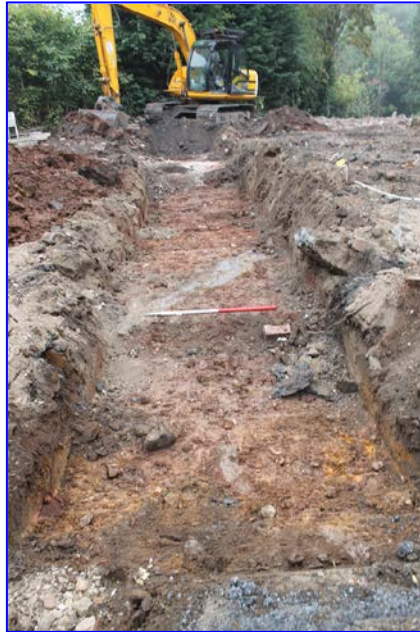
Plate 22: General view of Trench 1 from the north-west

- 6.1 The archaeological evaluation comprises two trenches located to the north of the development area, both of which had a large amount of hard-core and rubble (between 0.30m – 0.50m in depth) overlying a compact dark orangish stoney clay natural subsoil (Figure 11; Plate 22). Towards the south end of the trench, the hardcore became deeper where the ground sloped downwards to the south. A single concrete wall was located to the north of Trench 1 and to the south was the brick enclosure for the modern drainage (not excavated).

- 7.3 After the demolition of the buildings, the ground appeared to comprised mostly rubble and hardcore build-up, becoming deeper to the south, overlying natural subsoil. No archaeological features or finds were located and therefore it is recommended that no further archaeological works are required, although this must be confirmed by CECAS.
