Mansfield Road, Balerno, Edinburgh: Archaeological Evaluation Data Structure Report

AOCarcha1-160275
AOC Project 22403
30th September 2013

Archaeological Evaluation Data Structure Report

AOC Project No: **22403**

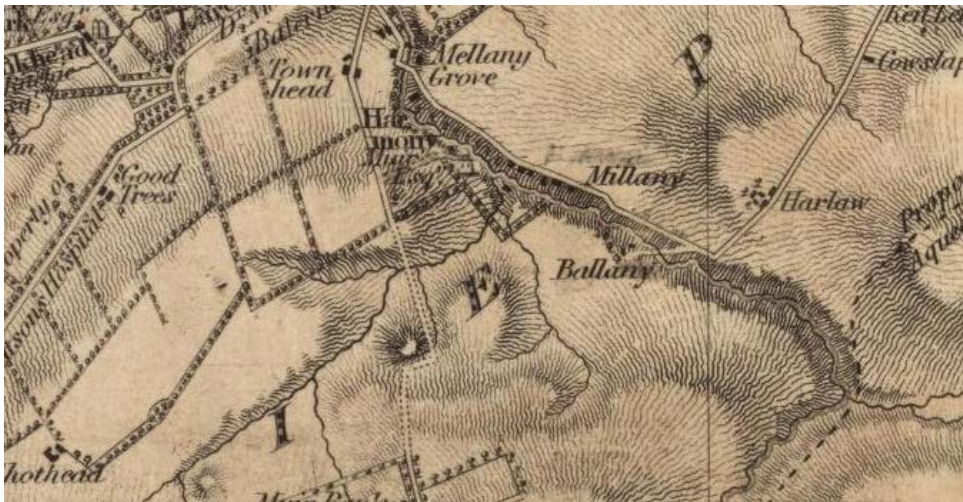
Figure 3: Extract from John Thompson's Atlas of Scotland 1832

Atlas of Scotland which shows only agricultural land and with burn crossing the development area. By the mid 19th century and the 1st Edition Ordnance Survey Map, (Figure 3) a 'Tile Works' has been built and a north to south track been constructed. It is probable given the need for water at a 'Tile Works' that the stream shown on the earlier map may have been to some extent canalised and follows the line of the track. The map shows one large structure and possibly a smaller second building to the north. Even a small estate tile and brick works would require at least two if not more buildings with a kiln and drying room prerequisites. It is also likely that the works would have been sited to take advantage of immediately accessible clay so it is likely that clay extraction pits maybe found close to the manufacturing site.

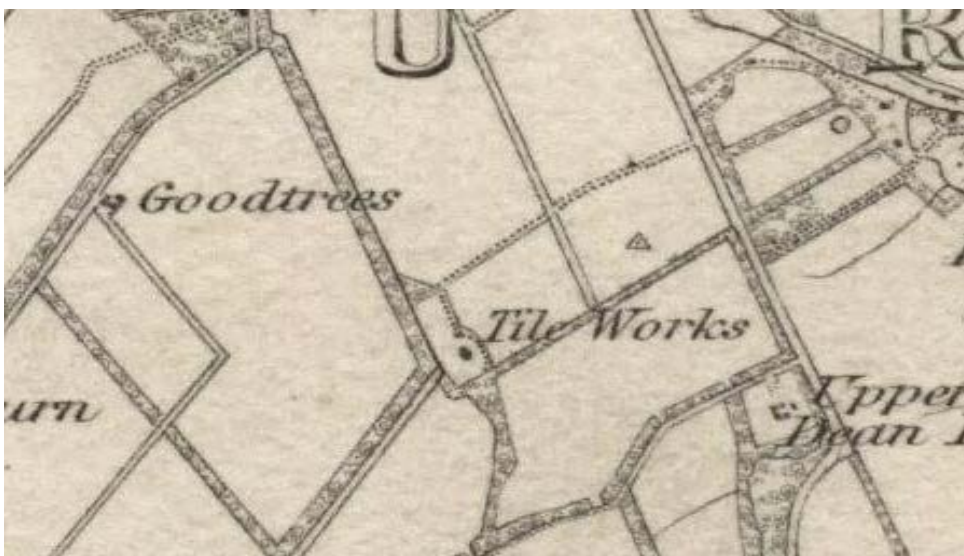
Figure 4: Extract from 1st Edition OS Map

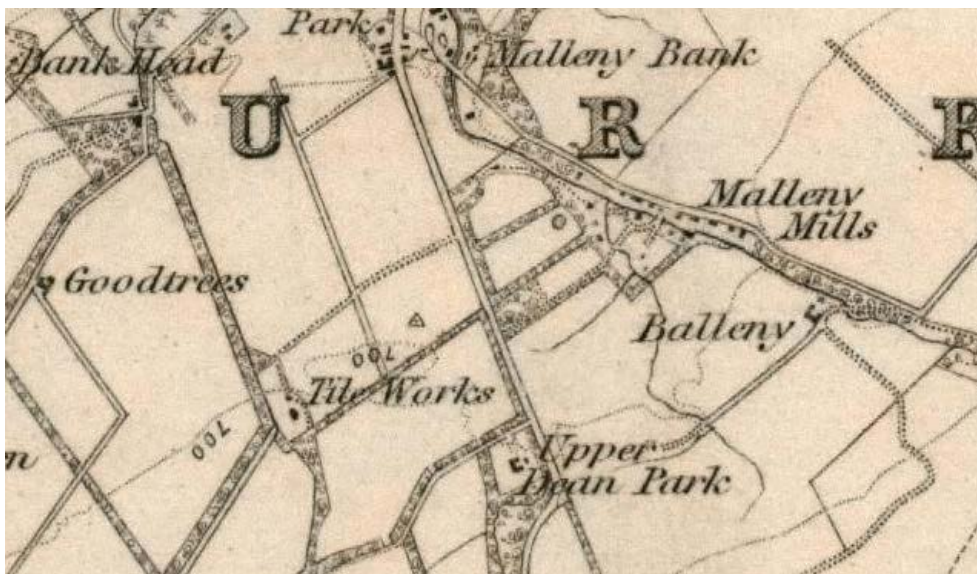
Figure 5: Extract from 2nd Edition Ordnance Survey map 1891

- 1.3.3 The 'Tile Works' were shown on the 1891 2nd Edition Ordnance Survey map, (Figure 4), demonstrating that the building was standing for numerous decades though by the 1901 3rd Edition Ordnance Survey map (Figure 5) the buildings were not depicted though the track that serviced the works is still extant.

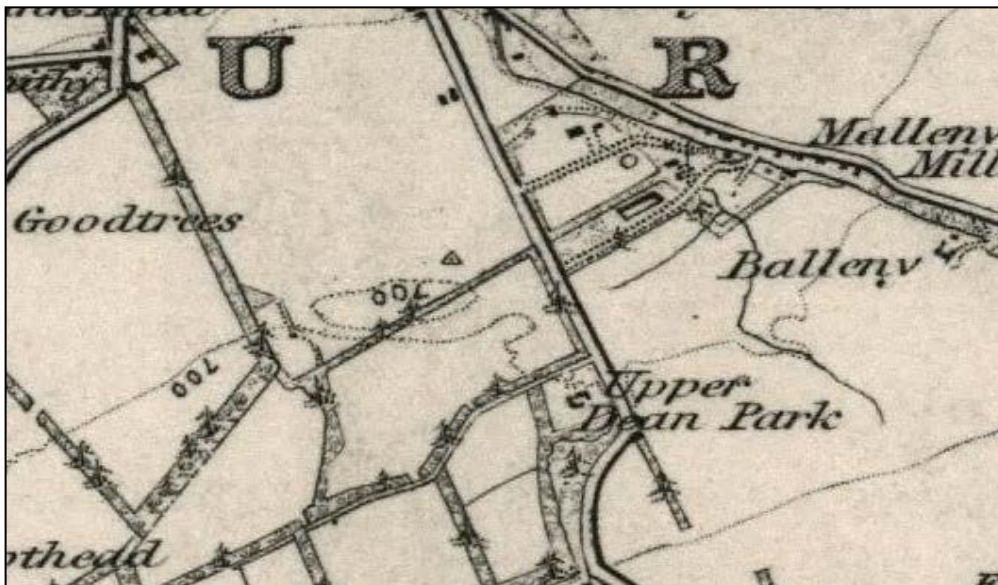
Figure 6: Extract from 3rd Edition Ordnance Survey map 1901

- 4.4.3 A further large anomaly was encountered along the existing track-way shown running north to south (figures 4-6). This may relate to the 19th century tile-works. The evaluation trench (Tr. 43) revealed a large area of disturbed sub-soil. This may represent the extraction of underlying clay deposits for the tile-works or the truncated and ploughed out area of the building itself.
- 4.4.4 Further evaluation of the tile-works area was restricted due to the presence of crossing over-head power-lines. Numerous fragments of clay tile were observed within the plough-soil. The present farmer Mr Fleming stated that a number of structural remains had been ploughed out over the years. Given the shallow nature of the top-soil, and the heavy plough-scarring encountered across the rest of the site, it is likely that all existing traces of the structure have been removed.

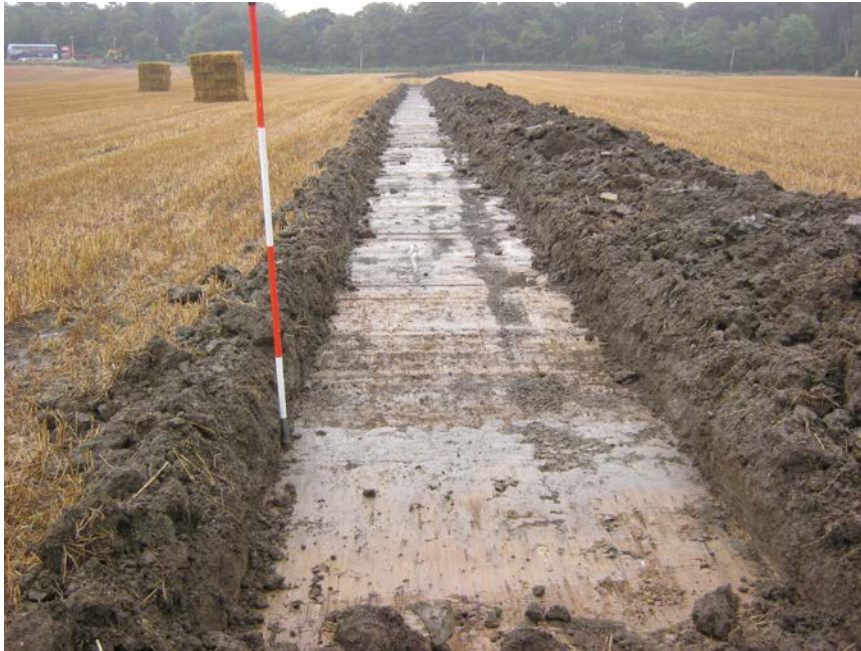
- 4.3 **Field A (Eastern Field)**
- 4.3.1 Trenches 1 – 32 were excavated within Field A. the trenches revealed a relatively shallow clay plough-soil ranging from 0.20 m to 0.50 m in depth. The top-soil had been heavily improved with numerous modern ceramics being observed. The top-soil overlaid a plough-scarred clay sub-soil. A natural hollow ran across the north-east of the site and contained a red-brown colluvium of sandy silt. This ranged from 0.10 m to 0.20 m in depth. The evaluation trenches crossed many of the proposed archaeological features recorded in the Geophysical Survey and revealed that these were in fact rubble drains and stone-holes related to modern farming methods. No archaeologically significant material was recorded.

Plate 1: Trench 1 showing shallow top-soil

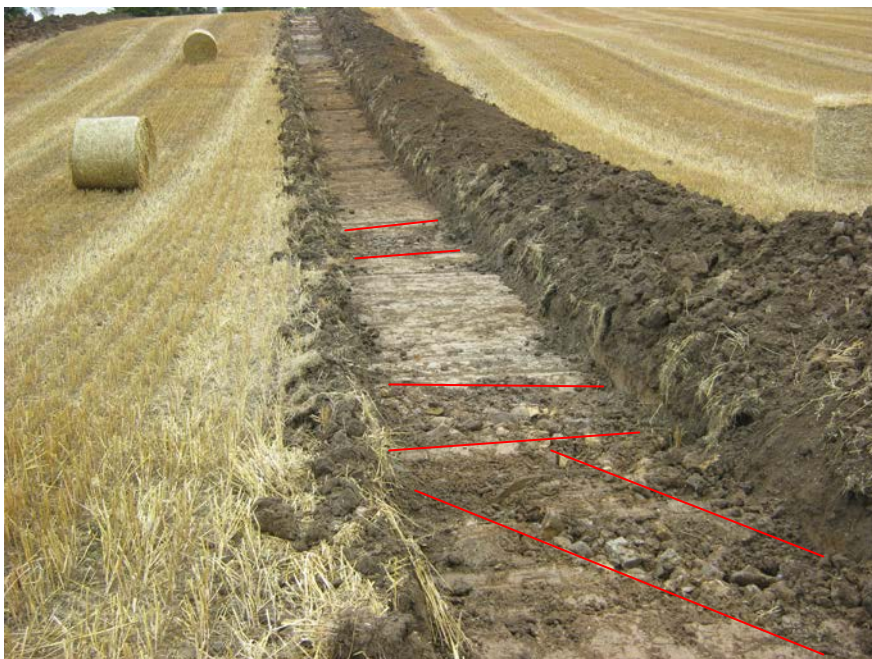
- 4.4.1 Field B contained the trenches 33 – 56. These trenches were again positioned to target the findings of the Geophysical Survey, in particular the position of the apparent double rectilinear enclosure and former tile-works. As within Field A the evaluation trenches revealed a relatively thin, clay plough-soil 0.30 m to 0.50 m in depth. This appeared particularly mixed with re-deposited sub-soil in the southern end of the field.
- 4.4.2 A substantial natural hollow occurred within the south-west of the field. The southern contours of this appeared to respect the general form of the positive anomalies revealed during the Geophysical Survey. The evaluation trenches 38, 39, 40 & 53 were therefore placed across this area. The trenches revealed a number of substantial rubble drains up to two metres in width. These modern features correspond with the position of the positive anomalies.

Plate 2: Trench 39 showing large rubble drains
