Altbreck Broch, Dalchork Archaeological Survey Report

Archaeological Survey Report

National Grid Reference (NGR): NC 5911 1035

AOC Project No: 22483

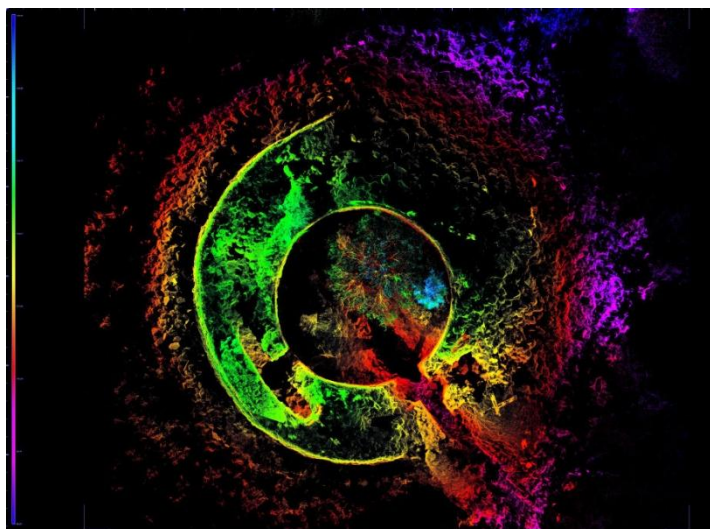
Figure 2a: Sallachy broch, Loch Shin (scan by AOC Archaeology Group)

7. Altbreck broch is one of several such monuments found around the Loch Shin area. Sallyhoy broch, on the W shore of Loch Shin, was laser scanned by AOC Archaeology Group in 2007. This latter broch differs in form in being solid-based, though the dimensions of the wall and general character of the setting are similar to Altbreck (see Figure 2). In the immediate vicinity of the broch is Altbreck 'homestead' (Figure 1), a small enclosure located to the SE of the broch and of unknown date. The site has been considered to be of potential prehistoric date, but on the basis of the observable upstanding remains an historic date seems equally plausible. Both Altbreck broch and the homestead are Scheduled Ancient Monuments (broch: SAM 1829; homestead: SAM 5563).

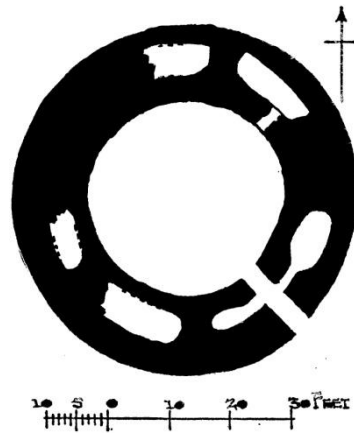
Figure 2b: RCAHMS Survey of Altbreck.

5. Altbreck Broch was noted by the RCAHMS in the 1911 inventory, and the features of the monument recorded at that time (RCAHMS, 1911). The RCAHMS recorded the monument as having an entrance on the SE, guard cells on either side of the entrance passage and four other intra-mural galleries. The RCAHMS recorded the site as standing to 1.2m in height, a similar level to which the site can be seen surviving today, although as discussed by Barber (see Appendix) there are grounds for suggesting that further depletion has occurred within the last century, obscuring some previously-visible features.

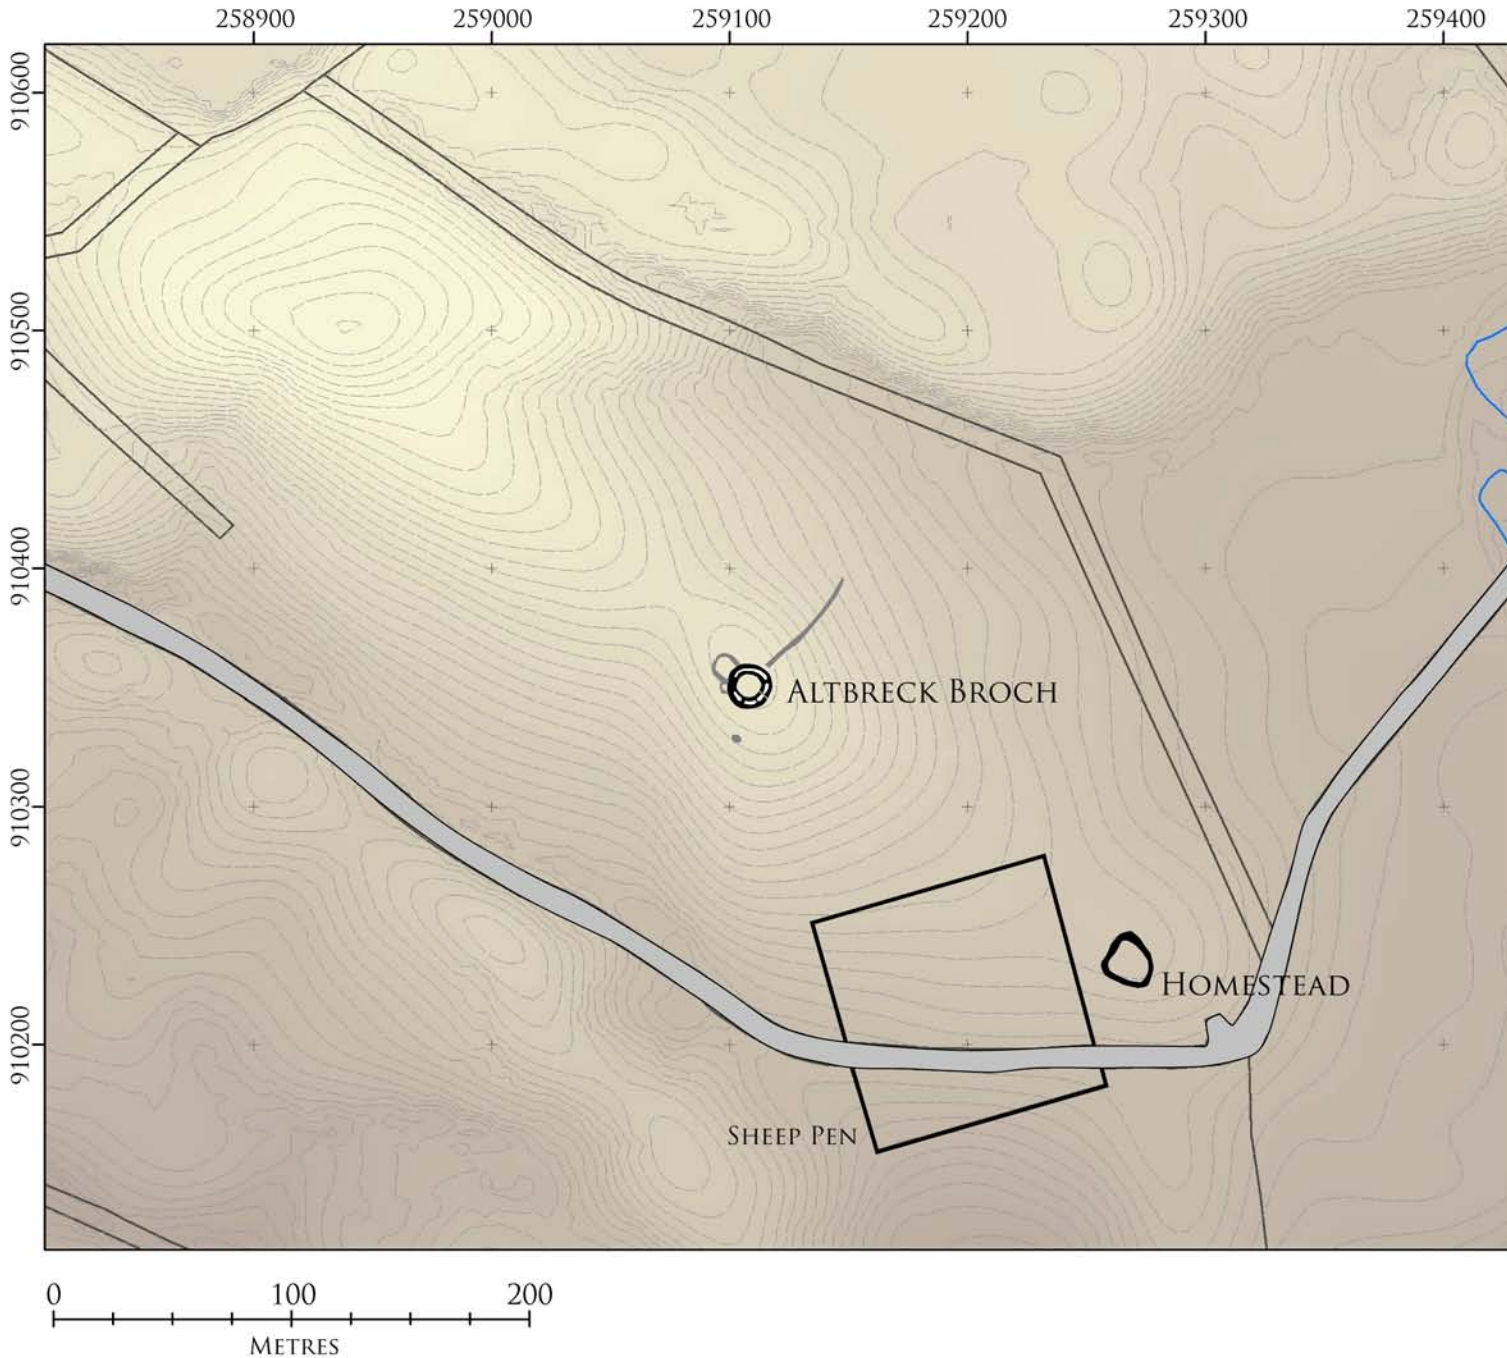
FIGURE 3: ALTBRECK BROCH AND SURROUNDING TOPOGRAPHY

8. Altbreck broch is a heavily robbed Atlantic roundhouse, sited on a naturally terraced knoll (Figures 3 and 4) running E-W, overlooking rolling topography and Loch Shin to the W. The structure comprises a roundhouse with walls averaging c.3.5m thick, circular in plan and measuring 18.57m in external diameter and 10.97m internally. The entrance, at point A on the survey plan (Figure 5) is aligned just north of E, and forms a passage 3.5m in length and c.0.8m wide. The passage is choked with rubble, but a large slab, now fallen into the passage 1.0m from the outer wall face indicates the presence of a door check (Plates 1 and 2). The entrance passage is otherwise choked with rubble and no other features are visible.

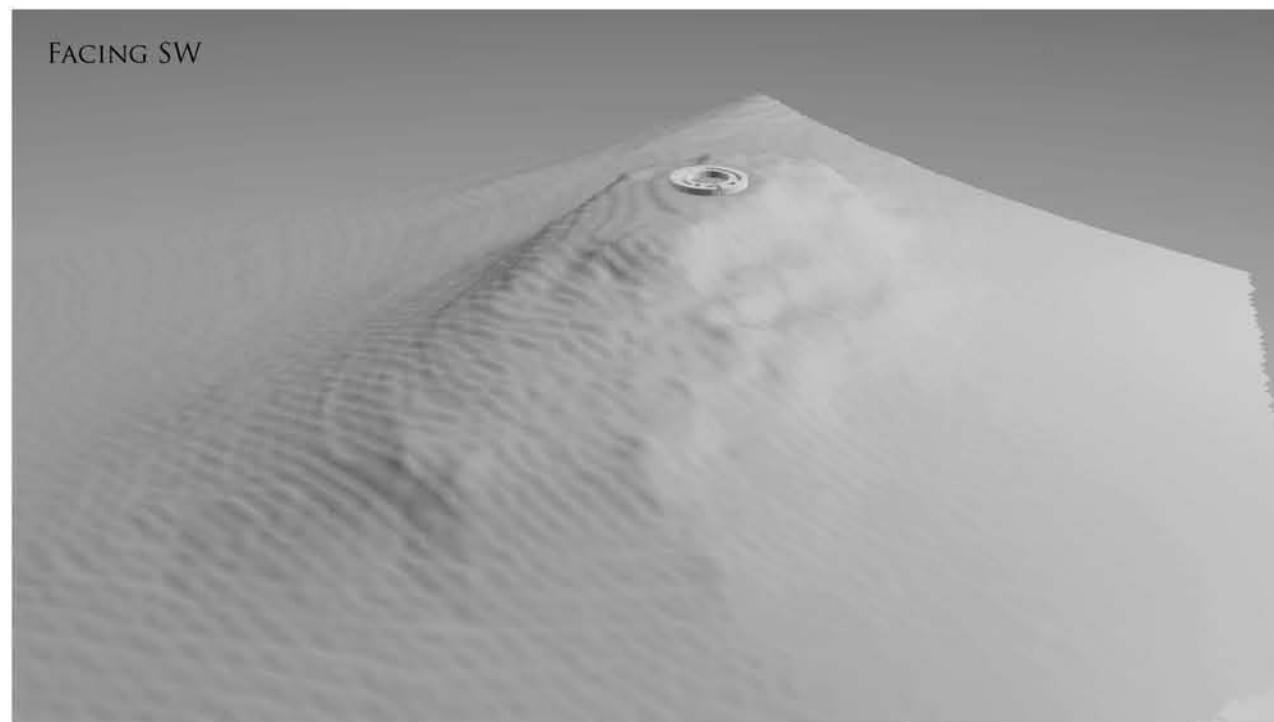
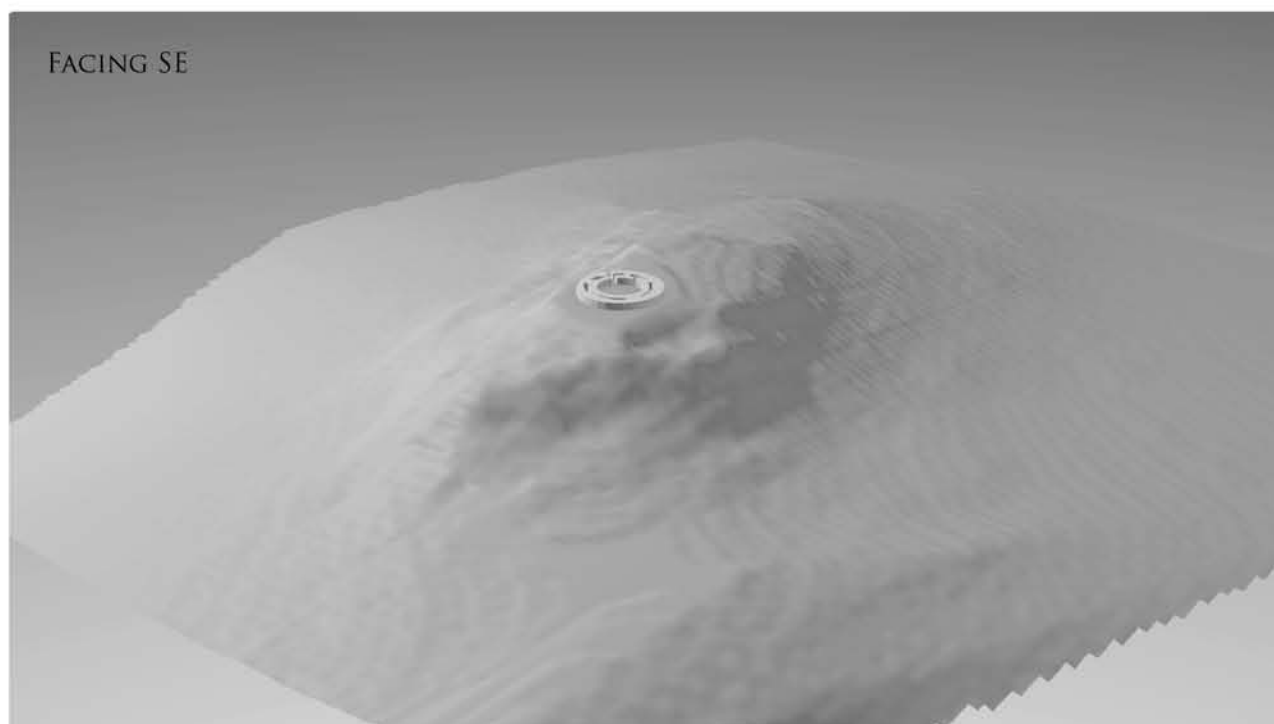
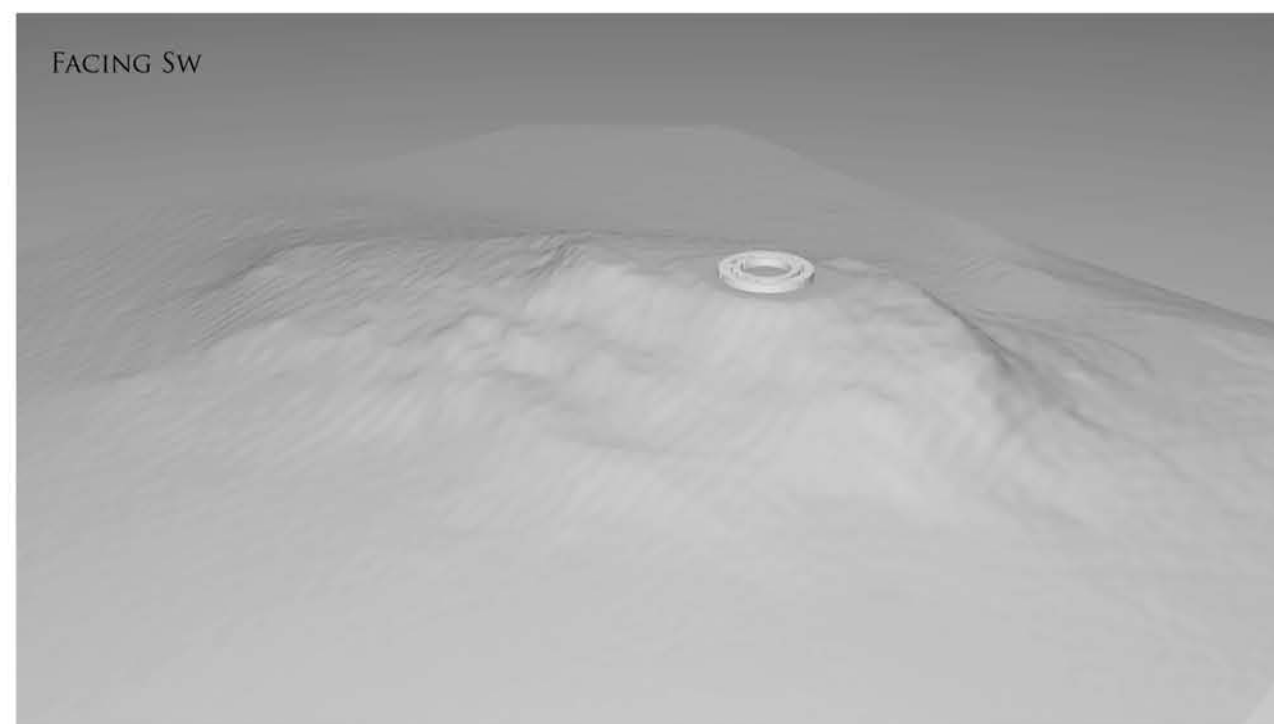
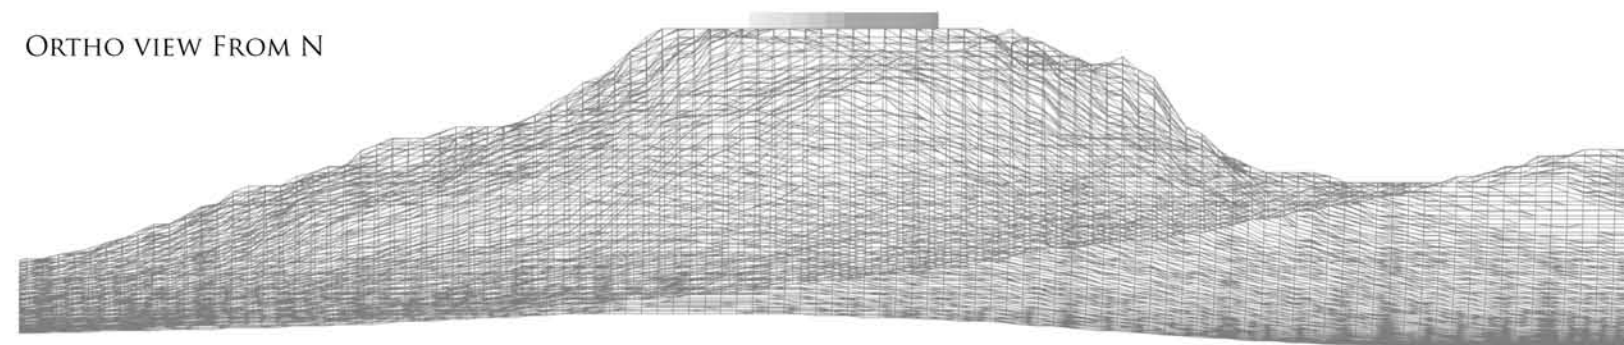
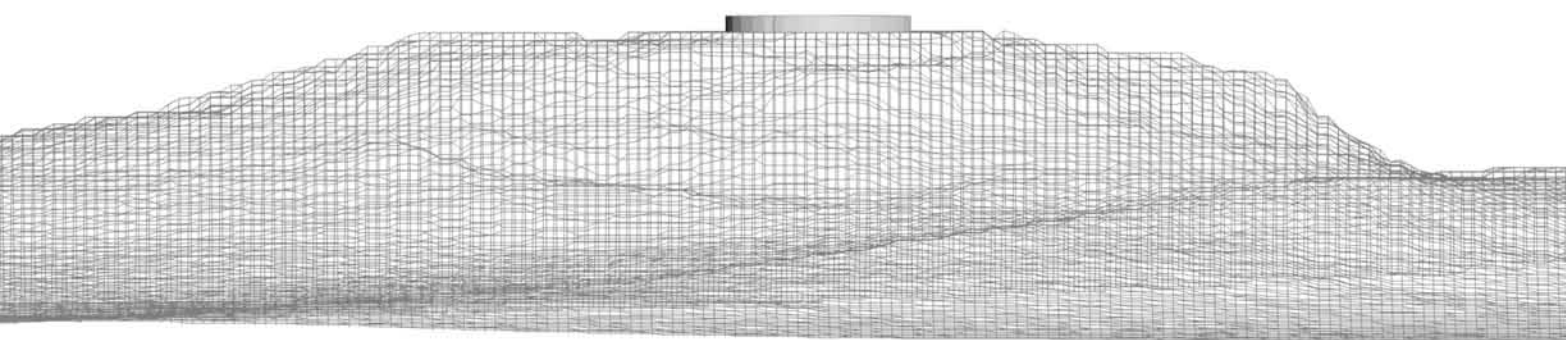
ORTHO VIEW FROM N

FACING SW

ORTHO VIEW FROM E

FIGURE 4:
3D VIEWS OF THE BROCH AND SURROUNDING TOPOGRAPHY

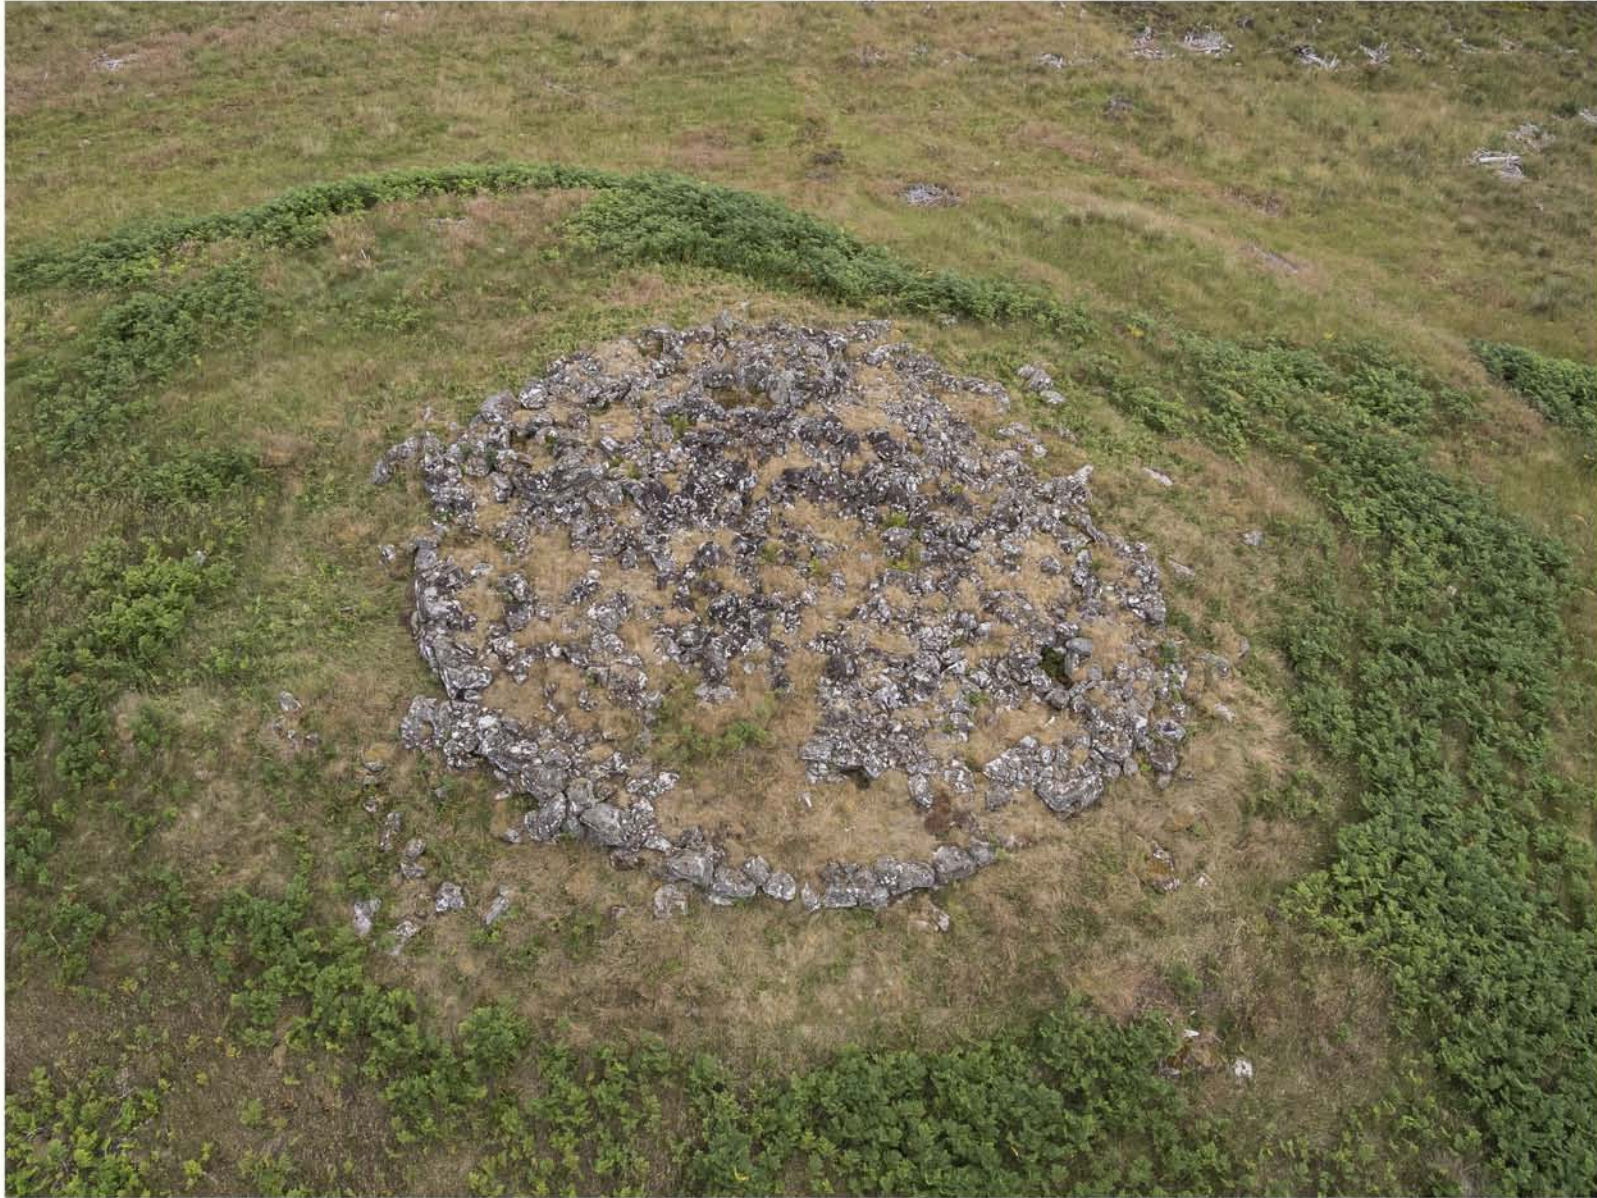
FIGURE 6: AERIAL PHOTO OF ALTBRECK BROCH (FORESTRY COMMISSION SCOTLAND)

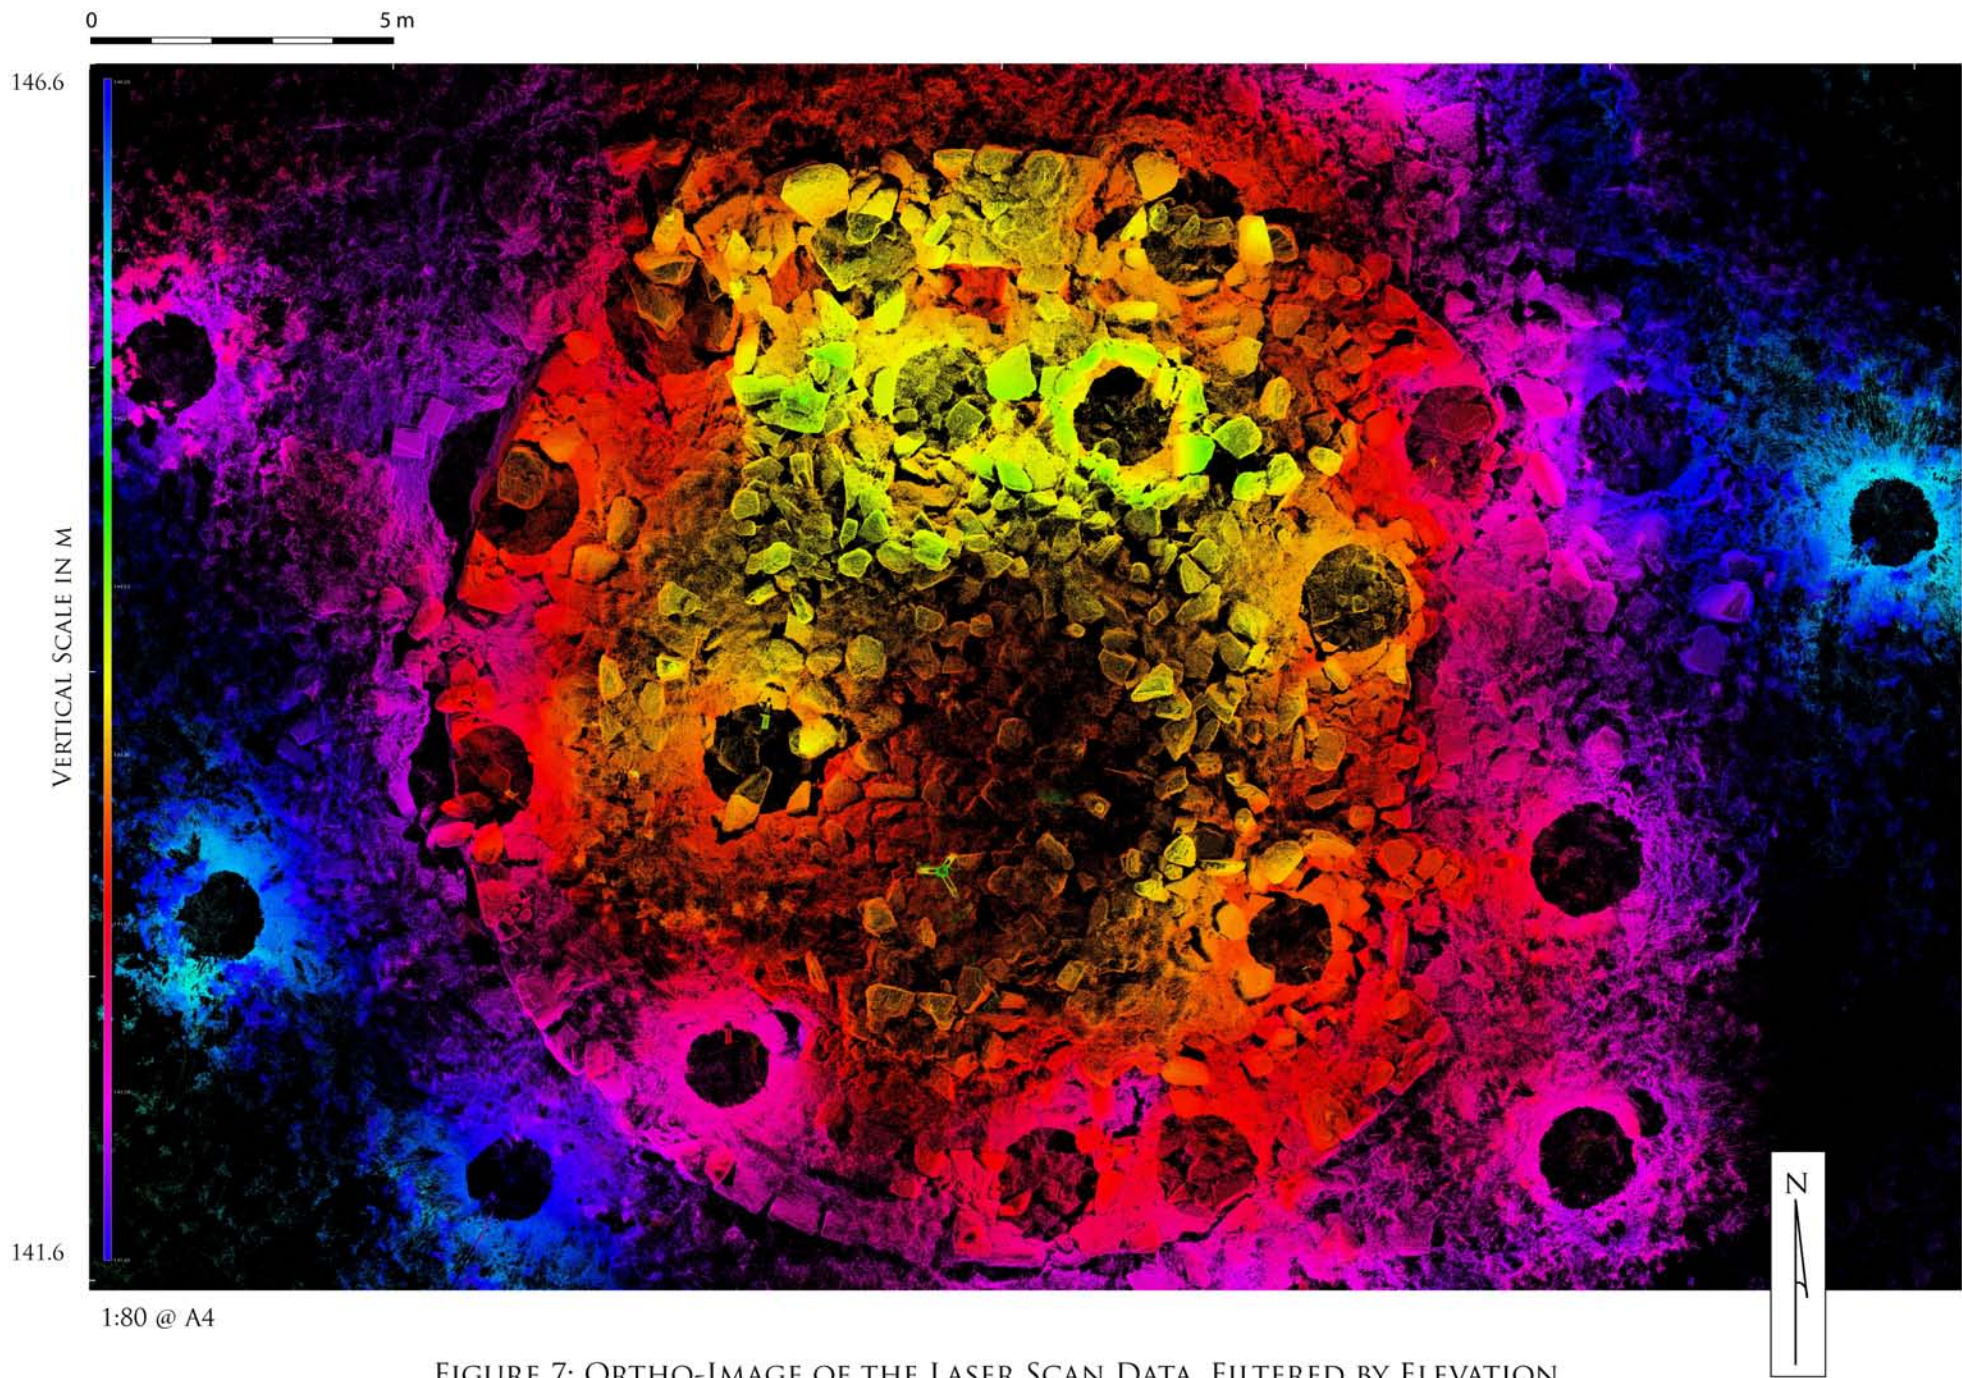
FIGURE 7: ORTHO-IMAGE OF THE LASER SCAN DATA, FILTERED BY ELEVATION

19. It has been noted by previous surveyors that the broch is distinctly oval in shape (see Mackie 2007; Mercer 1980). However, the orthographic view of the site provided by the digital survey undertaken here demonstrates that the site is in fact very nearly circular; it seems probable that the discrepancies in measurement in plan derive from the sloping surface onto which the broch was built, and the uneven survival of the upper portions of the wall itself, and the manual selection of points for measurement using a standard tape (see discussion by Barber in Appendix, below).

29. Mackie has suggested that the monument is not circular, but markedly elliptical with major and minor axes of 18.61 m and 15.86 m, contra the RCAHMS 1911, who render the monument as a circular one. Mackay is an acute field observer and his account merits exploration. The laser scan suggests that the monument is in fact circular. The averaged plane of the monument's erosion lies at slightly less than 5 degrees to the horizontal. If the broch had been a right cylinder, this oblique cut would yield an elliptical form, measured on the erosion surface, but the axes would differ by a mere 6 cm, not the 2.75 m that Euan implies. However, the broch is not a right cylinder, rather, where measurable, its outer face inclined inwards at c 25 degrees. This would reduce the measured, horizontal, diameter by 92 cm for every metre of height. Across the diameter at present, the

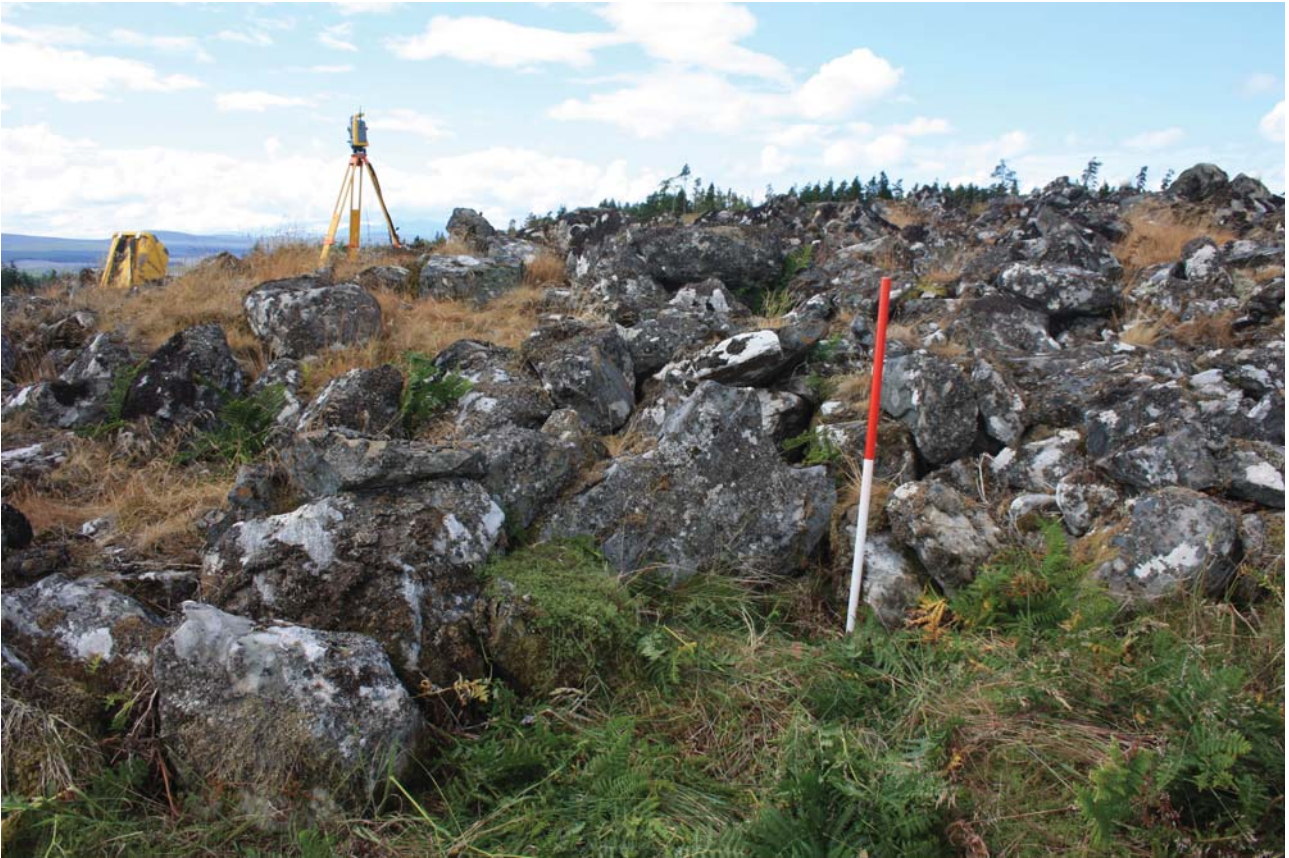
Plate 1: View of the entrance passage, showing the fallen door check slab on the S side

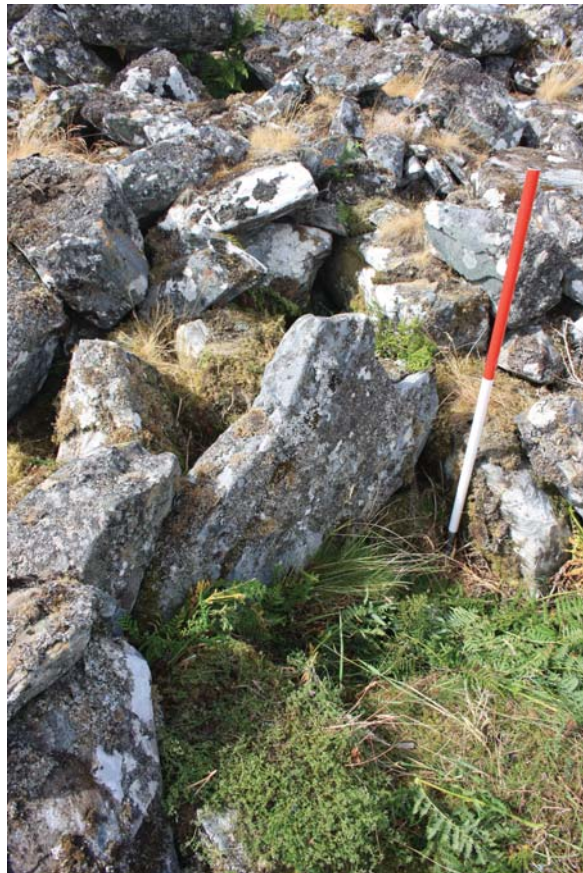
Plate 2: Detail of the fallen door check slab in the entrance passage

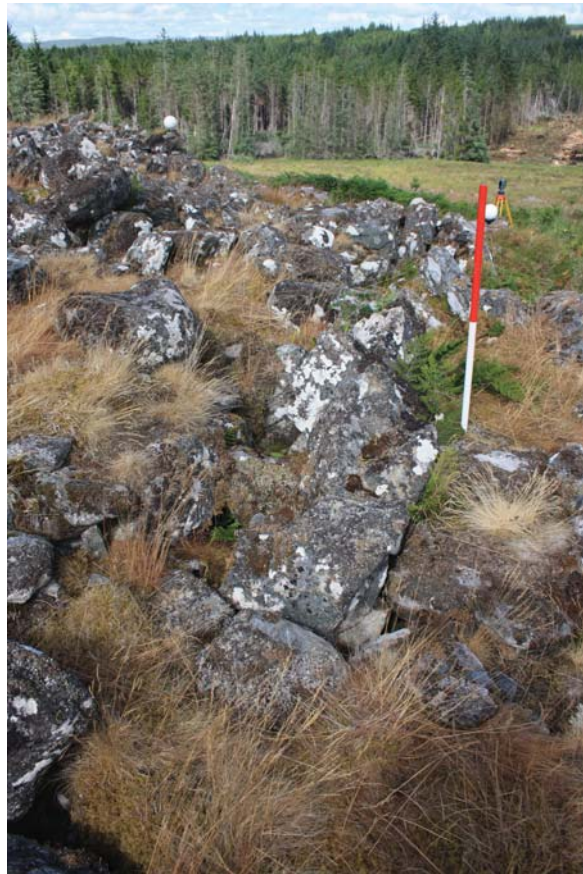
Plate 3: Cell 2, facing N, showing the terminal of the cell in the foreground.

9. Two intra-mural cells were accessed from the entrance passage. Cell 1, to the N of the entrance, forms a guard cell and was accessed via a passage 0.7m in width, set back 1.8m from the outer wall face of the broch. Two lintels of the passage to Cell 1 survive in situ; beyond these the cell widens to a maximum of 1.9m in width, although the E side is very ruinous. The W side of the cell is partially corbelled and survives to a height of 1.2m above the rubble surface. Cell 2 was also accessed from the broch entrance passage, with the entrance to that cell directly opposite Cell 1, but the entrance to Cell 2 is ruinous and choked with rubble. The cell itself is 2.5m in length and 0.7m in width, and terminates in a somewhat square return (Plate 3).

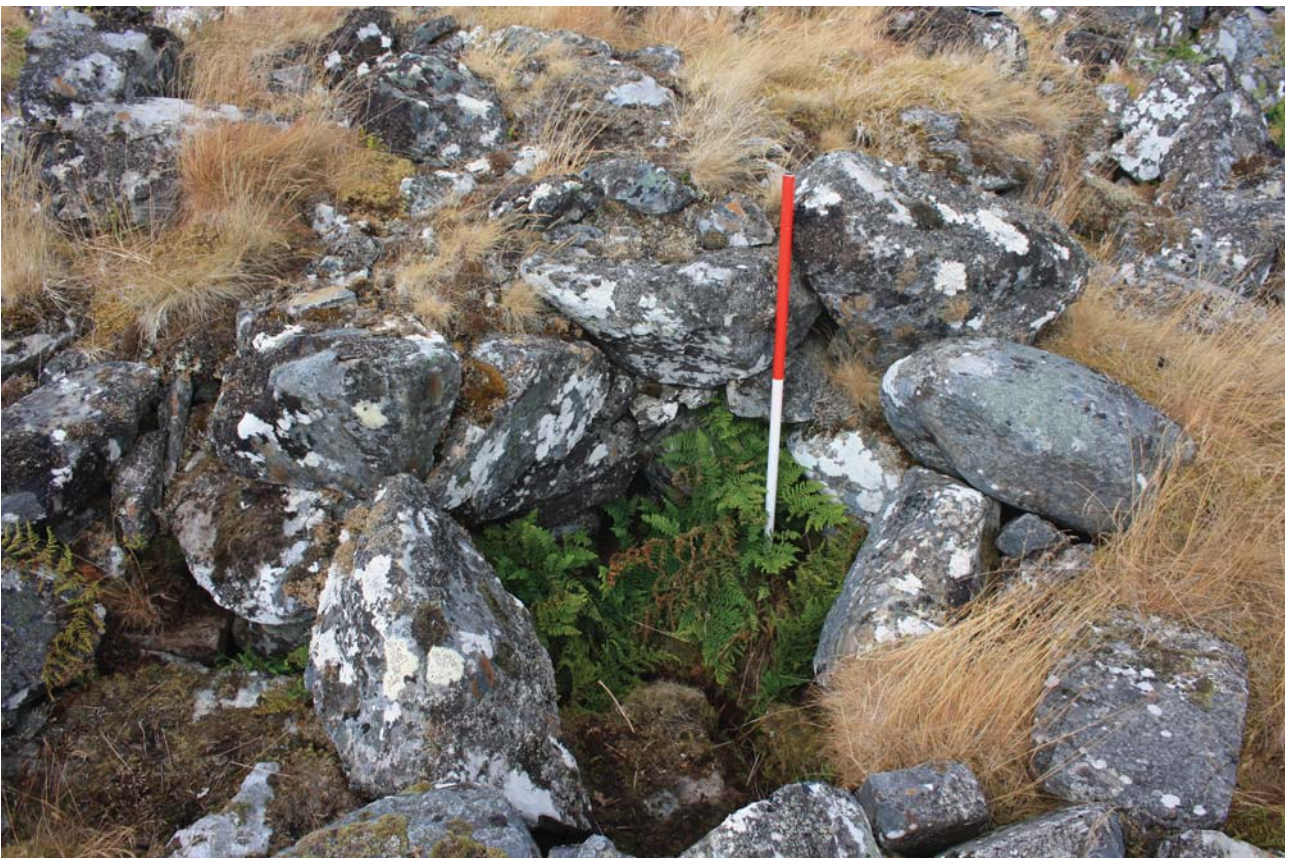
Plate 4: Reverse chamber to Cell 3 showing partial corbelling, facing NE

10. Cell 3 probably accommodates the stairs and is accessed via an entrance passage from the broch interior 1.3m long, leading into a reverse chamber at the foot of the stair, though this is rubble filled and little can be discerned of its form other than that it is c.1.4m in diameter, partially corbelled and stands to 1.3m in height above the rubble level. Cell 3 narrows to 0.9m in width to the W of the entrance and although no steps are visible beneath the rubble, it is probable that these were carried over the top of Cell 4 to the W, providing access to the first floor.

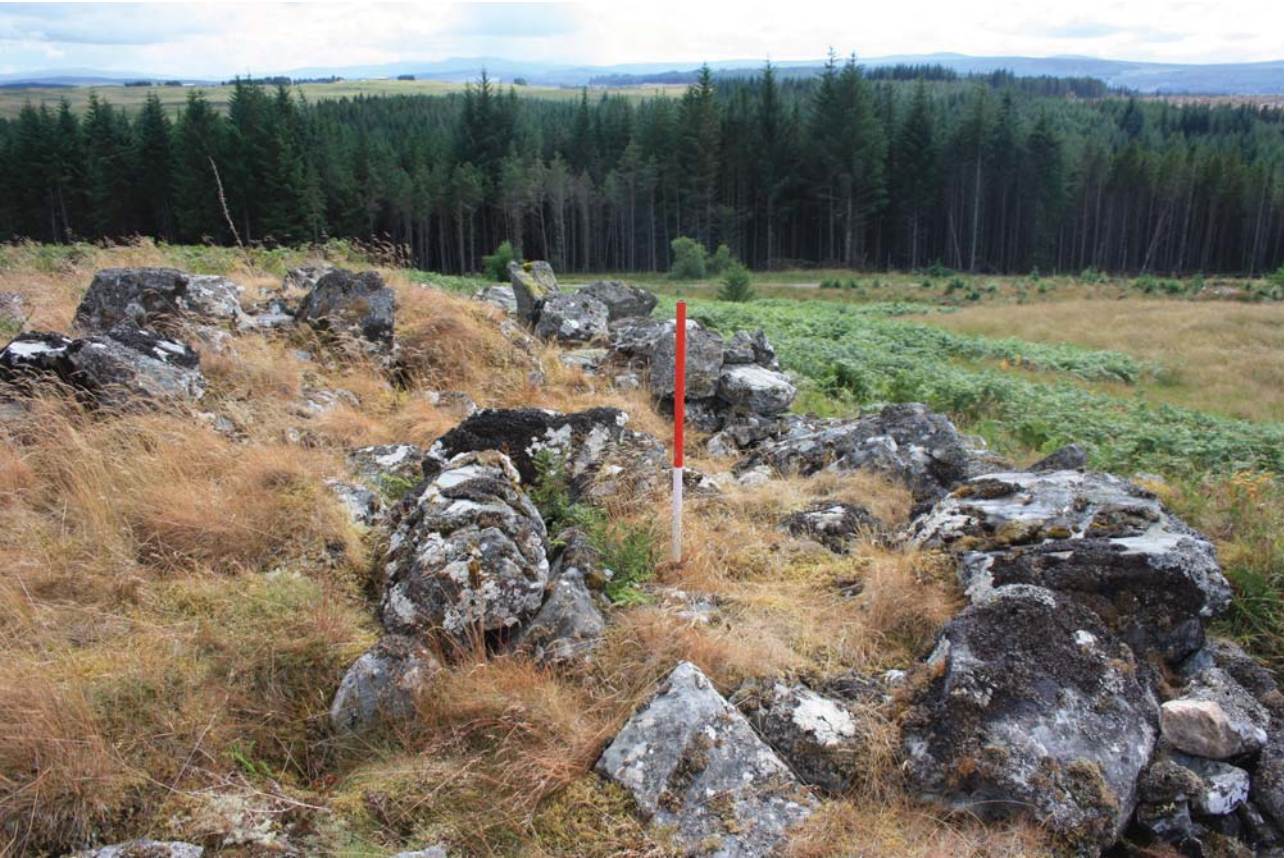
Plate 5: The intra-mural space in the broch wall at Point B, facing S

11. Cell 4 is visible as a round-ended, partially corbelled return within the thickness of the wall; the cell is ruinous and rubble filled, but may be continuous to the W. The western portion of the broch is ruinous and much disturbed, although the rubble between the inner and outer walls (at Point B) is

cavitous and may suggest the continuation of Cell 4. Some of this disturbance may be attributable to the construction of later structures abutting the roundhouse to the W (see below).

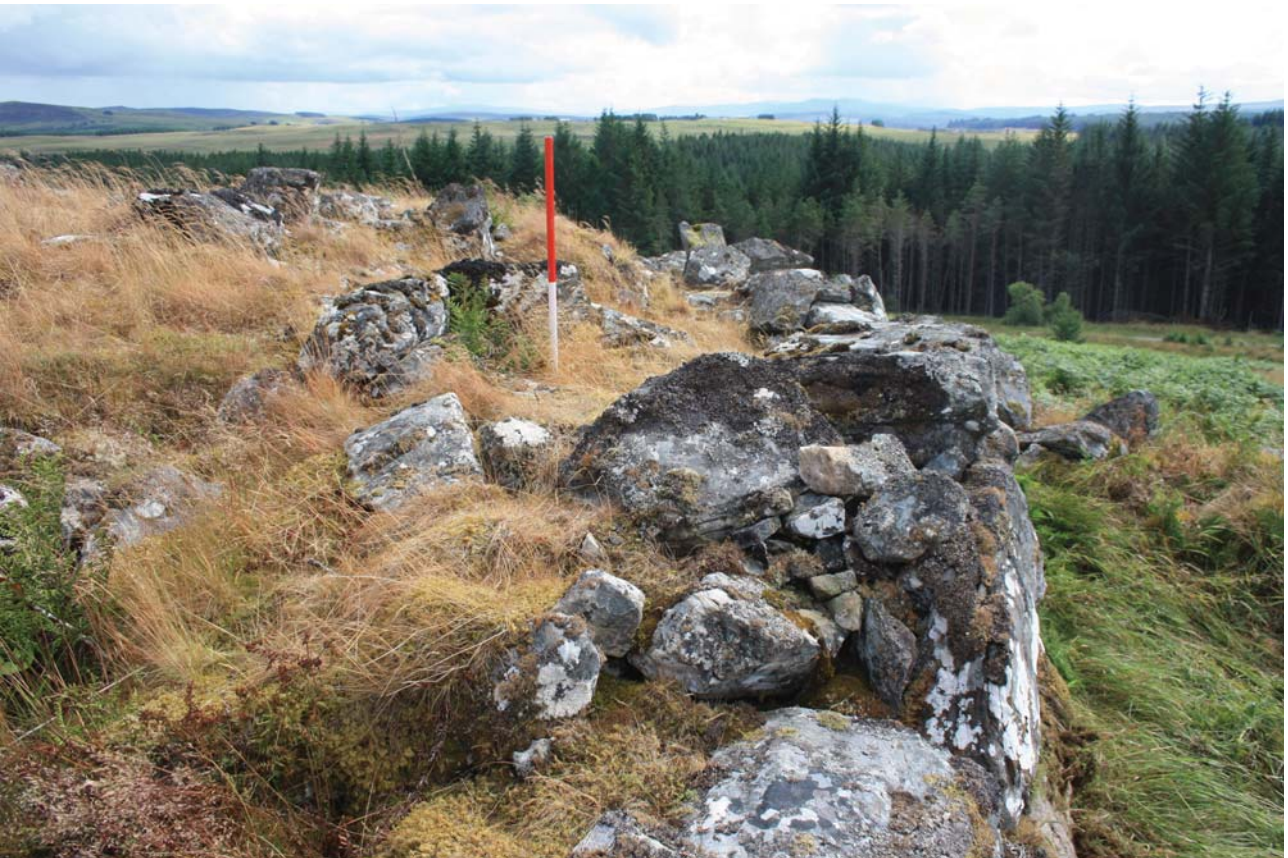
Plate 6: The intra-mural space in the broch wall at Point B, facing SE

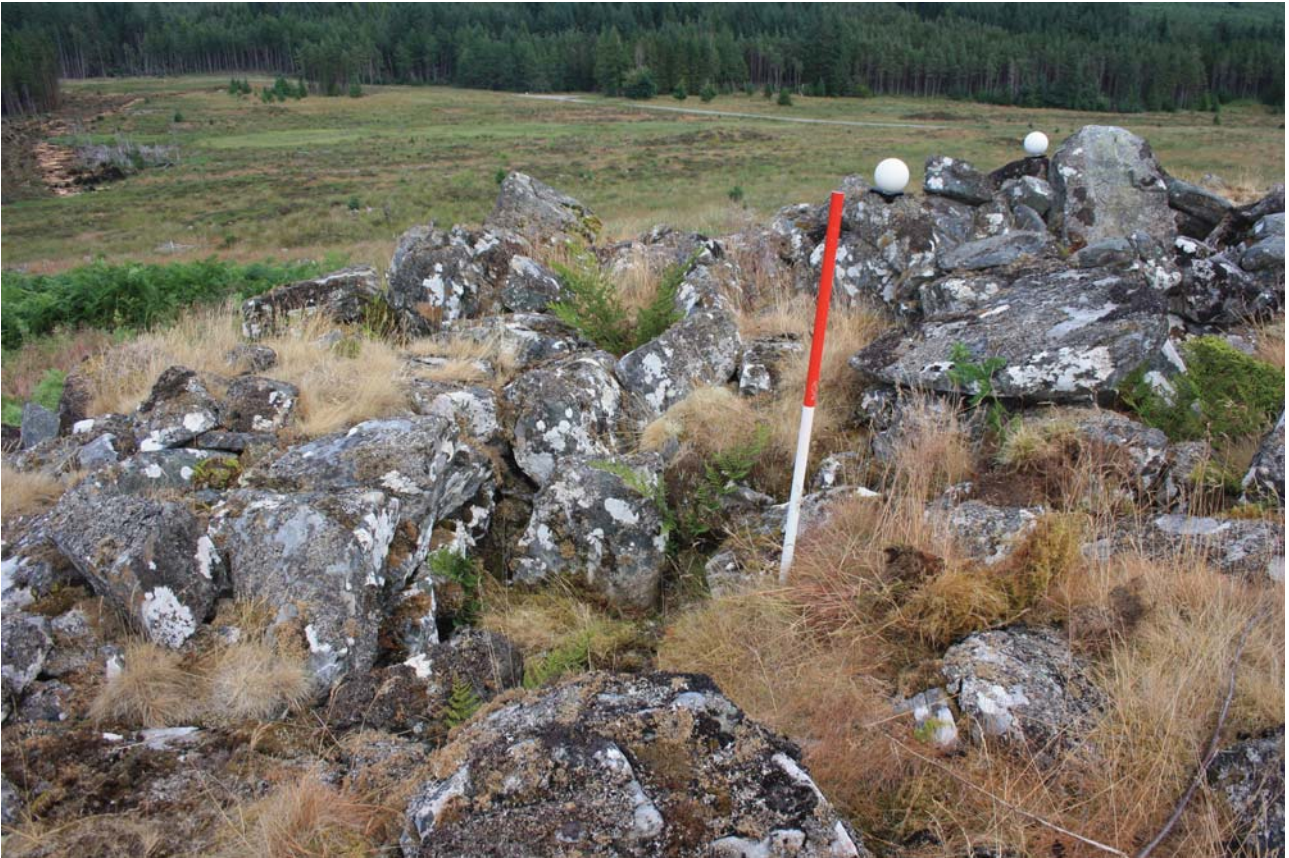
Plate 7: View of the best preserved area of Cell 5, showing the internal wall face, facing E

12. Cell 5 is visible beginning in the NW quadrant of the wall, running through much of the N side of the broch wall. A block of rubble around halfway along its length may suggest that Cell 5 should be considered two cells, but the evidence is equivocal and this masonry may simply be a fortuitous arrangement of collapse debris. Cell 5 is choked with large rubble blocks, and the E end is ruinous so that it is difficult to determine how close the terminus was to the rear of Cell 1; it seems likely that it was in the region of 1.5m.
13. The outer wall face of the broch makes use of some very large boulders, up to 1.5m across and 0.6m deep (see Plates 8 and 9); the pinning stones between many of these have been lost, implying expansion of the wall following collapse of the structure.

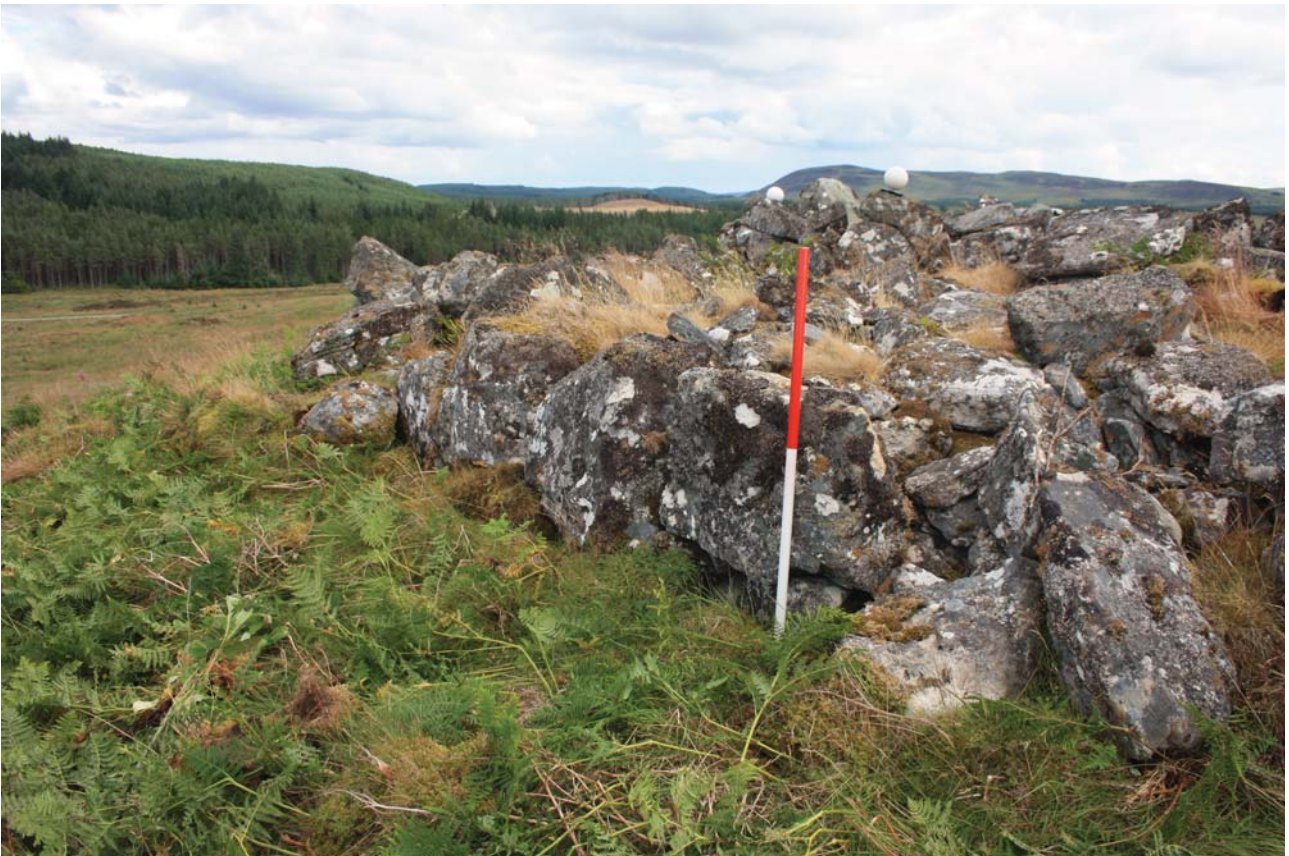
Plate 8: View of the outer wall face of the broch, on the N side, facing E

32. The largest stones in the external wallface are partially buried beneath soils developed on older collapse and their full extent is not known. They fracture into roughly prismatic shapes that are close to kite-shapes in cross section and taper to one end. They are sometimes disposed in alternating tall and short orthostatic arrangements and this assists the building on of the next course by providing a three-point contact for the stones of the next course. These are laid onto the lower orthostat and propped between the taller flankers, their [built] upper surfaces being levelled up with smaller stones in the core of the wall. Their tapering shapes make them ideal for building circular structures. No doubt the sizes of the stones would have reduced with height, as observed in all of the well preserved brochs, but as noted above, these will have been preferentially stripped away for reuse. Nonetheless, the surviving masses imply an ability to gather, transport and position stones of over half a metric tonne. This is unlikely to have been achieved without cartage and a substantial labour force.

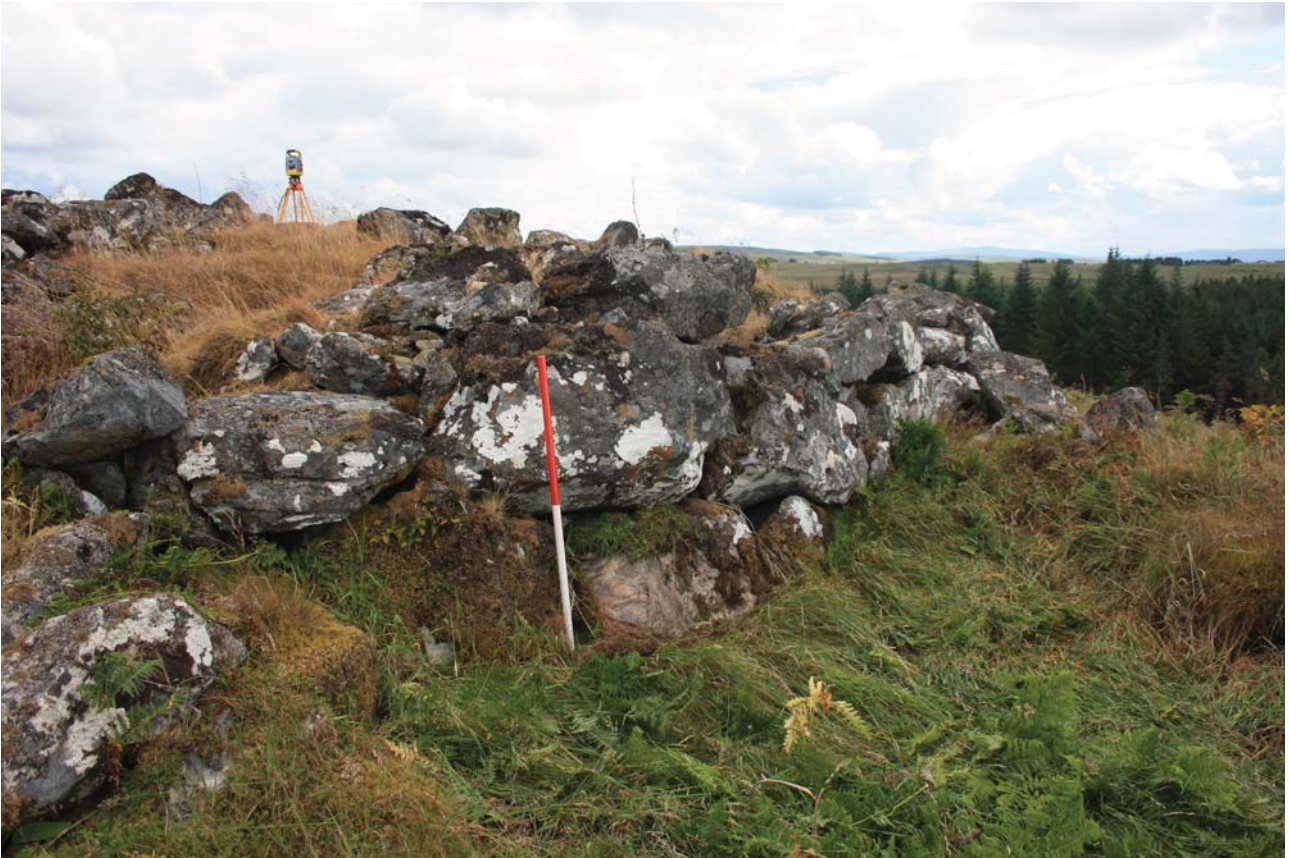
Plate 9: View of the outer wall face of the broch on the W side, facing SE.
