Altbreck Broch, Dalchork Archaeological Survey Report

Archaeological Survey Report

National Grid Reference (NGR): NC 5911 1035

AOC Project No: 22483

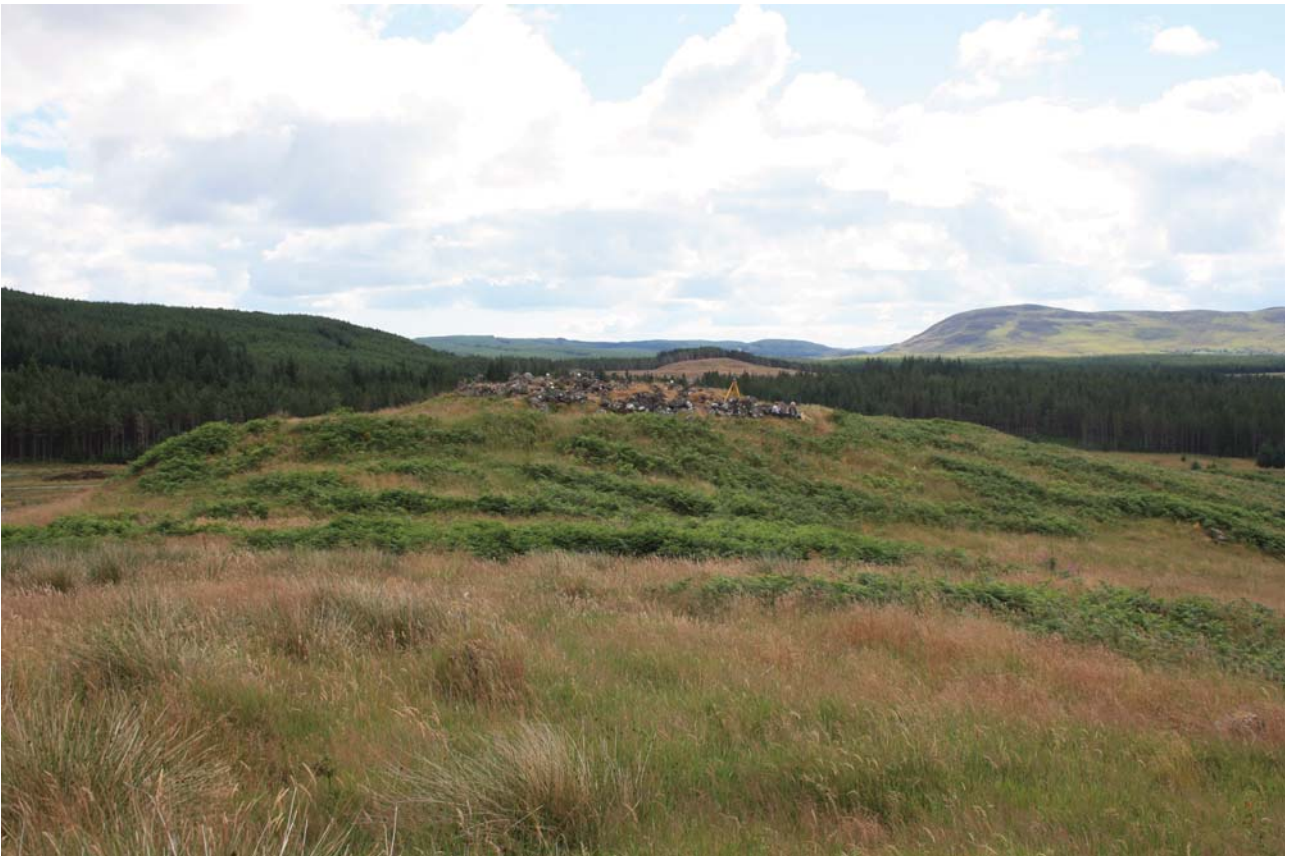
Plate 10: General view of the broch, from the W

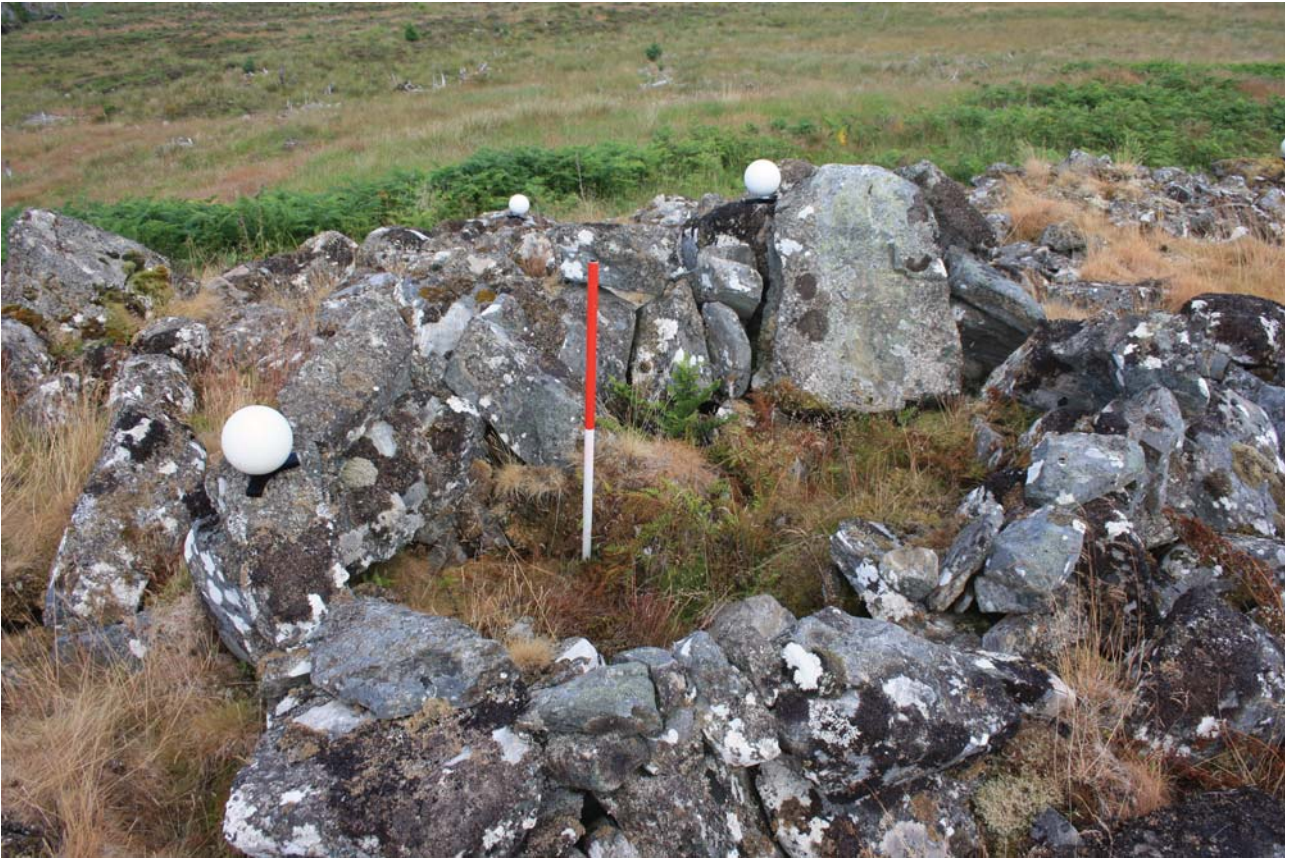
Plate 11: View of the recent shooting butt structure at Point C

14. At Point C, a small circular structure of recent origin has been constructed, probably as a shooting butt or for another similar function (Plate 11). Two further structures have been built up against the outer wall of the broch on the W side of the monument: at Point D a D-shaped bank encloses an area 7.25m by 7m internally (Plate 12) and at Point E a sub-rectangular enclosure measuring 4m by 2m internally may be a sheiling hut (Plate 13).

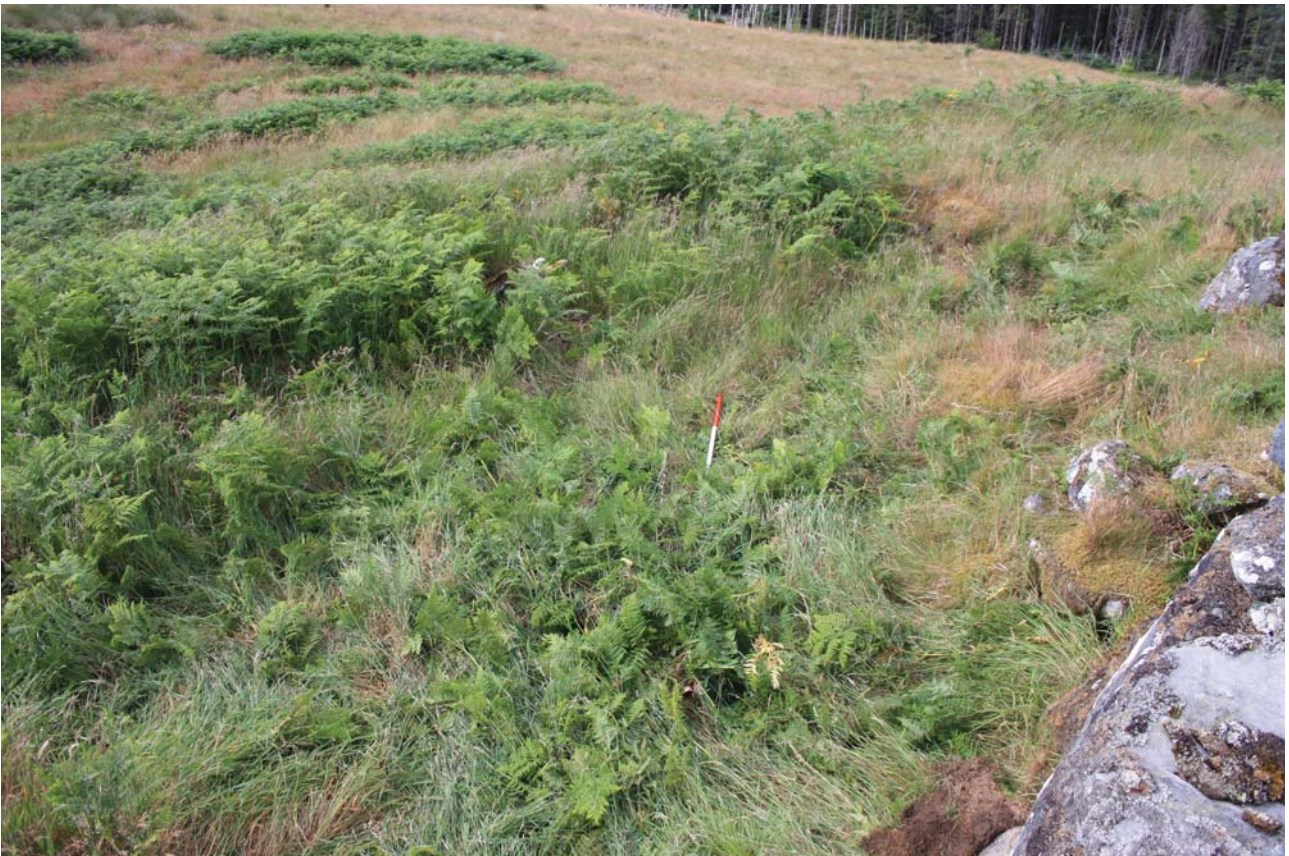
Plate 12: View of the larger enclosure abutting the broch wall at Point D (largely obscured by bracken), facing NW

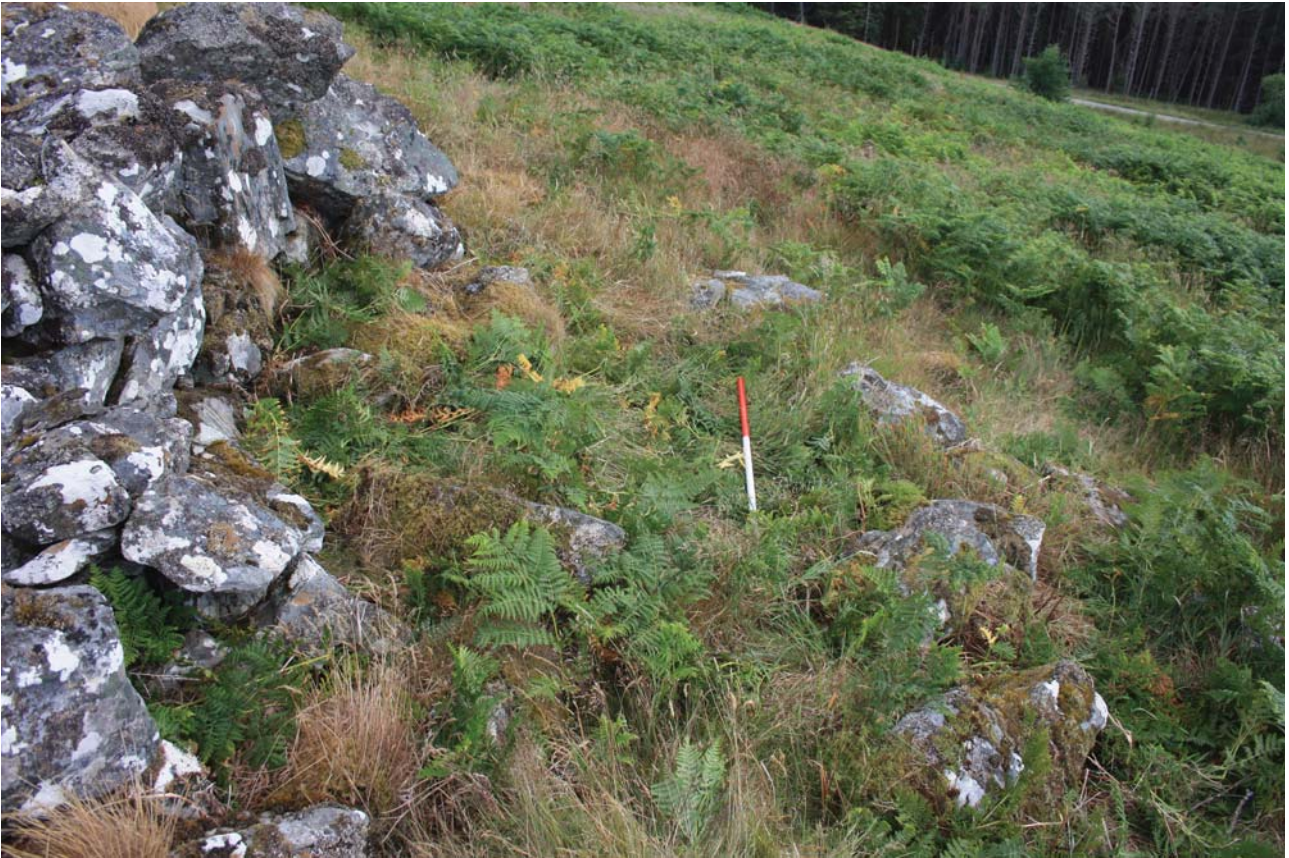
Plate 13: View of the smaller enclosure or building abutting the broch wall at Point E
