# Nos 4/4A & 5 West Park Place, Edinburgh: Historic Building Recording & Archaeological Evaluation Report

AOC 22619

19<sup>th</sup> February 2014

**AOC Project No:** 22619

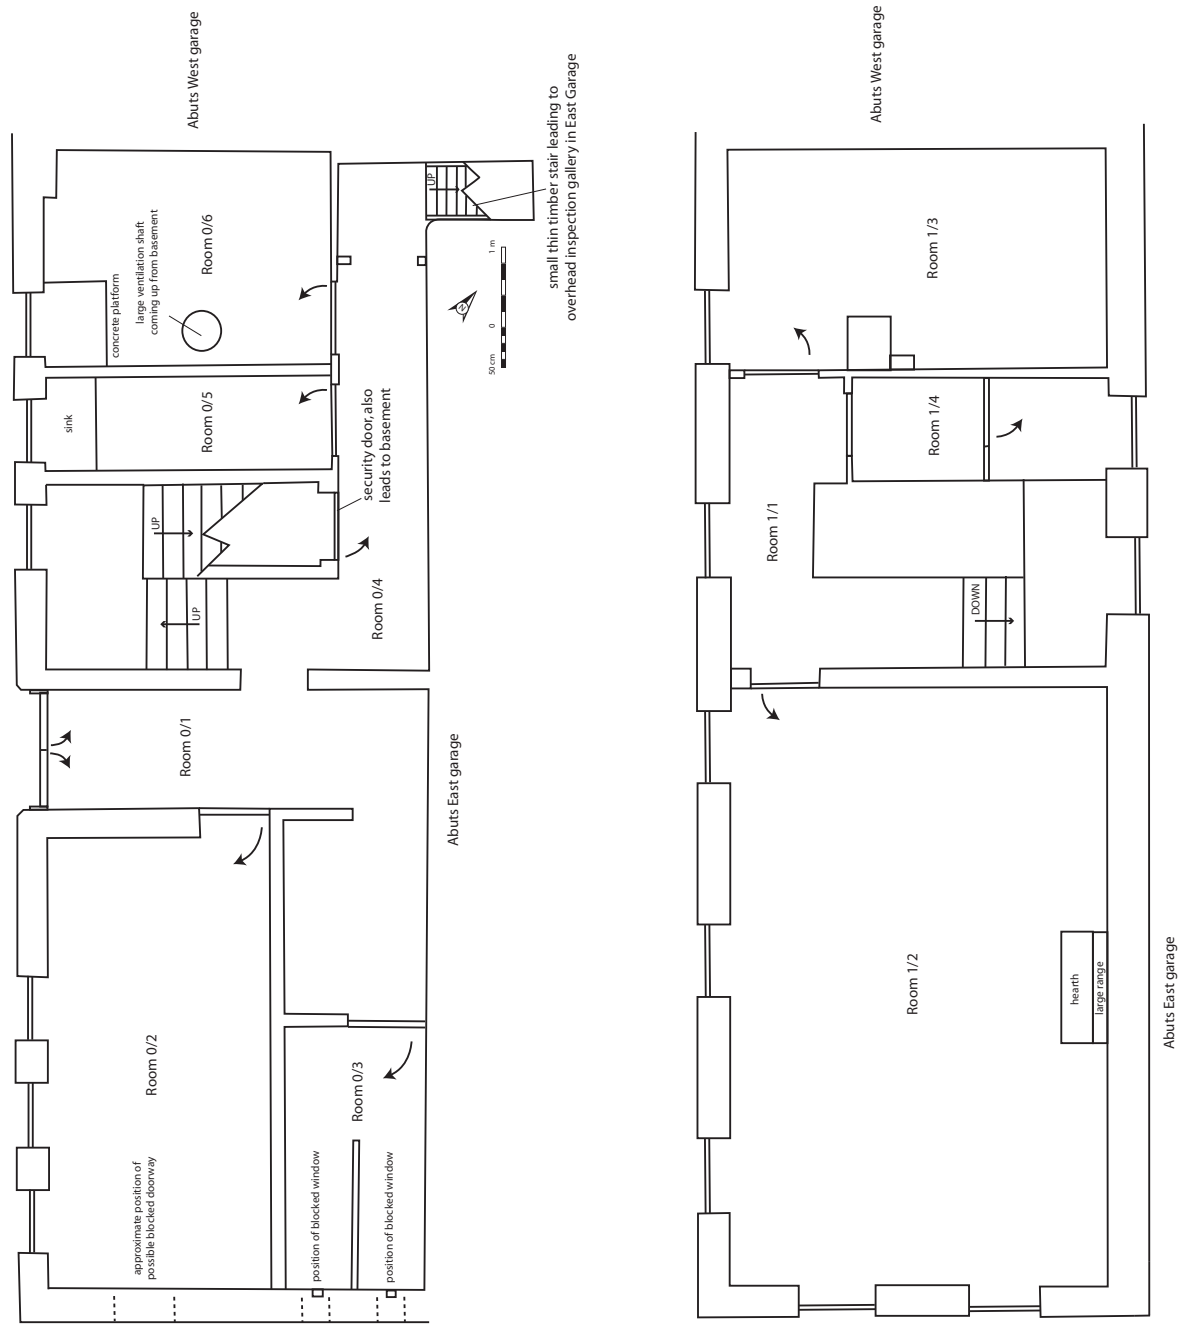
Figure 14: No 5 West Park Place, ground and first floor plan

- 5.3.3 Internally, the building is very simple in plan, with a central dog-leg stairwell (Figure 14). There is a small basement accessed from a reinforced steel door with bare brick walls to house the services (Plate 31). The ground floor then is accessed only from the main doorway to the south-west which opens out into a wide corridor (0/1) (Plate 32). From here, Room 0/2 is accessed to the south, taking in the three ground floor windows on this side (Plate 33). A small corridor leading to the toilets (0/3) is set behind this. To the north, Rooms 0/5 and 0/6 form a small kitchen and store room with generator respectively off a small north-east corridor (Plates 34 & 35). The central stair is very plain with stairwell windows to the north-east and south-west sides (Plate 36).

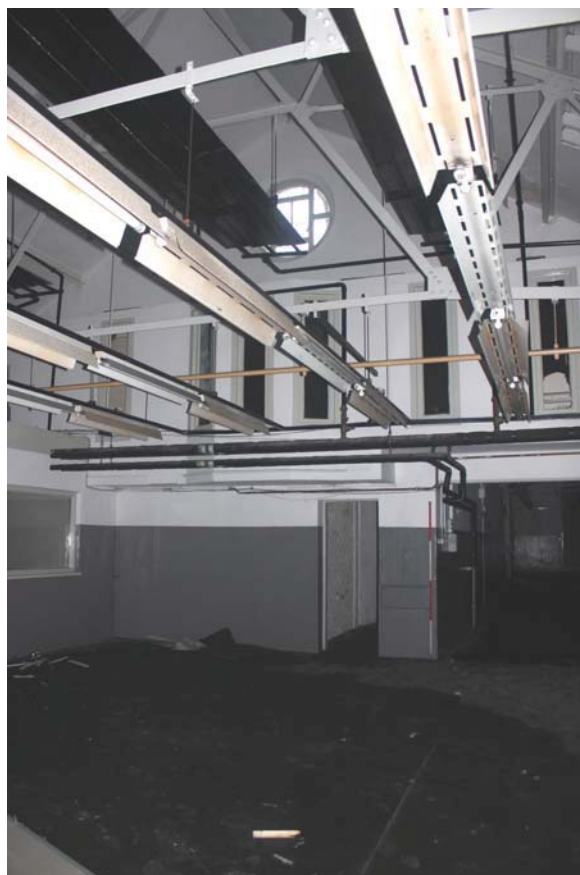
Plate 15: No 4 West Park Place, East Garage, general view of the interior (showing later 'inspection' gallery) from the east

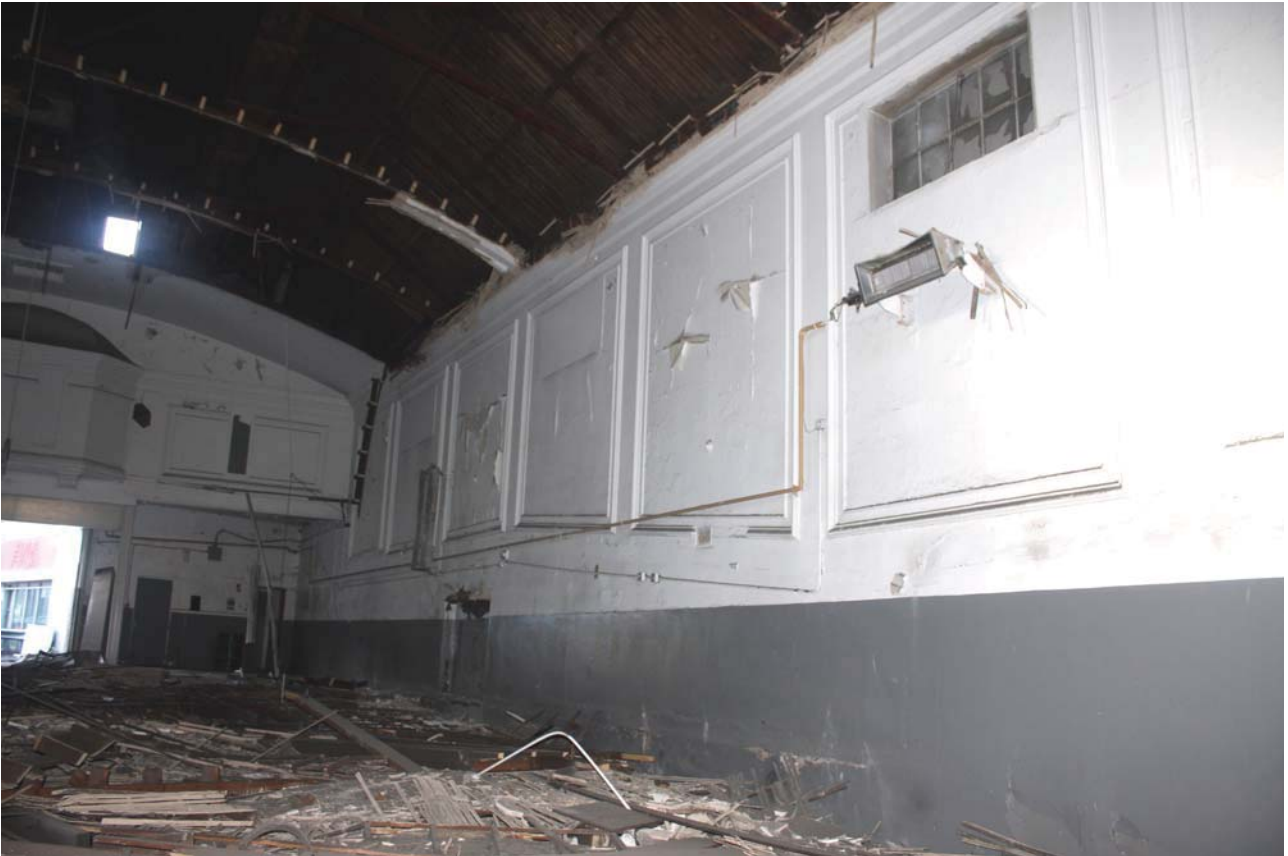
Plate 21: No 4A West Park Place, Former Cinema/Picture House, general view of north-west wall showing panelling from the east

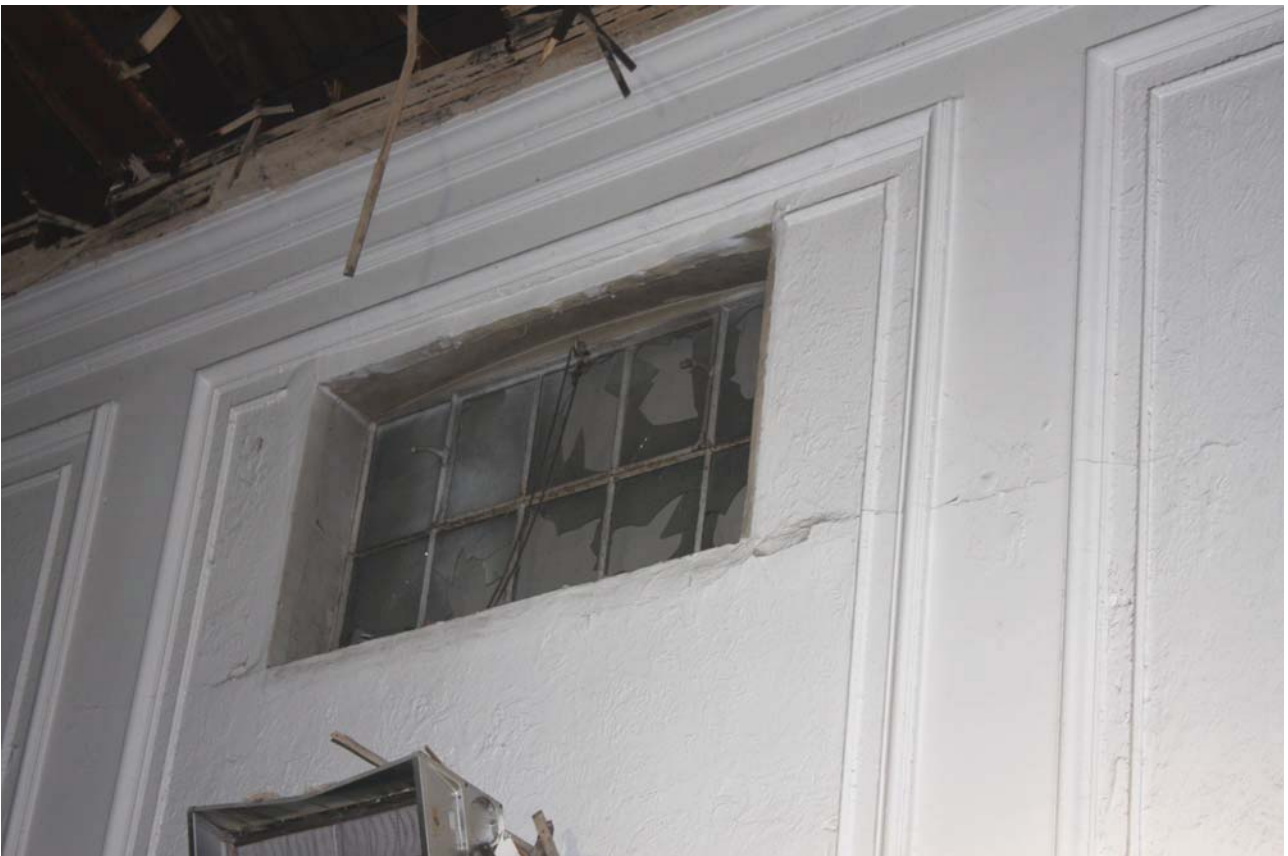
Plate 22: No 4A West Park Place, Former Cinema/Picture House, detail of boarded up window on the north-west wall from the east

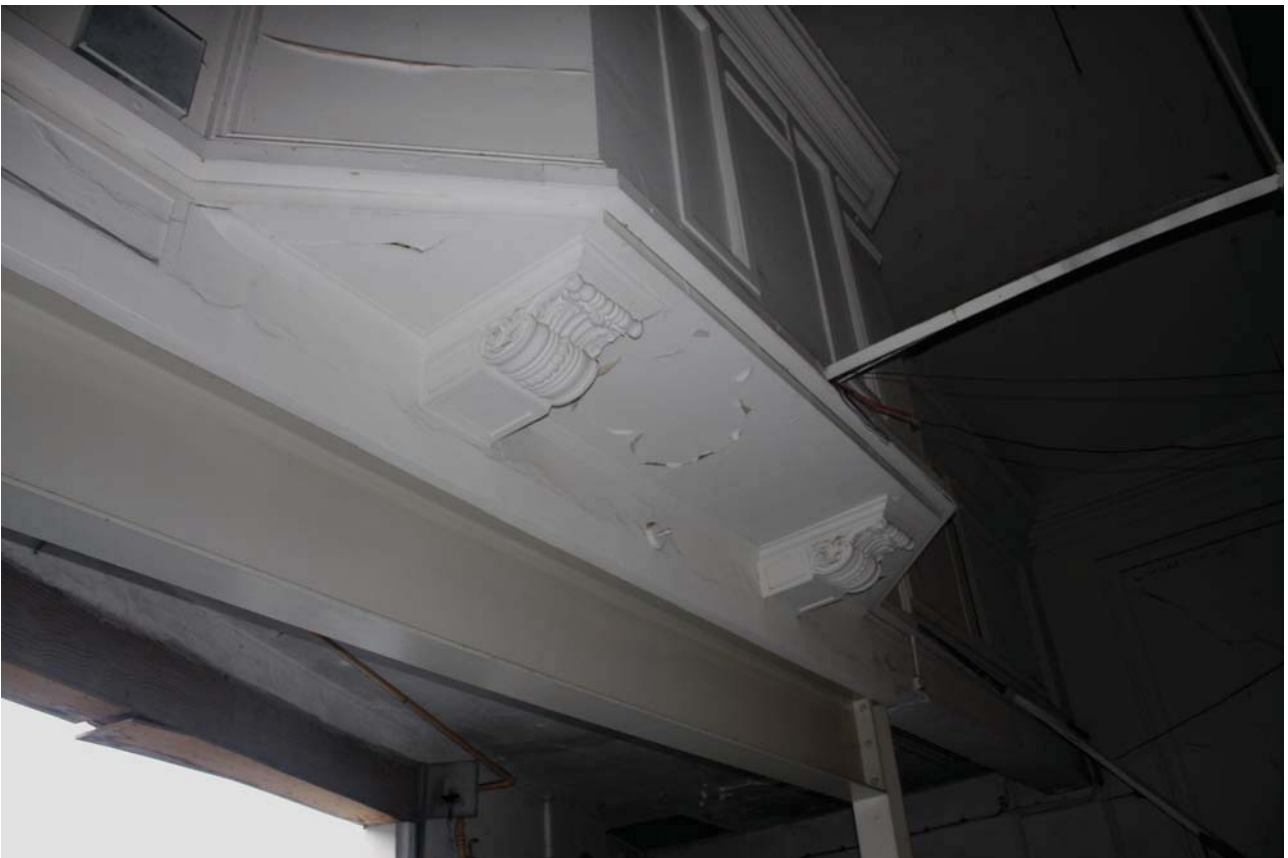
Plate 24: No 4A West Park Place, Former Cinema/Picture House, detail of decorative corbels supporting the gallery from the east

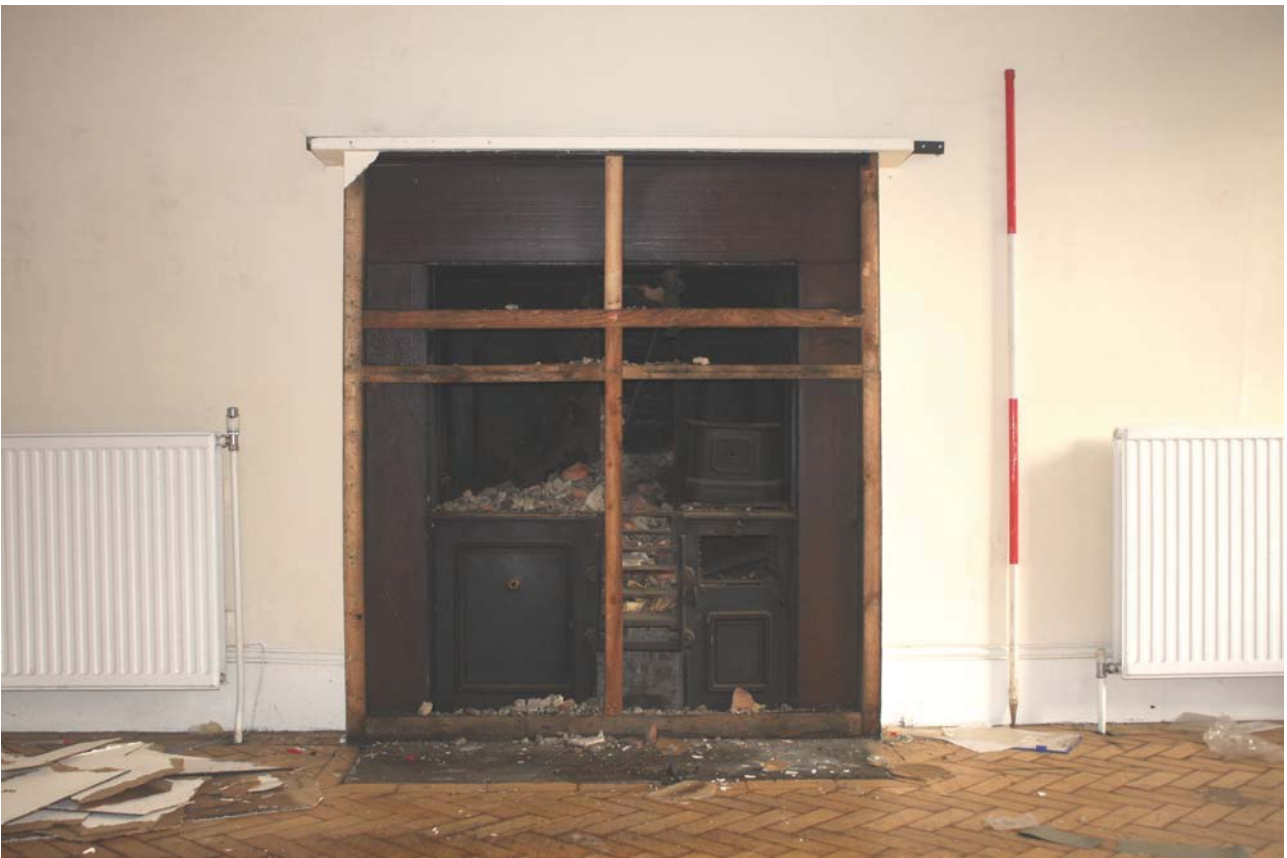
Plate 38: No 5 West Park Place, Former Post Office, Room 1/2, detail of the range in the north-east wall from the south-west

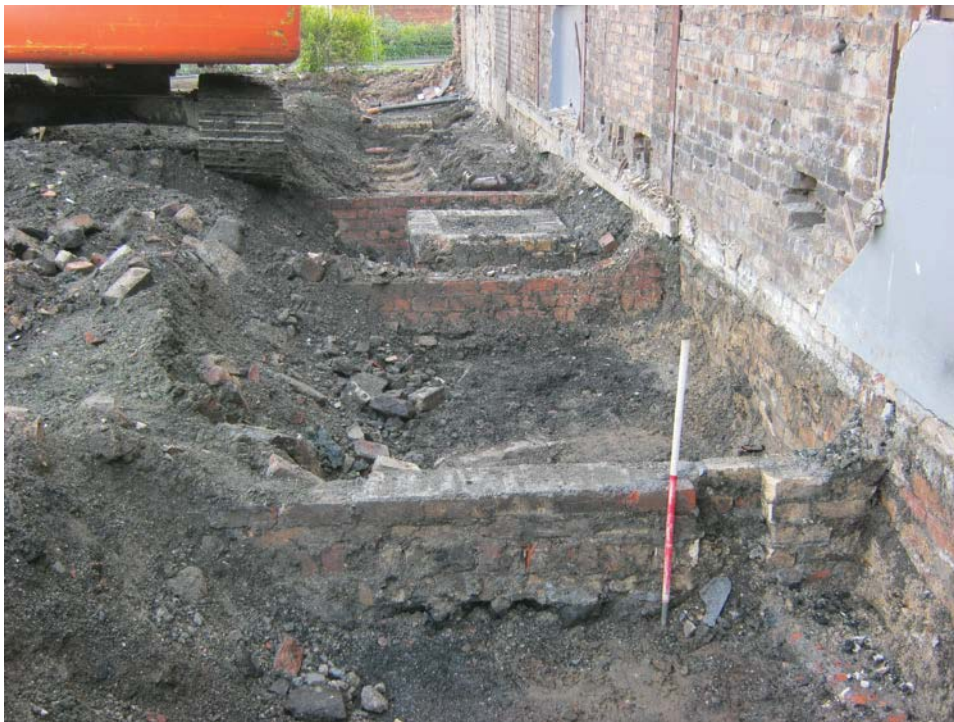
Plate 40 Trench 3, general view of the brick interior foundation walls from south-west

- 6.2 The archaeological evaluation revealed several brick foundations within Trenches 2, 3 and 4. The wall recorded within Trench 2 formed the rear wall of the 20<sup>th</sup> century garage building. This wall was previously associated with the Cabinet Works shown on the OS Map of 1877. A further Cabinet Works foundation was revealed in Trench 4 running north-east/south-west. Several brick foundations were also located at the south-western end of Trench 3. These walls ran south-east/north-west and are most probably internal/dividing walls associated with a building visible on the 1909 and 1920 OS maps. All of the walls related to this phase were approximately 0.50 m to 0.70m in elevation and cut directly into the natural sands.

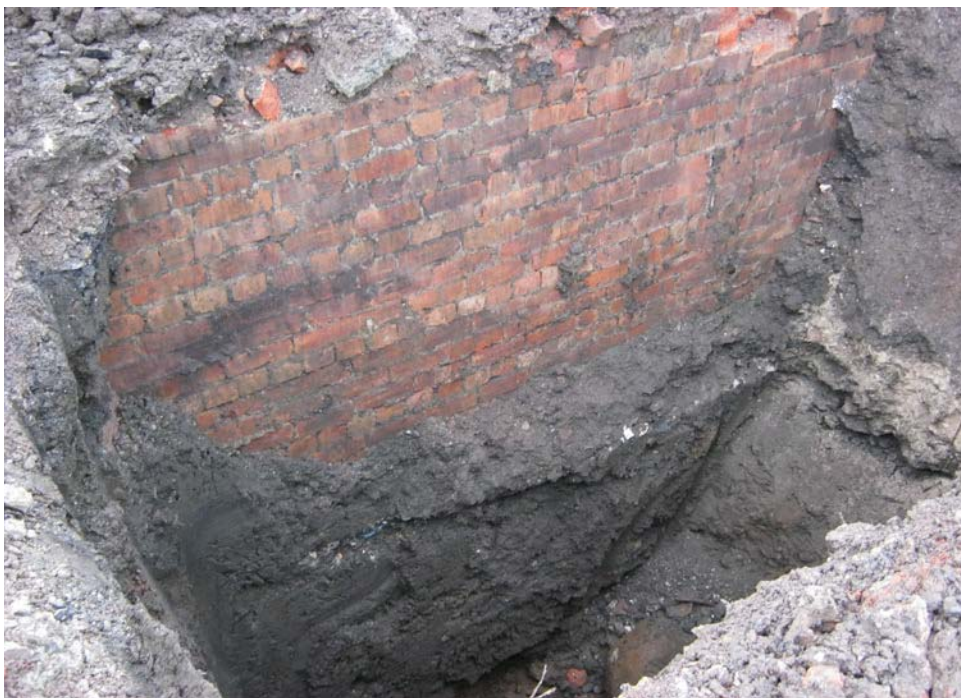
Plate 42 Trench 1, general view of the brick foundation wall from north-east

- 6.4 A brick foundation associated with the modern perimeter of the site was recorded within Trench 1. This wall was 1.75m in height and overlay a deposit of made-ground 2.25m in depth. The wall is visible on the OS maps of 1877, 1894 and 1908.

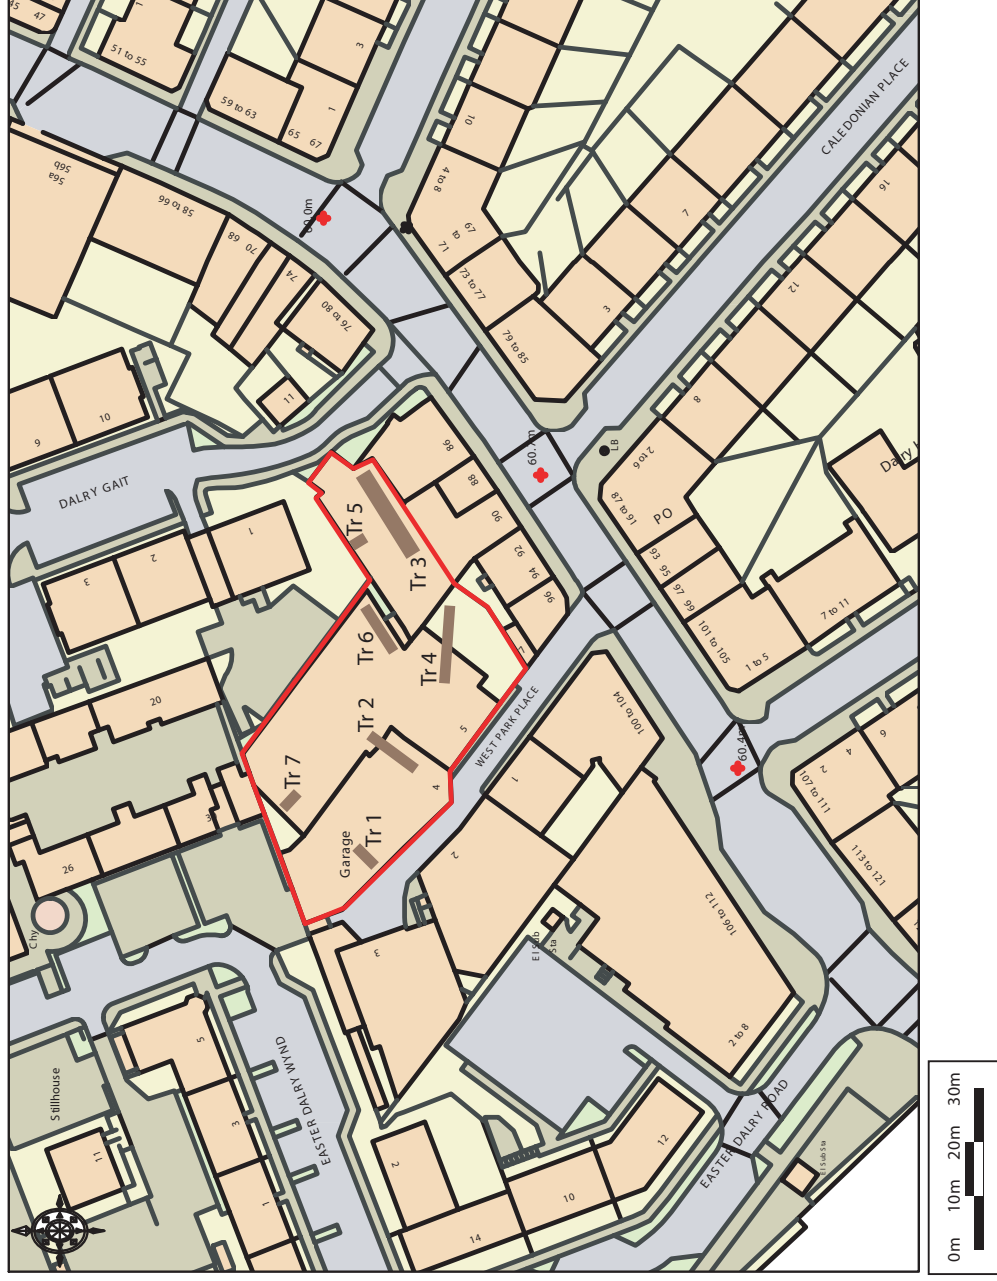
Figure 15: Site plan showing location of evaluation trenches

- 6.1 The archaeological evaluation was undertaken on the 5<sup>th</sup> February 2014. Five trenches were excavated and their position was dictated by present ground conditions and the presence of several live services (Figure 15). Nevertheless the positions of the 19<sup>th</sup> century buildings were successfully targeted.
