Cannonball House, 356 Castlehill, Edinburgh

Archaeological and Structural Watching Brief Report

AOC 22573

31st March 2014

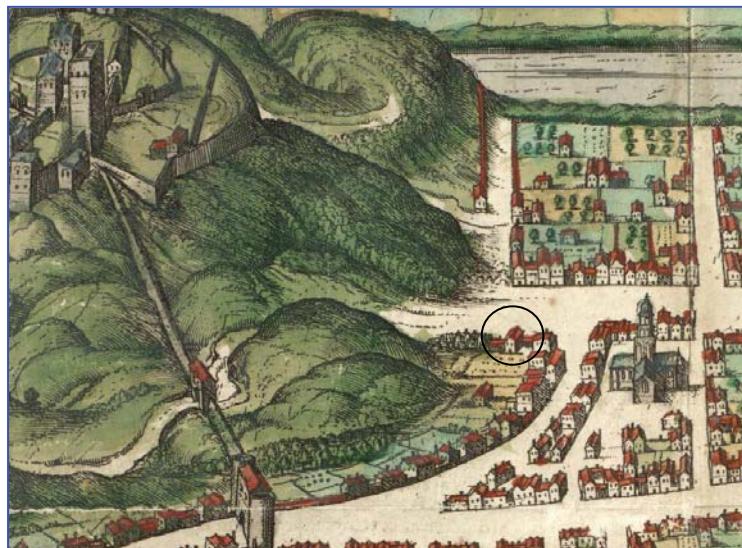
Figure 2: Extract from Braun's map, 1582

- 4.1 The frontage of Cannonball House dates to the late 16th century with a later wing to the rear completed in 1630 by Alexander Mure (McWilliam *et al* 1991, 193). Braun and Hogenberg's stylised map of Edinburgh of 1582 shows a building in its position, with a gable fronting Castlehill and to the rear (Figure 2). James Gordon's more detailed 1647 map shows the building in more detail, with what is presumably the rear 1630 extension to the east side (Figure 3).

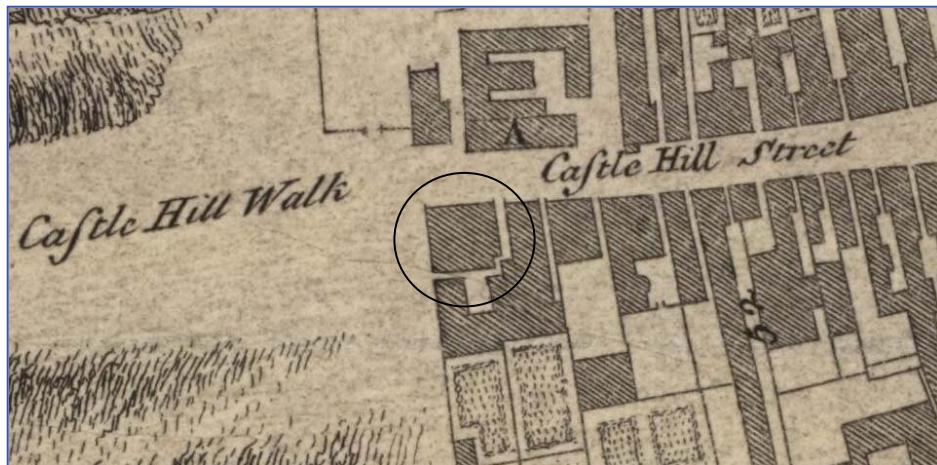
Figure 4: Extract from Edgar's map, 1765

- 4.2 The house was also later extended in the 18th century to the east side and remodelled with a lower pitched roof (McWilliam *et al* 1991, 193). In Edgar's 1765 map, it is shown as a simple rectangular block with a small recess to the south-east corner and adjacent to Blair's Close to the east (Figure 4). The same layout is seen throughout the later 18th century and early 19th century mapping.

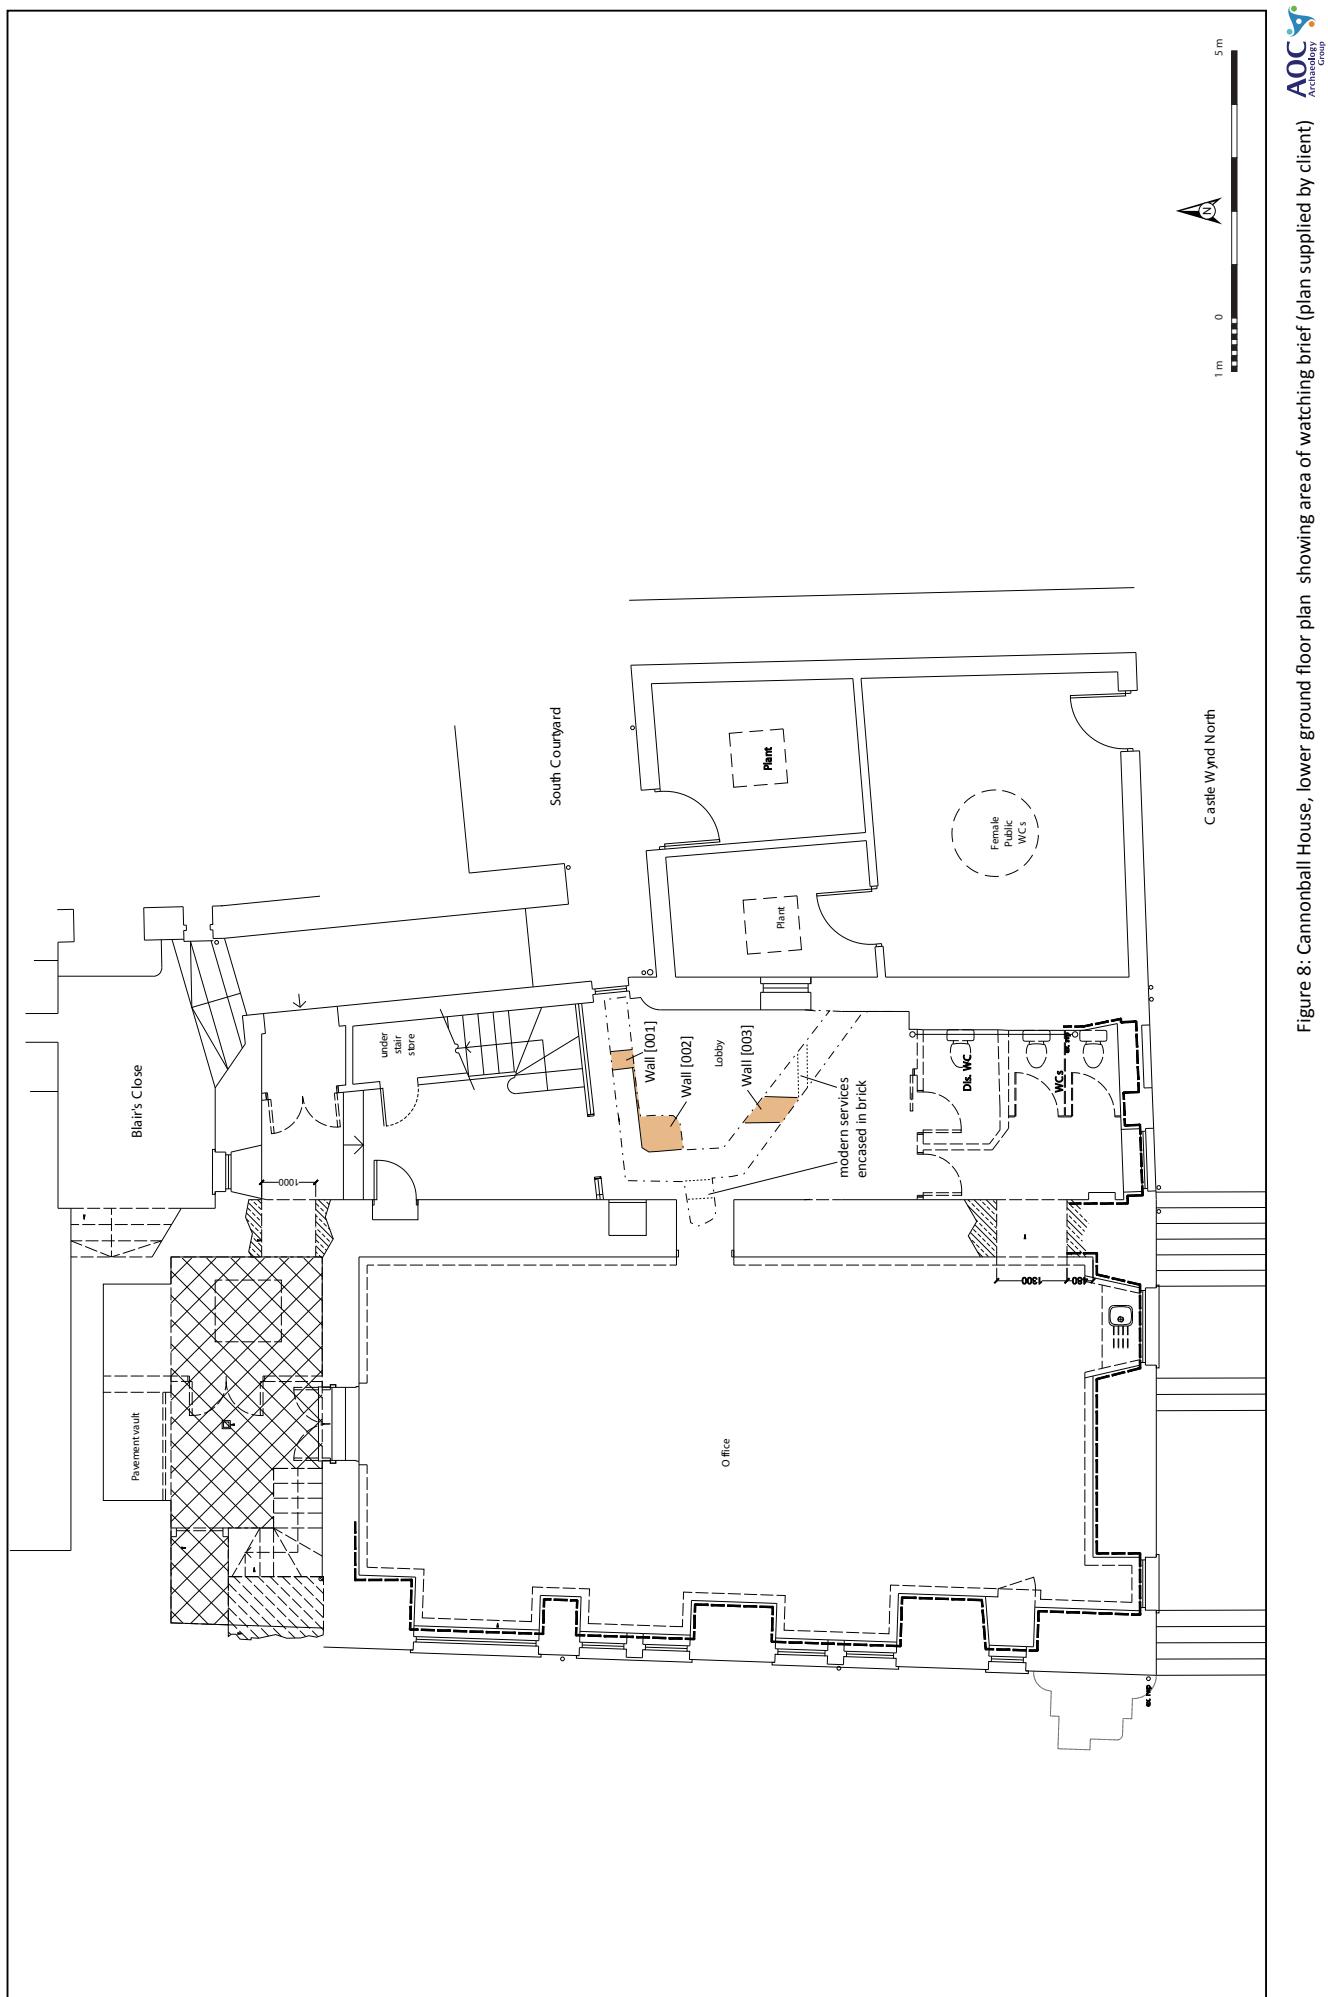
Figure 8: Cannonball House, lower ground floor plan showing area of watching brief (plan supplied by client)

- 5.2.1 The ground-breaking works associated with the renovation of Cannonball House were limited in scope and area and all undertaken in the lower ground floor (Figure 8). The excavations comprised drainage trenches, 0.5m wide and 0.7m deep which tied in to existing drainage outside. A plan of the excavations can be found in Figure 8.

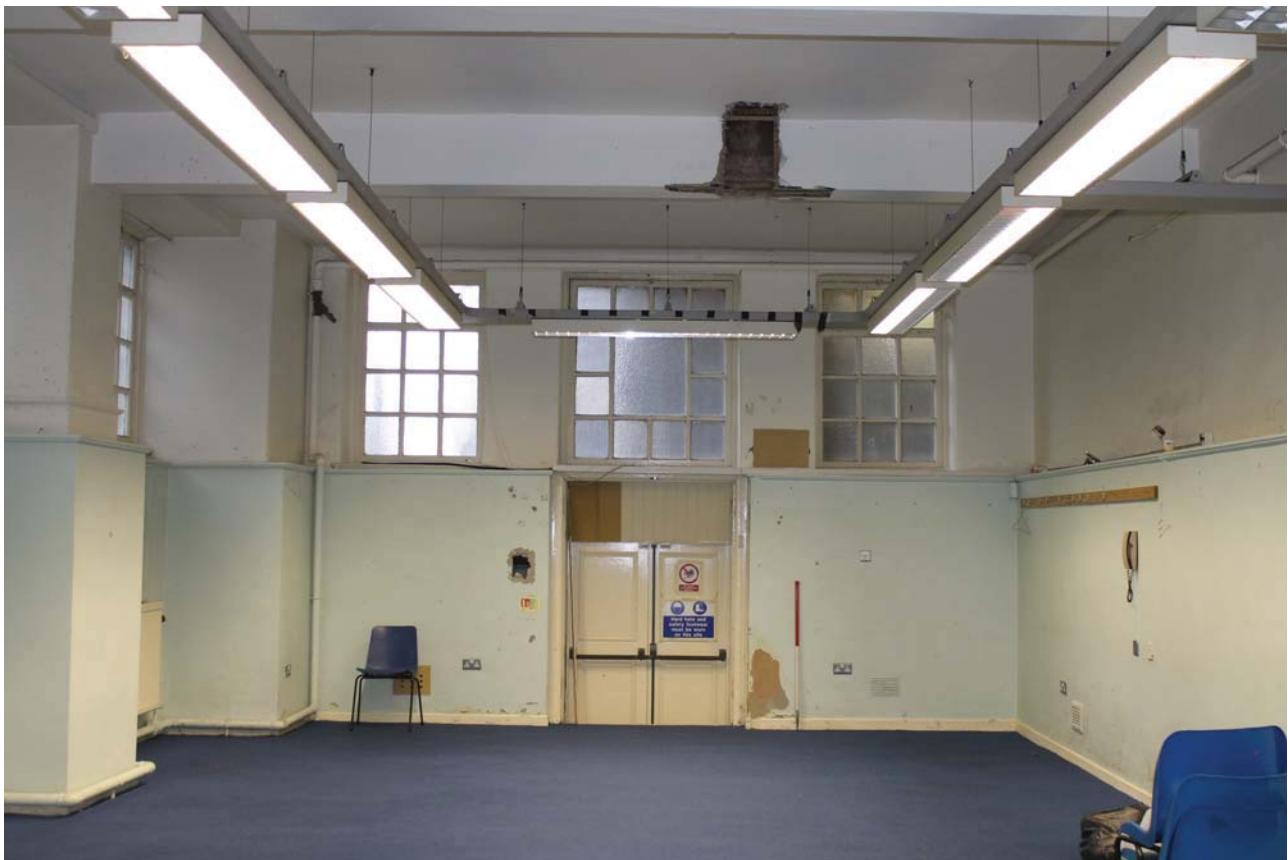
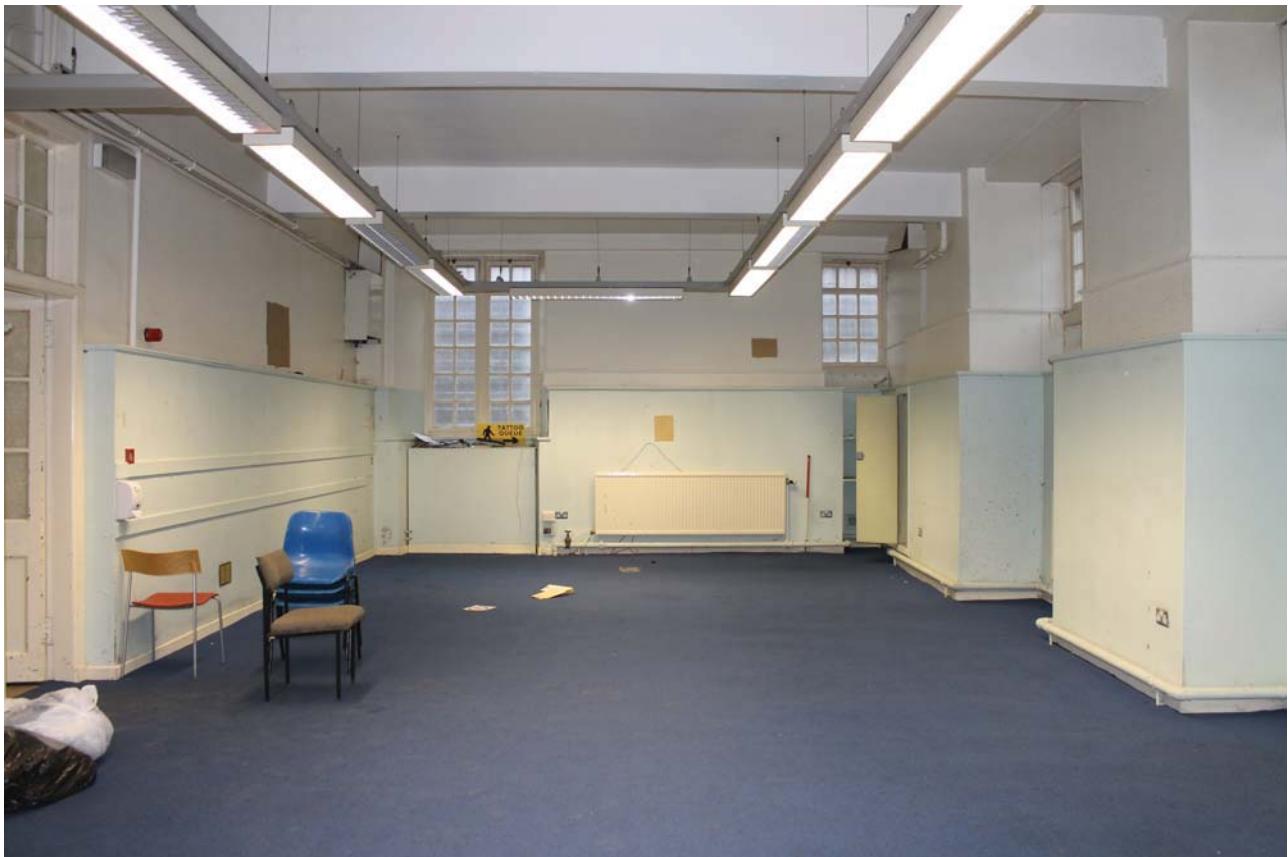
- 5.1.2 The lower ground floor consisted of the main entrance to the building on the north side with a long thin corridor to the east with a dog-leg stair in the north-east corner. The rest of the floor was taken up with a large four- by two-bay office to the west side (Figure 8; Plates 1 & 2). The casement windows date to the 1913 phase, with a fire exit door installed to the north wall and a number of irregularly-shaped windows elsewhere. The development called for a slapping for a new doorway to the south side of the east wall of this room (see Figure 8). Exposure of the wall behind this identified lath-and-plaster covering a heavily mortared stone rubble wall (Plate 3).

Plate 1: Cannonball House, lower ground floor, general view of the westernmost room from the south

Plate 2: Cannonball House, lower ground floor, general view of the westernmost room from the north

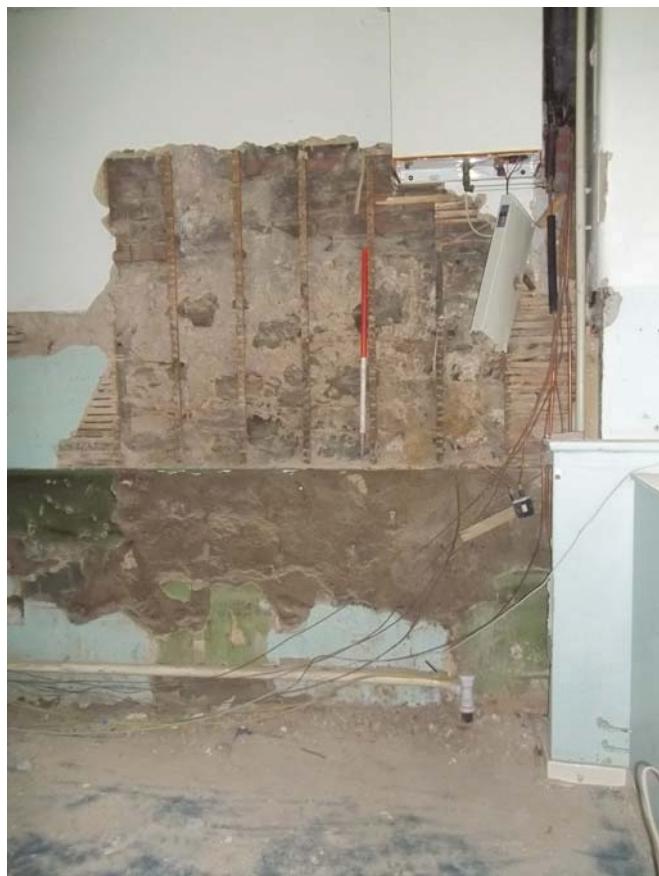
Plate 3: Cannonball House, lower ground floor, detail of exposed area to the south of the east wall from the west

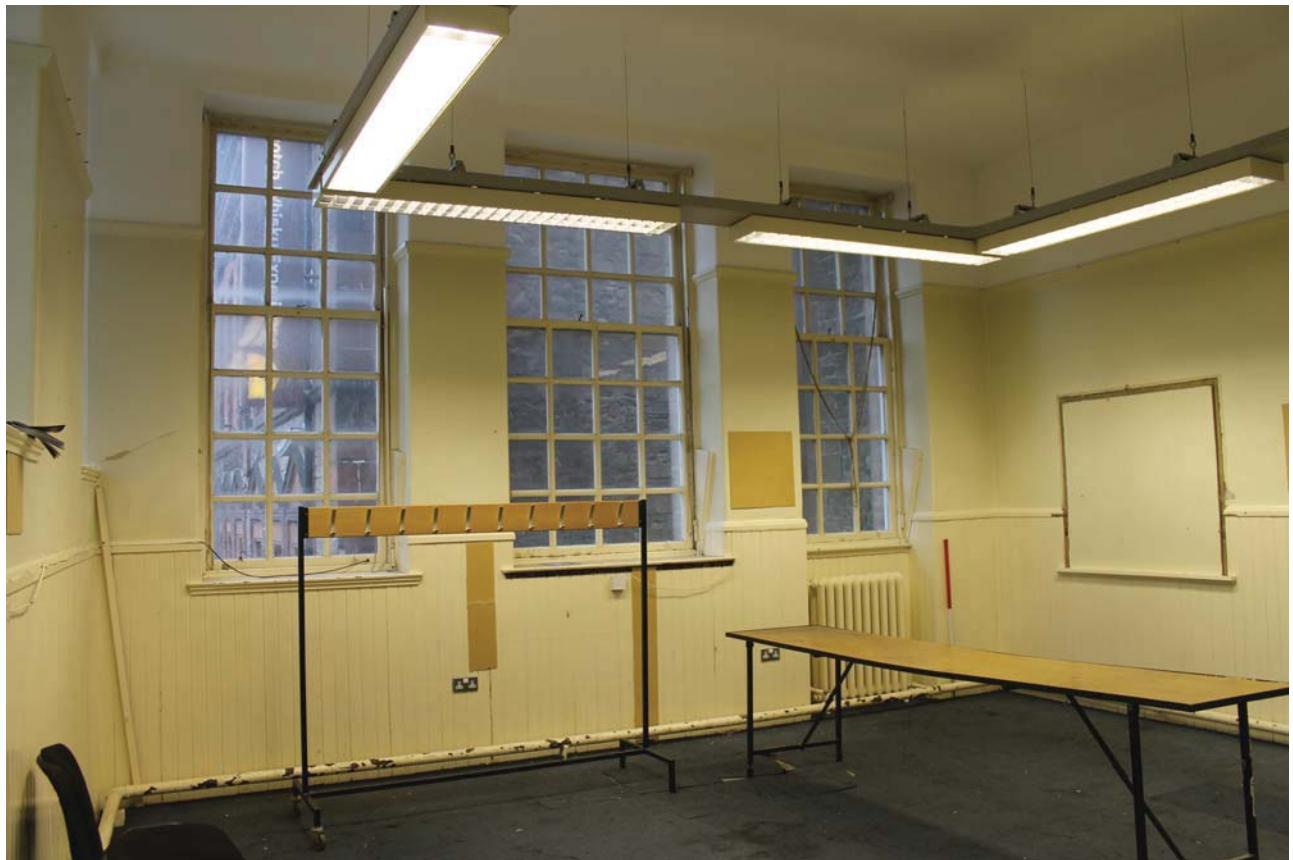
- 5.1.3 The ground floor consisted of the stairwell to the north-east corner leading on to a wide corridor to the east side (with a toilet block to the south) and two offices to the west side (Figure 9). The northernmost office had three windows to the north wall, four to the west and a partition wall to the south (Plates 4 – 6). The toilet to the south end had a small window to the south side of the east wall, a probable original window opening (Plate 7). No areas on this floor level were subject to any soft strip.

Plate 4: Cannonball House, ground floor, general view of the westernmost office from the south-west

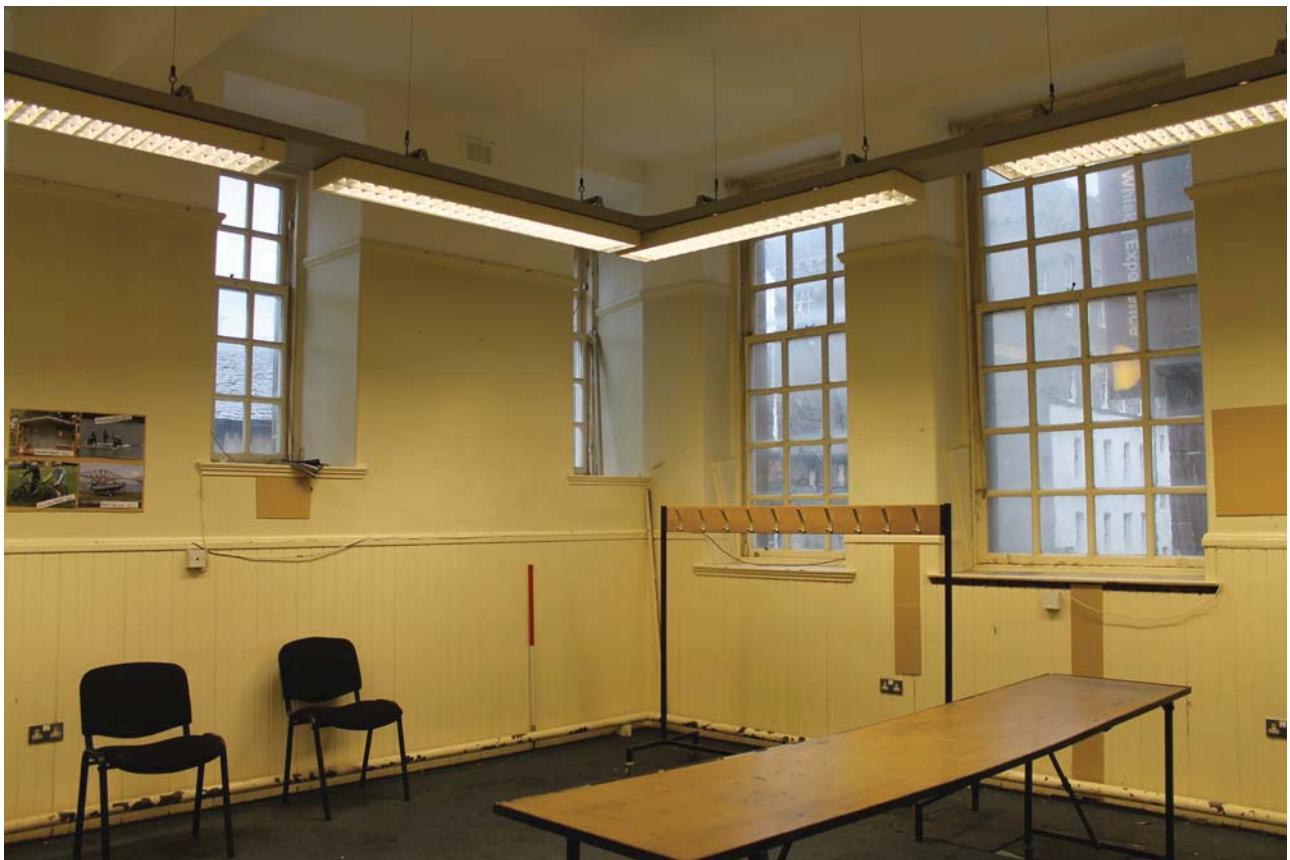
Plate 5: Cannonball House, ground floor, general view of the westernmost office from the south-east

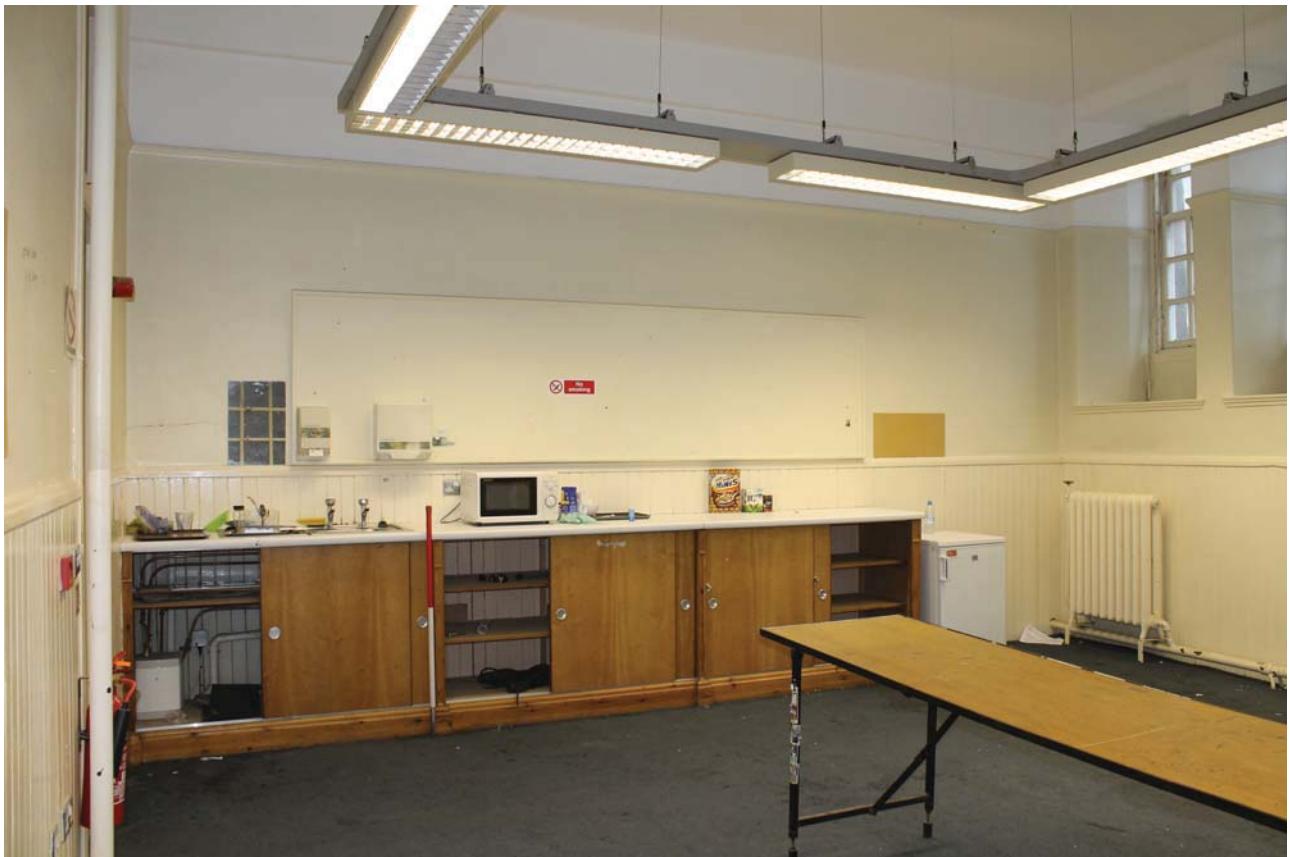
Plate 6: Cannonball House, ground floor, general view of the westernmost office from the north-east

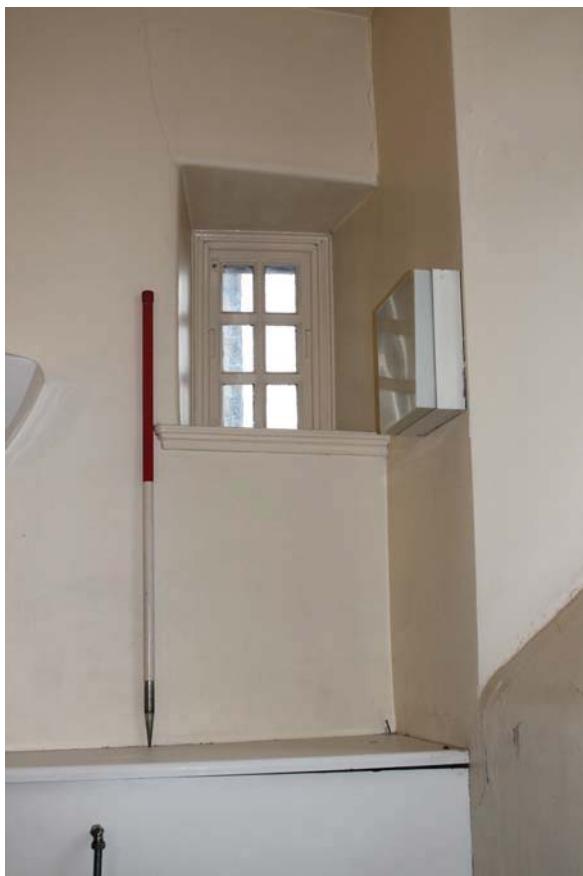
Plate 7: Cannonball House, detail of small early window to toilet block to the south in the south side of the east wall, from the west

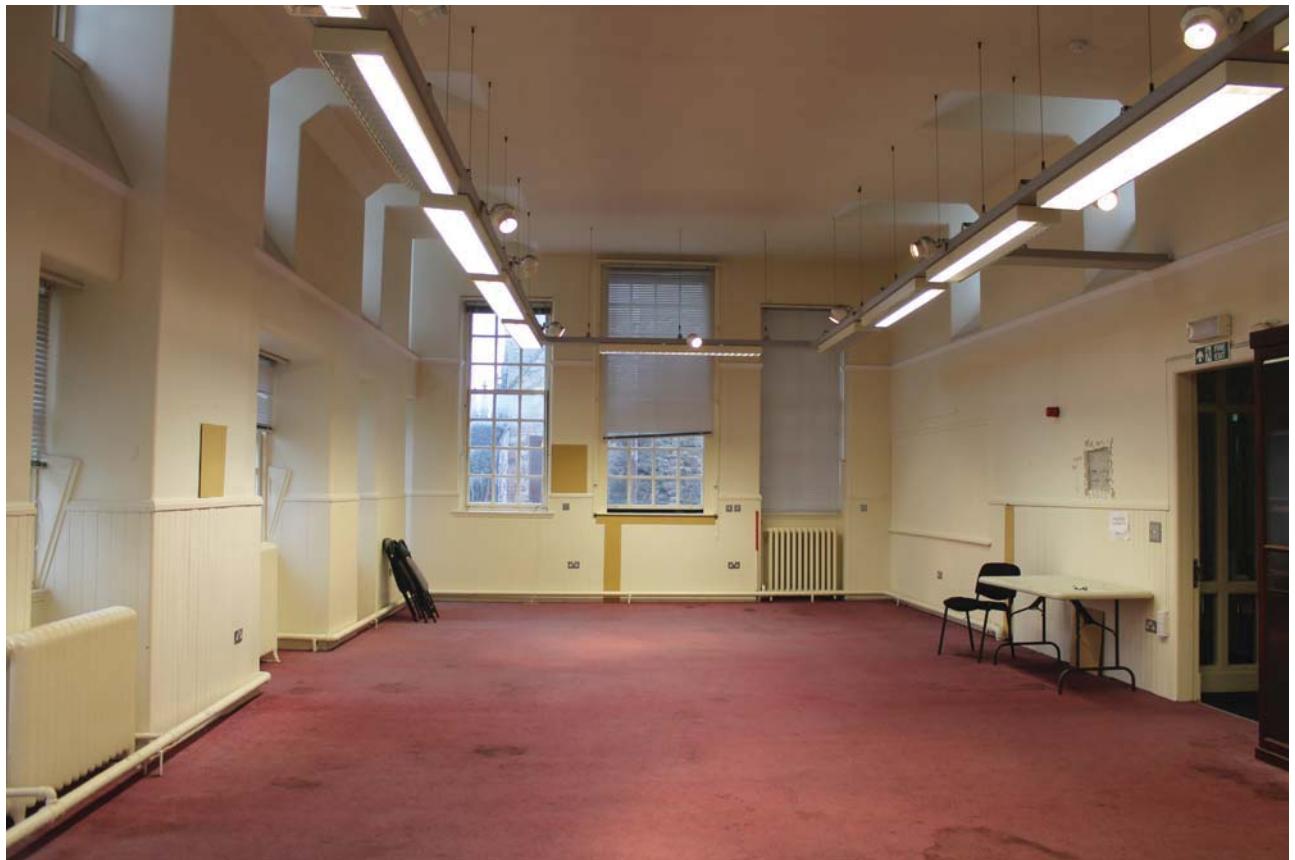
- 5.1.4 The first floor consisted of the top level of the building with the stairwell to the north-east side, opening out into a wide lobby (a modern partition separates them). There is a small office to the south and a large office to the west side taking up the entirety of the building here (Figure 10; Plates 8 & 9). As with the floors below, the three windows along this wall demonstrates the 1913 remodelling of the frontage (see Plate 8). The rest of the windows are much more irregular corresponding to the earlier 17th century building with later 18th century modifications. The west wall consists of three double windows with small separate windows to the north side. The south wall also has an irregular arrangement of windows with a small window to the far west side (see Plate 9). A door slapping was placed to the south side of the east wall and this exposed a heavily rendered stone rubble wall with an area of brick patching above the dado level above the timber panelling (Plate 10). To the far southern end of this east wall, a small cupboard was also exposed, which revealed a brick blocking to the wall, possibly a blocking of an original doorway through to the office to the east side (Plate 11).

Plate 8: Cannonball House, first floor, general view of the westernmost room from the south

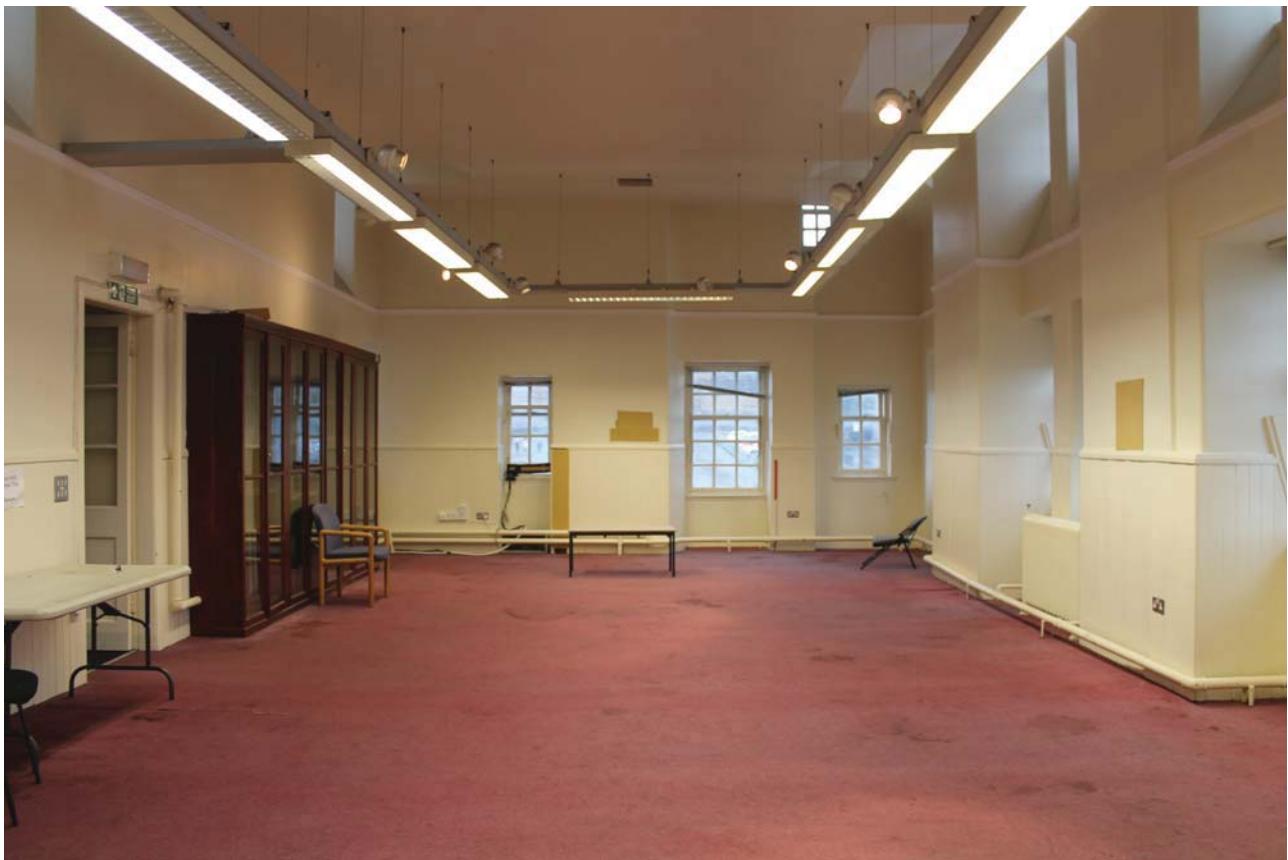
Plate 9: Cannonball House, first floor, general view of the westernmost room from the north

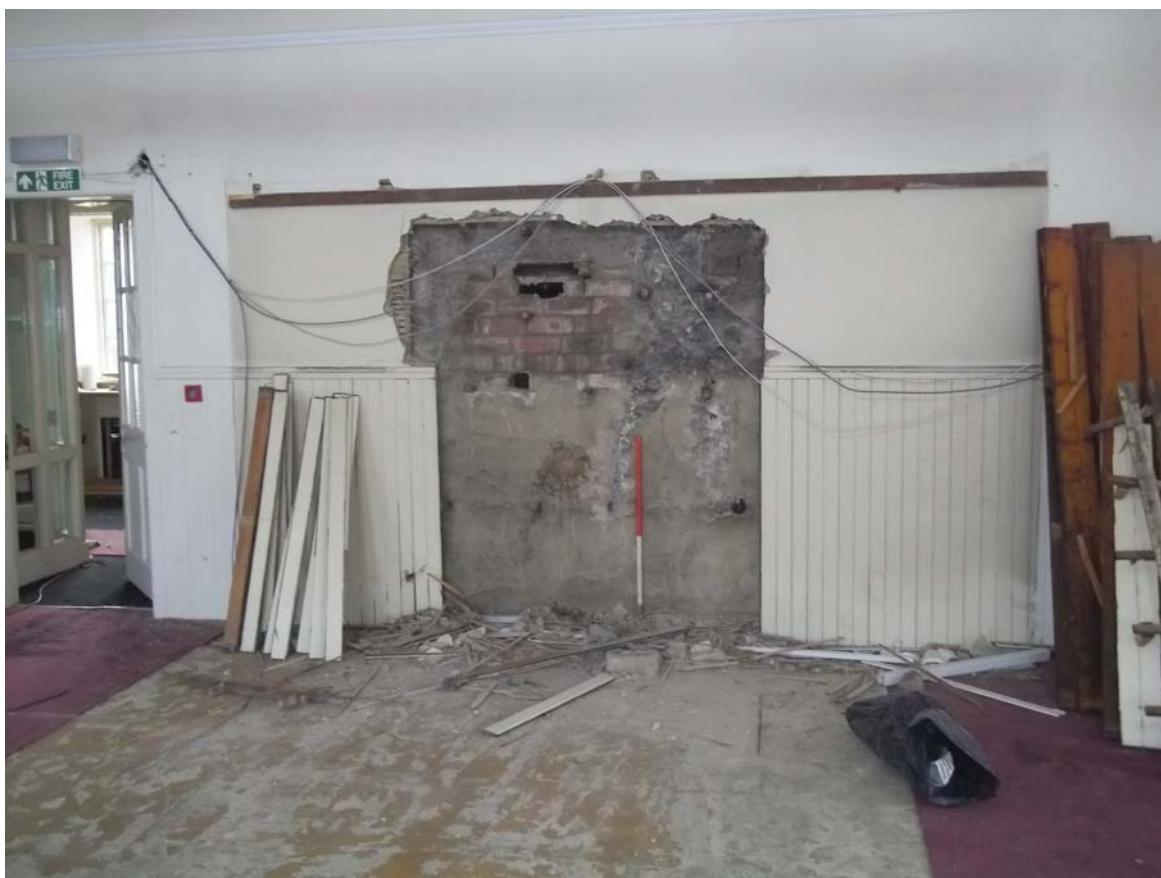
Plate 10: Cannonball House, first floor, detail of the exposed walling to the east side of the south wall from the west

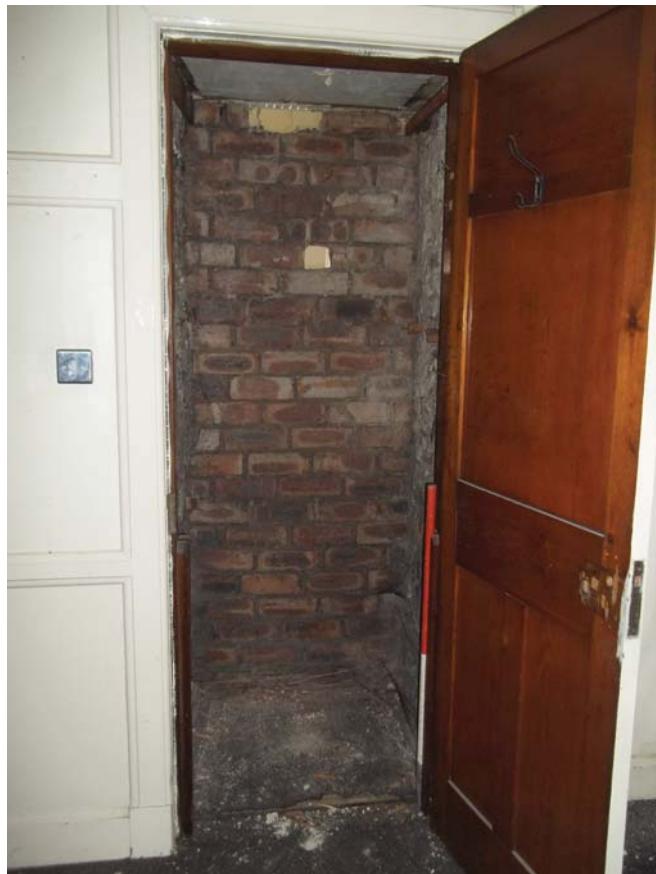
6.1.1 The renovations in the house were very minimal and did not reveal any features of note within the building. The cupboard in the second floor to the south of the east wall was possibly an original doorway through to the office on the opposite side.

Plate 11: Cannonball House, first floor, detail of the small cupboard to the far south side of the east wall from the west

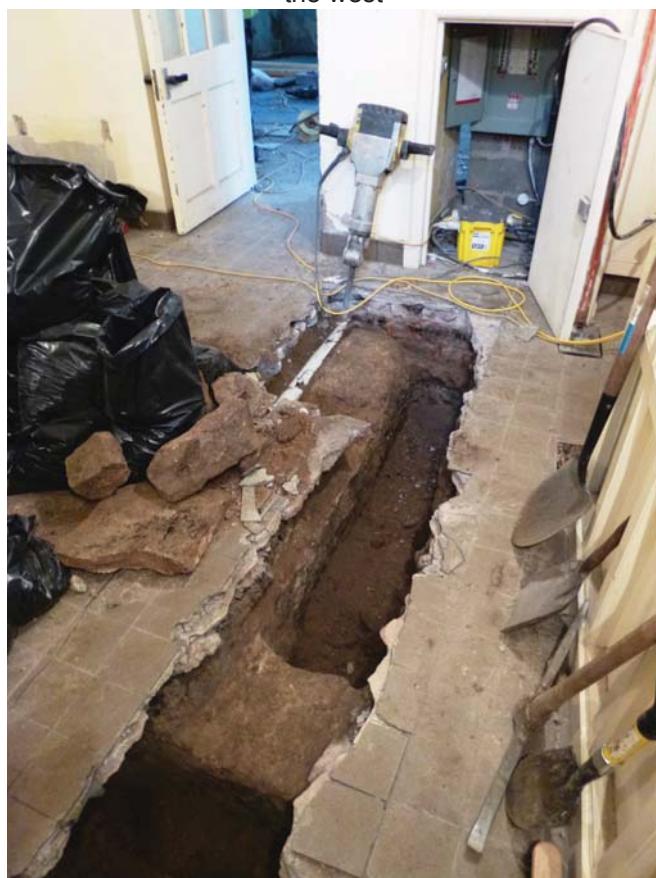
- 5.2.2 Four sandstone walls were exposed. Walls [001] & [002] were constructed of a single course of ashlar sandstone blocks, between 0.33m and 0.35m in size, bonded with lime mortar. The walls were clearly keyed into each other, therefore being of the same phase of construction (Plate 12). Wall [003] was wider, 0.5m in width, and parallel to the line of Wall [001]. It was exposed to 0.8m of its length in the small service trench that was excavated (see Figure 8; Plate 13). Wall [004] lay directly below it, although on the same alignment, as an upstanding internal wall foundation. It was 1.2m in width and composed of irregular sandstone blocks bonded with lime mortar.

Plate 12: Cannonball House, lower ground floor, detail of the service trench exposing Wall [001] (to the foreground) and Wall [002] (running perpendicular to it from Wall [001], from the south)

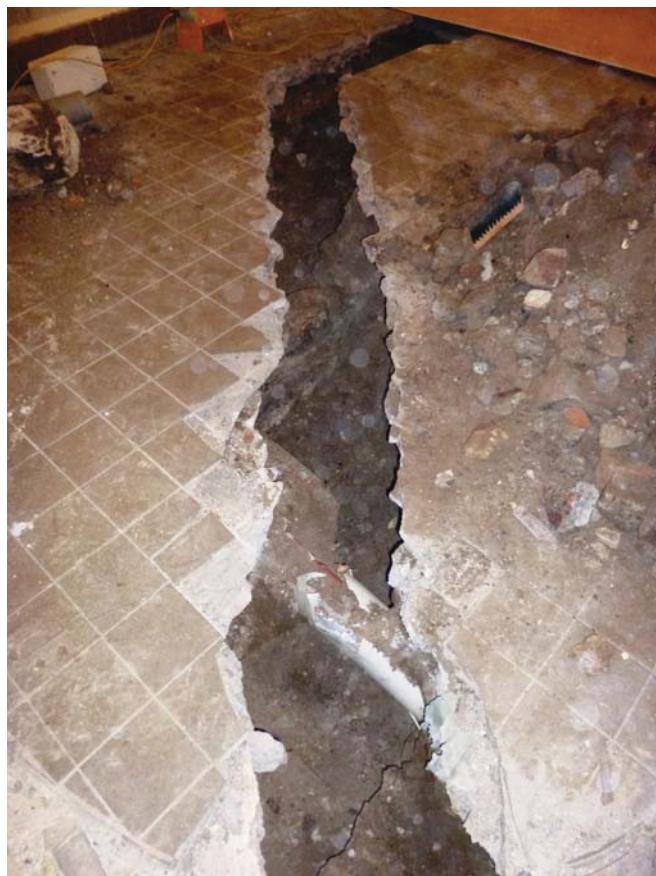
Plate 13: Cannonball House, lower ground floor, detail of the service trench exposing Wall [003] from the south - note that a modern brick and concrete service is located below this to the south
