# Mallards, Southside Common, Wimbledon, London Borough of Merton: An Archaeological Watching Brief Report

Planning Reference: 13/P1291

AOC Project No: 32515

Date: January 2014

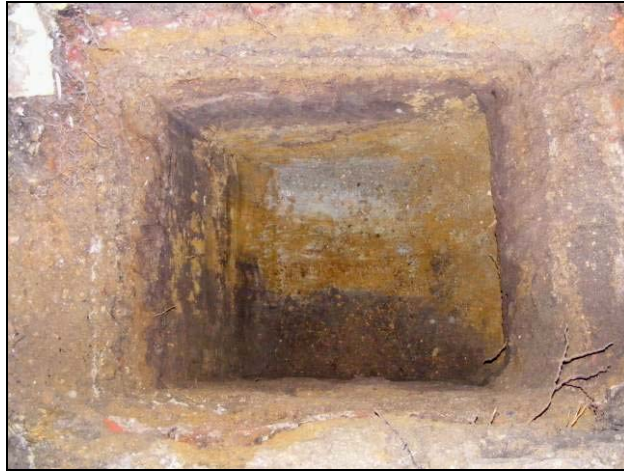
- 7.1.2 At the same height as (20), approximately 54.21mOD, was a possible cut feature recorded as [10] (Plate 1 and Figure 3). The feature, which was only observed within the base and section of a small underpinning pit, appeared to be curved, measuring 1.20m x 0.60m x 0.50m deep. The cut was filled by (11), a mid grey brown silty clay with inclusions of small stones. It is unclear what the feature is, although a tree bowl or garden feature could be possible functions.

**Plate 1 – Cut feature [10]**

- 9.2 A possible cut feature was observed within the same pit which may be the remains of an earlier tree bowl or garden feature related to Lauriston House and a formal garden layout. The fill of the pit was similar in composition as the soil horizon described above; as such it is likely that they are contemporary.

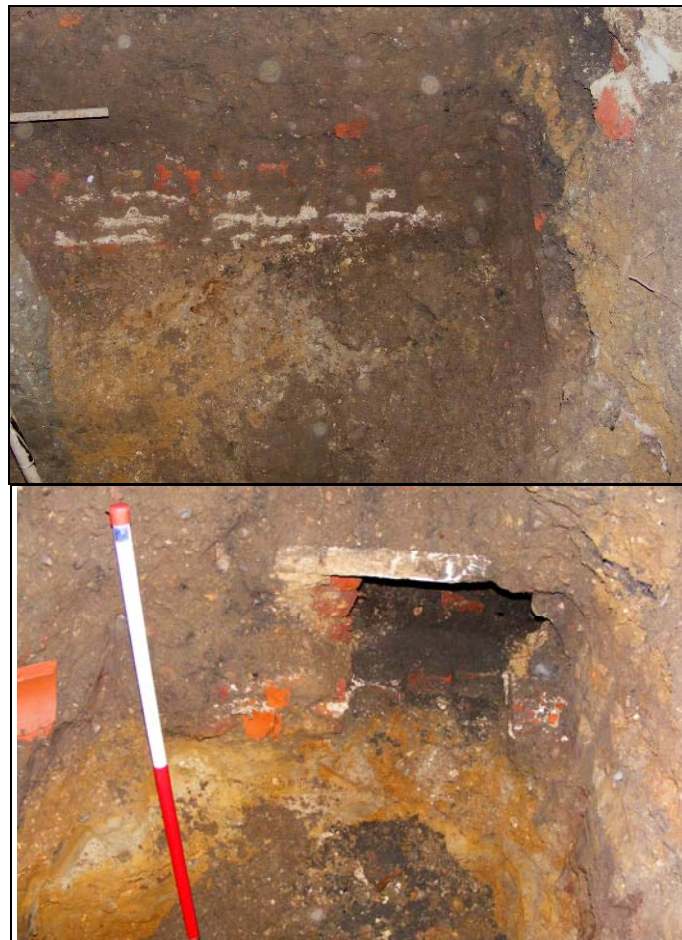
7.1.3 During both stages of underpinning pits and ground reduction, a number of brick walls and drains were recorded (Figure 3). Wall [1], recorded at a height of 54.21mOD, was located to the northwest of the current property lying directly on the natural clay and gravel (Plate 2). The wall, measuring 1.30m x 0.45m high, was composed of red and yellow brick, measuring 220mm x 80mm; width unknown. The bricks were bonded by lime mortar. The southeastern edge of the wall extends below the current building and was recorded in section within another underpinning pit and recorded as wall [2] (Plate 3).

**Plate 2 & 3 – Wall [1] (upper plate) and Wall [2] (lower plate) facing southwest**

7.1.4 Wall [2] was composed of the same brick as wall [1]. However, above the highest course of brickwork, within the exposed section, was a slab of cut stone overlying an opening within the wall.

Initial observations on site suggest that the opening maybe for a drain. The wall measured 1.20m x 0.35m x 0.60m high at a height of 54.65mOD.

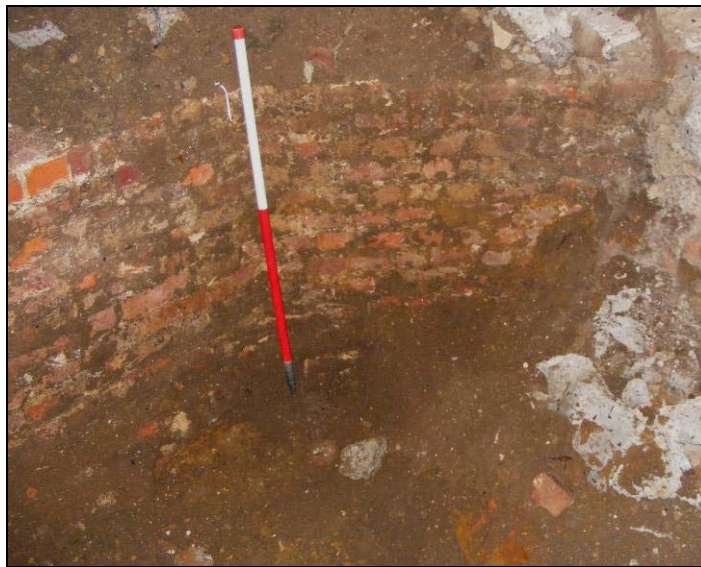
- 7.1.6 Walls [4] and [5] were located within the former kitchen area towards the south-eastern corner of the site at an upper height of 54.79mOD. Wall [5] ran northwest-southeast whilst wall [4] ran north-south and then northeast-southwest. Wall [4] measured 3.50m x 0.95m x 0.44m high and was composed of red and purple red bricks measuring 220mm x 80mm x 65mm (Plate 4). The bricks were bonded with lime mortar with no apparent coursing design. At least 10 courses were recorded *in situ* suggesting the remains are the foundations of the previous structure on site.

**Plate 4 – Wall [4] facing north**

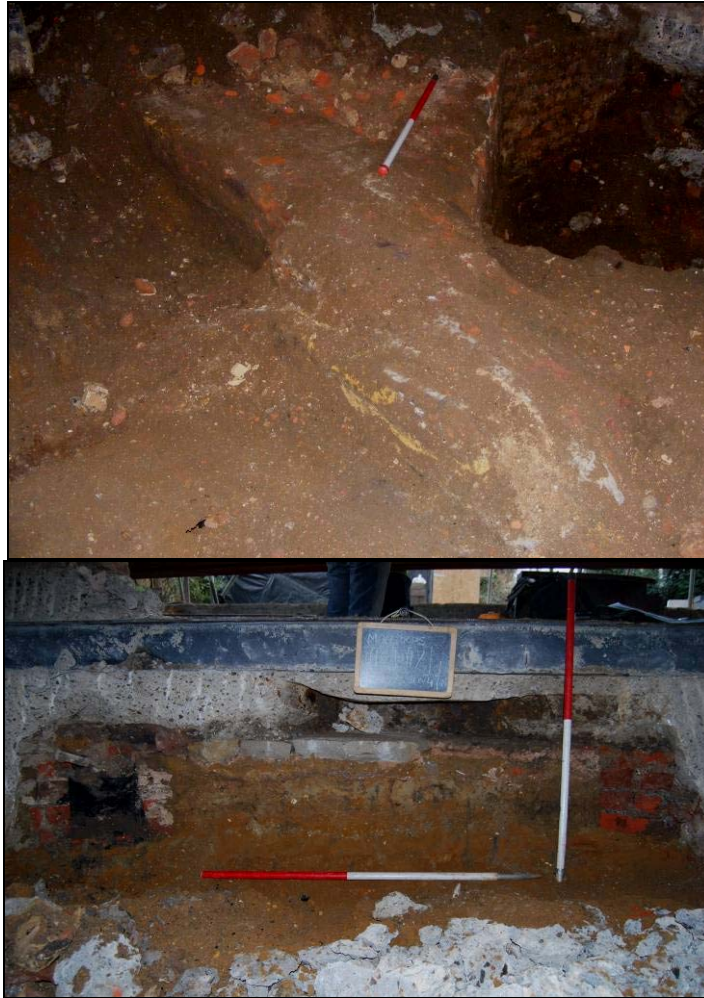
- 7.1.7 Wall [5] abutted wall [4] and measured 0.95m x 0.45m x 0.95m high (Plate 5). The same bricks were used in this wall as within wall [4], however yellow bricks and a concrete top layer were also observed within wall [5]. The wall was also recorded in section during the main ground reduction on site as [17], (Plate 6 and Figure 4, Section 2). From the section it was clear that for the construction of the wall a layer of 0.11m thick redeposited natural (25) had been laid, overlain with a deposit of fine yellow sand (26). Cutting into these was [24] the foundation cut for wall [17] / [5]. The foundation cut which measured 0.30m x 0.38m deep, was backfilled with (23) a dark to mid brown gravely silty clay. Adjacent to the wall and above (26) was a layer of cut stone slabs (27) which are likely the remains of the original surface. Wall [17] was recorded at an upper height of 54.19mOD.

**Plate 5 & 6 – Wall [5] facing north (upper plate) and Wall [17] and drain [16] facing southeast (lower plate)**

- 7.1.8 On the adjacent side to the stone slabs was the remains of a brick box drain [16], composed of red brick walls and tiled base (Plate 6 and Figure 4, Section 2). The interior of the structure was observed as a black silt. The cut for the drain was recorded as [22] whilst the light brown orange sandy clay backfill was recorded as (21). The drain measured 0.45m wide x 0.24m deep.
- 7.1.9 Another brick drain similar in construction to [16] was recorded as [18] and was observed in section within the northwest corner of the former breakfast room (Plate 7 and Figure 4, Section 3 & 4). The exposed section, recorded at a height of 54.30mOD, measured 0.90m x 0.30m x 0.25m deep and was formed of red half bricks measuring 100mm x 100mm x 70mm and red tiles measuring 300mm x 250mm x 40mm.

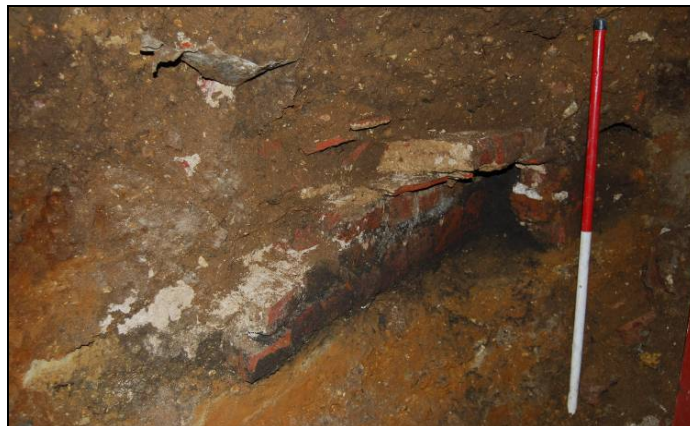
**Plate 7 – Drain [18] facing southwest**

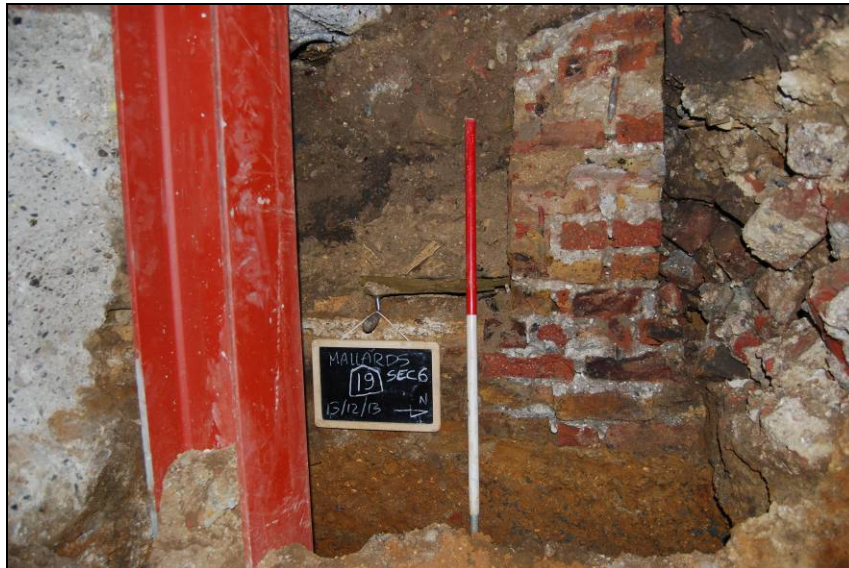
- 7.1.13 The final wall recorded on site was observed during ground reduction within the former breakfast room. Wall [19] measured 0.56m wide and 1.04m deep and was surrounded on both sides by made ground and modern rubble (Plate 8 and Figure 4, Section 5). The wall, recorded at an upper height of 54.80mOD, was composed of red and yellow brick measuring 220mm x 100mm x 70mm and bonded by lime mortar. The foundation cut for the wall was observed on its southeastern side and recorded as [29]. The backfill of dark grey sandy silty clay was recorded as (28). Overlying the cut was (30) a 0.06m thick layer of concrete which in turn was overlaid by a sandstone slab recorded as (31). These layers may represent another surface to the original structure.

**Plate 8 – Wall [19] facing southwest**
