Triple Kirks Excavation, Aberdeen: Data Structure Report

AOC Project 22001
OASIS ID aocarcha1-169899
29th January 2014

Triple Kirks Evaluation, Aberdeen: Data Structure Report

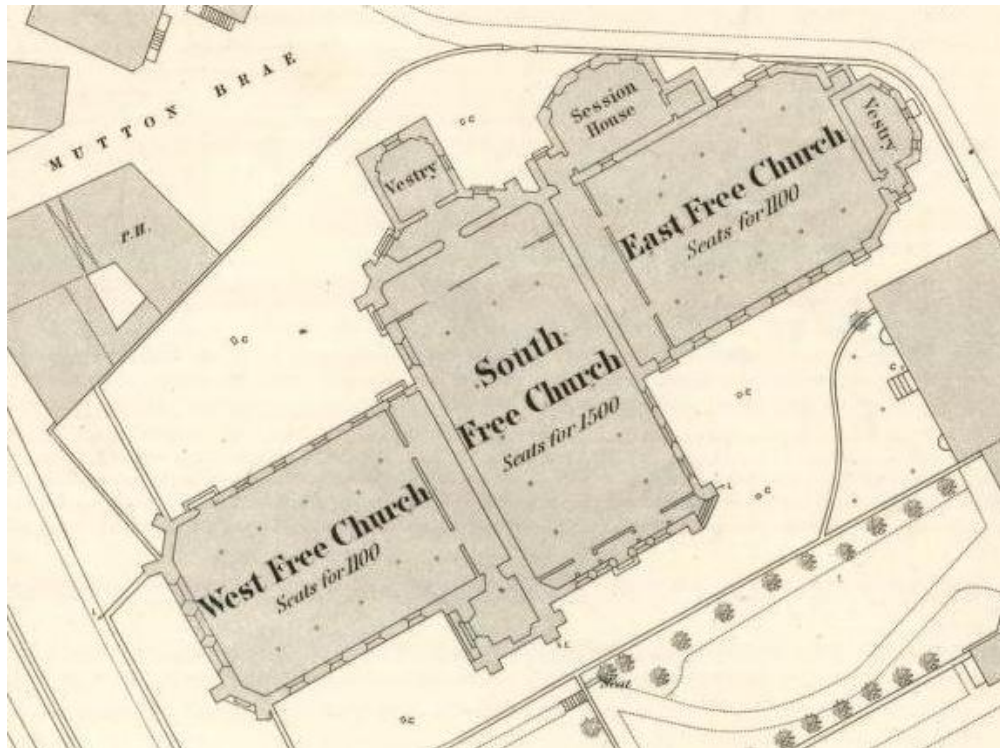
Plate 1 Detail from 1867 1st Edition Ordnance Survey map, 25 inch, Sheet LXXV, 11.13

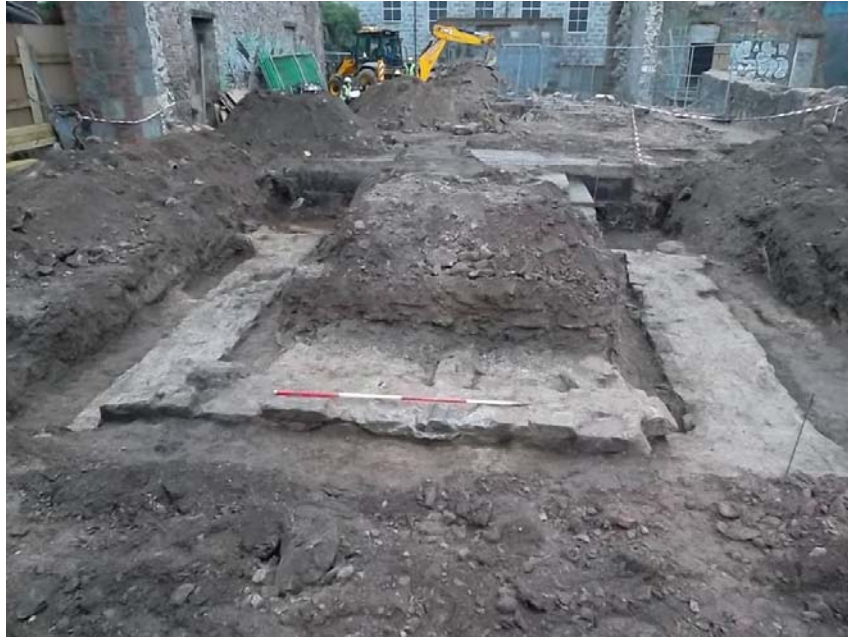
- v) Appendix 5 contains reproduces the *Discovery and Excavation in Scotland* entry
- 4.2 The northern half of the excavation area revealed in-situ remains of the walls of the South Free Church Vestry, which had originally been identified in Trench 1 of the evaluation (AOC 2012). This consisted of a wall [002] constructed of large blocks of mortared stone, between 0.70 – 0.80 m wide, and up to 0.40 m high. This was sat directly over a foundation level [001], consisting of a layer of massive mortared stone slabs, up to 1.10 m wide. A cut [018] was identified below the foundations, within which a made ground deposit containing dark brown/black sandy clay and silt with fragments of stone, mortar and cinder. Artefactual material was recovered from deposit [017], including pottery, bone, red roof tile, and red brick. The pottery from this deposit has been dated to exclusively c 1820 – 1930 (George Haggarty pers comm.). This deposit directly overlies natural sands and gravels [014] and has been interpreted as a levelling deposit, on which the foundations of the Vestry wall lie.

Plate 2: Vestry Foundations [001] and Wall [002].
