St Ninian's Way, West Lothian: Data Structure Report

AOC Project 22673
OASIS ID: aocarcha1-175405
March 2014

Data Structure Report

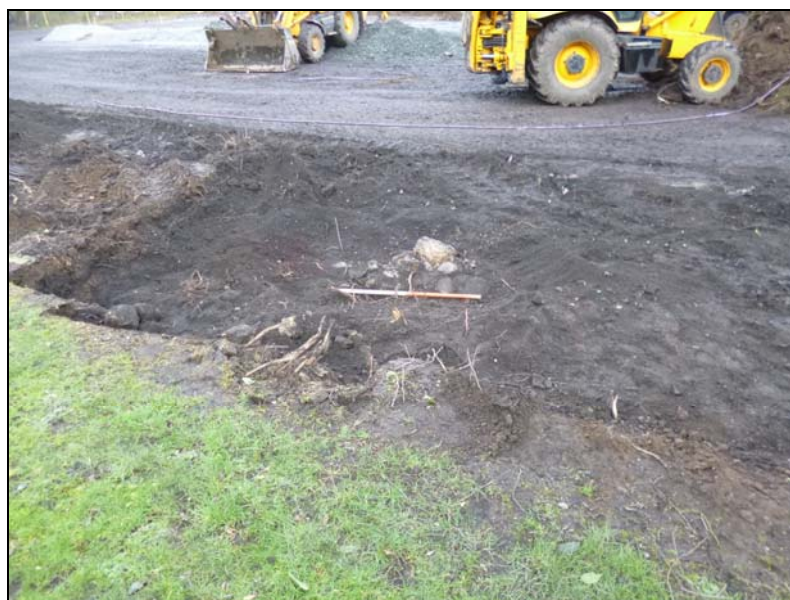
Plate 1- Demolished wall fragment [007] within made ground [013]

(this material may have been imported into the central reservation). This topsoil varied in depth, but was commonly between 0.4 m and 0.7 m in depth (though locally 1.1 m in depth in the south-west of the site). This fairly loose topsoil overlay a more compact mid-dark reddish brown sandy silt soil (013), which commonly contained modern debris (including plastic and metal) and rubble and varied considerably in depth from 0.1 to 0.5 m. It was also present to the east of the existing car park, with common lenses of light-mid reddish brown sandy silt (002). Deposit (013) was interpreted as made ground or a former topsoil, likely disturbed at the time of the construction of the existing car park. The total depth of modern topsoil deposits (001) and (013) extended commonly to between 0.6 m and 0.9 m. Various services and drainage features were found to cut these deposits, including a roughly south/north-aligned drain (015), which contained a fill (014) largely made up of rounded and subrounded stones with occasional brick fragments. In the west of the site (013) was found to enclose a 1.0 m long fragment of mortared rubble wall (007), which was clearly not in situ, and likely represents the demolition of a boundary wall in this area (Plate 1).

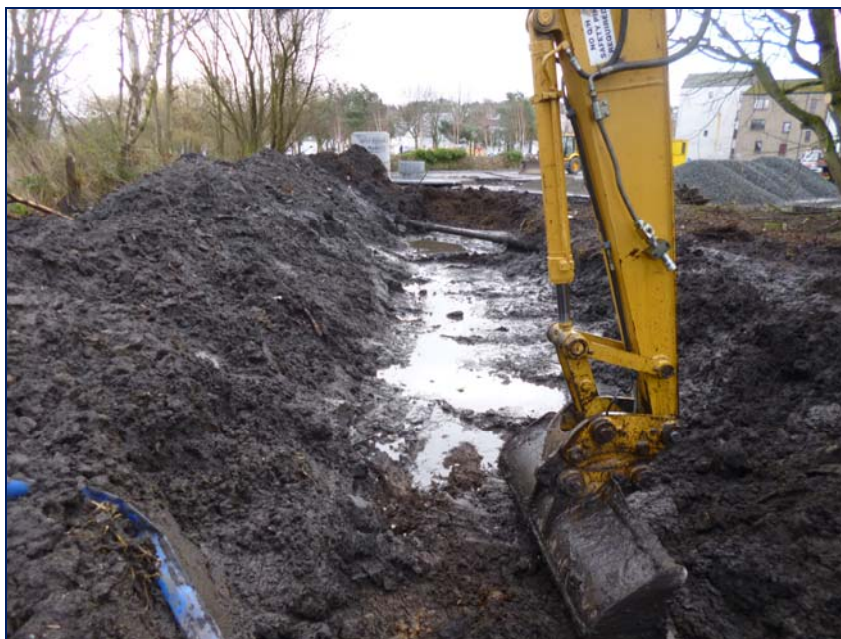
Plate 2- Excavation of Filter Trench to north of car park, with Sam's Dyke [012] in distance to east

- 4.2.3 In the north of the central reservation, and in the north and east of the site generally, where excavation within drainage gullies and trenches extended to a depth of c. 0.8 m or more, a deposit of light reddish brown and light grey gritty silt with gravel and stone (016) was commonly seen, under (013). This appears to be a demolition/made ground deposit. Much the same material (018), though clearly containing occasional brick fragments and at a shallower depth (c.0.4 m from the surface), was seen in the excavations to the north of the existing car park, in particular within the surface water Filter Trench (Plate 2), indicating extensive modern disturbance of the area around the car park and south of the loch.
