Royal Edinburgh Hospital, Edinburgh

Archaeological Evaluation & Historic Building

Recording

AOC 22595
31st March 2014

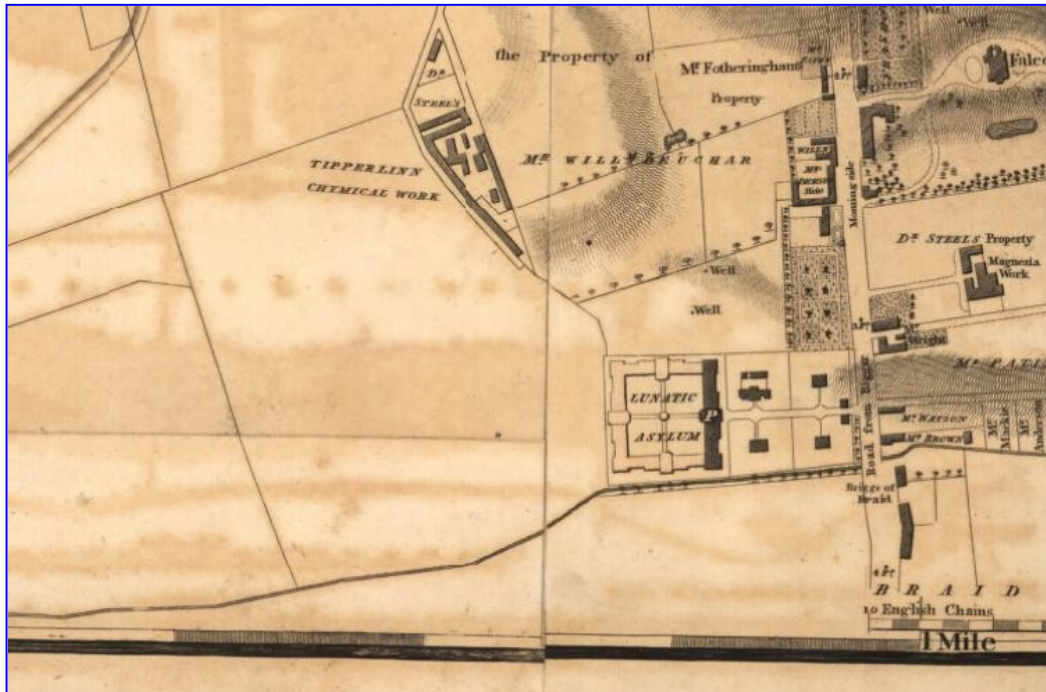
- 1.3.1 A lunatic asylum was constructed to the east of the present Royal Edinburgh Hospital in 1813, and it can clearly be seen in Kirkwood's 1817 map (Figure 2). The site to the immediate west of this (the position of the future Royal Edinburgh Hospital) is open farmland. Tipperlin Chemical Works is shown to the north of the site.

Figure 2: Extract from Kirkwood's map, 1817 (The area of the present Royal Edinburgh Hospital is to the west of the building annotated 'Lunatic Asylum')

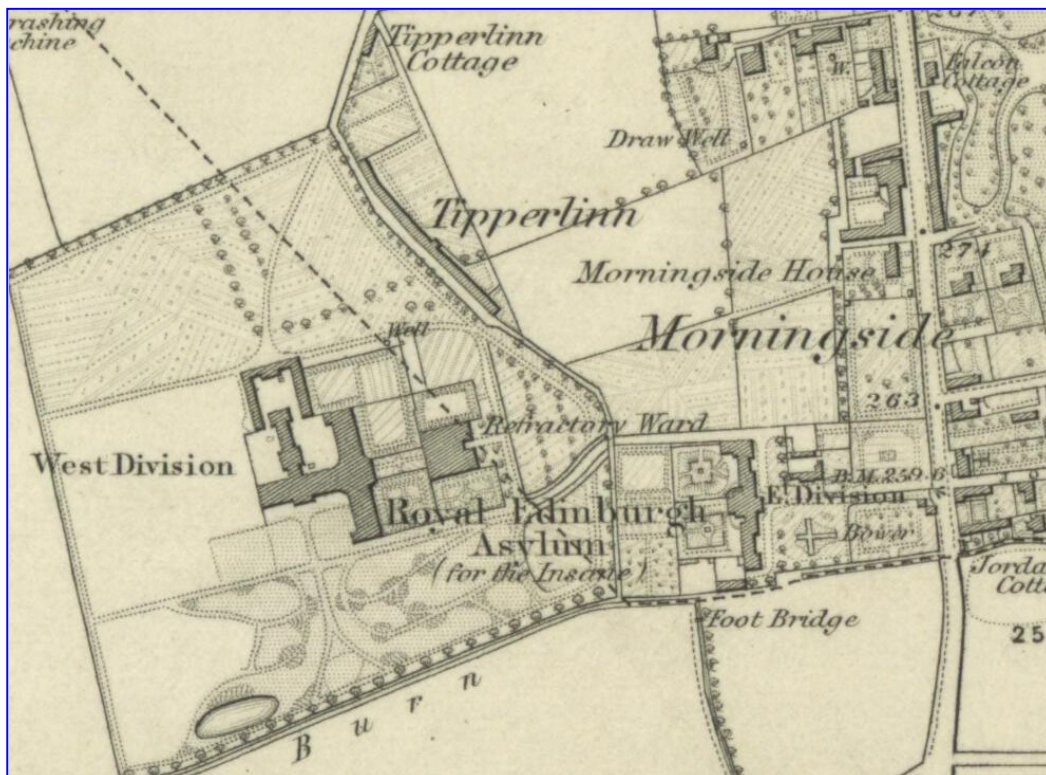
- 1.3.2 The Royal Edinburgh Hospital was constructed between 1839 and 1842 to a design by the renowned architect of the time, William Burn, and can clearly be seen on the First Edition Ordnance Survey map of 1852 (Figure 3). It was constructed as a three-storey lunatic asylum with an additional service court to the north-west side. The original asylum 1813 still existed to the east. By the time of the 1897 Ordnance Survey map, the H-plan of the new hospital had been completed (Figure 4).

Figure 3: Extract from Ordnance Survey map, 1852
(The earlier 1813 asylum is to the east, annotated 'E Division')

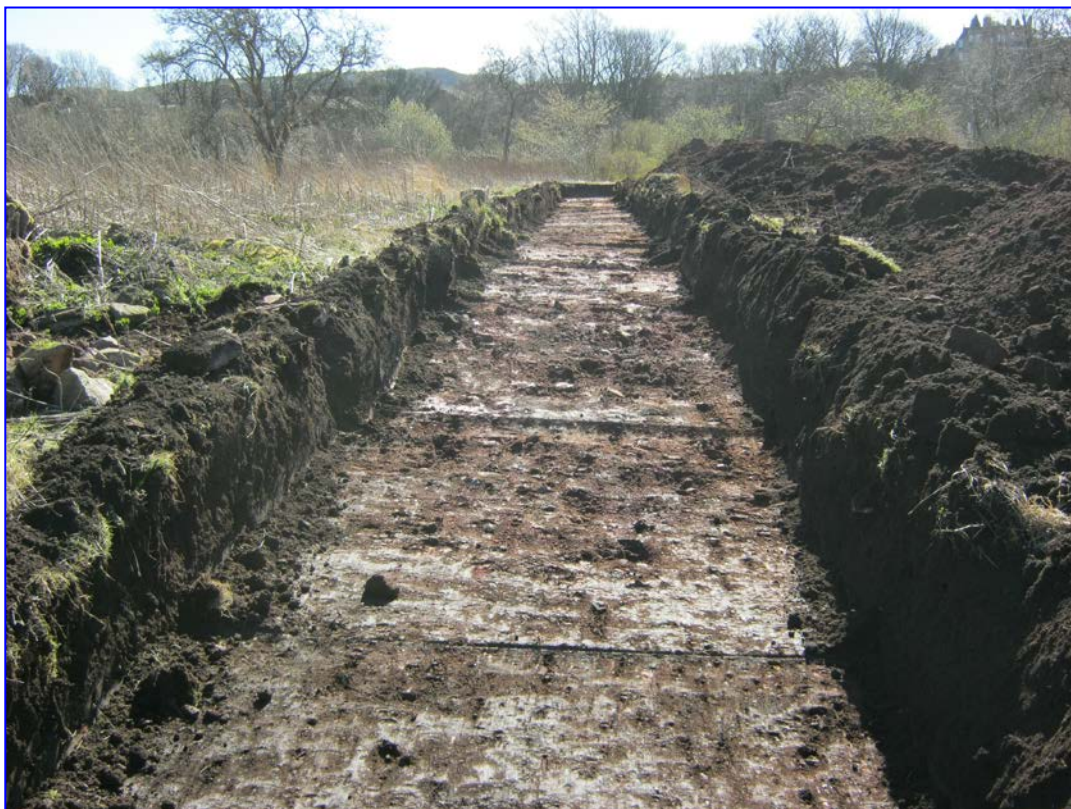
- 4.1.3 The north part of the site appeared to have been built up with a deposit of made ground 0.30m – 0.70m in depth immediately underlying this garden soil. The deposit consisted of demolition material and re-deposited topsoil and was visible within Trench 1 and the northern ends of Trenches 3 – 5 (Plates 1 - 3). This in turn overlay the natural subsoil.

Plate 1: Trench 2, general post-excavation shot from the NNW

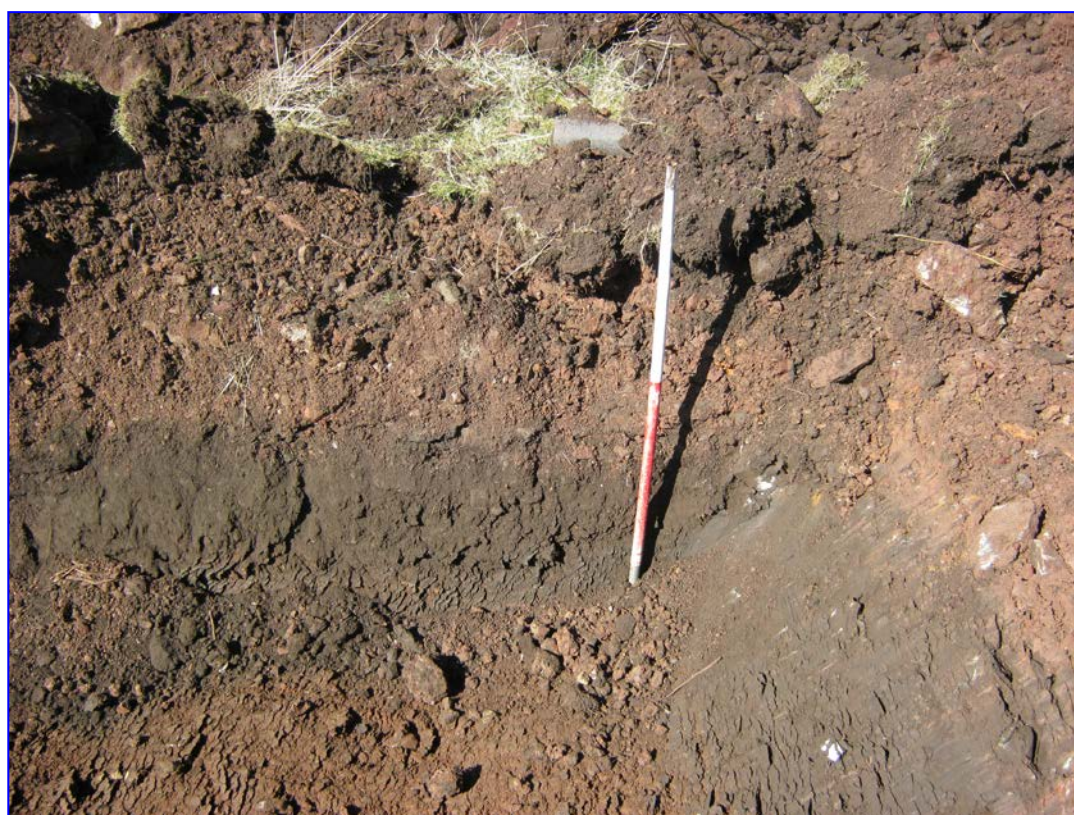
Plate 2: Trench 3, detail of the south-east facing section

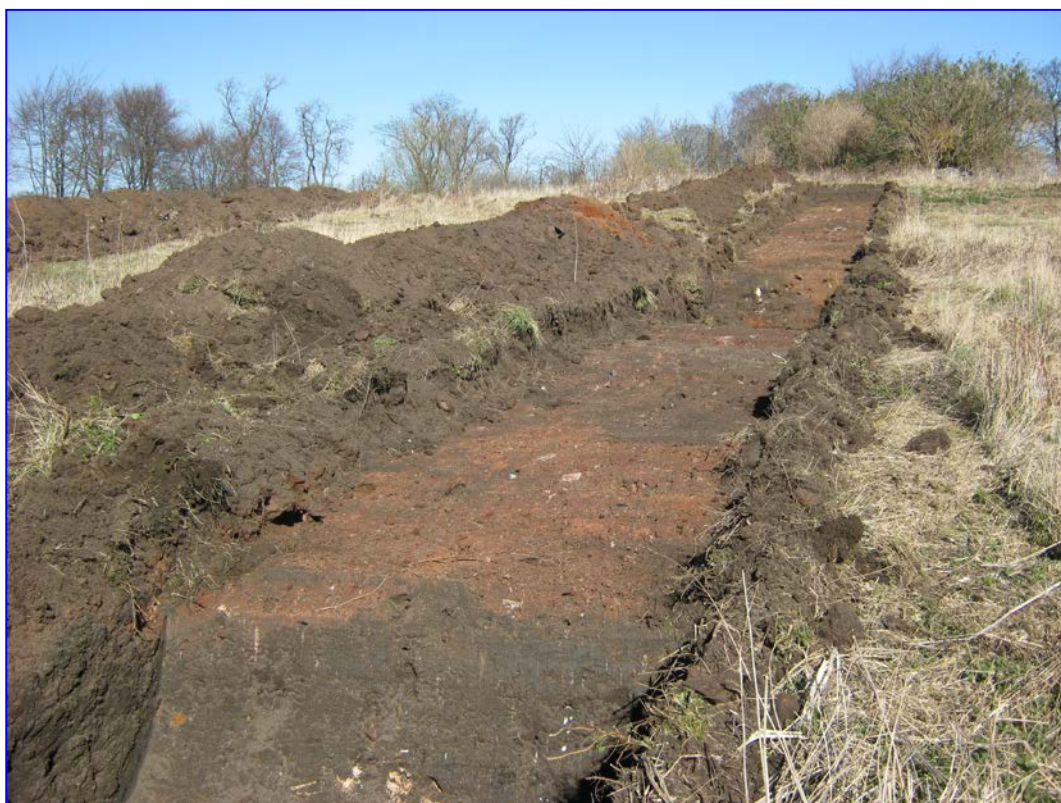
Plate 3: Trench 5, general post-excitation shot from the south-west

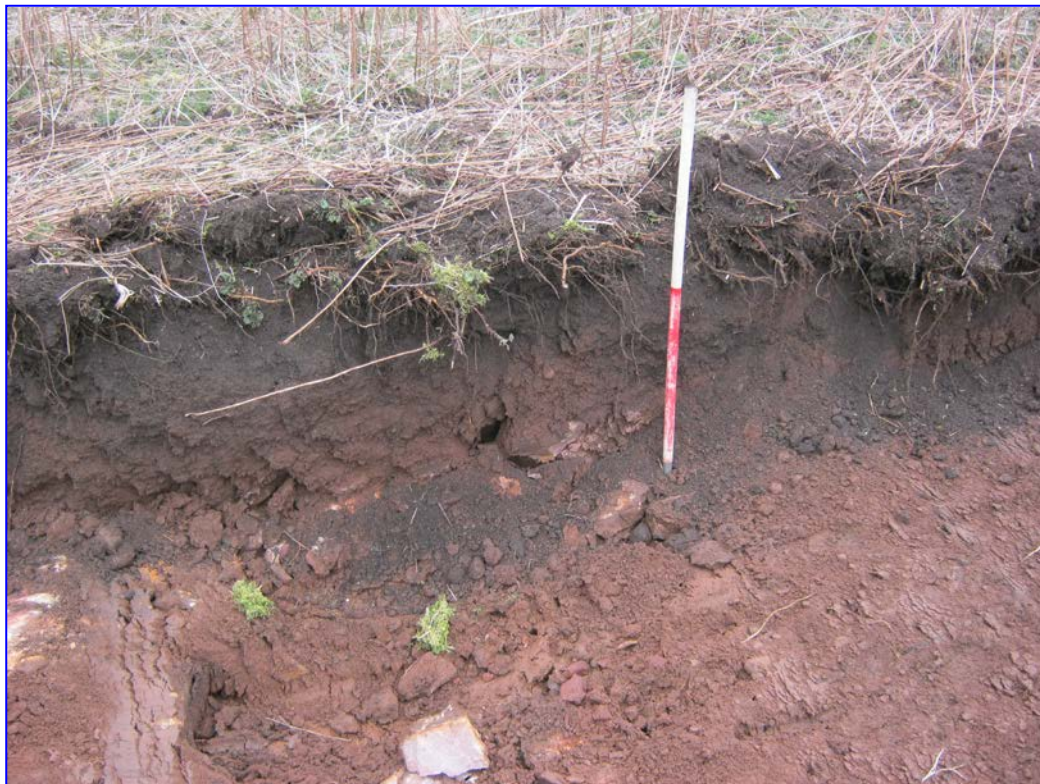
- 4.1.4 The southern portions of Trenches 3 – 5 and the Trenches 2 & 6 – 18 revealed a buried agricultural soil of pale brown sandy silt 0.10m - 0.30m in depth (Plate 4). This soil was most probably the original ground surface prior to the area being developed as hospital grounds. Occasional white ceramics and glass was observed within this deposit. Occasional plough scars and stone drags were also in evidence within the underlying sub-soil within these trenches.

Plate 4: Trench 13, west-facing section showing buried soil

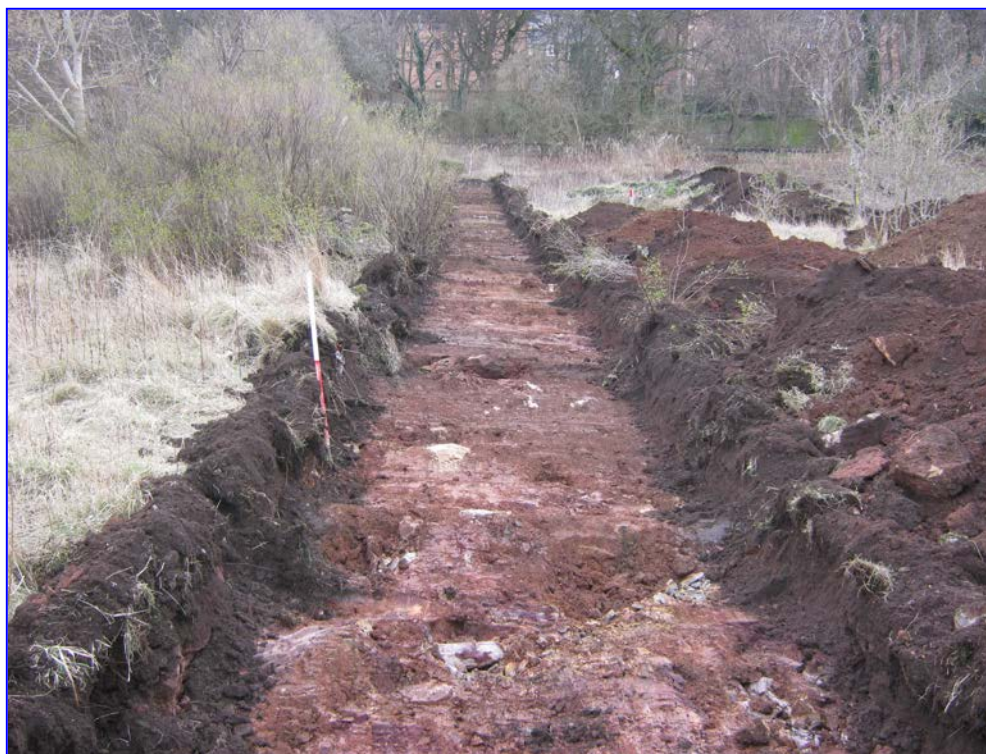
Plate 5: Trench 10, post-excitation shot from the north

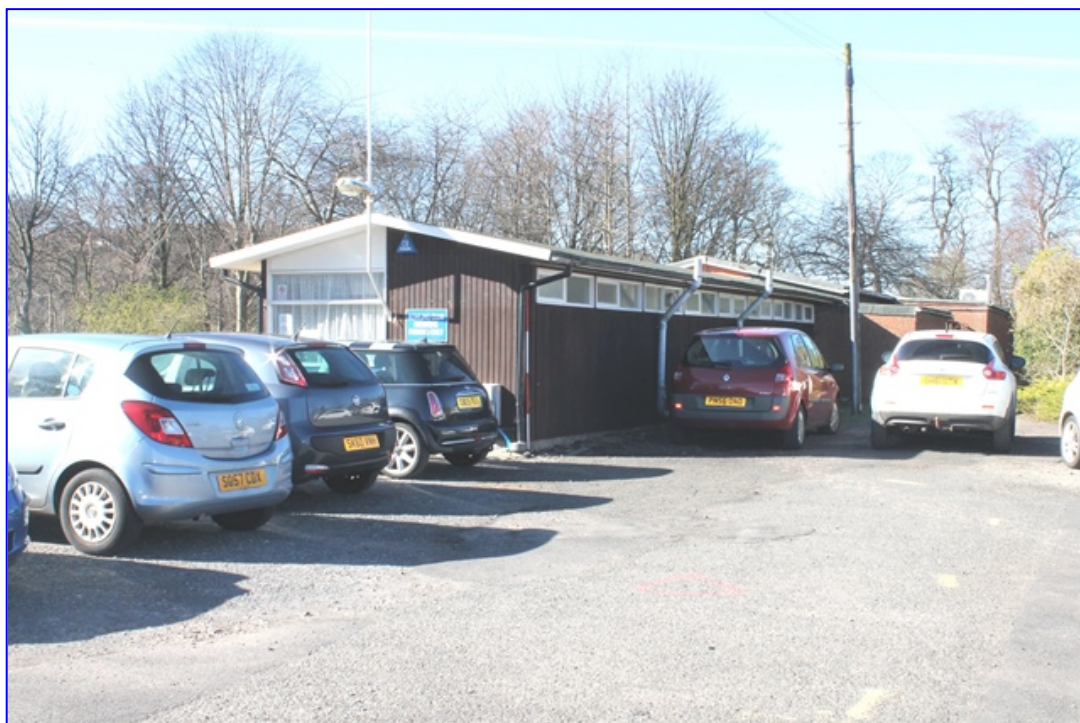
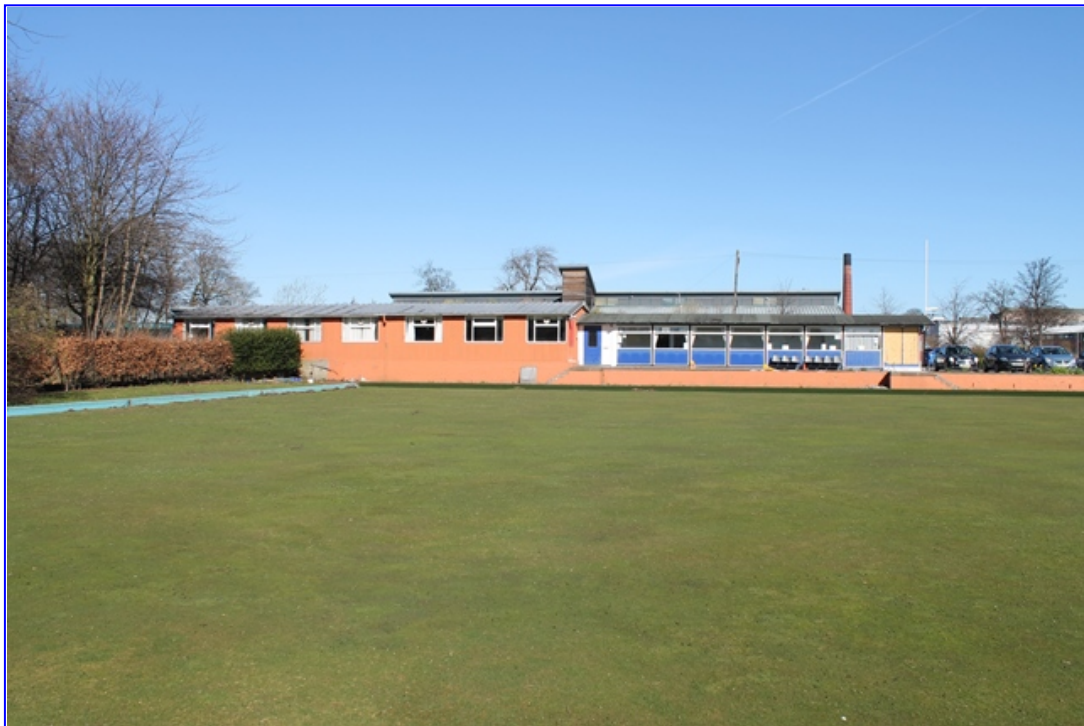
The Bowling Club Pavilion was located to the west of the hospital grounds and first appears on Ordnance Survey map of 1969 as a single rectangular block giving it a construction date of 1948 – 1969. This earlier section was timber clad with vertical timbers with a shallow pitched roof and timber-framed casements (Plates 6 & 7).

Plate 6: Bowling Club Pavilion, general view from the north-east

Plate 7: Bowling Club Pavilion, general view from the south

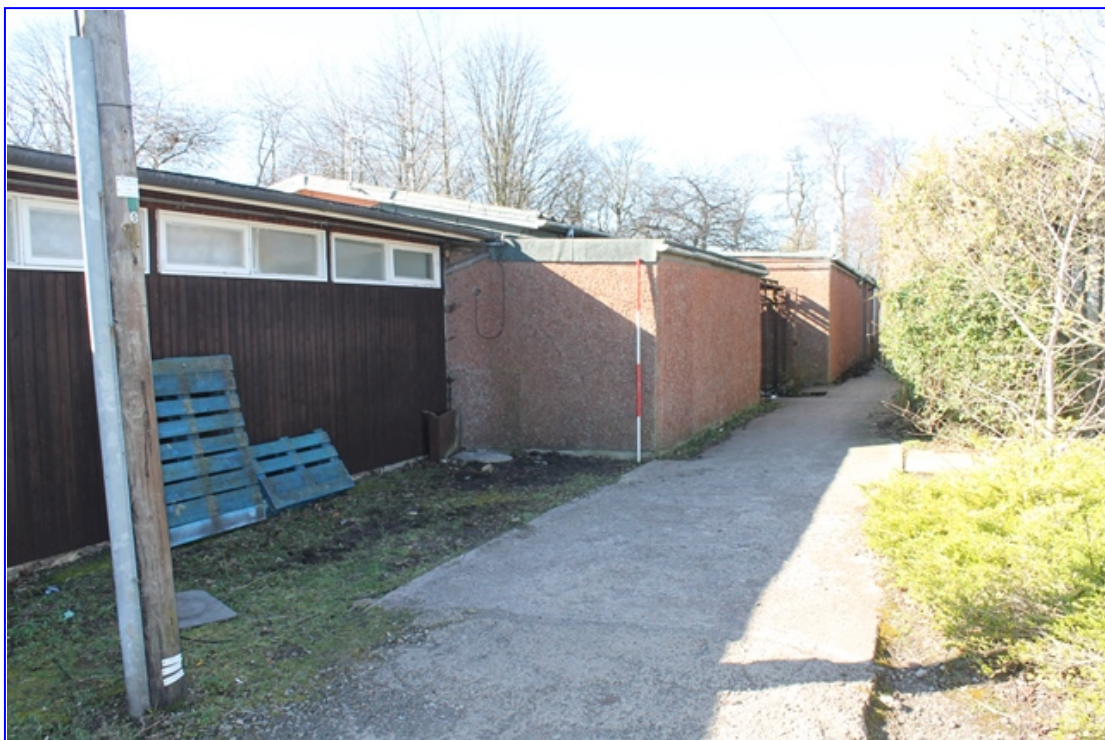
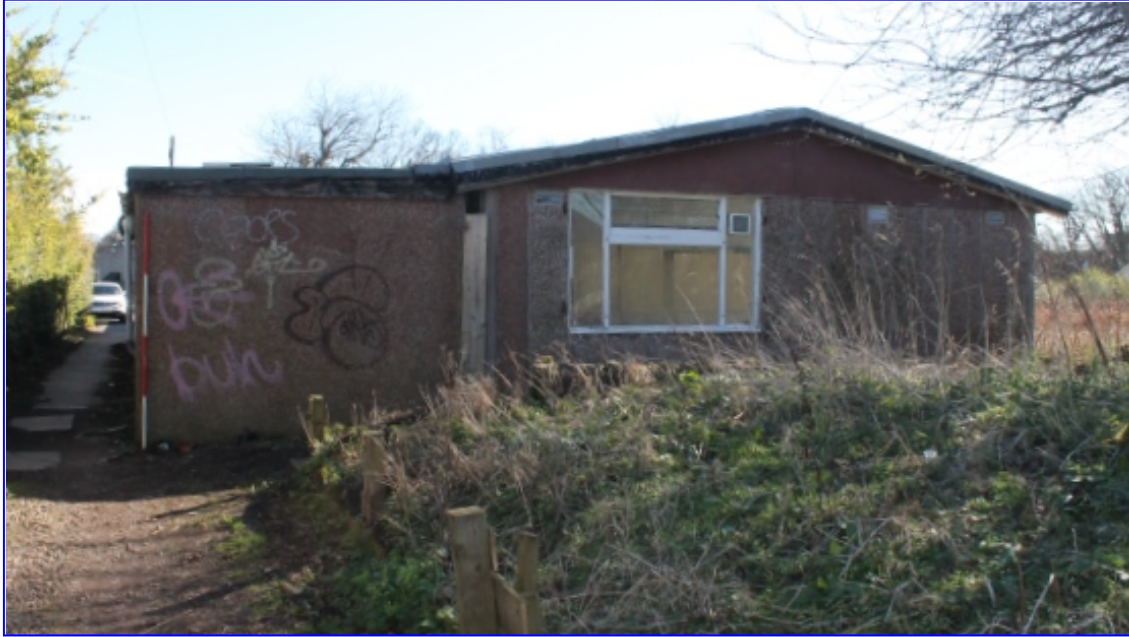
The Pavilion was then extended between 1969 – 1977 with a long L-shaped wing to the west side (Plates 8 & 9). This, too, had a shallow pitched roof and was covered in a roughcast render.

Plate 8: Bowling Club Pavilion, general view showing later extension from the north-east

Plate 9: Bowling Club Pavilion, general view from the SWW showing the later extension

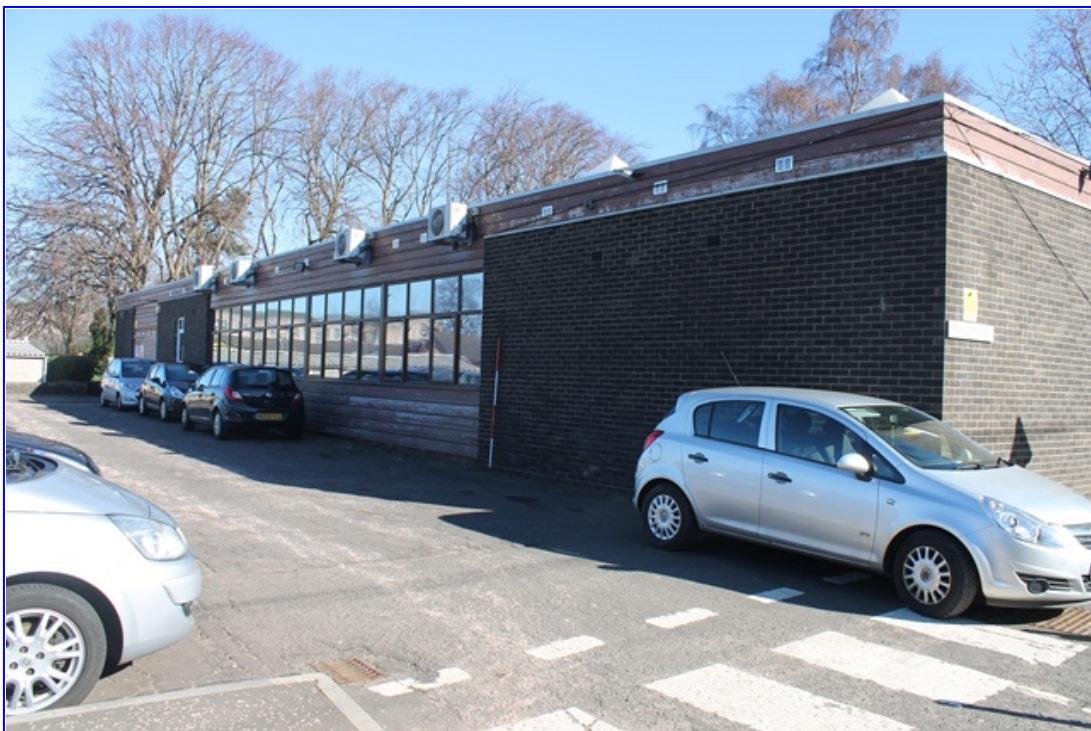
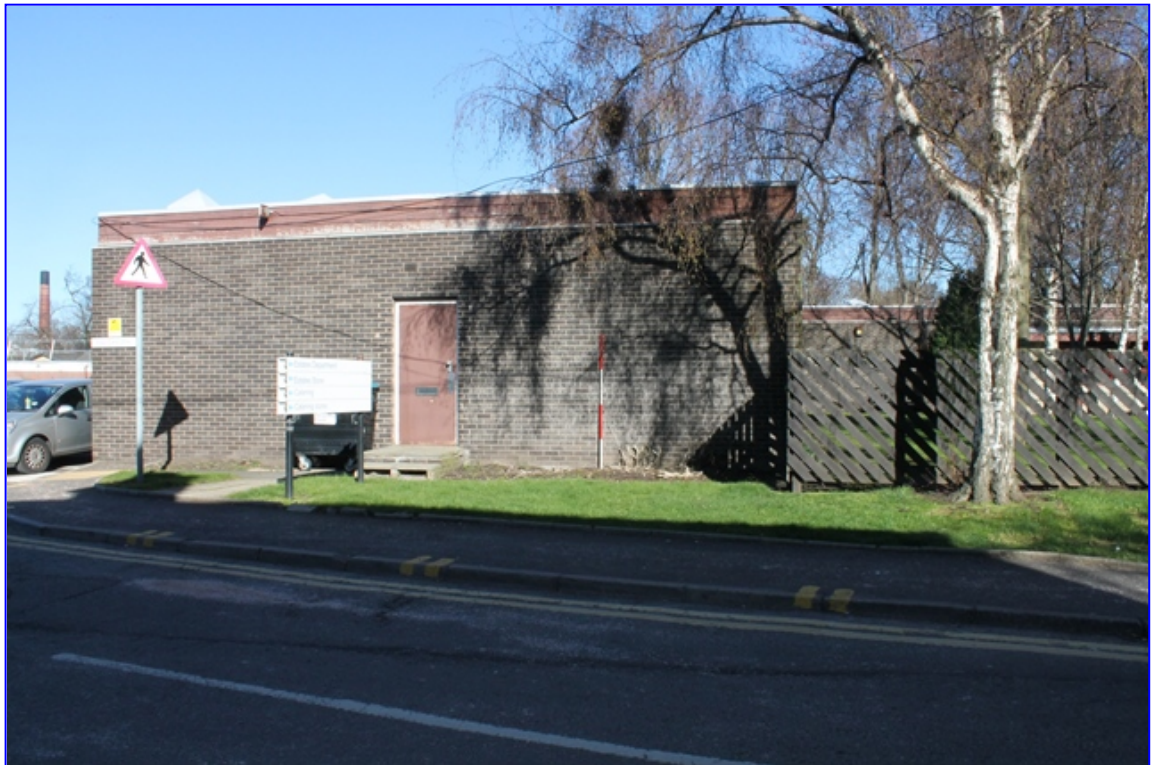
The earlier phase of this building (1948 – 1969, also first appearing on the 1969 Ordnance Survey map) was to the west, comprising a single-storey dark brown brick construction with horizontal timber boards and a flat roof (Plates 10 & 11). The later extension to the east was constructed between 1990 – 1996 (Plate 12).

Plate 10: Scottish Ambulance Centre, general view from the south-west

Plate 11: Scottish Ambulance Centre, general view from the SSE

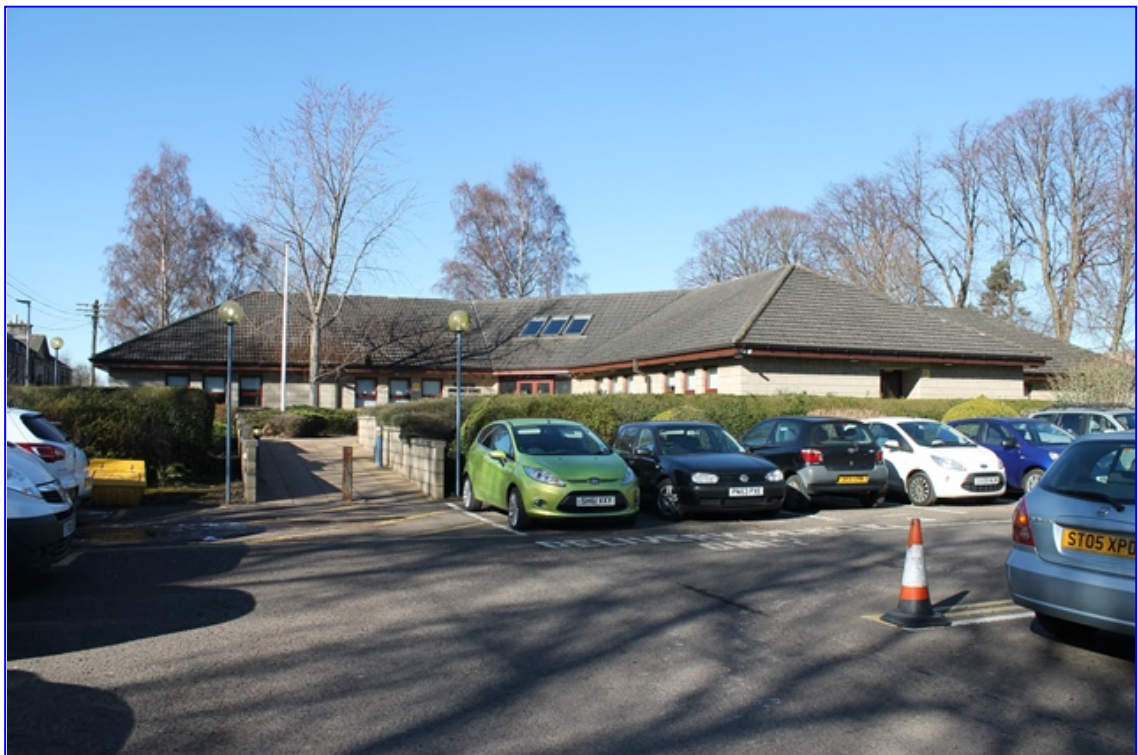
Plate 12: Scottish Ambulance Centre, general view of modern 1990s extension to the east, from the south-east
