The Ritz Hotel

AN ARCHAEOLOGICAL WATCHING BRIEF SUMMARY REPORT

- 1.1 *Between 25th July and 17th August 2006 an archaeological watching brief was undertaken by AOC Archaeology at The Ritz Hotel, 150 Piccadilly, London, on behalf of RPS Planning, Transport & Environment.*

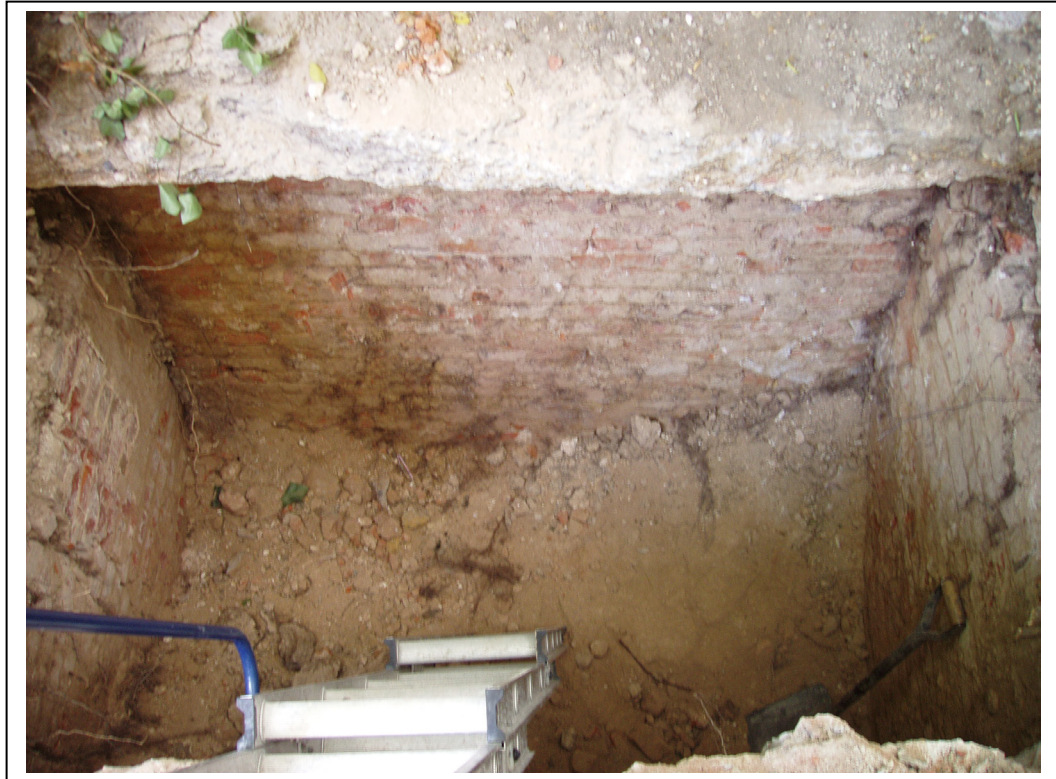
- 6.5 The earliest deposit recorded in Test Pit 3 was a red brick wall (3/010) of probable 20th century date, given its location directly below the present wall. It comprised the same build as (2/005) in Test Pit 2. Backfill material (3/012) was observed to its north side. This was overlain by three deposits of made ground (3/007 – 3/005) which were in turn sealed by a concrete foundation layer (3/004) for a brick floor (3/003). Cutting these deposits was a construction cut [3/009]. This was initially filled with a chalky backfill (3/011) which was sealed with a concrete foundation layer (3/008) for wall (3/002). To the south of the wall was a garden soil deposit (3/001).
- 6.6 No archaeological deposits or residual finds were identified predating the late 19th/20th century wall (3/010).

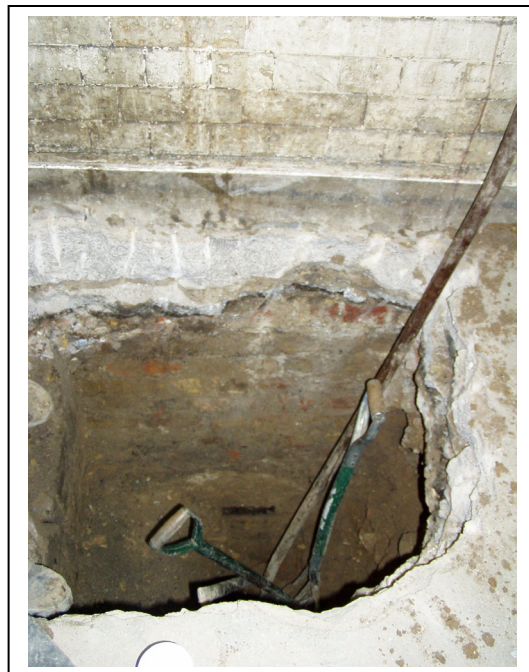
Test Pit 13

- 6.10 The earliest deposit was the natural London clay (13/004). Overlying this was a concrete foundation (13/005), adjacent to a contemporary brick wall (13/002). To the west of these structural elements was a backfill deposit (13/003) which was sealed by the concrete ground slab (13/001).
