# Selkirk Flood Prevention Scheme, Selkirk, Scottish Borders

Archaeological Evaluation, Metal Detecting Survey & Historic  
Building Recording Report

AOC 22700

22<sup>nd</sup> May 2014

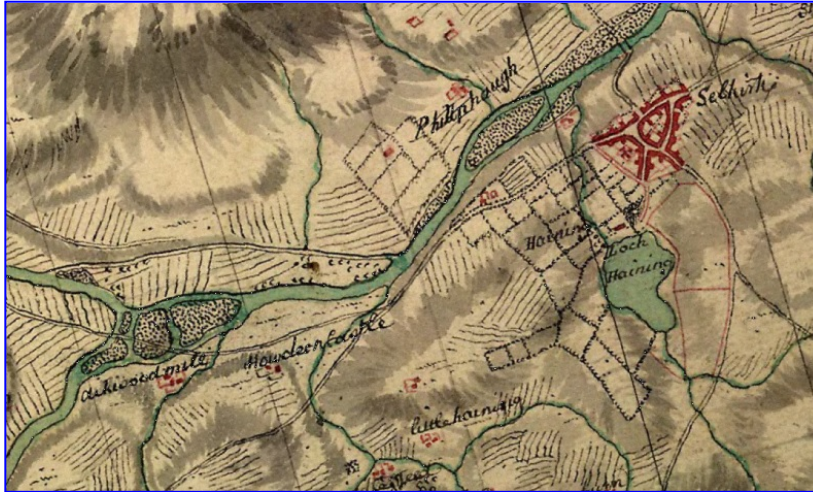
- 1.3.8 In terms of the industrial heritage of the immediate area, it is clear that this goes back into at least the 18<sup>th</sup> century. General William Roy's Military Map of Scotland dating to ca. 1747 – 55 shows the settlement of Philiphaugh to the west of the town (Figure 2). Loch Hanning is shown and to the west of this, and to the south-west of the town is the Ettrick Water, with its island to the immediate south-east of Philiphaugh, which is probably an early farm settlement. The mill lade is shown as coming westwards from the Ettrick Water surrounded by agricultural land. However, no mills or buildings are depicted on the map along the length of the lade.

Figure 2: Extract from Roy's map, ca. 1747 – 55

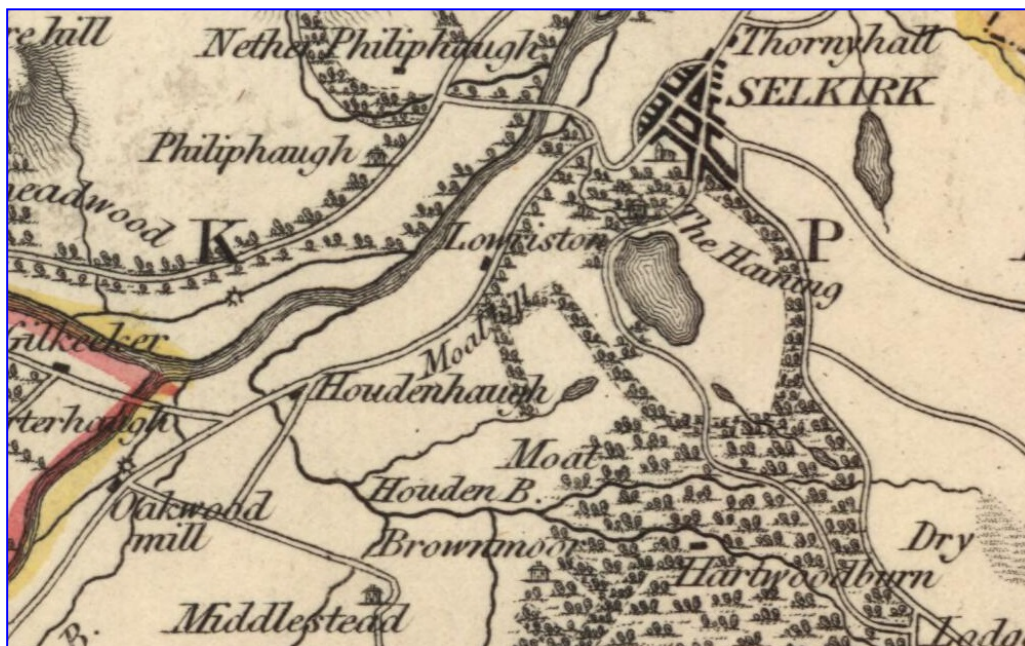
- 1.3.9 By the early 19<sup>th</sup> century, the historic mapping shows us that a mill *has* been established along a mill lade. Thomson's 1824 map shows a water wheel to the north of the lade (see Figure 3) although it is unannotated. The settlement of Philiphaugh – the farm – is annotated to the north of the site and to the west of the town, as it is on Roy's mid-18<sup>th</sup> century map.

Figure 3: Extract from Thomson's map, 1824

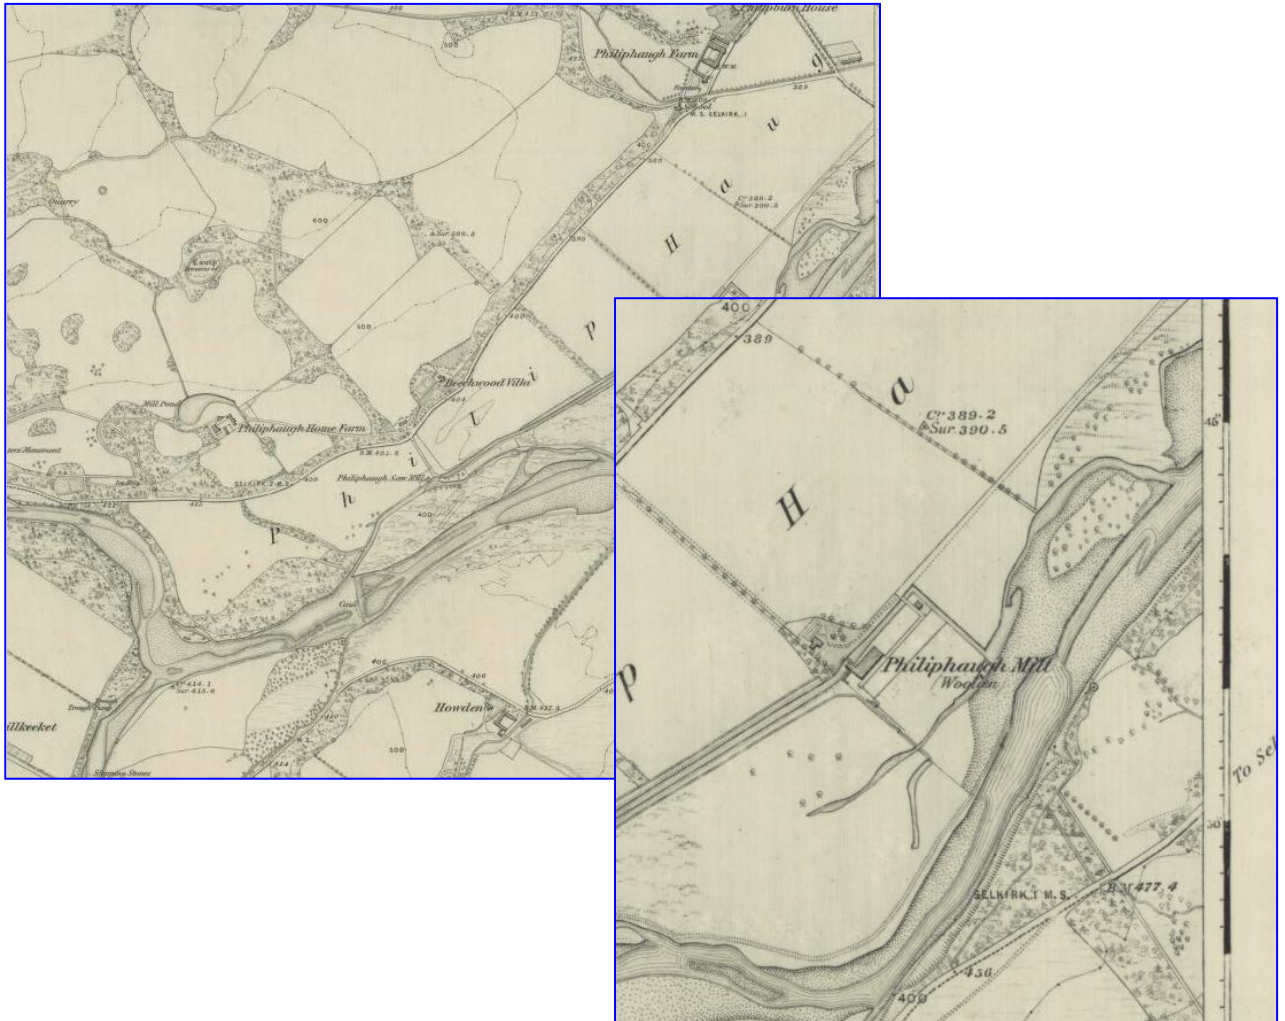
Figure 4a: Extract from Ordnance Survey map, 1863

- 1.3.10 The 1863 Ordnance Survey map (First Edition) shows the mill in more detail as Philiphaugh Mill (see Figure 4). It is annotated as a woollen mill. The mill lade is clearly depicted to the west of the mill, although less so to the east side. The lade that is depicted to the east side, appears to be an earlier lade which meets up with the Ettrick Water much sooner than the later/present arrangement.

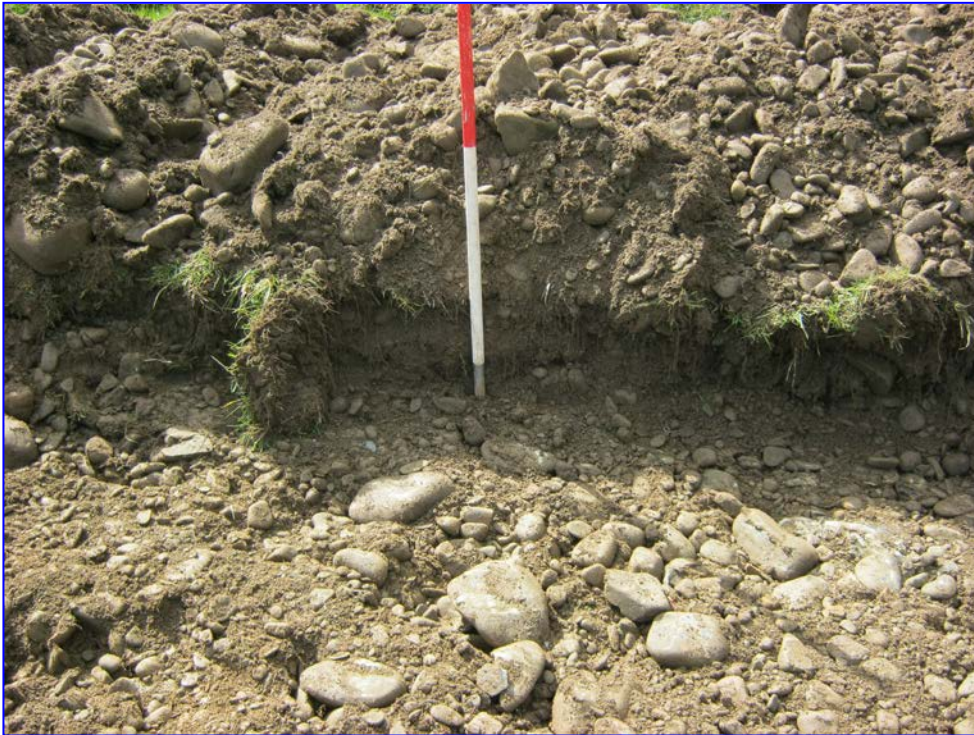
- 3.1.3 Both areas of evaluation were covered with a red brown ploughsoil 0.30m - 0.40m in depth. Occasional white ceramics and glass were observed within the deposit. This directly overlay a natural sub-soil of river gravels set within a matrix of sand and pink brown silt clay (Plates 1 – 3).

**Plate 1: Trench 2, general view of west-facing section**

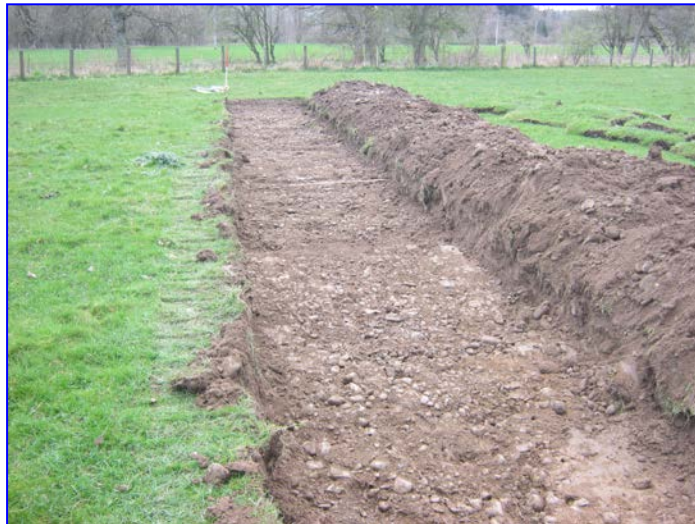
Plate 2: Trench 4, general post-excitation shot from the east

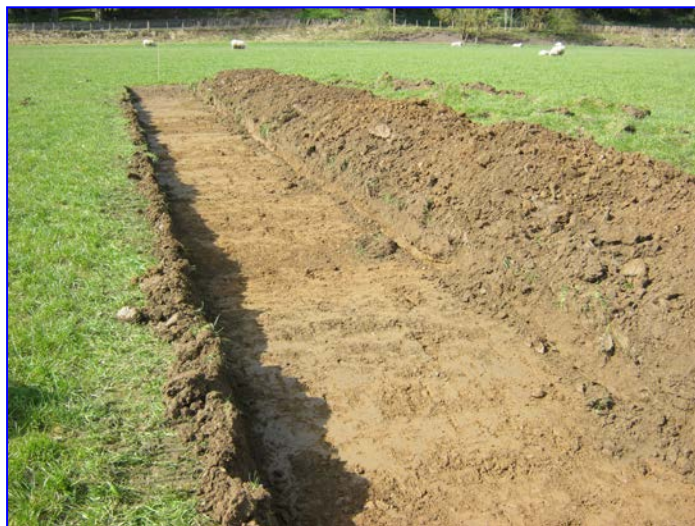
Plate 3: Trench 11, general post-excitation shot from the north-west

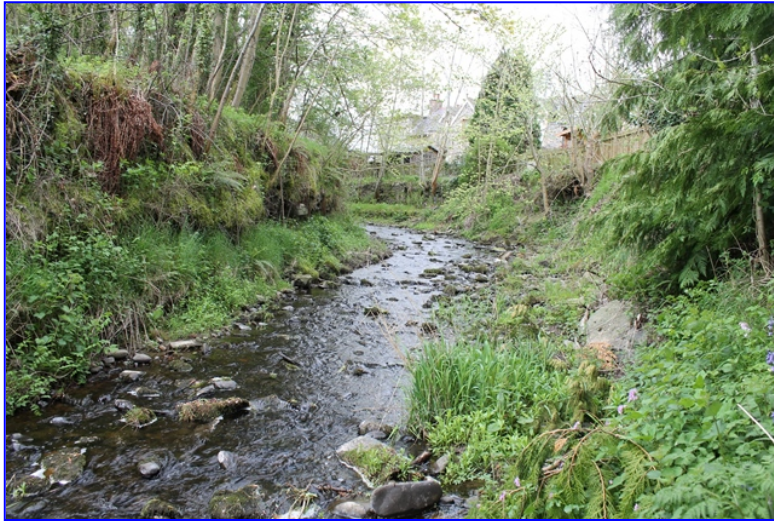
- 3.2.1 The mill lade was extremely difficult to access at the time of survey and was very difficult to identify due to heavy vegetation. The lade meets the Ettrick Water to the north side on the latter's western edge and flows to the south-west just to the south of the present road bridge. The water today is relatively shallow compared to the Ettrick Water, and is extremely overgrown, bounded with water-borne rounded pebbles and boulders (Plate 4). On the south side is evidence of a purpose-built stone rubble wall, although this is very degraded and is covered in vegetation (Plates 5 - 7).

**Plate 4: General view of the mill lade (northern end) from the east**

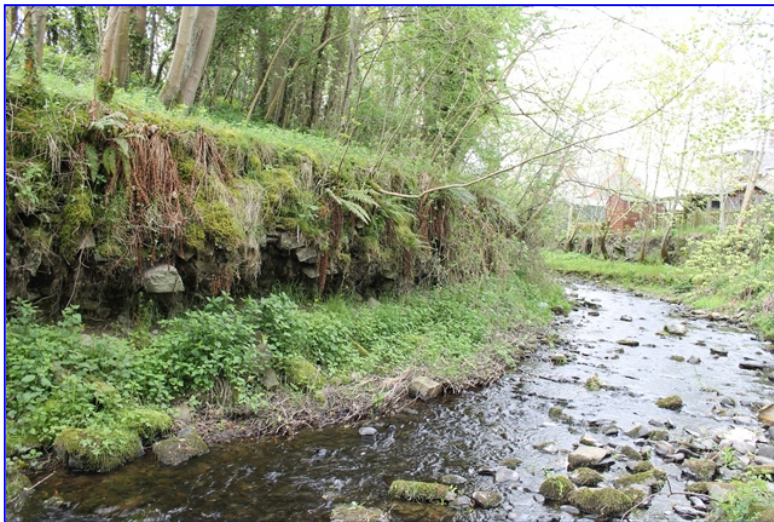
**Plate 5: General view of the mill lade from the east, showing the wall to the south side (left)**

- 4.2 The mill lade, although difficult to access, seems to be a reasonably substantial build to the south side at least, although is now in a poor state of repair, not least due to the heavy vegetation and trees along its length. Looking at the historic mapping, this latter phase of the mill lade's history was probably established in the last quarter of the 19<sup>th</sup> century coinciding with an expansion of Philiphaugh Woollen Mill.

- 3.2.2 The lade was then limited in access through most of its length up to the former Philiphaugh Mill. Access from the rear of the houses along Ettrickhaugh Road may have been possible, although this is private land and no access was allowed at the time of survey. More direct access and visibility of the remains of the lade may be possible once works on the scheme begin and more of the vegetation is cleared away.

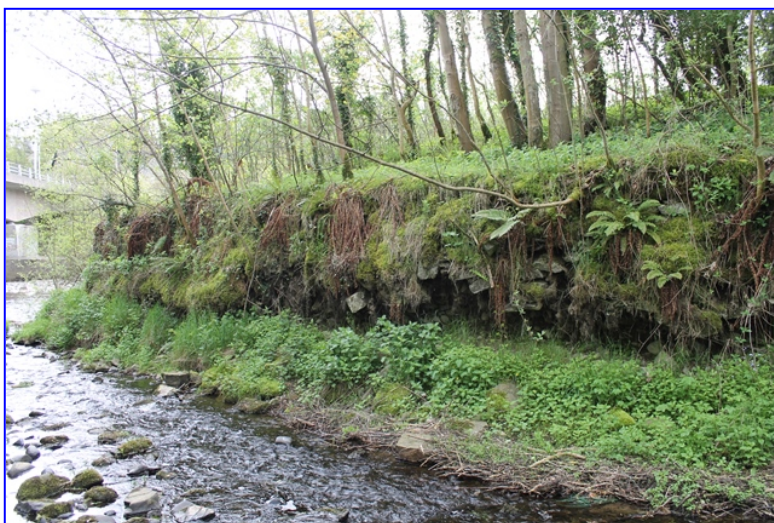
**Plate 6: General view of the mill lade (northern end) from the west, showing the wall to the south side**

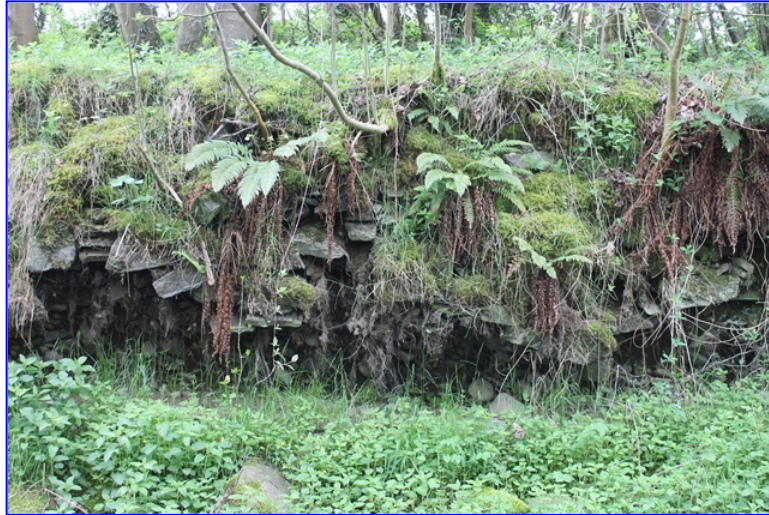
Plate 7: Detail of the remains of the mill lade wall (south side, northern end), from the north
