136 Peffermill Road, Edinburgh: Archaeological Watching Brief Data Structure Report

AOC 22762

3rd July 2014

On Behalf of: The City of Edinburgh Council

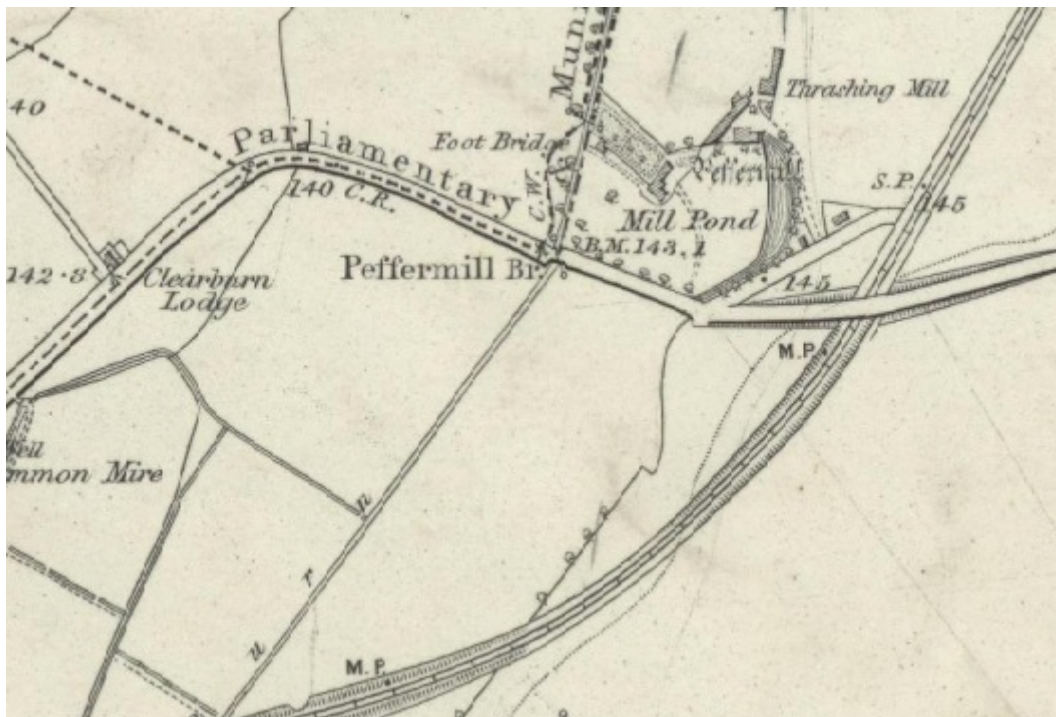
Figure 2 - 1850's OS map showing development area

1.3.1 The development area is located within what were historically open fields due south of Peffermill House. In the area of Peffermill House there was a mill recorded as being in existence in 1630. The First Edition Ordnance Survey map of the 1850's (Figure 3) shows a surviving mill pond to the west of Peffermill House and to the north of the development area. This mill pond appear to be fed by a possibly an earlier course of the Braid (Peffer) Burn or an actual mill lade which can be clearly seen as a tree lined north to south aligned feature crossing the development area on Figure 2. The Braid (Peffer) Burn has since been canalized and presently forms the northwestern boundary of the current development area.

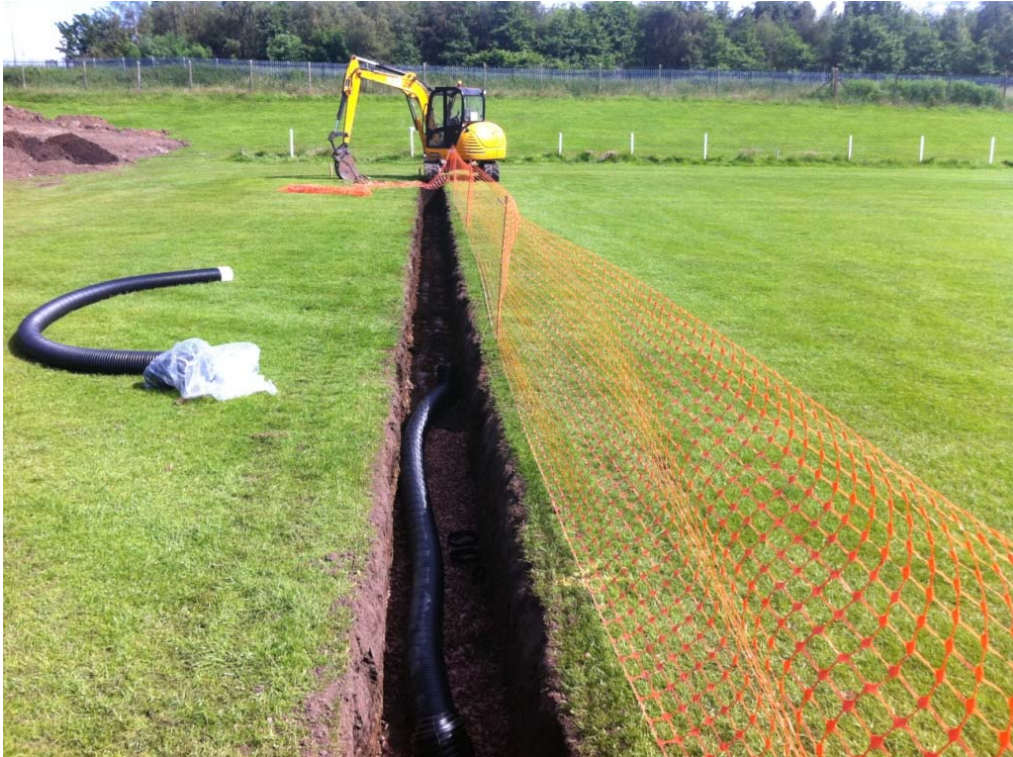
- 5.2 Topsoil [001] throughout the site was a very compact dark greyish brown silty clay averaging 0.35 m deep across the site. This covered a made ground [002] up to 0.8 m deep that consisted of compact greyish brown silty clay with frequent small sub angular stones and coal flecks (Plate 1). Some larger stones [003] and a mortar spread [004] were noted within the natural boulder clay [006] along the NE edge, most likely representing disturbance of the subsoil by previous activity on site (Plate 2).

Plate 1 - General shot of main drain trench

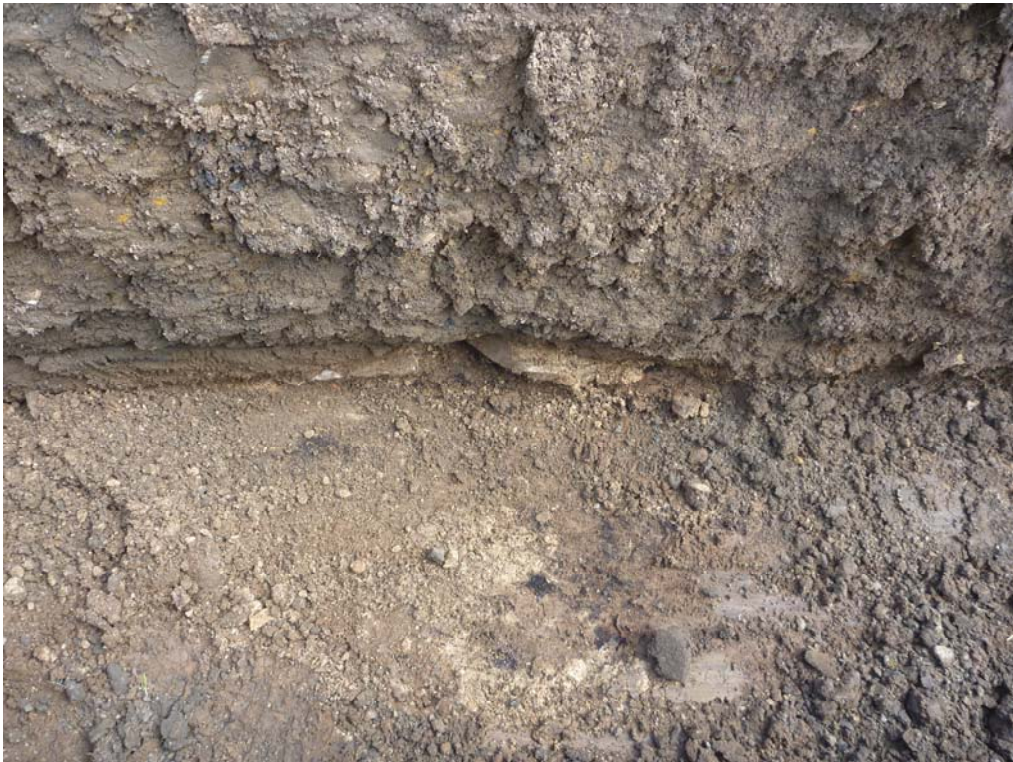
Plate 2- Shot of stones [003] and mortar [004]

- 6.1 The archaeological excavations revealed two stone deposits that most likely relate to disturbance of the subsoil during the earlier creation of the playing fields and the deposition of the made ground that covers the site.
- 6.2 No significant archaeological features or artefacts were encountered during the watching brief.

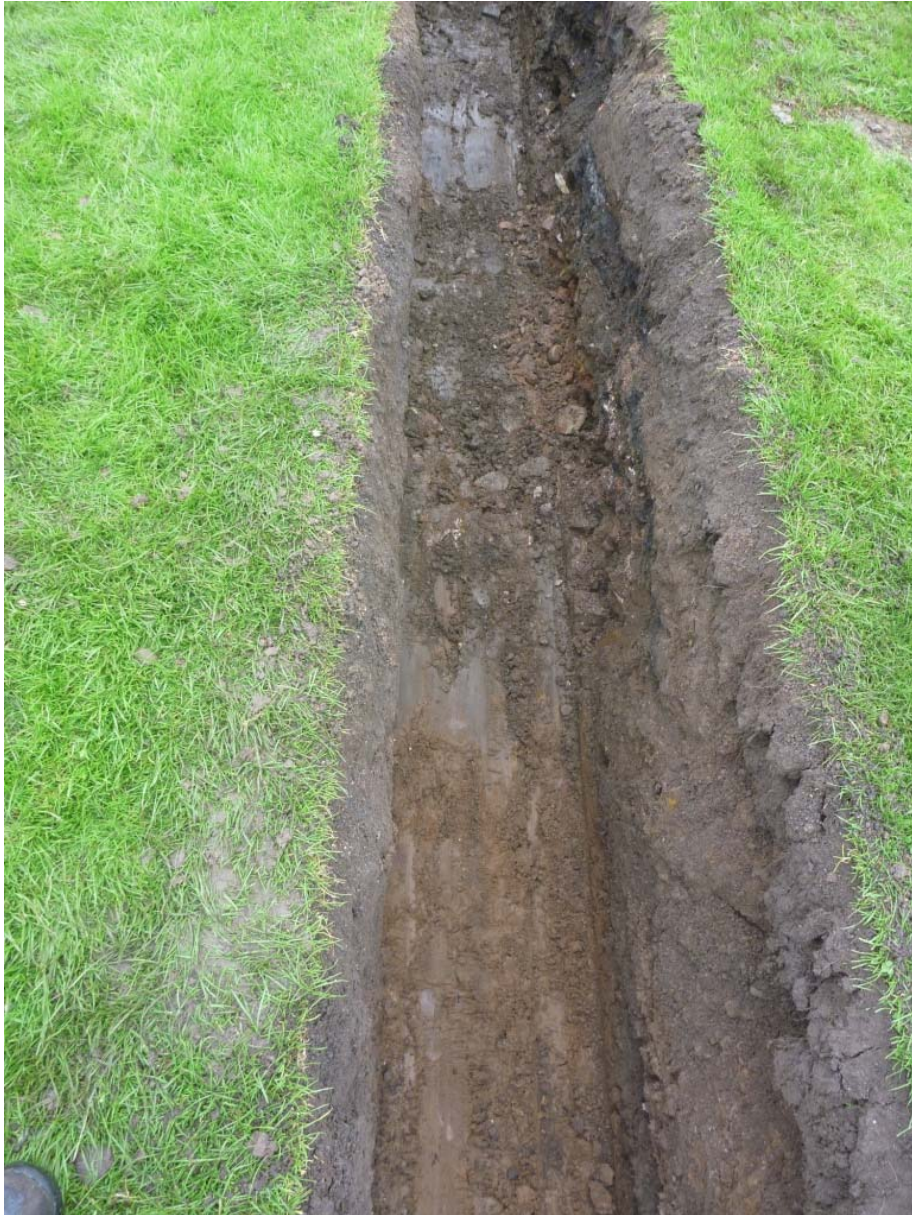
- 5.3 Furthermore, a deposit of sub-angular stones [005] aligned NE-SW were also noted along the NE edge drain (Plate 3). The stone deposit measured 5.5 m wide but was not noted in any other trenches to the south or west and is most likely natural.

Plate 3 - General shot showing deposit [005]

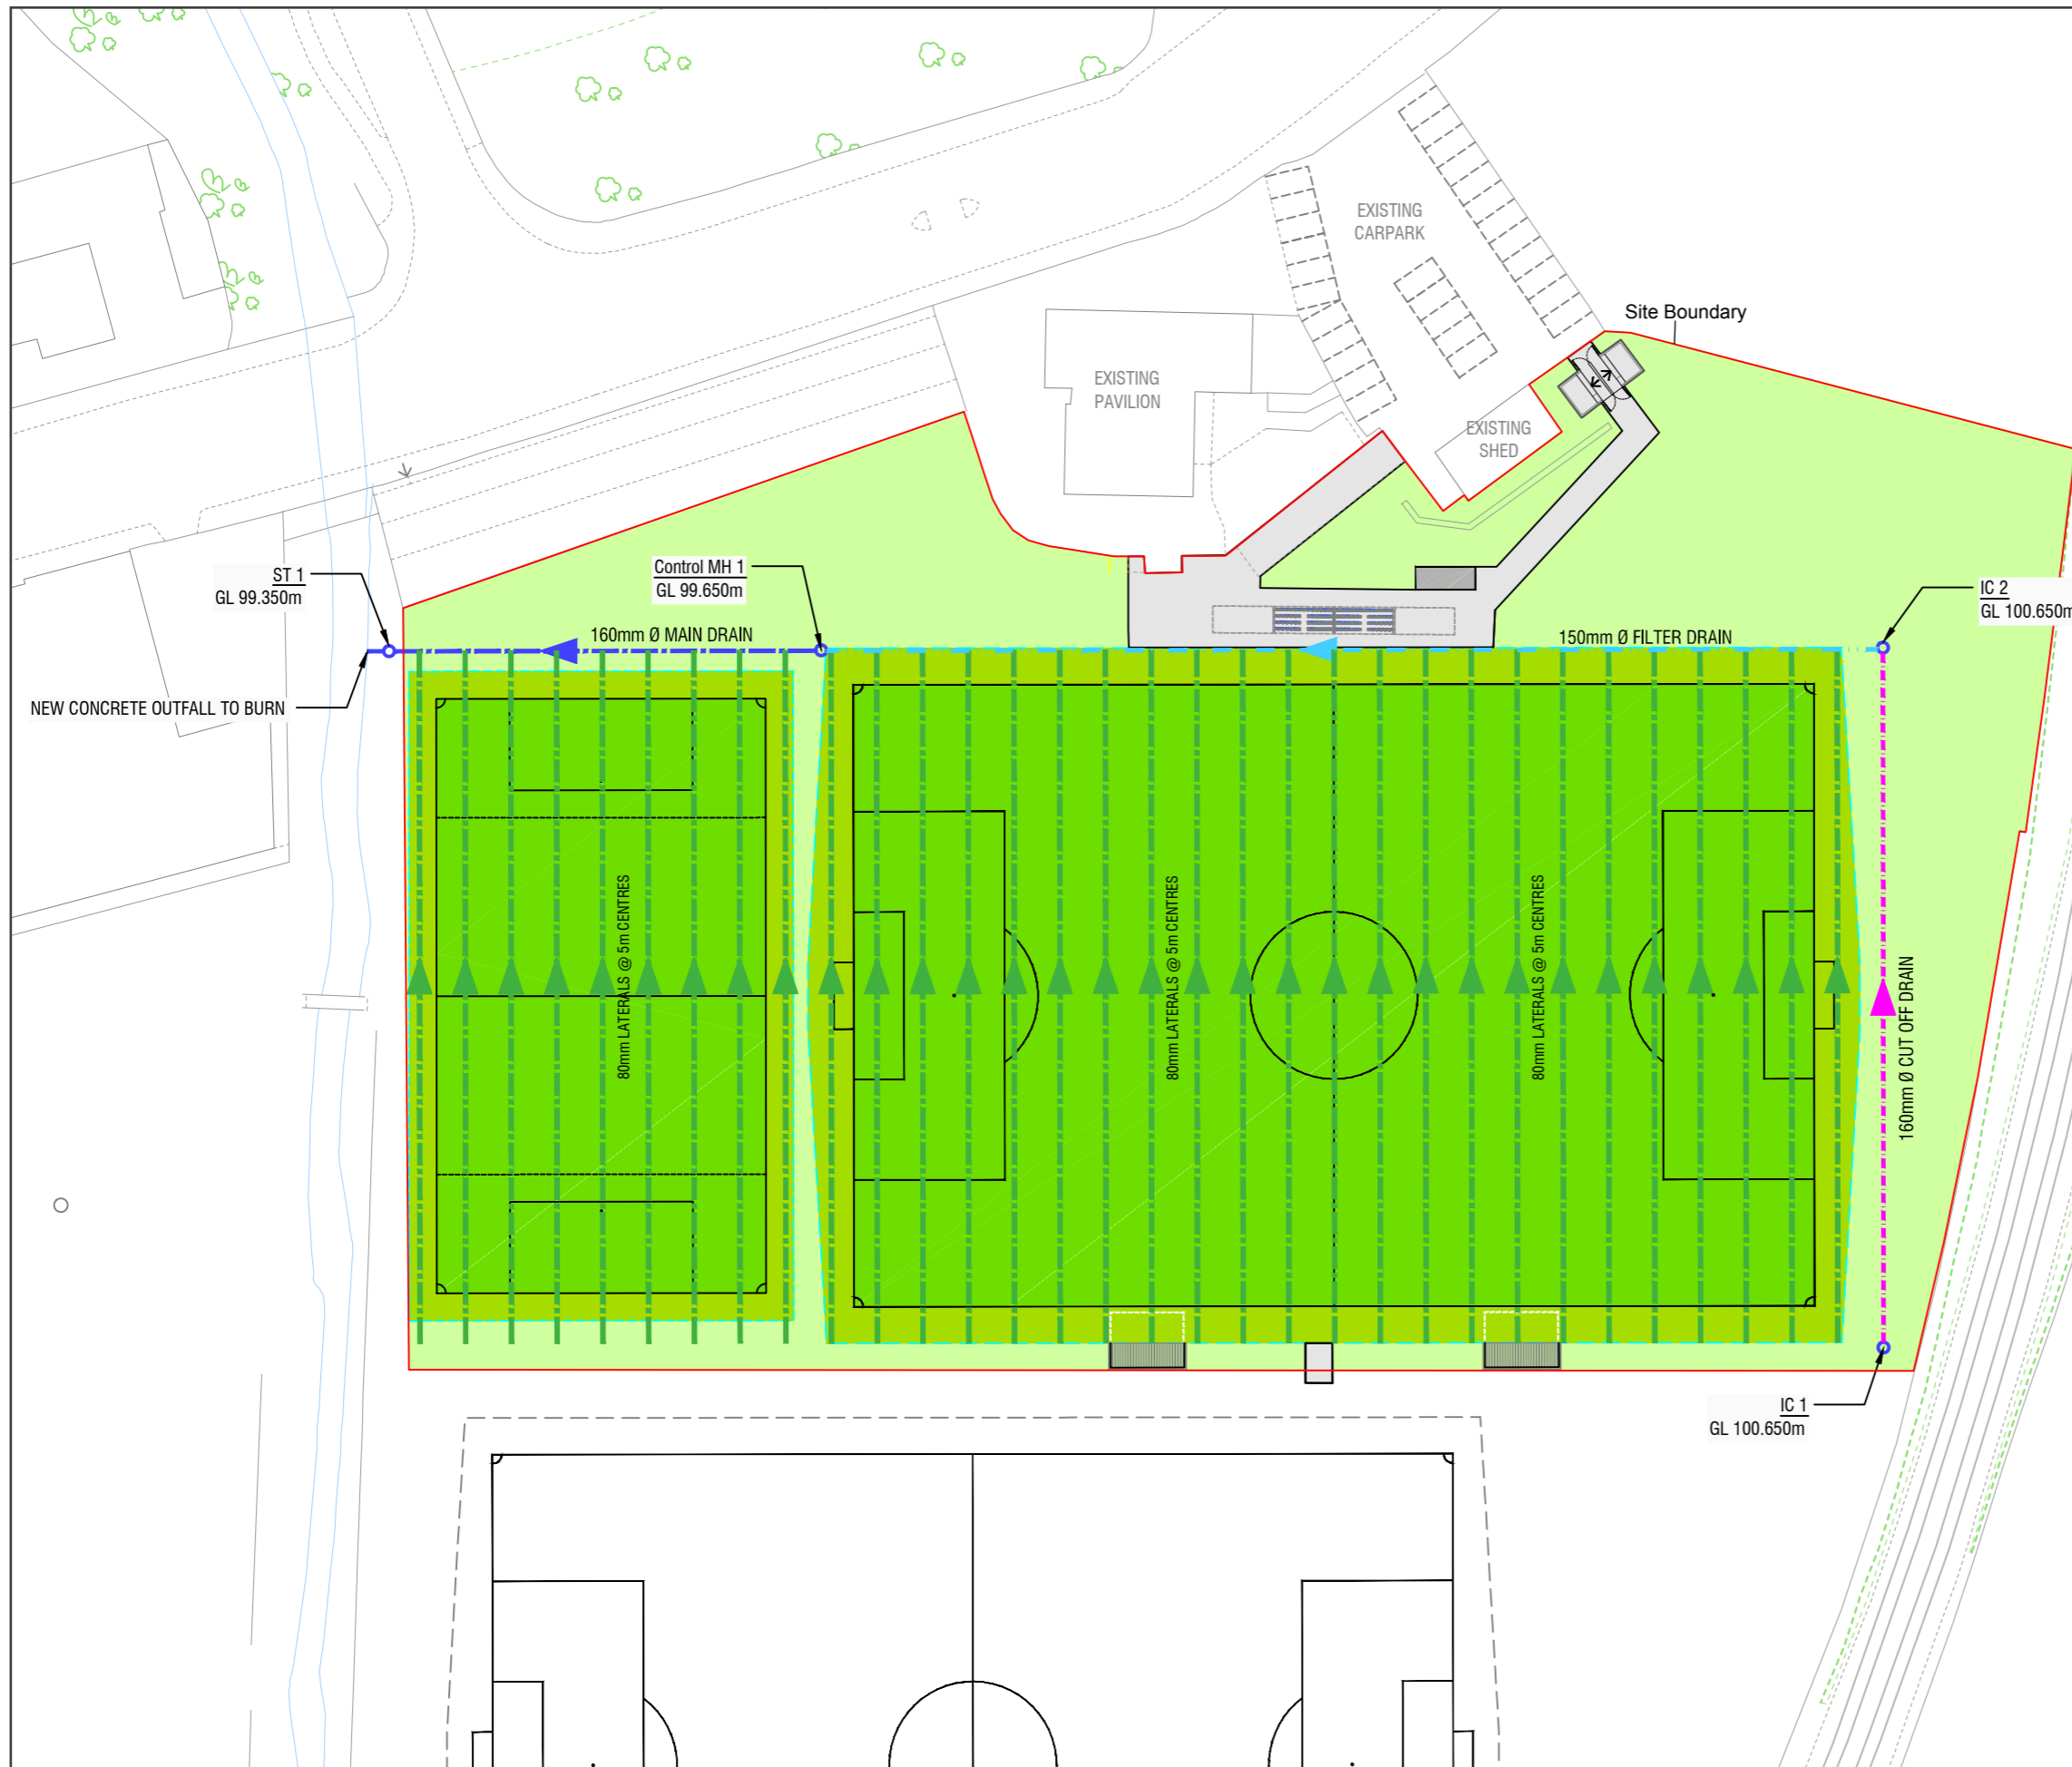
Figure 2: Detailed Site Plan showing
 Location of Drainage Works to be Monitored

- 160mm Ø Main Drain
- 80mm Ø Laterals @ 5m Centres
- 160mm Ø Cut-off Drain
- 150mm Filter Drain
