# Archaeological Evaluation on Land at Malleny Park, Currie Rugby Football Club: Evaluation Data Structure Report

AOC Project 22840

Planning Ref No 14/00821/FUL

11<sup>th</sup> August 2014

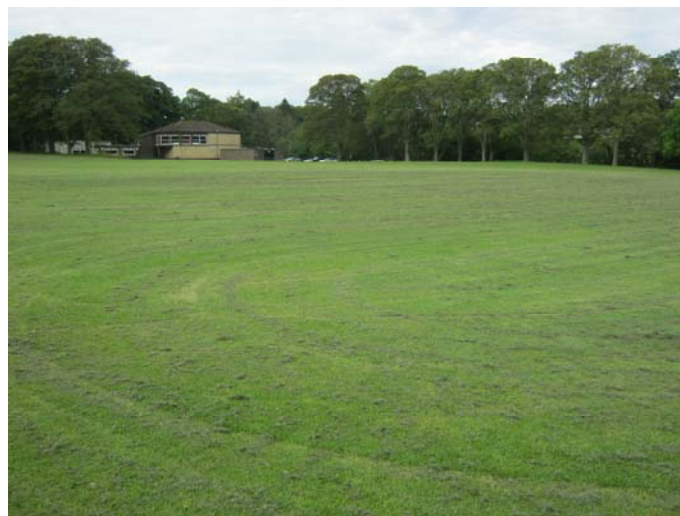
Plate 1 – Pre-excavation shot of area from north-east

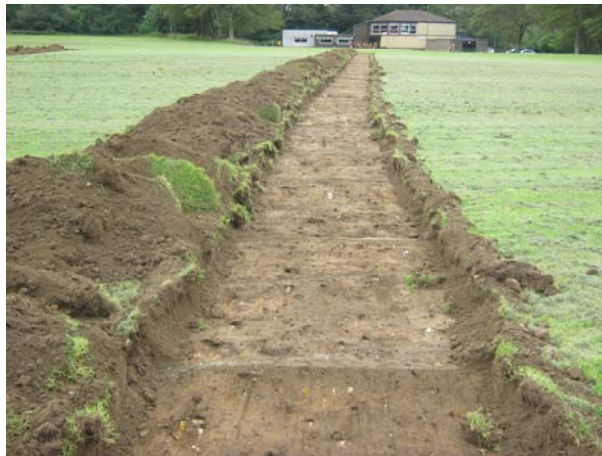
- 4.2 The entire site was covered in a thin layer of a well sorted imported top-soil, comprising a red brown clay rich sandy matrix. This topsoil varied in depth from c.0.15 m to 0.25 m and contained very little anthropic material with only very occasional fragments of white glazed ceramics or green bottle glass noticed. The subsoil consisted of a dark brown to orange coloured sandy clay with numerous small to medium sized sub-angular stones.
- 4.3 All four trenches revealed plastic drains covered in pea gravel. These were placed at one metre intervals and were aligned north-west to south-east.
- 4.4 Neither significant archaeological features nor unstratified artefacts were found in any of the trenches. Archaeological material was restricted to occasional white ceramics and modern glass within the topsoil.

**Plate 2 - Trench 4 from north-east**
