# Dumyat Fort (Castle Law), Stirling Archaeological Survey

23rd June 2014

# **Dumyat Fort (Castle Law), Stirling**

## **Archaeological Survey**

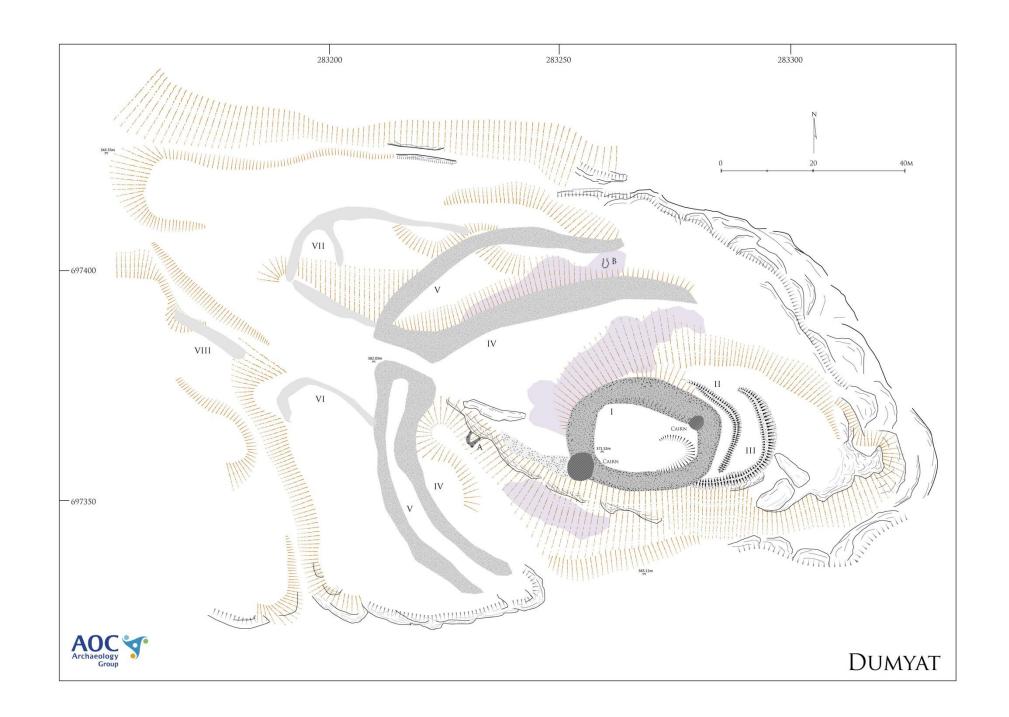
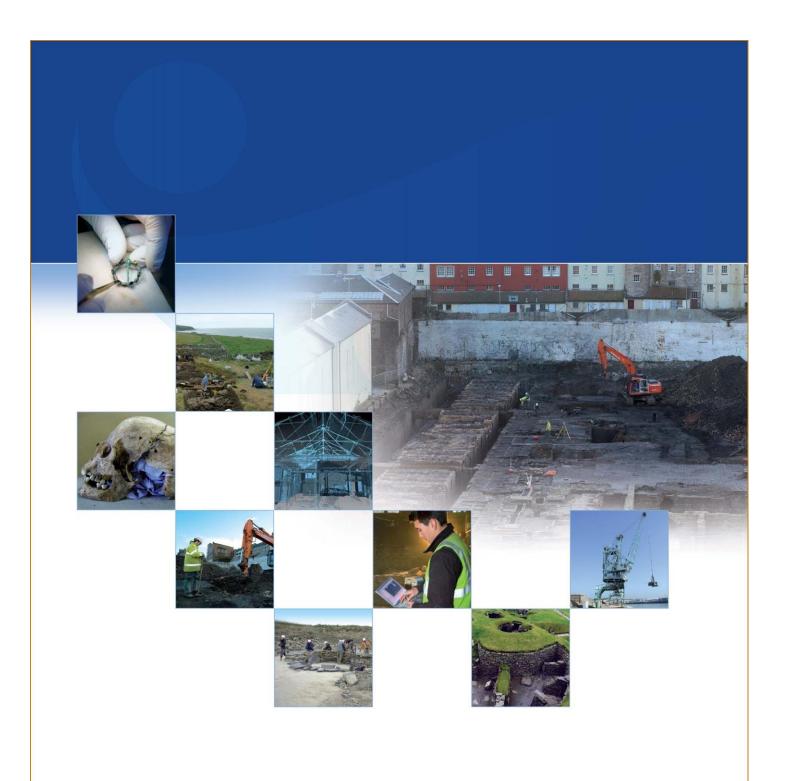
- 2. The site occupies a craggy buttress with commanding views over the hillfoots area and the Forth plain to the south and making use of the naturally defensive location formed by cliffs and gullies to the N, E and S. The central area of the site comprises a dun-like enclosure (I) comprising a substantial rubble wall, up to 4m thick in places and sub-oval in plan. No facing stones were obvious and the position of the entrance is not apparent, though the RCAHMS are probably correct in estimating that this was located in the SW area. The interior of enclosure I is largely featureless, though a crescentic depression in the SE area could represent the remains of a building. Two walkers cairns have been constructed on the rampart, one in the SW and a second in the NE; the latter is not marked on the RCAHMS plan of 1963 and as such has probably been built since then.

- 3. To the E of enclosure I, two light earthworks (II and III) curve across the promontory. The innermost of these, II, is only around 1m across and appears to respect the curve of enclosure I, suggesting contemporaneity (or, as RCAHMS suggest, may be attributable to robbing of the facing stones), but earthwork III may predate both. The relationship between enclosure I and earthwork III is not clear, but it is possible that I overlies III, which may have originally enclosed a larger area on the summit of the ridge. Vitrified material was observed both within the rubble of enclosure I and in the rubble spreads to the NW of I.

- 4. The outer areas of the fort are defined by two outworks, IV and V. The chronological position of these defences is uncertain, and the merging of rubble from both around the entrance area means that they cannot be separated sequentially from one another. The innermost wall, IV, is slightly thicker, averaging between 3 and 4m across; in one area in the SW outer face of the southern rampart, a few possible displaced facing stones were observed, though elsewhere the rampart is entirely ruinous. The outermost rampart, V, is of very similar composition; vitrified material was observed in several places in both ramparts. The outworks are conjoined at the entrance area, and although they are very ruinous it seems probable that they were linked, forming an entrance passage

- 5. Outside the ramparts, to the W, lighter walls have been constructed (VI and VII), visible and turfcovered banks forming a series of enclosures. It is likely that these post-date the fort although a ruinous bank, VIII, may have helped to define the route into the site via a natural gully leading up the hill.
- 6. Two small structures, perhaps shellings or shelters have been constructed from the ruins of the ramparts. The first, A, is little more than an arc of stones built against the bedrock outcrop to the W of the fort while B is a small circular cell dug into the rubble collapse of rampart IV.
