Laigh Corton Farm & High Corton Farm, Ayrshire: Historic Building Recording & Archaeological Evaluation Report

AOC 22156

5th December, 2014

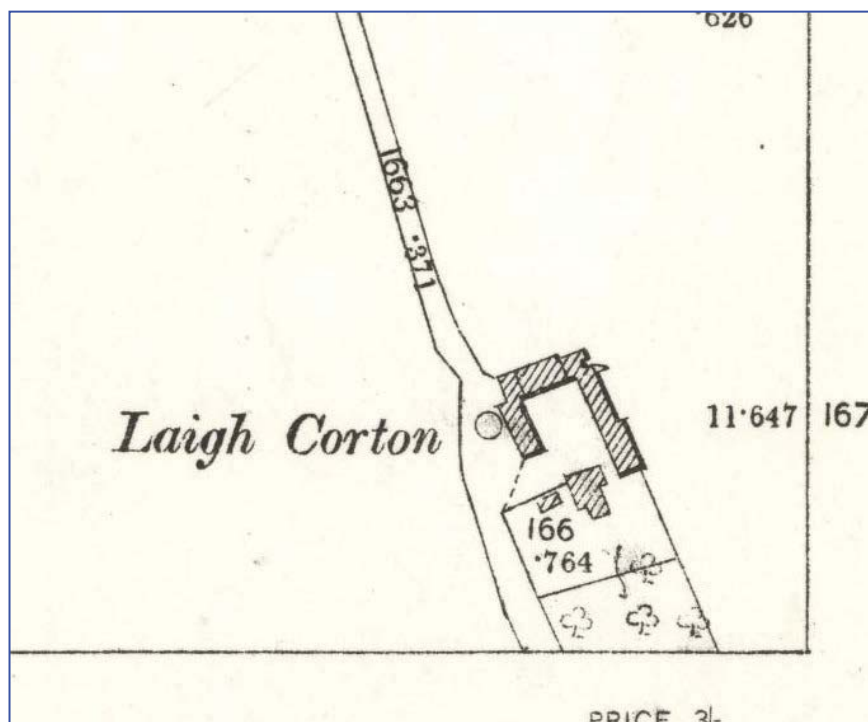
Figure 5: Extract from Ordnance Survey, 1896

Into the 20th century, the 1908 map shows that there has been few changes, although the detached barn to the south of the site has been demolished and there is a small lean to erected to the north corner of the courtyard (Figure 6). The later 1937 Ordnance Survey maps shows that there has been great expansion of the farm, mostly to the south-east, with the addition of four new large barns, one of which has replaced the detached barn to the south-east of the courtyard (Figure 7). A small projection has also been added to the north-west range to the south-east side. In the late 20th century, the north-east range was partially demolished to the south-east side and a new brick barn built in its place, creating an L-shaped barn.

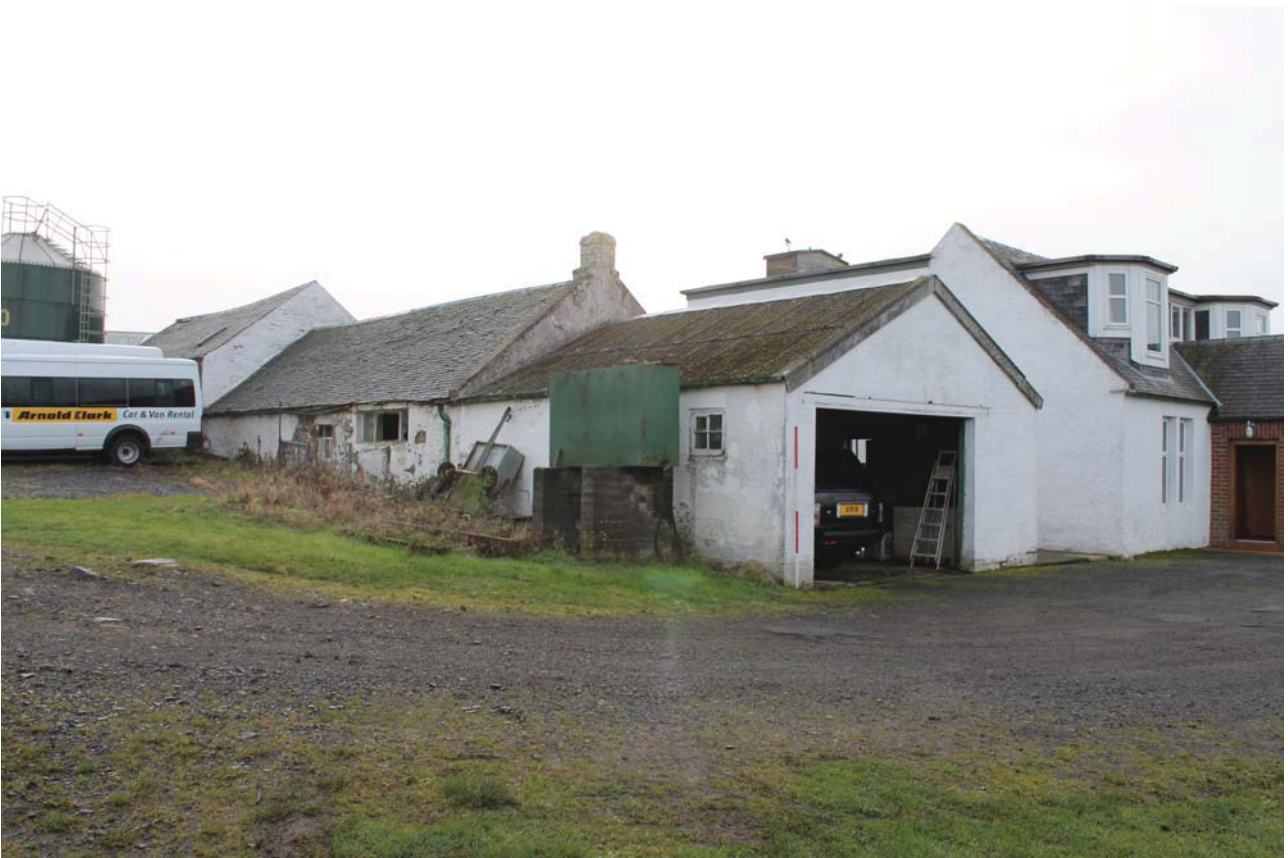
Plate 62: High Corton Farm, Barn D, general view from the north

This linear barn is clearly in three phases, with the central stone rubble barn and a later garage extension to the north-west and another larger two-storey extension to the south-east (Plates 58 - 60). The central original barn has a doorway flanked by a window to each side and a larger sliding door entrance and another window to the south-east side (Plate 61). The roof is pitched slate with a brick chimney to the north-west. The later garage extension is lower in height with a doorway and small window. The brick extension to the south-east is a five-bay two-storey build with a pitched slate roof with a door, two windows and a larger wider entrance to the ground floor and a single loading door to the first floor. The rear north-east elevation also shows the different phases of build with small windows to the original barn (Plates 62 & 63). A timber shed has been

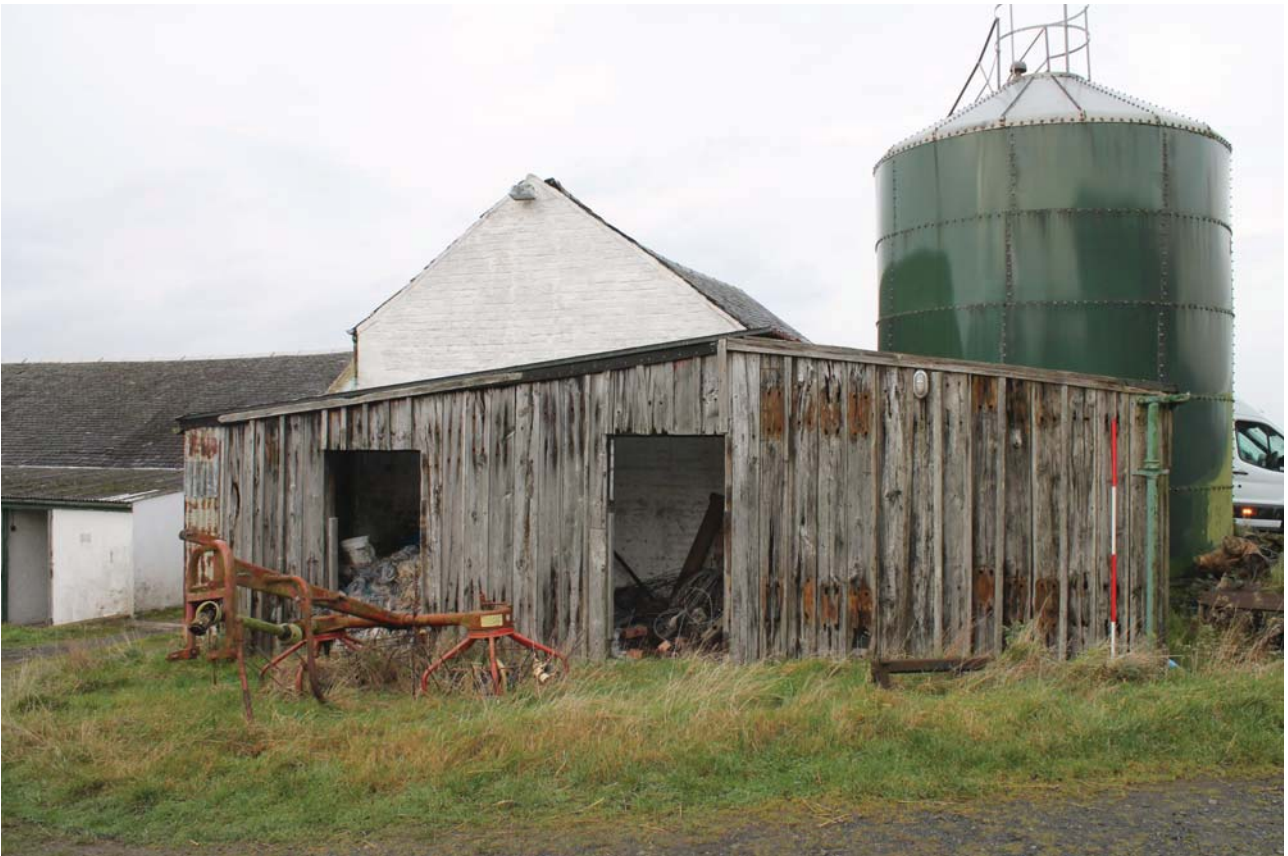
Plate 64: High Corton Farm, Barn D, general view from the south-east

built onto the south-east side (Plate 64). Internally, the barn is still used by the tenant farmer as storage, with rendered walls throughout.

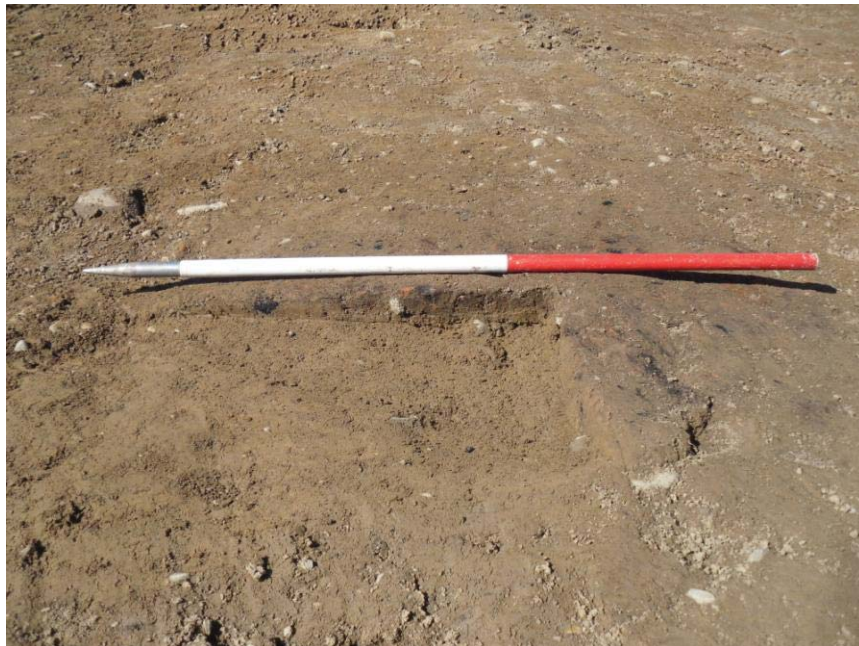
- 4.4 Two features, a possible hearth [007] and adjacent possible post-hole [009] were identified in Trench 27, on a flat area, between a south-facing and a north-facing slope (Figures 2 & 3). These two features were fully excavated and sampled. The largest and most prominent feature [007] comprised a sub-circular hearth pit with shallow sides running in to a rounded base. Measuring 1.08 m by 0.94 m by 0.05 m in depth, the pit was filled by a single context [008], consisting an orange brown silt with inclusions of charcoal and burnt clay. Feature [009] comprised a possible post-hole, sub-circular in plan, with very shallow sides running into a flat base. Measuring 0.24 m by 0.16 m by 0.04 m in depth, the feature was filled by a single deposit of brown silt [010] with occasional charcoal flecks.

Plate 2 Post-excavation shot of feature [007]

- 6.1 The evaluation has identified these areas as generally archaeologically sterile. Two adjacent features in Trench 27 were excavated and recorded. The other evaluation trenches yielded negative results.
- 6.2 No further on-site works within Areas B and E are considered necessary. This recommendation will require confirmation by WoSAS on behalf of the planning authority. Following a site monitoring visits by the WoSAS case officer (Mr McBrien) it was indicated that post-excavation analyses (soil processing and radiocarbon date) will be required on soil samples recovered from hearth [007].

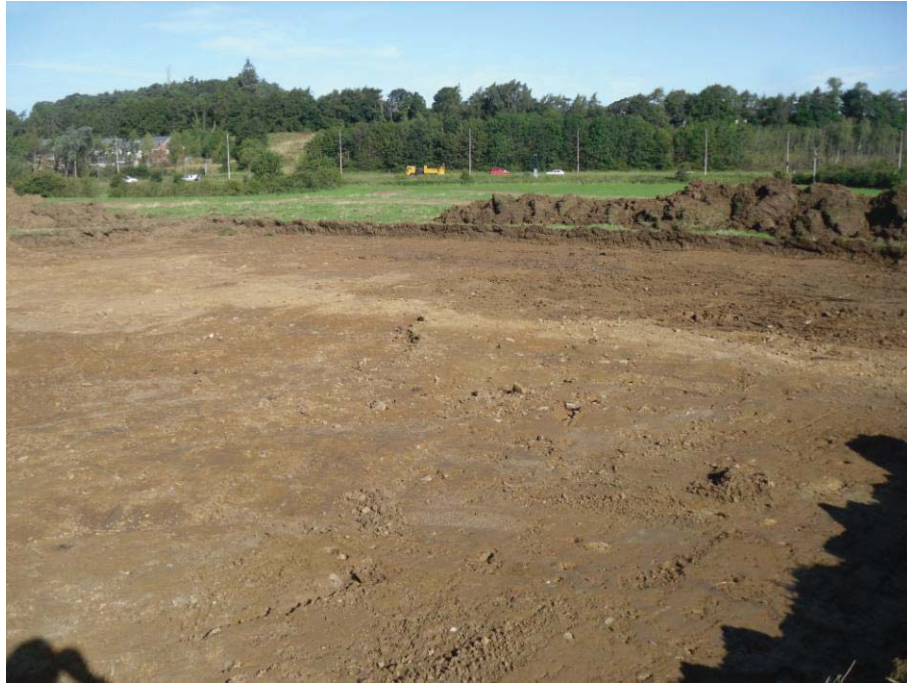
Plate 3 Detail of box trench stripping around feature [007]

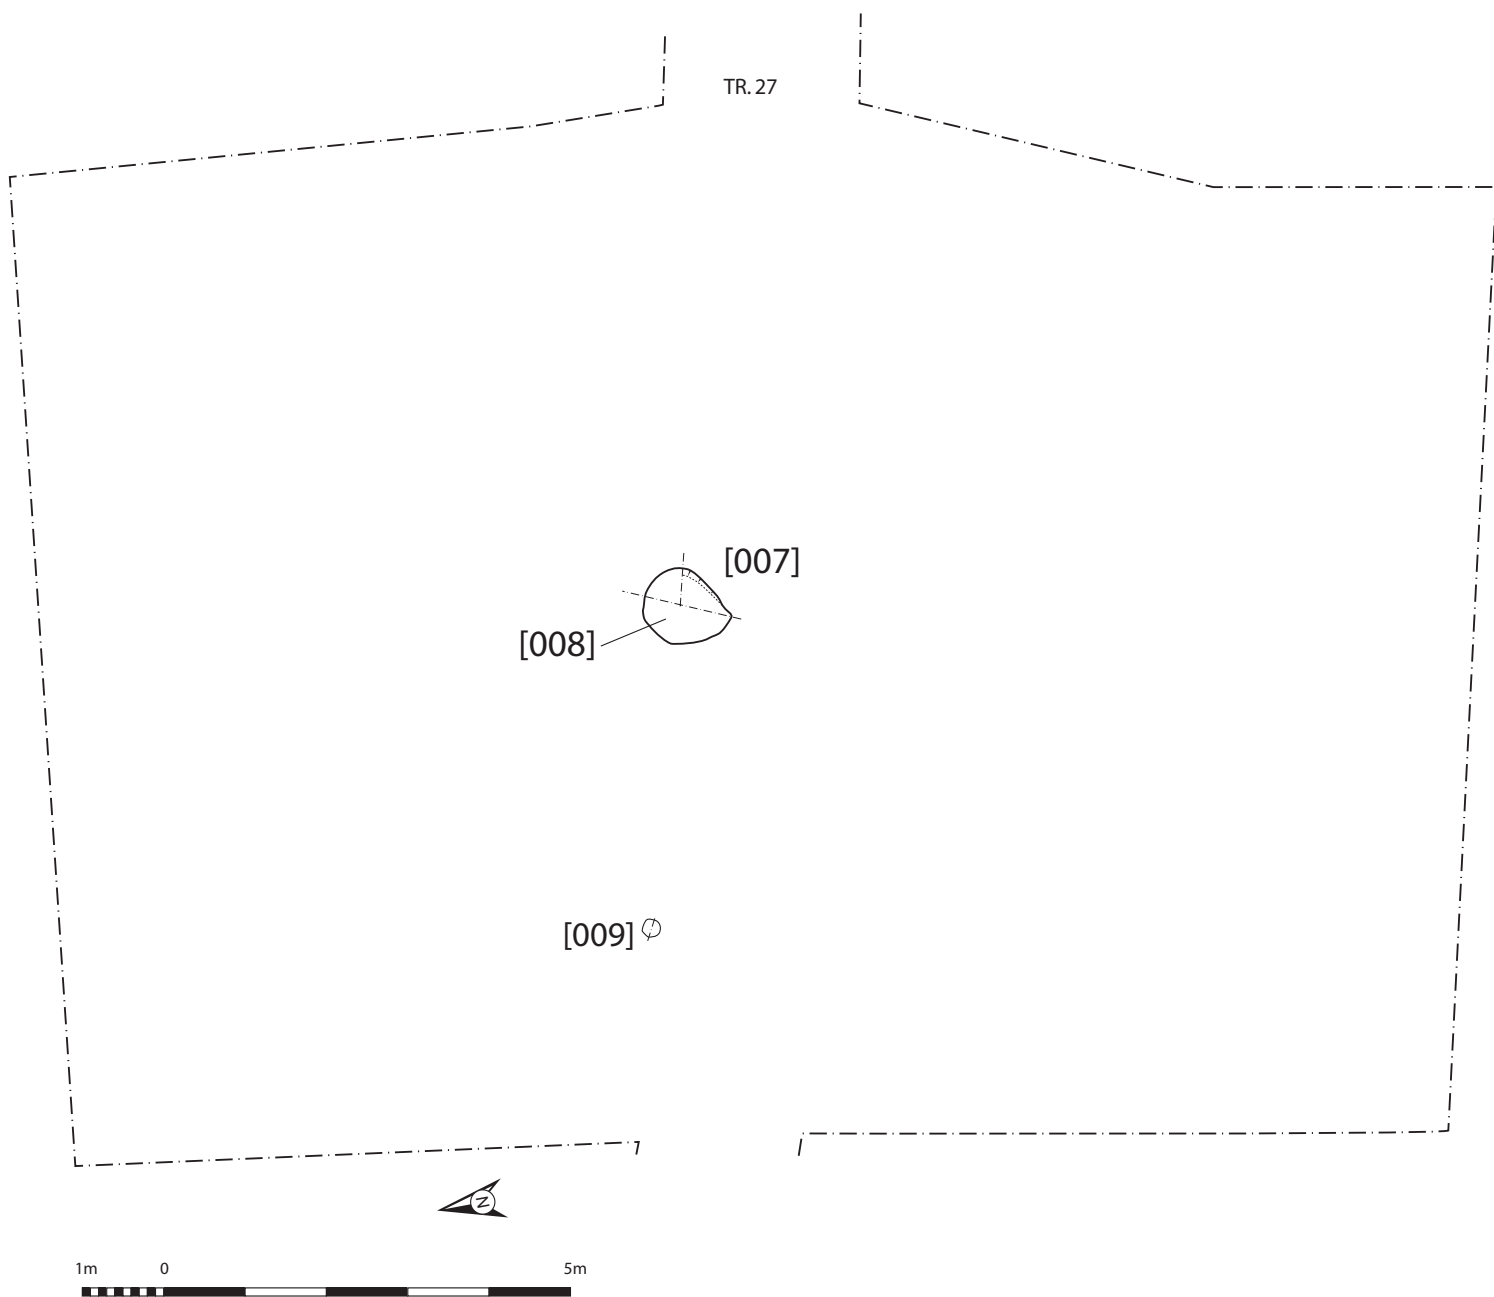
Figures 3 & 4: location plan and section of Feature [007]

Context	Description
001	Cut of natural feature
002	Fill of cut [001]
003	Cut of drain
004	Fill of field drain [003]
005	Natural feature
006	Fill of [005]
007	Cut of sub-circular feature, with shallow sides running in to a rounded base. Measuring 1.08 m by 0.94 m by 0.05 m in depth. Filled by [008].
008	Fill of cut [007], comprising orange/brown silt, with inclusions of charcoal and burnt clay.
009	Cut of possible post-hole, sub-circular in plan, with shallow sides running in to a flat base. Measuring 0.24 m by 0.16 m by 0.04 m in depth.
010	Fill of cut [009] comprising brown silt with possible charcoal flecks.
