Archaeological Works Data Structure Report

AOC Project 22817
11th December 2014

Wallyford Expansion (Areas 1 & 4), East Lothian: Archaeological Works Data Structure Report

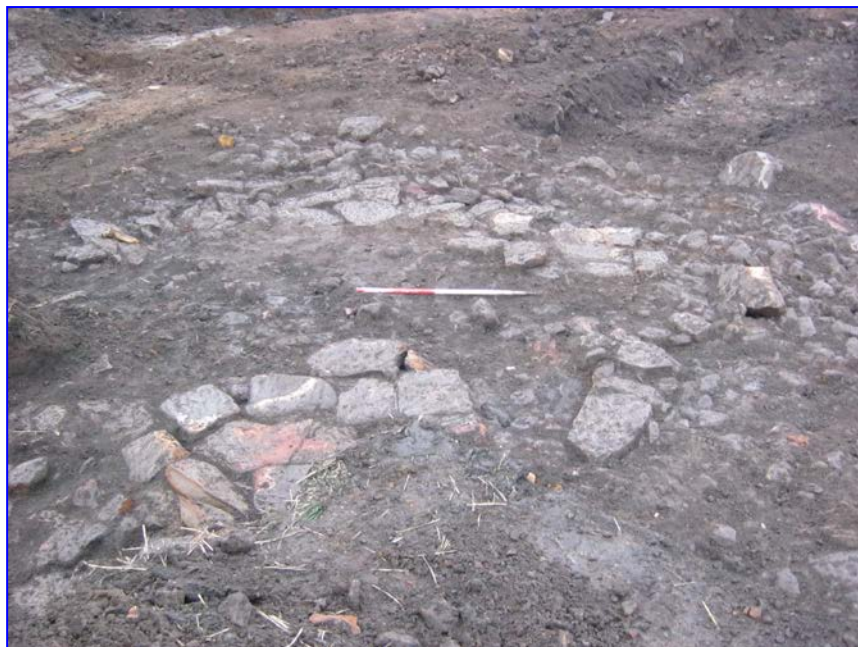
Plate 1: General view of the interior stone surface [152] from the south-west

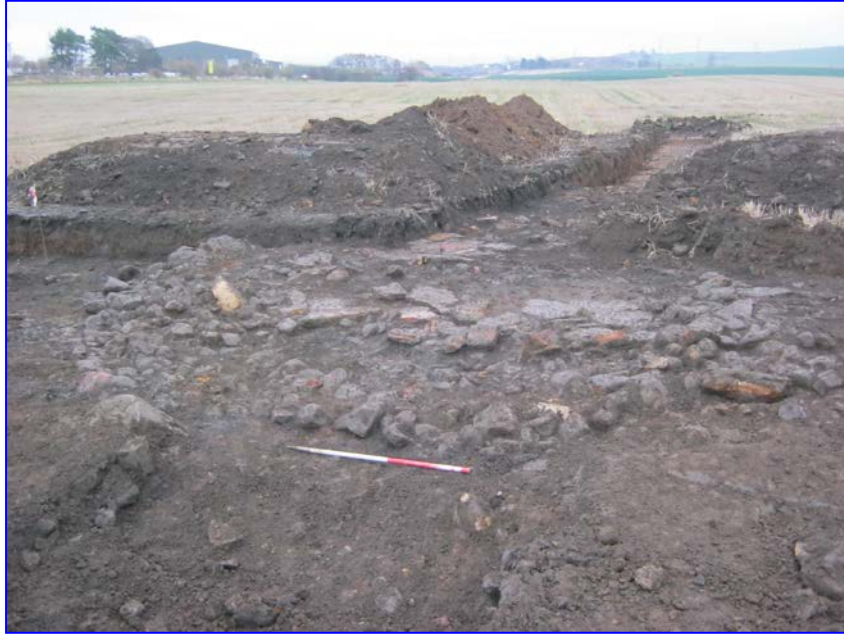
Plate 2: General view of the machine stalk base interior [152] from the north-east

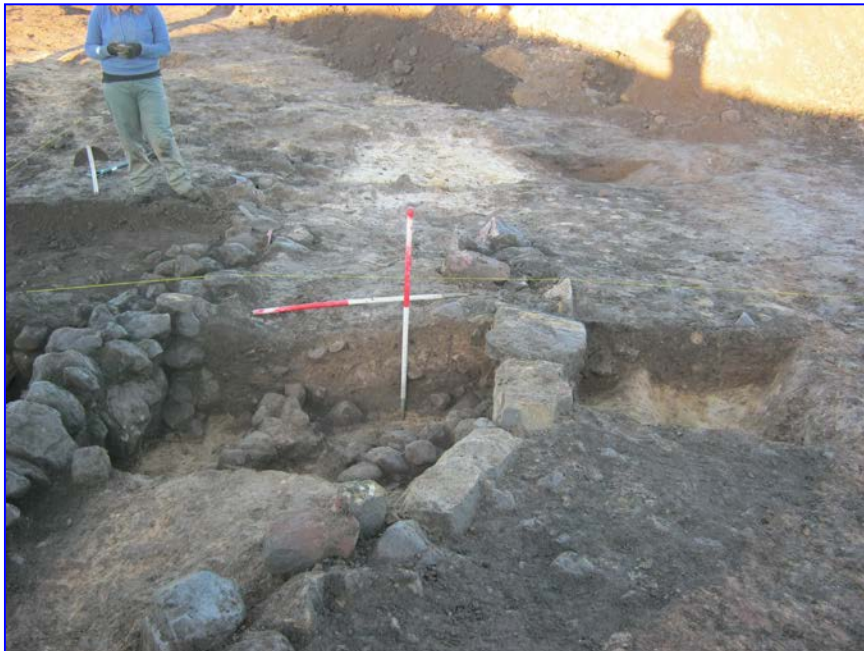
Plate 3: Area 4, detail showing relationship between wall [140] & Integral ditch [124]

4.4.2.2 The roundhouse wall [141] was 1m in width with an elevation of 0.60m. It was visible for 6m and was of drystone construction. A substantial, integral drainage ditch [124] was also associated with the structure channelling water from the eastern ground-slope away from the building to the north-west. The ditch ranged from 1m to 1.30m in width and was 0.40m in depth. The ditch appeared cut by the wall [141].

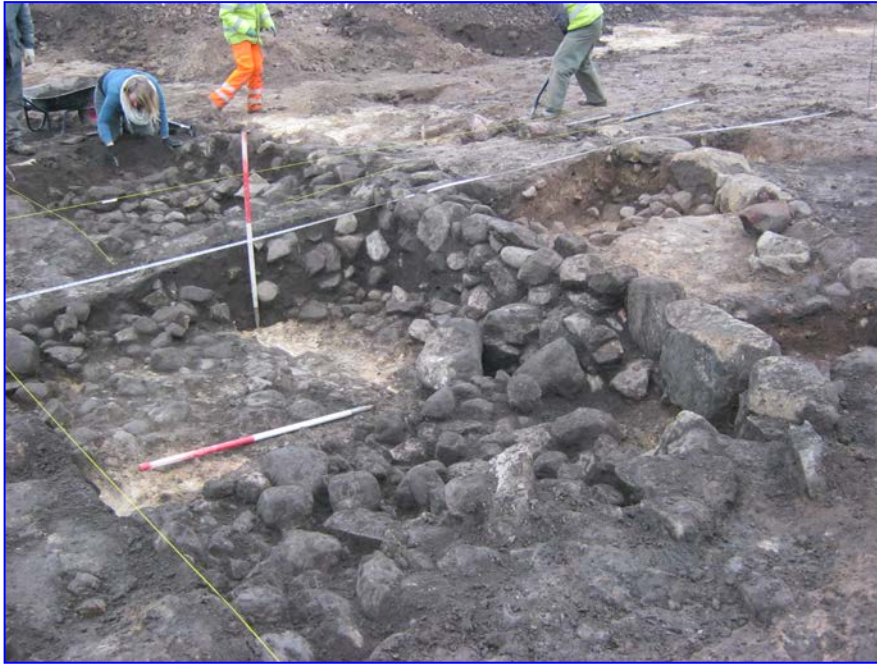
Plate 4: Area 4, detail showing second phase wall [139] and interior deposits

4.4.2.3 The excavation of the north-eastern portion of the structure revealed that the internal face of the roundhouse wall had been altered forming a linear wall [139] 10m in length and orientated east-west. The wall was 0.80m in elevation and 0.50m in width. The cut of the wall [142] appeared to truncate several deposits within the interior of the outer wall [141]. The cut of the roundhouse [141] also appeared to have been modified along the eastern edge creating a straighter more rectangular ground-plan.

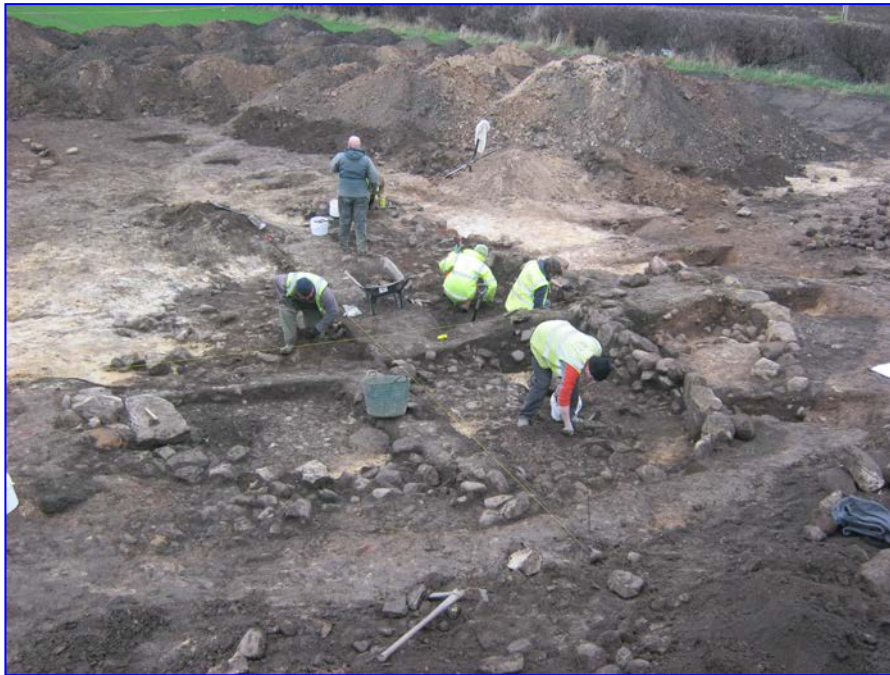
Plate 5: Area 4, general view of Structure [127] under excavation from east

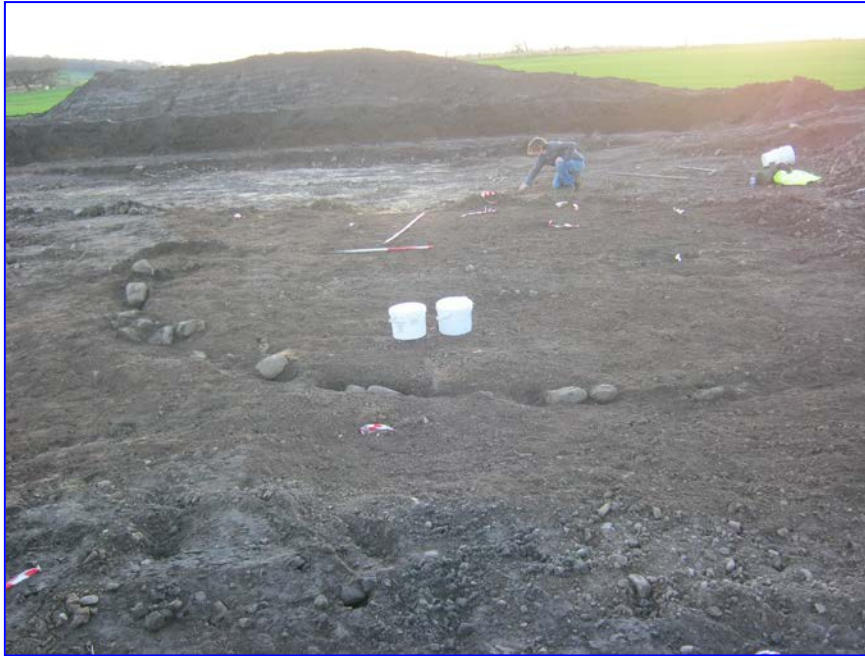
4.4.4.1 The top-soil strip revealed the truncated remains of a prehistoric ring-groove roundhouse measuring 9.0m in diameter (Plate 6). This was located to the south-west of the revetted structure [127] and consisted of a substantial curvilinear ring-groove feature [120] and several internal pit/post-holes [102,104, 106, 108, 110, 112, 114, 116, 118] (Figure 4). The ring-groove was 9m in length ending in a terminal at the south-eastern end. The feature was 0.80m in width with a depth of 0.40m. It had moderate to steep sloping sides and a gently concave base and was filled with a deposit of dark grey brown compact clay silt (121) containing numerous medium-sized sub-angular stones. These are probable packing stones for posts. A saddle quern rubber (SF 7) was recovered from the fill of the ring-groove. The internal pit/post-holes were heavily truncated and ranged from 0.30m to 0.70m in diameter with depths ranging from 0.10m to 0.30m.

Plate 6: General view of ring-groove Roundhouse Structure [129] from north

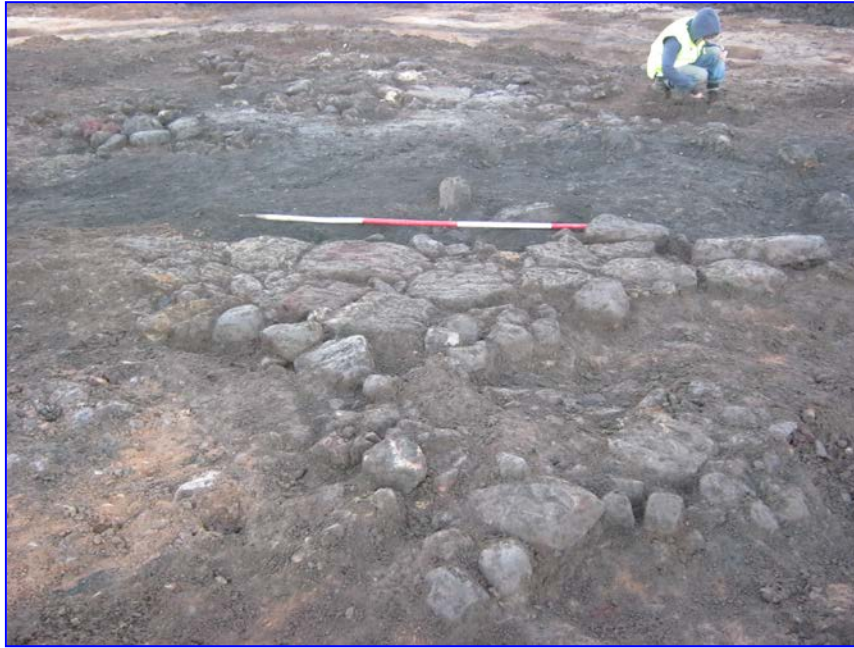
- 4.5.2 The stone platform was composed of closely-packed medium-sized sub-rounded stones placed over a setting deposit (012) of sandy clay. The platform contains patches of flat stone [013] and compact clay (014) which are the probable remains of a floor surface. The platform is between 0.20m and 0.30m in elevation with a slight slope to the west.

Plate 7: General view of platform [011] from the east

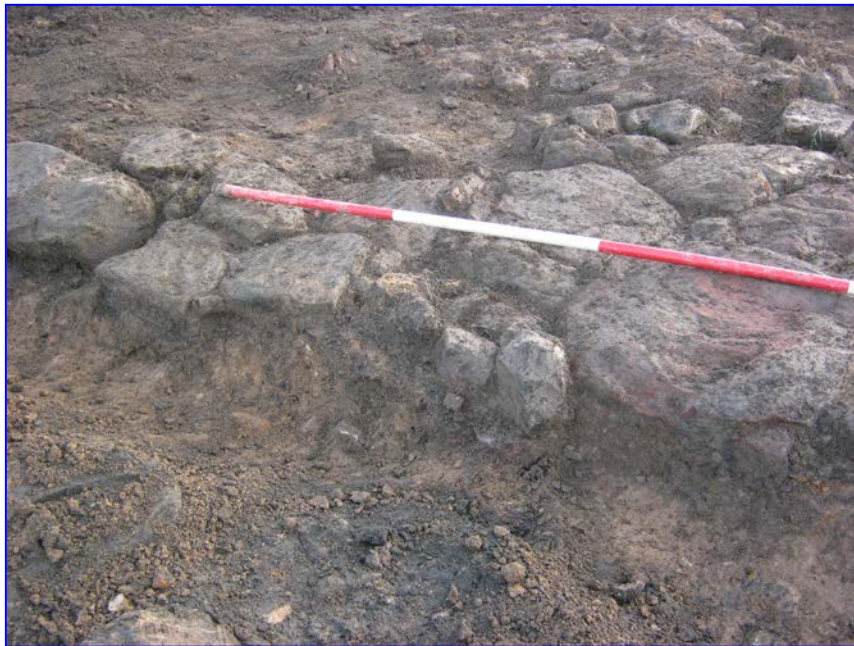
Plate 8: Detail of west facing section through platform [011]

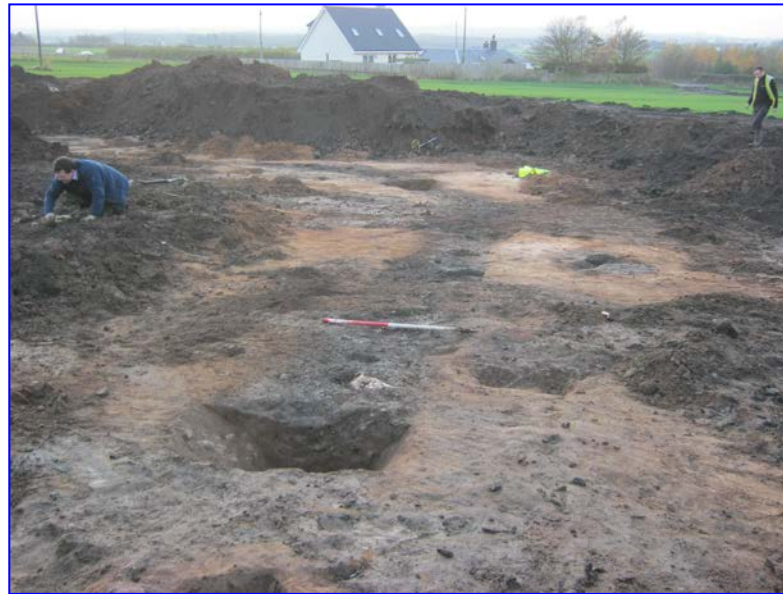
- 4.5.3 The platform was partially enclosed to the west and south-west by a large partially segmented curvilinear ditch [003-008]. The main length of ditch [003] was 20m in length and ended in two rounded terminals with a width ranging from 1.0m to 1.20m (Plates 9 & 10). The ditch had steeply sloping sides and a flat to concave base varying between 0.70m to 0.75m in depth. The ditch contained two fills (004-005) and was re-cut by [006]. A small linear segment of ditch [008] was located to the south. This was 5.0m in length by 1.4m wide by 0.70m in depth. The south-eastern end of this feature ended in a rounded terminal with the north-western end truncated by a modern drain. A 5.0m gap was identified between this segment and Ditch [003]. No evidence of the ditch was identified east of the stone platform [011].

Plate 9: General view of Ditch [003] under excavation from the north-east

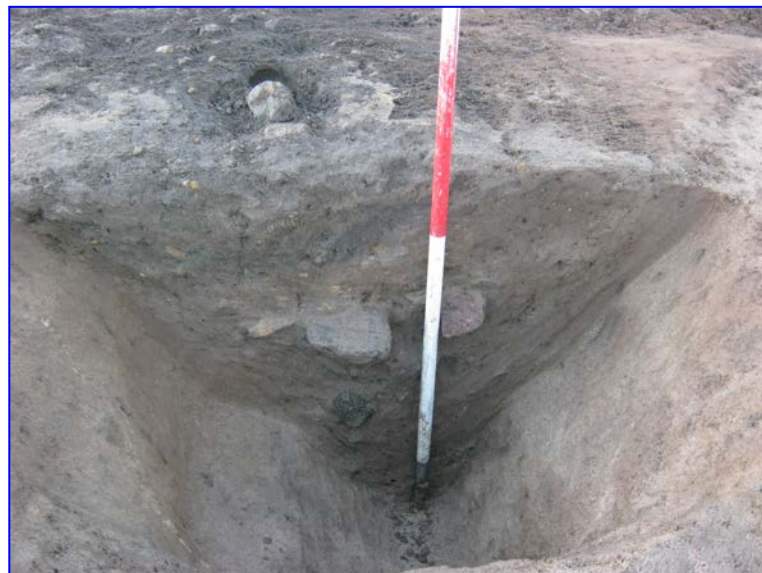
Plate 10: Detail of the north-facing section through ditch [003]-[006]

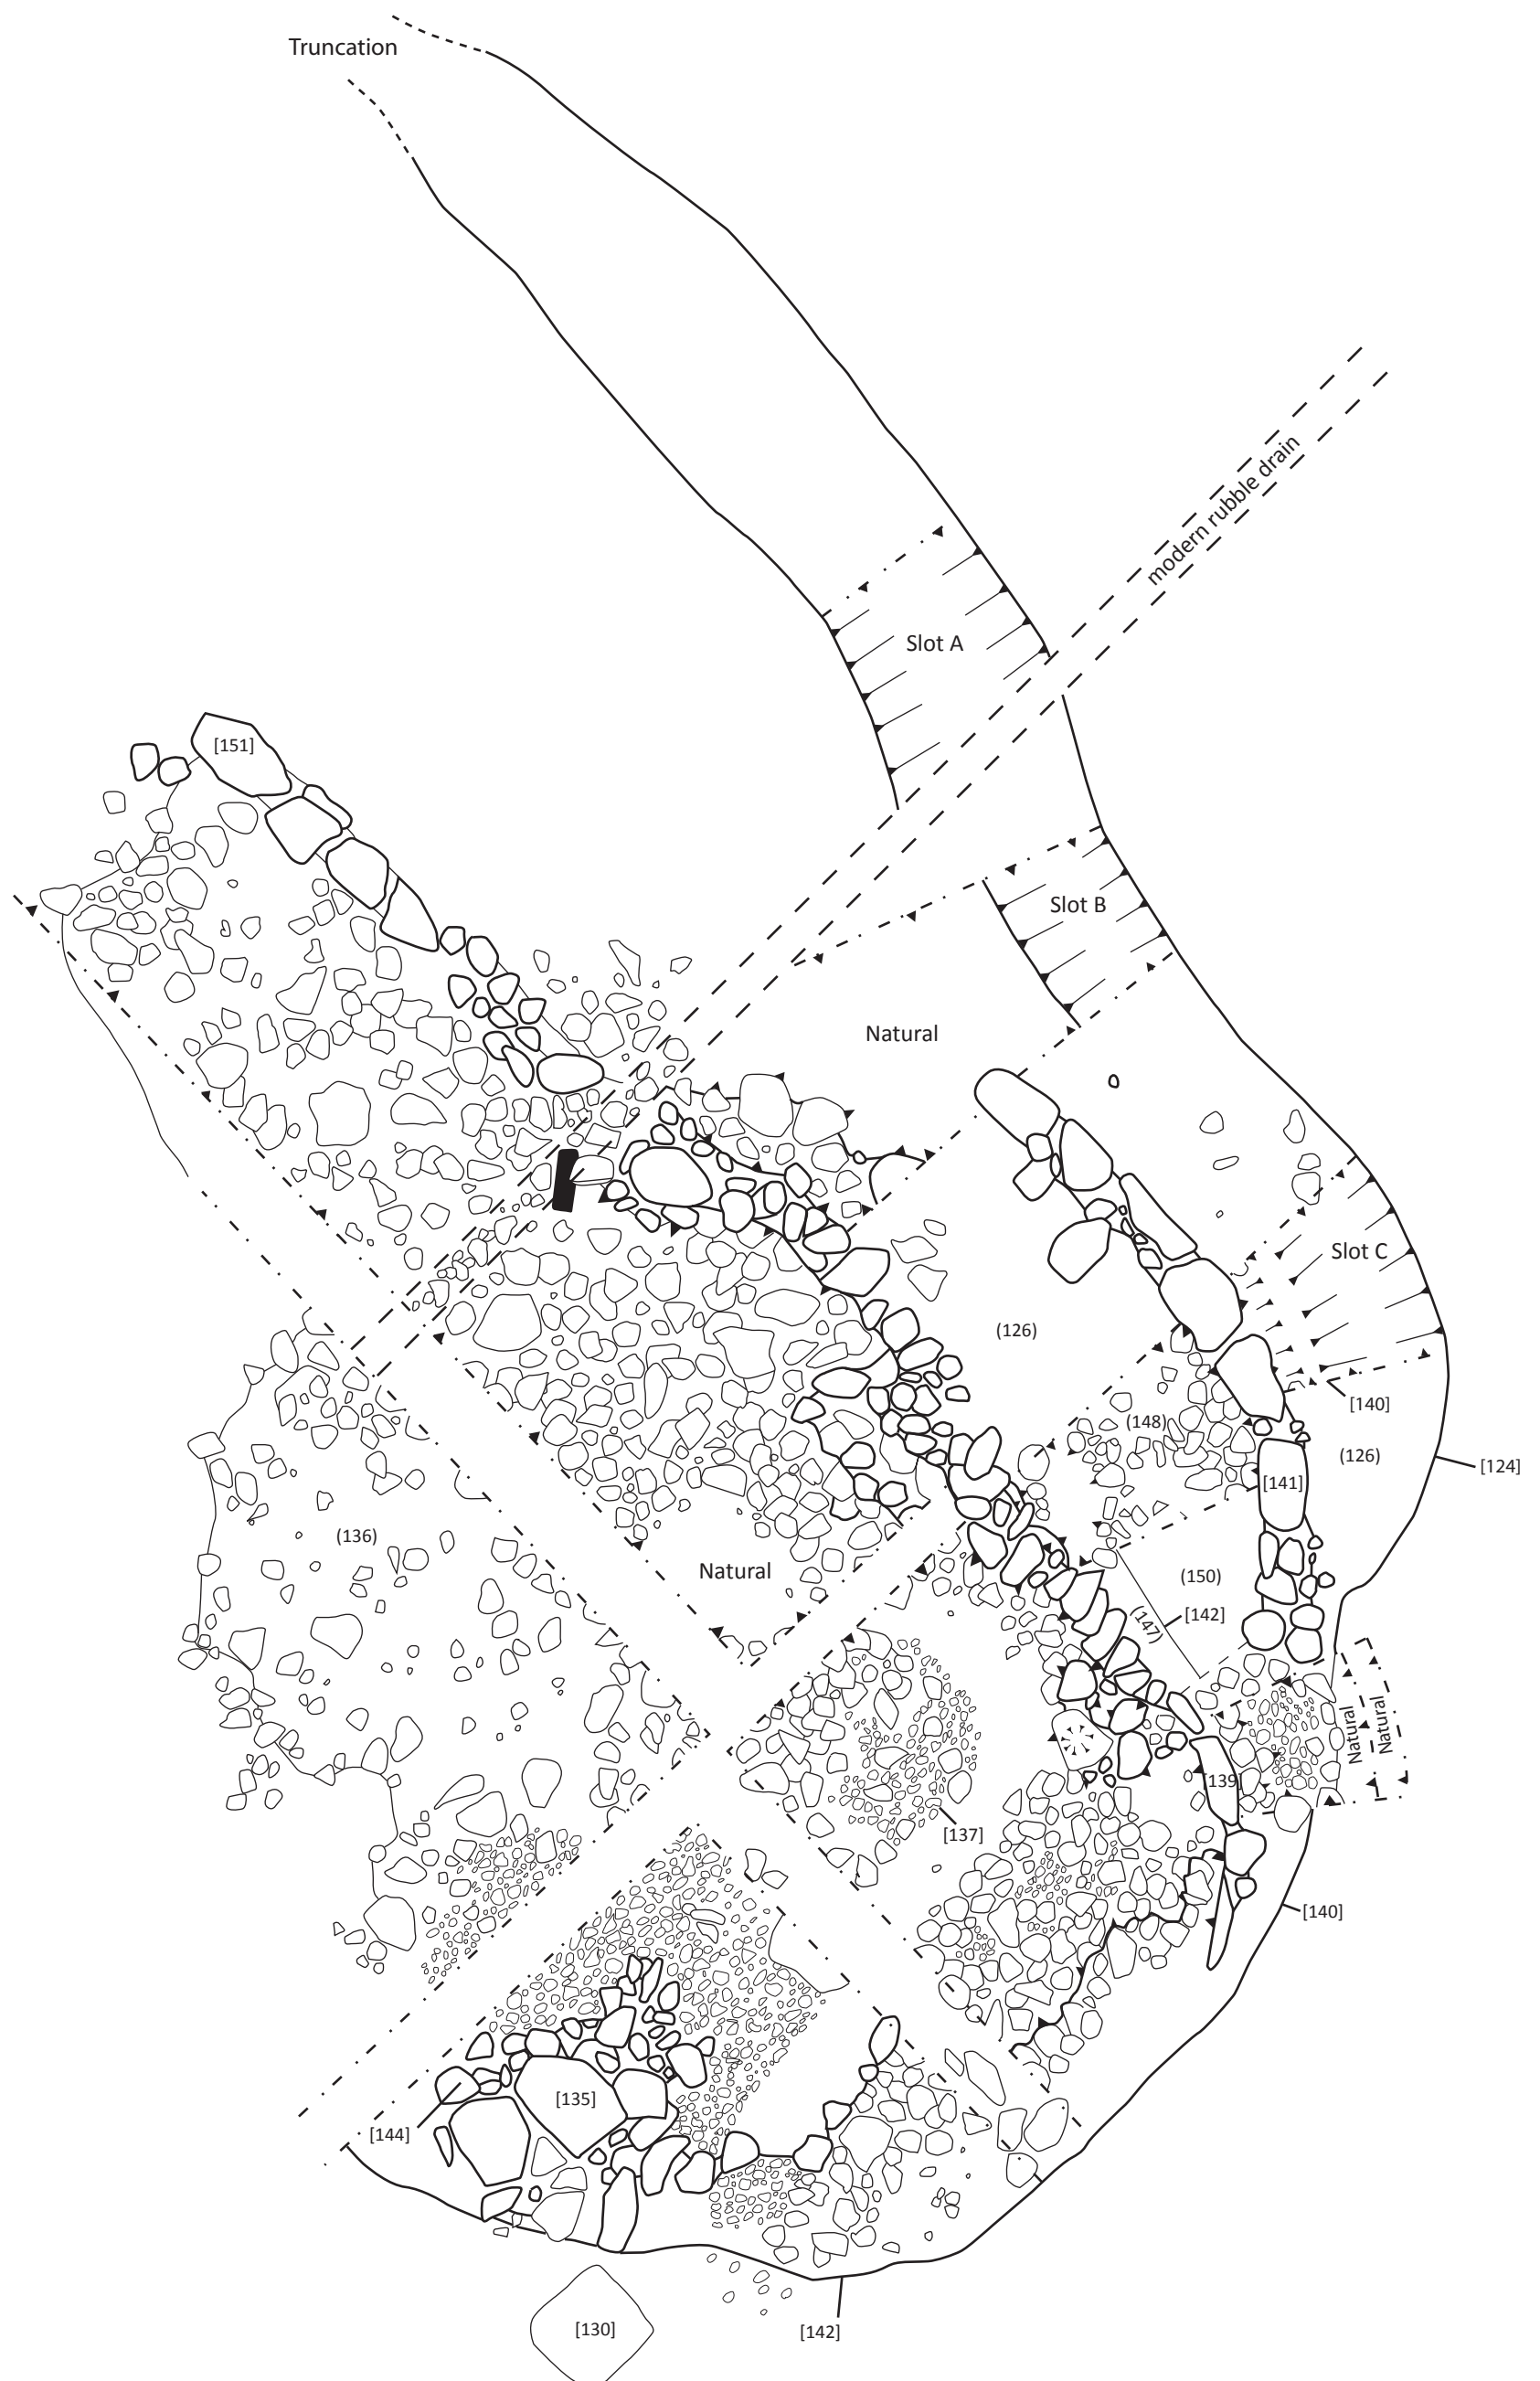
- 4.4.2.1 The earlier evaluation of Site ID 8 (Mitchell 2008a) revealed a sunken floored feature. The subsequent top-soil strip undertaken as part of these works revealed this to be the substantial remains of a stone-built prehistoric roundhouse structure [127] measuring 9m by 12m, partially revetted into the natural west-facing slope. The roundhouse revealed two phases of construction with the original circular wall

construction cut [140] undergoing significant alteration with a re-alignment of the inner face of the wall [142] creating a more sub-rectangular structure measuring 10m by 6m (Figures 5&6). This phase contained a partially metallised floor [137] of small sub-rounded stone cobbles set into the natural to the western half of the structure. A possible threshold [135] is located at the south-east corner and it was filled by a dark brown organic clay silt (136) which enclosed significant amounts of tumble (138). This produced ceramics of probable Iron Age date together with 19th century ceramics.

Figure 5: Plan of Roundhouse Structure [127]

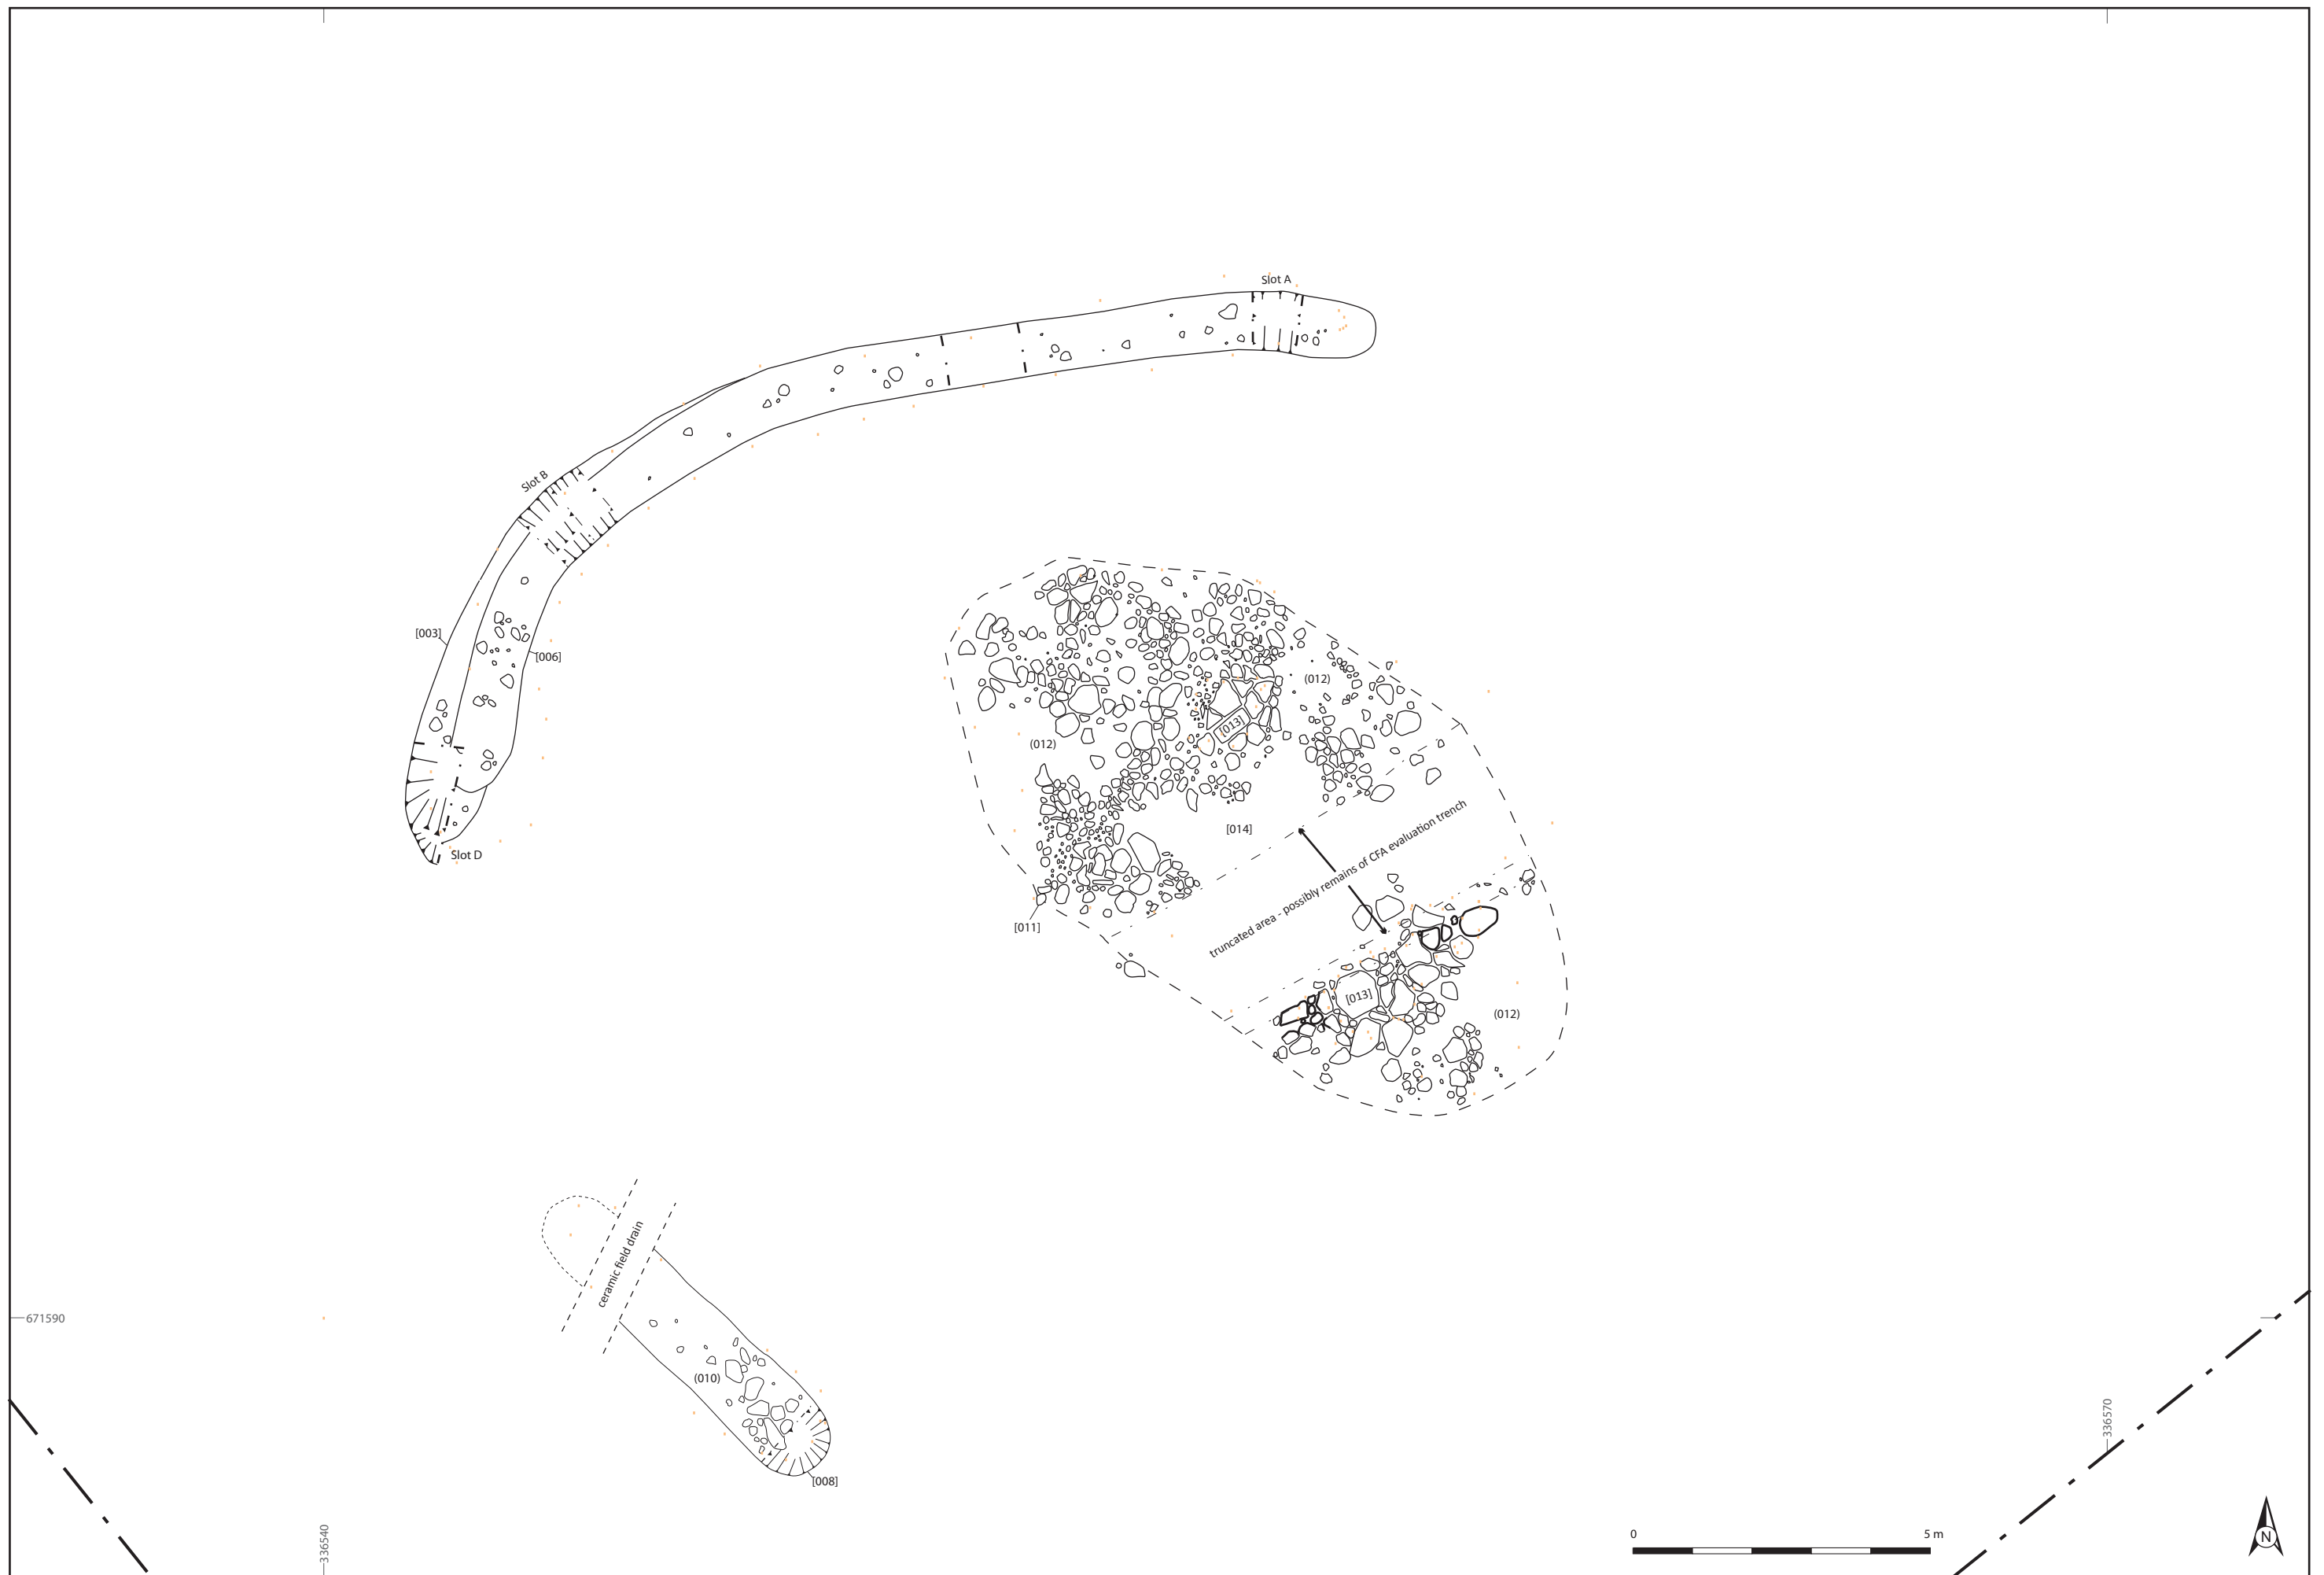
Figure 7: Plan of Site ID 9, Area 4
