# Birkwood House, Lesmahagow: Archaeological Evaluation Data Structure Report

AOC Project 22981  
23<sup>rd</sup> February 2015

<b>On Behalf of:</b>	<b>G Taylor Design</b> Blackhall Studio Hawksland Road Lesmahagow ML11 9PY
<b>National Grid Reference (NGR):</b>	<b>NS 8115 3928</b>
<b>AOC Project No:</b>	<b>22897</b>
<b>Associated Planning Ref:</b>	<b>CL/14/0413</b>
<b>OASIS No:</b>	<b>204521</b>
<b>Prepared by:</b>	<b>Kevin Paton</b>
<b>Date of Fieldwork:</b>	<b>20<sup>th</sup> February 2015</b>
<b>Date of Report:</b>	<b>23<sup>rd</sup> February 2015</b>

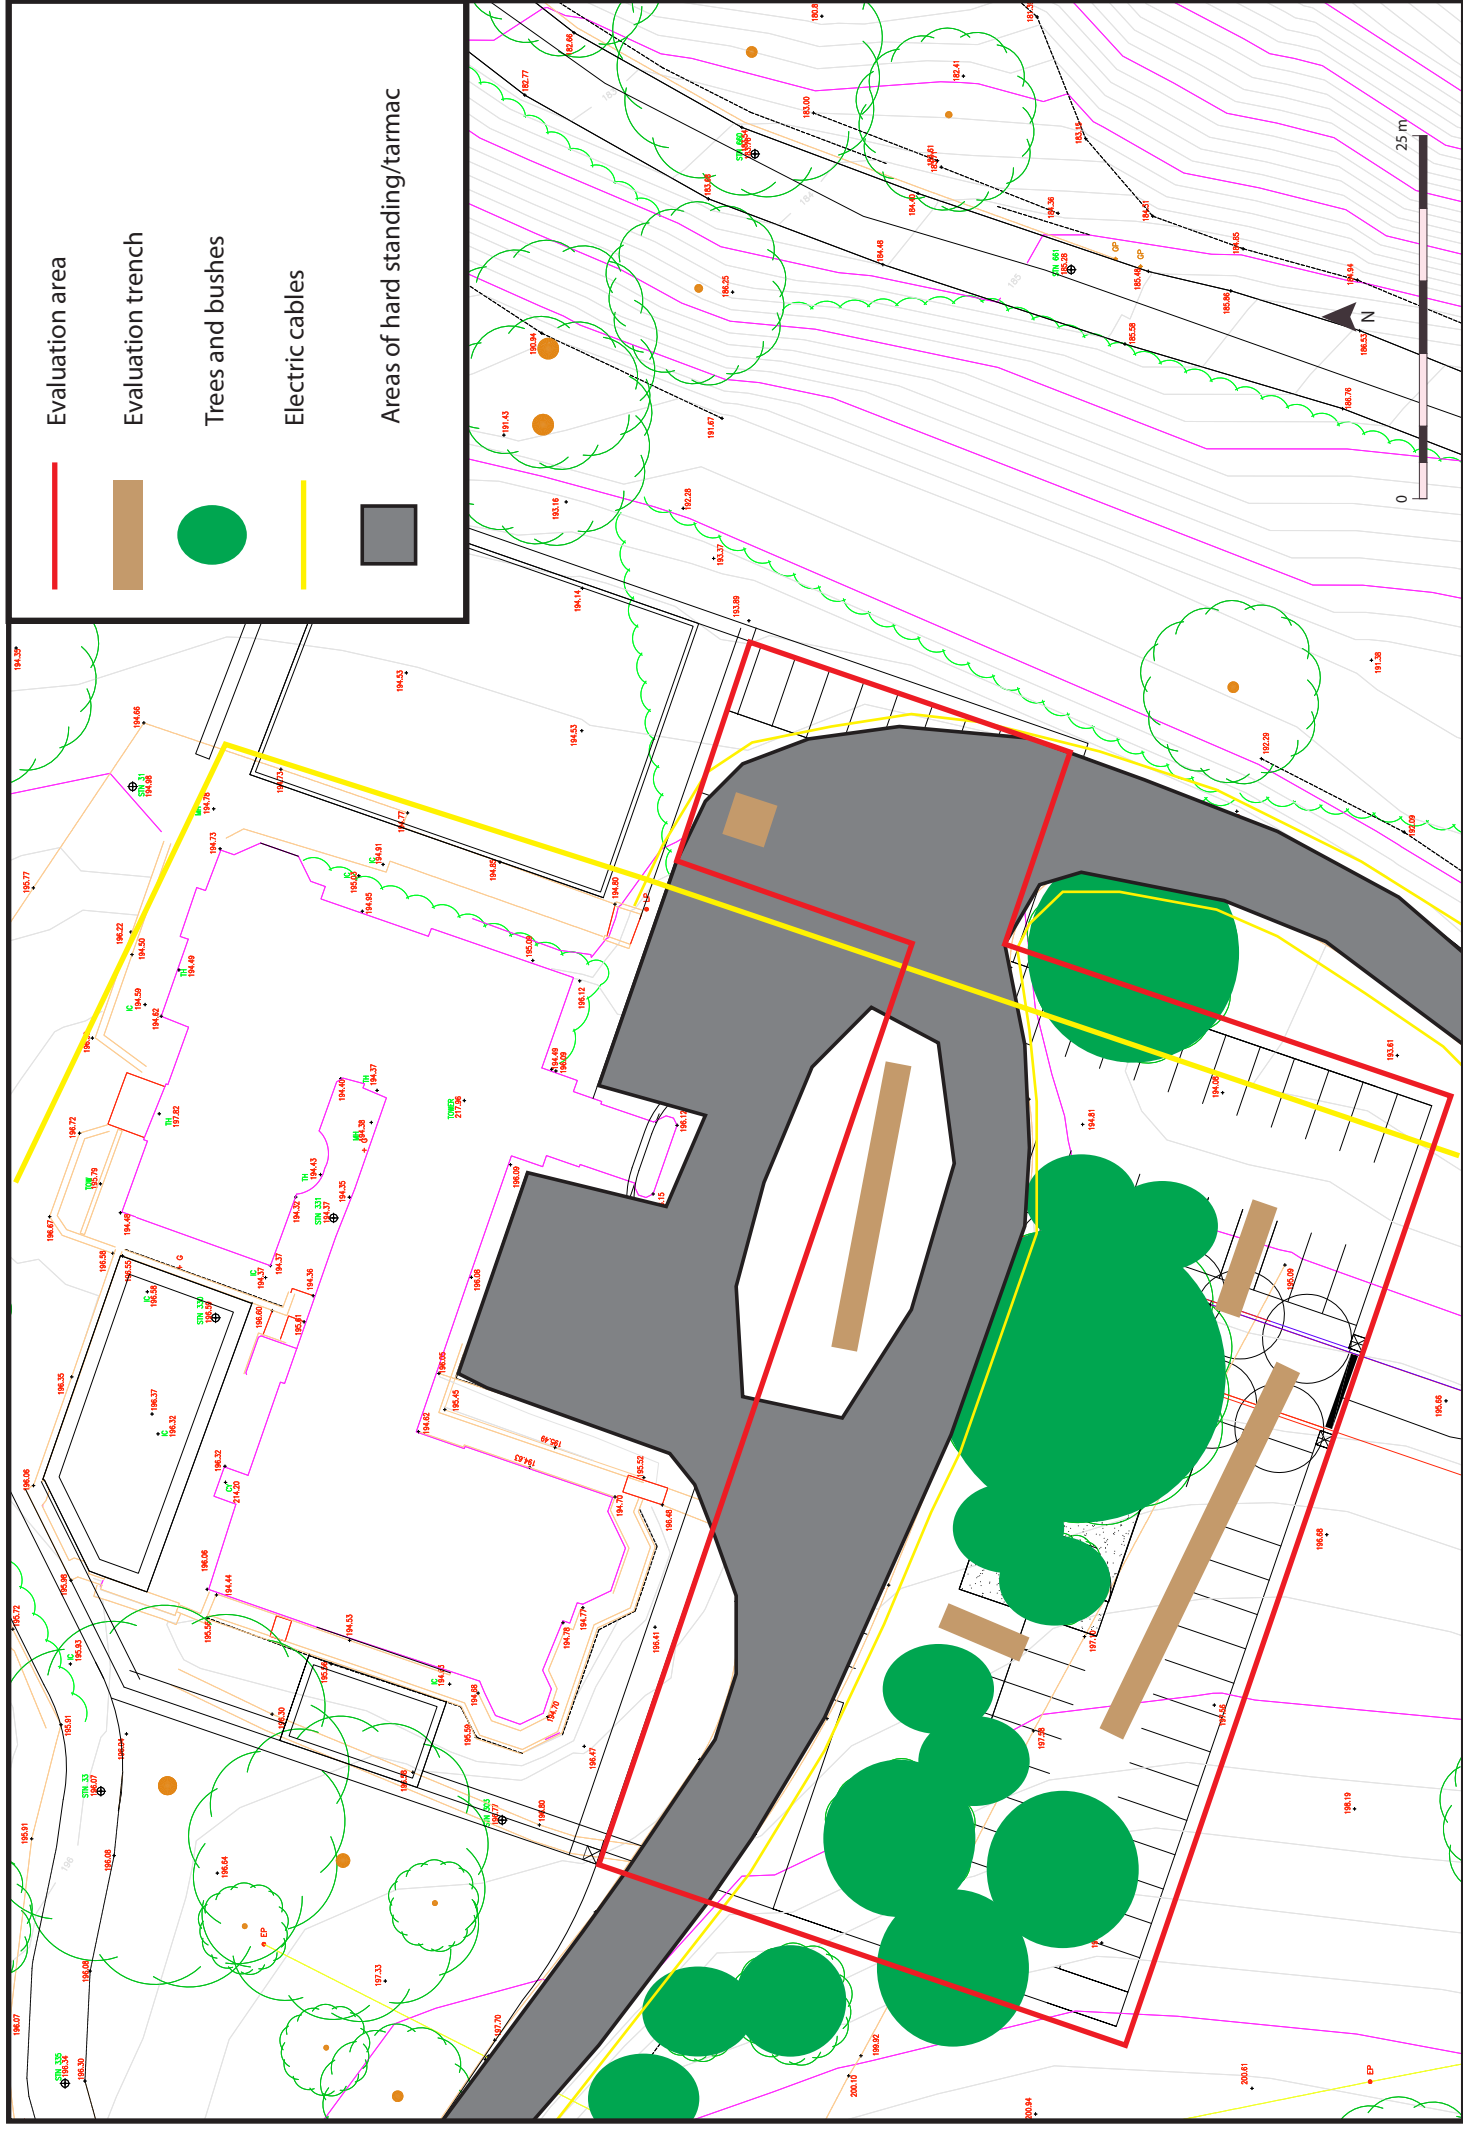
Figure 2 - Evaluation trench location plan

- 4.1 The archaeological evaluation was undertaken on the 20<sup>th</sup> February 2015. Weather conditions were mostly fair allowing for good archaeological visibility throughout the evaluation. In total, 62 m of linear trench and a 3 m<sup>2</sup> trench was opened, positioned throughout the development area (Figure 2).

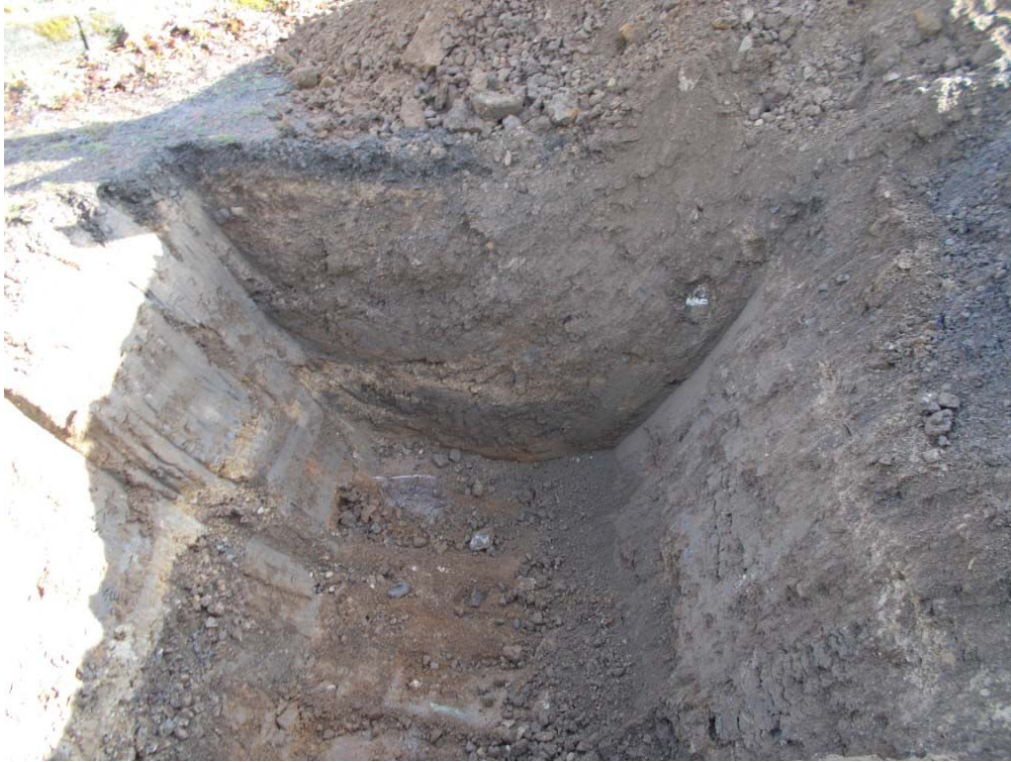
Plate 1 - Made ground within Trench 4

- 4.2 Trenches 1 and 4 to the N of the driveway indicated that the natural slope in front of and surrounding Birkwood House had been landscaped and levelled with up to 2 m of made ground present to the E edge of the development area (Trench 4; Plate 1) and 0.6 m of made ground and topsoil towards the W (Trench 1). Further W, an embankment to the S of the driveway indicates that this area has been previously truncated during the house and driveway construction. Furthermore, from the excavation of Trench 4 it appears that the E edge of the development area has also been truncated prior to being made up.

<i>Dimensions</i>	3 m by 3 m
<i>Total Area</i>	9 m <sup>2</sup>
<i>Excavated Orientation</i>	N/A
<i>Soil Make-up</i>	Hard standing – Red chip stone – max. depth 0.15 m; Made ground – mixture of crushed sandstone rubble, grey clay and mid brown clayey soil, and compact stone – max depth 1.85 m
<i>Depth of Excavation</i>	2 m
<i>Significant Features</i>	None
<i>Other Features</i>	None
<i>Natural Subsoil</i>	Orange sand and large boulders
<i>Finds</i>	None

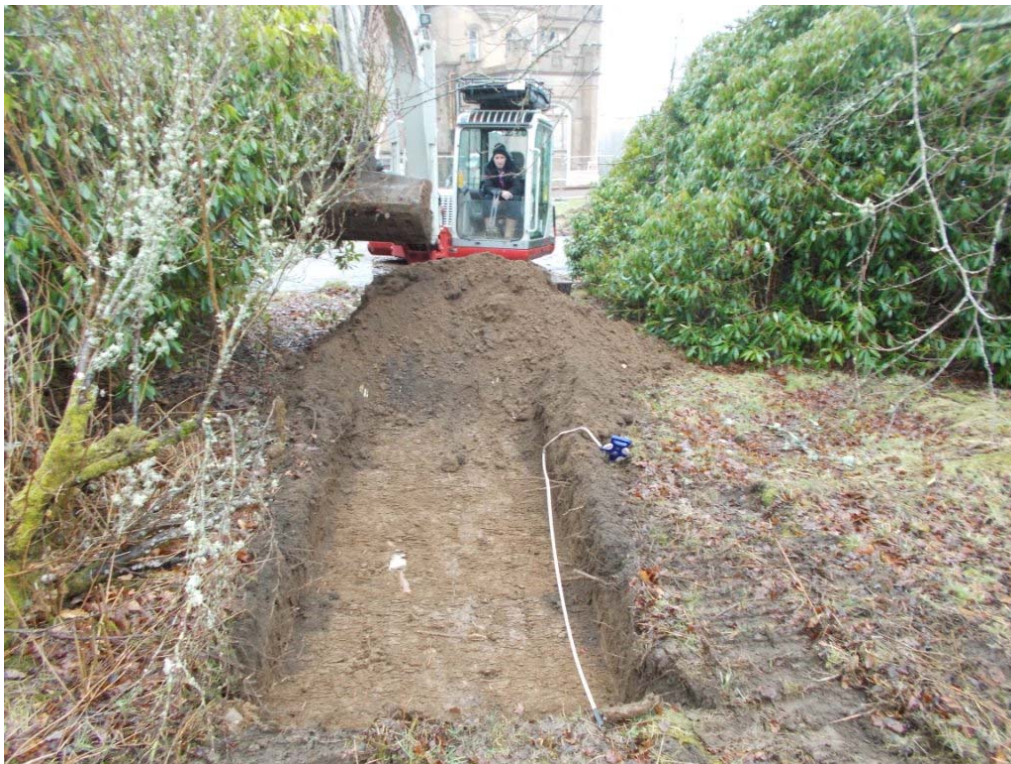
Plate 2 - Location of Trench 3 within bushes

- 4.3 The other three trenches were situated to the S of the landscaped areas and driveway. Trench 2 was placed along the S edge within a bounded field; Trench 3 was placed between two very large mature bushes (Plate 2) and Trench 5 was placed to the SE edge of the mature trees. Trenches 3 and 5 indicated that the line of trees and bushes had disturbed the top 0.1 to 0.2 m of the underlying geological deposits through root action. Trench 2 revealed no signs of plough truncation or landscaping disturbance indicating that the field system had not been previously disturbed (Plate 3).
- 4.4 The underlying geology throughout the majority of the site was an orange and grey sandy clay with frequent small stone inclusions, interpreted as glacial till. No significant archaeological features or artefacts were revealed.

<i>Dimensions</i>	6 m by 1.8 m
<i>Total Area</i>	10.8 m <sup>2</sup>
<i>Excavated Orientation</i>	SW to NE
<i>Soil Make-up</i>	Topsoil – dark greyish brown clay loam – max depth 0.4 m
<i>Depth of Excavation</i>	0.4 m
<i>Significant Features</i>	None
<i>Other Features</i>	Ce storm drain from 0 m to 3 m
<i>Natural Subsoil</i>	Rooted orangey brown and grey clayey sand
<i>Finds</i>	None
