Saughton Hall, Edinburgh: Archaeological Evaluation Data Structure Report

AOC Project 22747

5th March 2015

Data Structure Report

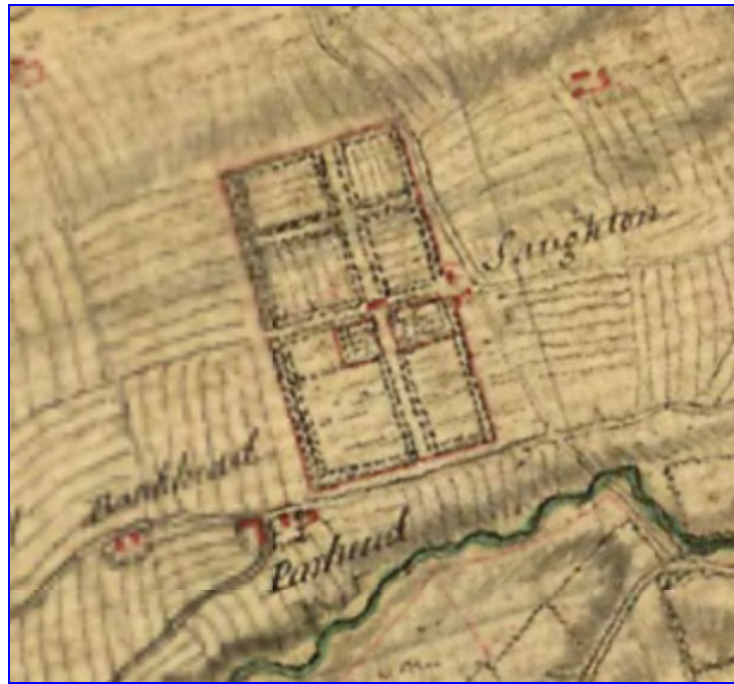
Figure 4: Extract from Roy's map, ca. 1747 - 55

- 1.3.5 The maps throughout the 18th century show the general layout of the estate, including the mansion house and its gardens, with Roy's Military Map of Scotland from ca. 1747 – 55 showing the house and grounds in a rectangular plot of land roughly orientated NNW/SSE (Figure 4). This is clearly a slightly earlier form of layout than is seen later in the 19th century, which stretches to the east and west of the house.

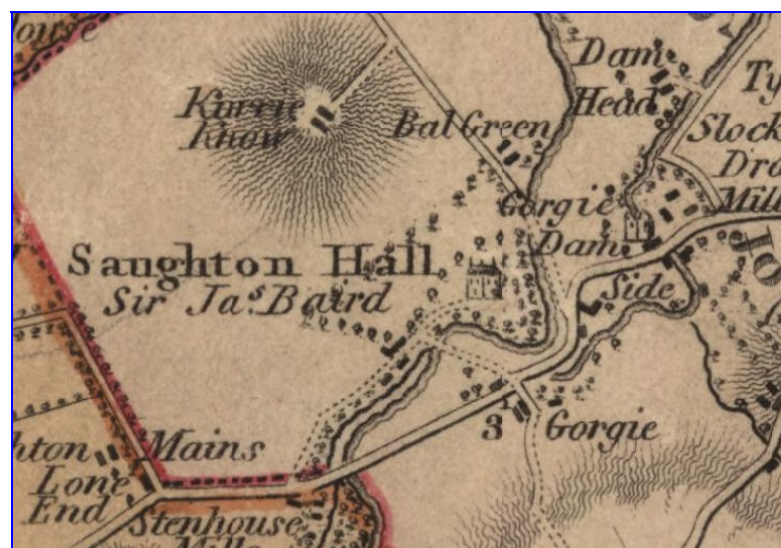
Figure 5: Extract from Knox's plan, 1816

- 1.3.6 Into the 19th century, the mansion house and gardens appear much the same. James Knox's 1816 plan even annotates the estate as belonging to Sir Ja[mes]s Baird, indicating that the estate remained in the hands of the Baird family from the 17th century to this time (Figure 5). In 1824, the house was leased to the Institute of the Recovery of the Insane - essentially a 'private' lunatic asylum for those of higher ranks - admitting over 100 patients from 1824 – 1840. The 1855 Ordnance Survey map details the mansion house and estate, including the extent of its outbuildings and the sundial in the garden (Figure 6). The grounds are extensive with pathed walkways bounded by rows of mature trees and with an open expanse of land to the south where the estate meets the Water of Leith. Two large mill complexes have also sprung up to the north-east (Gorgie Mills) and to the south-west (Saughton Mills).

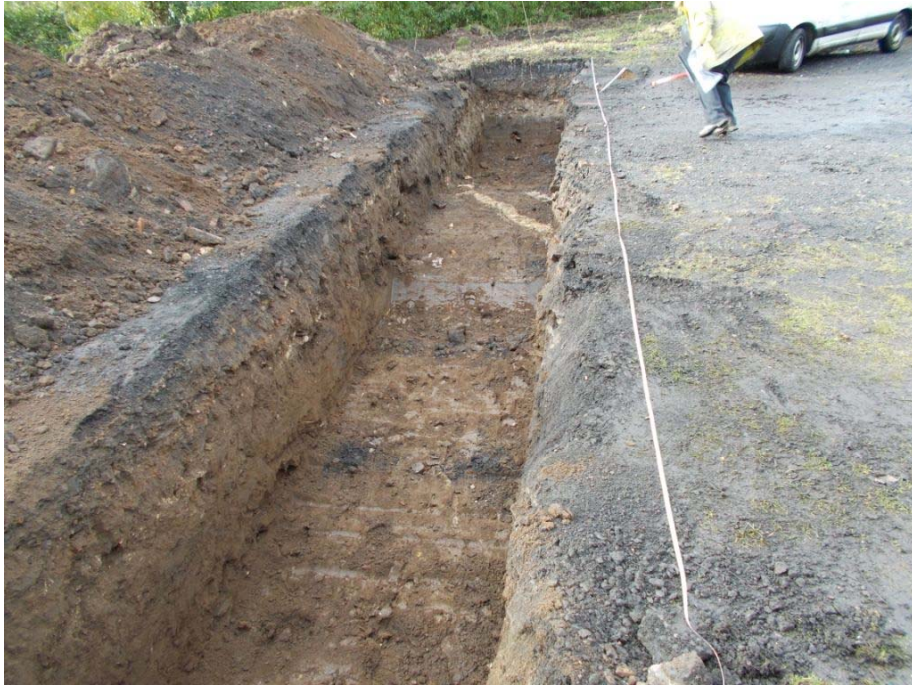
Plate 1 – Post excavation view of Trench 1

- 4.2.1 The uppermost deposit in all three trenches was a layer of hard standing (type 1 stone) covering a mixture of made ground deposits up to 0.8 m thick, overlying an alluvial sandy clay subsoil up to 0.7 m thick in places (Plate 1). Sandstone culvert [001] was revealed cut into the top of this subsoil deposit, aligned N-S and measuring 0.6 m wide with rounded stones on either side of the channel and capped with a sandstone slab (Plate 2).

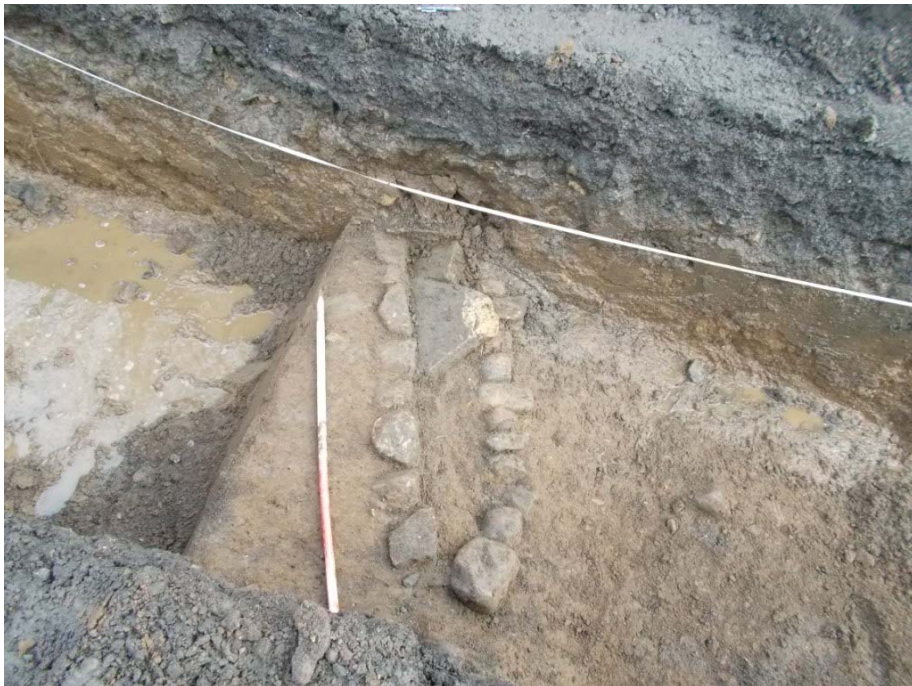
Plate 2 - Culvert [001] in Trench 3

Context No.	Area	Description and Interpretation
001	Trench 3	Angular and rounded sandstones aligned N/S. Built to support a sandstone cap for drainage possibly for Saughton Hall. Dimensions: 1.90m x 0.60m. At a depth of 0.80m. Cut into natural subsoil. Culvert related to Saughton House
002	Trench 3	Loose orange brown silt matrix and roots. Fill of culvert
003	Trench 4	Partially concreted type 1 stone. Hard standing for the compound
004	Trench 4	Compact mortar and rubble covering the walls in T4. Demolition layer
005	Trench 4	Light brown yellow sandy gravel with frequent stone. Possible natural below [004]
006	Trench 4	One course of sandstone aligned NE/SW at a depth of 0.25m. Dimensions: 1.95m x 0.60m. It is covered by deposit [004] but it is unclear what it sits on and if there are other courses. It is most likely a wall relating to the buildings at Saughton Hall. Sandstone wall related to Saughton House

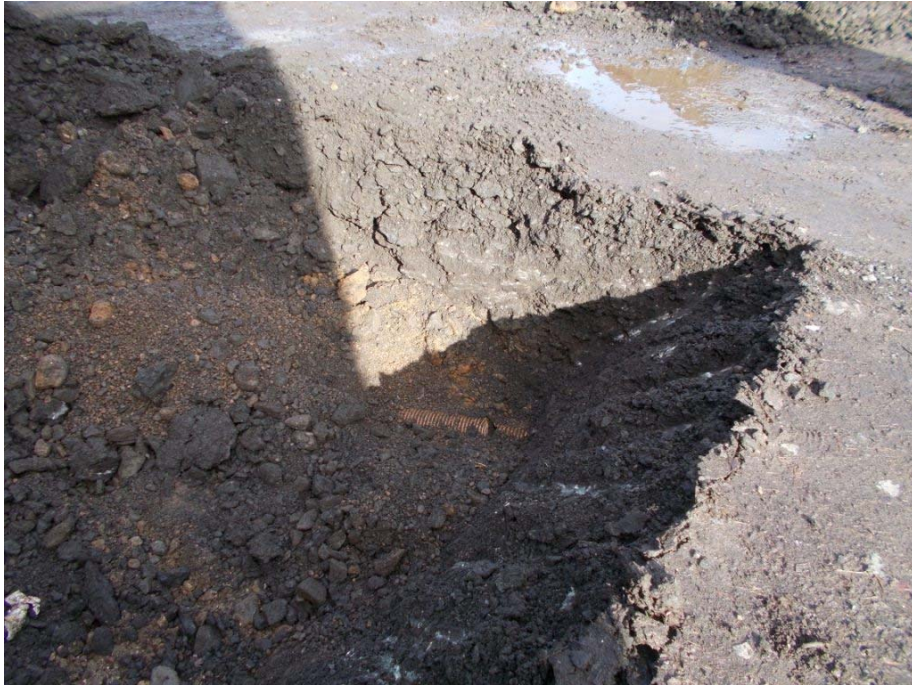
Plate 3 - Modern drain in Trench 5

- 4.3.1 Trenches 5&6 were placed within the compound area, on the W side of an underground electric cable. Trench 5 had to be abandoned at a depth of 0.4 m due to the presence of a modern plastic drain that was aligned in the same direction as the trench (Plate 3).

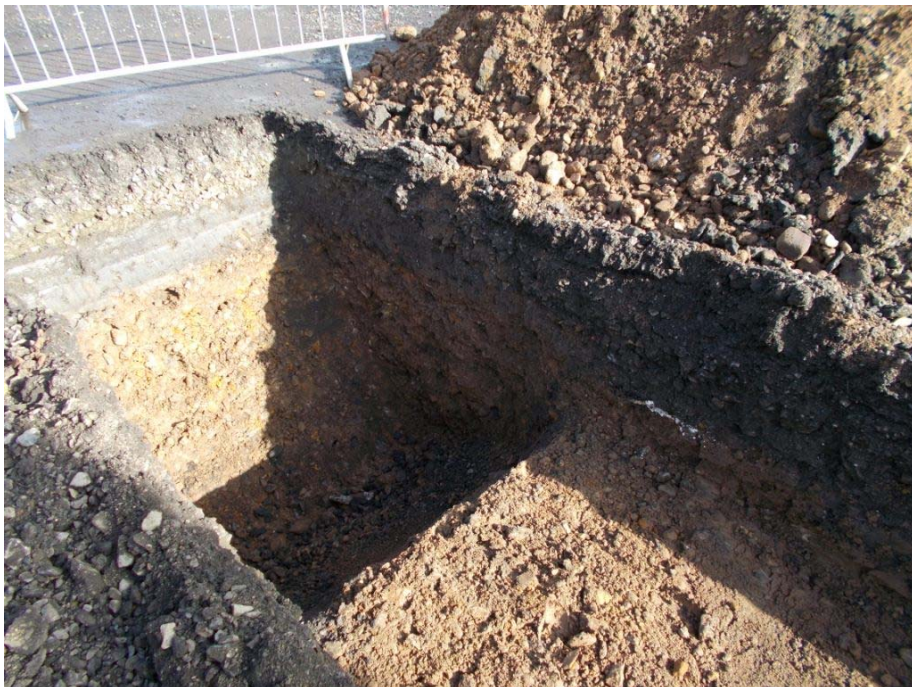
Plate 4 - NNW-facing section through Trench 6

- 4.3.2 Trench 6 consisted of 0.65 m of hard standing and compact clay and ash overlying the natural geology of coarse sand and gravel (Plate 4). In some areas of the trench this gravel appeared to be re-deposited with occasional sandstone rubble present to a depth of 0.8 m.

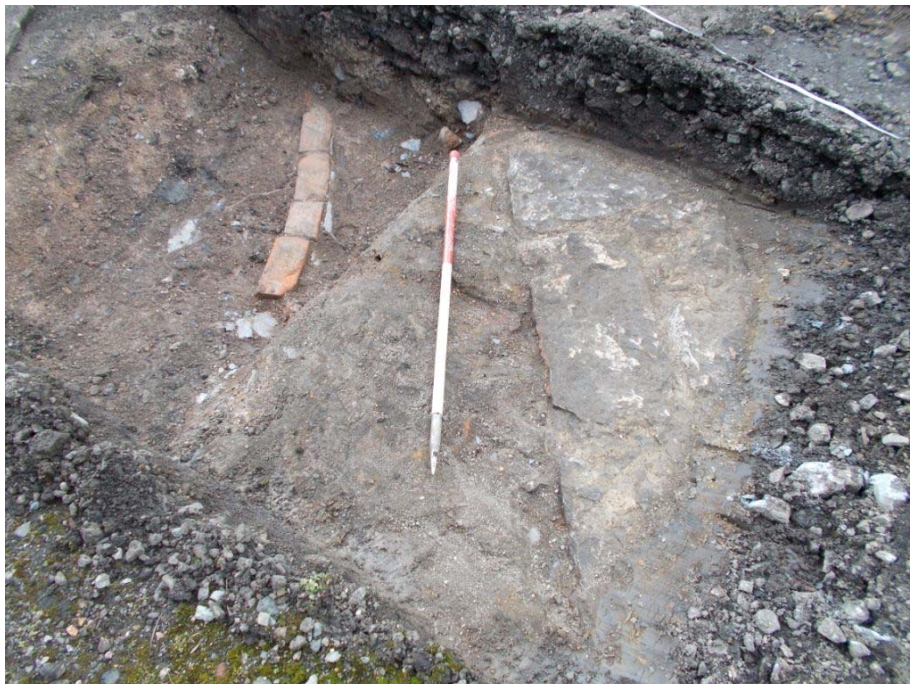
Plate 6 - Wall [006] and possible culvert [007]

- 4.4.3 Other features within the trench include a single course of bricks [007] curving SW-NE that may have been part of a drainage channel now truncated (Plate 6). A deposit of demolition

007	Trench 4	Single line of bricks at a depth of 0.60m and aligned NE/SW. Dimensions: 0.15 x 1.07m. Sits within or at base of deposit (005). Possible culvert remains
008	Trench 4	Large L-shaped sandstone wall. At a depth of 0.4m and aligned NE/SW then SE/NW. Only one course visible. Sandstone wall related to Saughton House
009	Trench 4	Three courses of sandstone wall were exposed at a depth of 0.35m. Dimensions: 1.30m x 0.60m. The wall is aligned NE/SW and could be joined to [008] and [017]. Sandstone wall related to Saughton House
010	Trench 4	Very compact dark grey clay deposit. It partly covers wall [009] and appears to be sterile. It could have been a bonding deposit for walls [008] and [009]. Construction deposit
011	Trench 4	One single course of large angular sandstones at a depth of 0.45m. Dimensions: 1.00m x 0.30m. Follows the same alignment as most of the walls in the trench (NE/SW) and could be related to wall [012]. Sandstone wall related to Saughton House

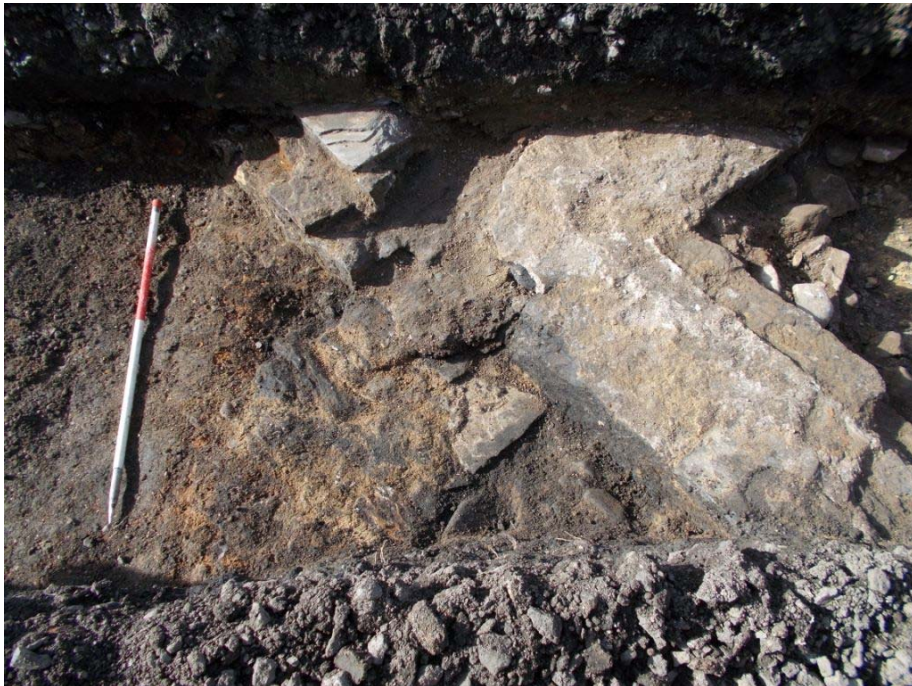
Plate 8 - Walls [008] & [009] with deposit [017]

material [005] was also present between the walls [006] and [014] as well as [009] and [012]. Finally, a possible foundation pad [017] consisting of sandstone blocks covered with a sand and lime mortar was revealed to the SE of wall [008], possibly running underneath the foundation (Figure 11; Plate 8).

017	Trench 4	Mixed deposit of sandstone blocks and mortar underlying wall [009] and deposit (010) at a depth of 0.75m. Aligned NW/SE. Construction deposit
100	Test-pit 1	Pale brown and orange mottled sand. Geological deposit
101	Test-pit 1	Dark greyish brown sandy clay. Up to 0.2 m thick. Topsoil
102	Test-pit 1	Very compact grey/black sand, stone and cinders up to 0.2 m thick. Made ground
103	Test-pit 1	Mid brown and orange sandy clay with occasional stone and coal flecks.

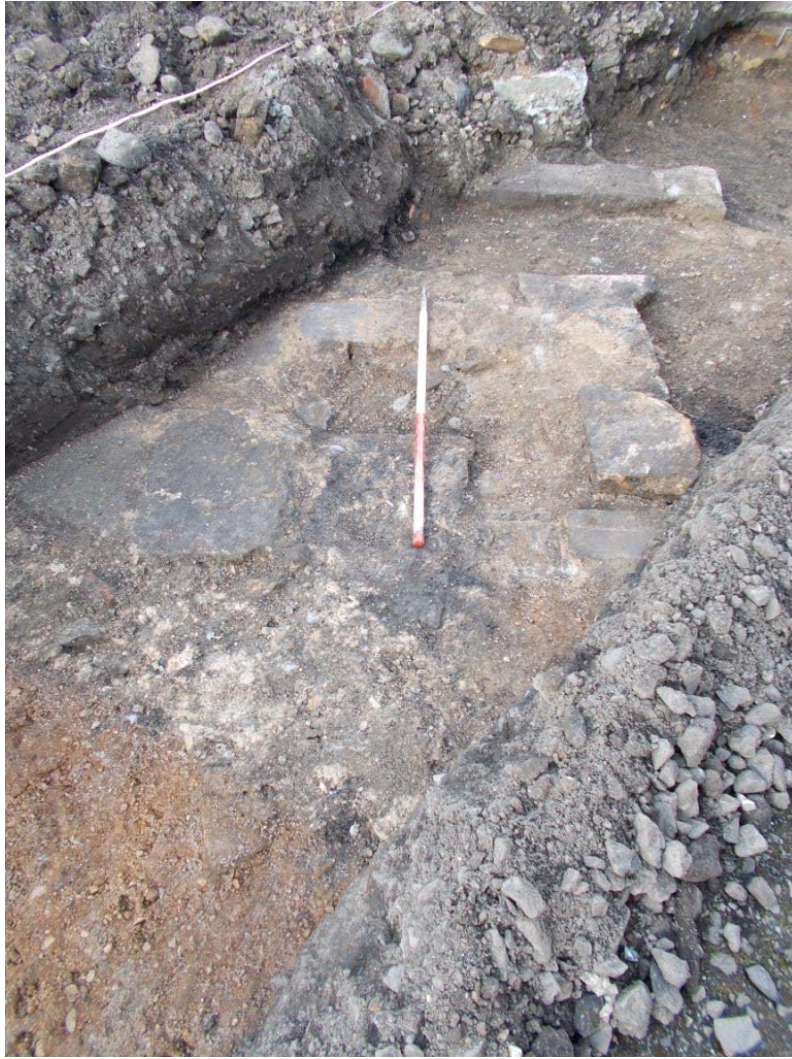
Plate 9 - Wall [011] and foundation [012]

- 4.4.2 As well as these walls a large rectangular foundation [012] was also revealed at the S end of the trench (Plates 9&10). This structure consisted of three sandstone walls, with two walls aligned NE-SW and a shorter wall joining the NE ends, aligned NW-SE. Indications are that this foundation may be the base of a stairwell related to Saughton Hall.

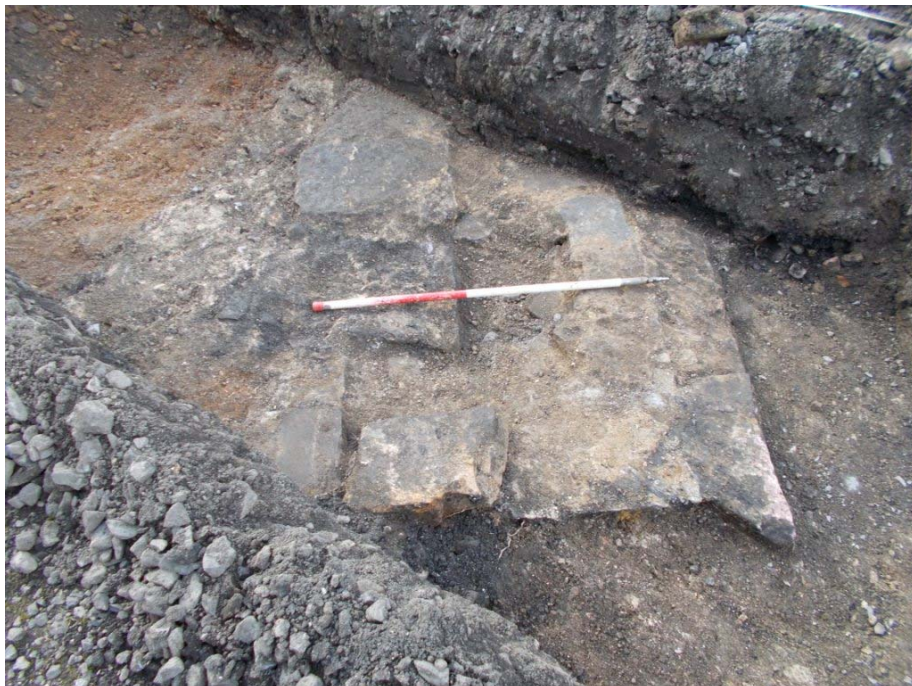
Plate 10 - Foundation [012]

012	Trench 4	A rectangular structure formed by sandstone walls aligned NE/SW. A layer of mortar (004) covers most of the stones. At a depth of 0.50m. Dimensions: 1.95m x 1.50m. Possible stairwell foundation related to Saughton House
013	Trench 4	Loose light orange brown sandy river gravel. Levelling deposit for construction – re-deposited natural
014	Trench 4	At least two courses of large sub-angular sandstones at a depth of 0.35m, aligned NE-SW. Dimensions: 1.34m x 0.32m. Sandstone wall related to Saughton House
015	Trench 7	Sandstone foundation aligned SE/NW and abutted by wall [016] on the SW face. At a depth of 0.50m there is one course exposed. Dimensions: 1.95m x 0.65m. Sand and lime mortar has been used. The wall is covered by compact ash and clay. Sandstone wall related to Saughton House
016	Trench 7	Sandstone foundation aligned SW/NE and abuts the SW face of wall [015]. There is at least one course with sand and lime mortar at a depth 0.37m. Dimensions: 1.10m x 0.60m. Sandstone wall related to Saughton House

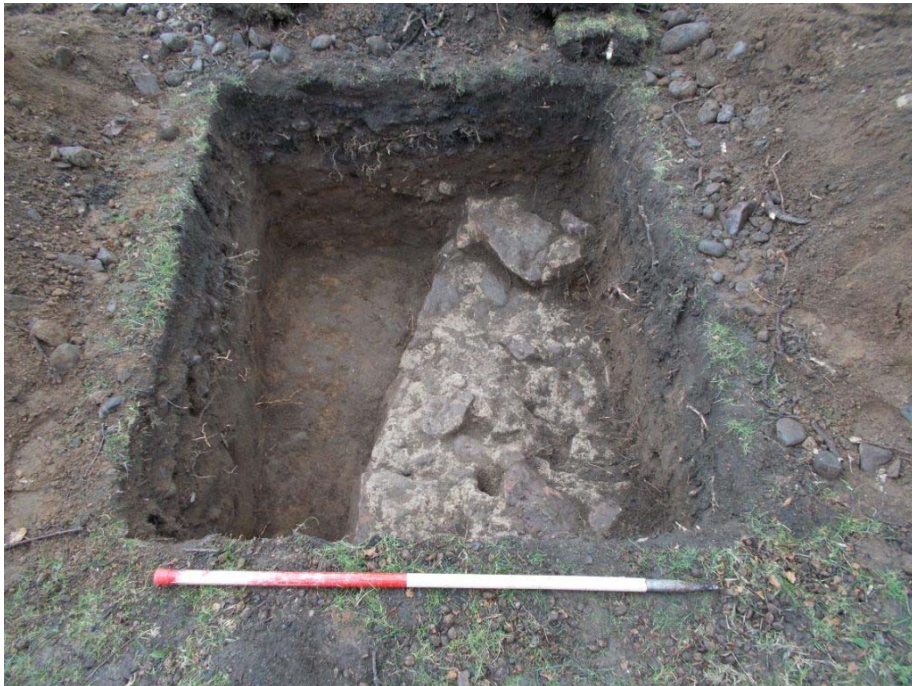
Plate 12 - Wall [106] within Test-pit 1

4.5.1 Test pit 1 was placed close to the river bank, next to the location of the weir. The trench consisted of 0.2 m of turf and topsoil onto a very compact ash and cinder deposit and re-deposited river gravels overlying a large sandstone wall [106] that was sitting within construction cut [104], abutted by packing deposit [105] (Figure 11; Plate 12). Only the N face of the E-W aligned wall was revealed within the test-pit, measuring over 1.1 m wide by 0.3 m high.

- 5.2 The features within Test-pits 1 & 4, are of unknown origin and date, as no maps from the 18th or 19th centuries indicate the presence of buildings along this side of the river. The large wall may relate to the construction of the weir as a retaining wall, but it could also be part of an unknown structure dating to the 18th or 17th centuries, or even the late medieval period. Only further excavation of a larger area around the test-pit would be able to answer these questions.

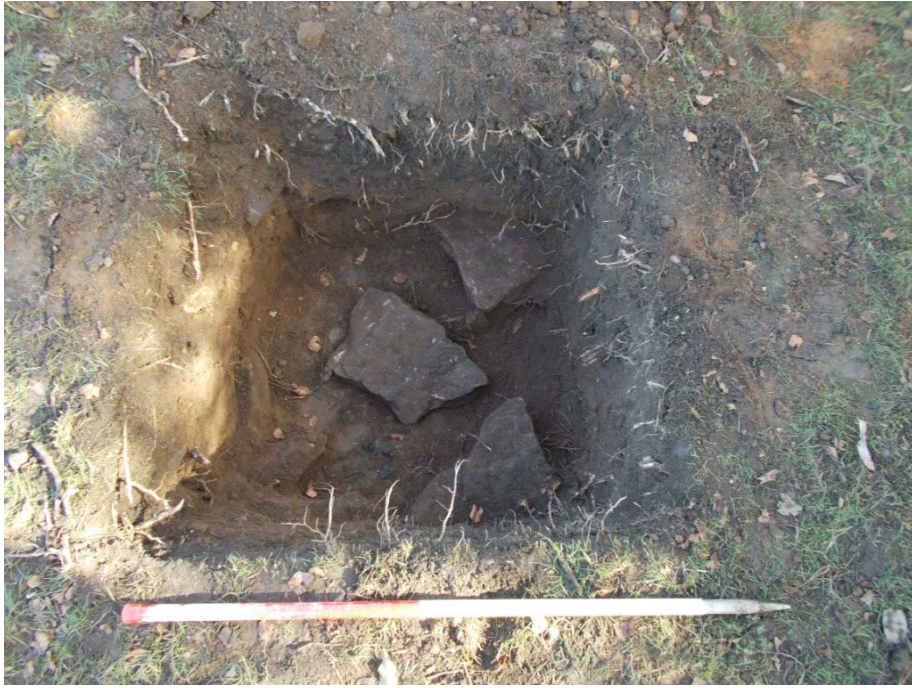
Plate 13 - Possible surface [107] in Test-pit 4

4.5.2 Test-pit 4 was positioned approximately 25 m SE of Test-pit 1, and consisted of 0.2 m of turf/topsoil over re-deposited river gravels. At the base of the test-pit, flat, angular sandstone blocks [107] were revealed covering the majority of the test-pit base (Figure 11; Plate 13). The stones were not tightly knit together but may be part of a truncated floor surface.

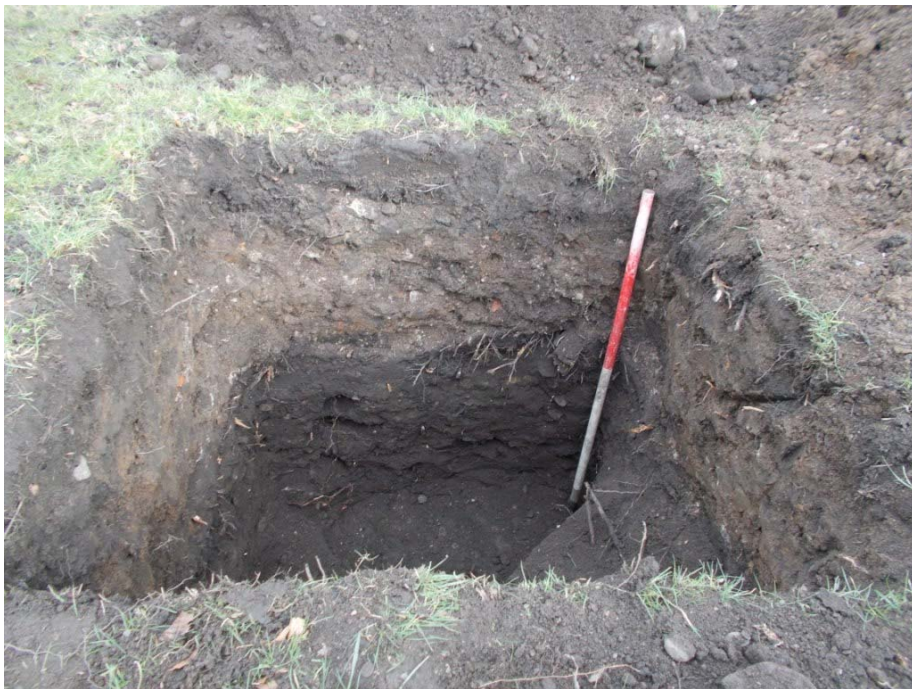
Plate 14 - NW-facing section of Test-pit 9

4.7.1 The final two test-pits were located to the far SE, across the other side of the raised road leading from the SE gate. Both of these test-pits revealed similar deposits consisting of imported topsoil (0.2 m) covering demolition material (0.4 m), overlying an earlier soil horizon (0.3 m), overlying an earlier made ground (0.3 m +) (Plate 14). The underlying geological deposits were not reached due to the depth exceeding 1.2 m. The presence of concrete fragments within the base deposit indicates that the area had been built up and levelled, most likely in the early 20th century, before being covered with topsoil. This topsoil was then covered by a deposit of levelling material (demolition rubble) and then covered with more topsoil.
